STUDENTS NOTE BOOK

P.J. CONNOR
JEBEL KHALID 1987
NORTH WEST TOWER TRENCH 1/2.

NW Tower Jebel Khalid.

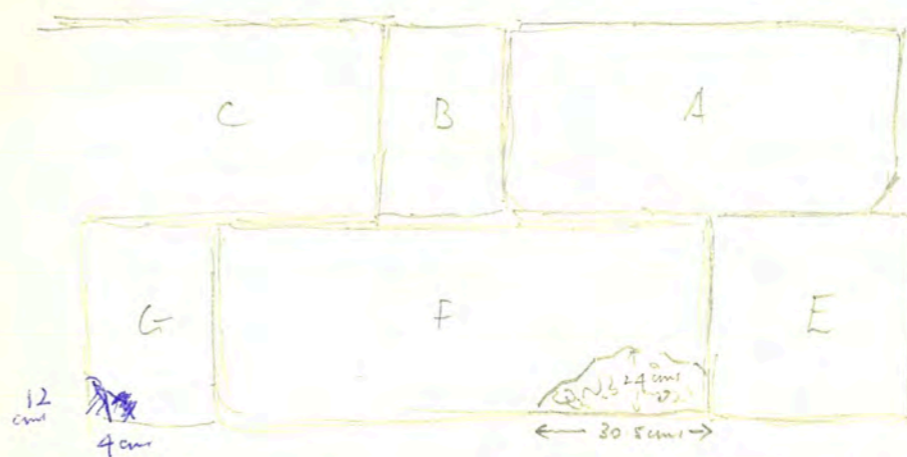
See sketch
2.5.87

The present measurable height of the plaster patch is 24 cms. but there is a narrow gap between between bedrock and wall, where the foundation trench was dug.

The bedrock in this corner has strange shapes on its surface but it is worn and smoothed as if walked on regularly in antiquity.

8 am. *Marker
patch* Inspection of the corner of the gateway, on the E face
of the tower wall reveals that the bottom right hand corner
of the large block has been completed in plaster to repair a
defective corner. Does this mean that these blocks were visible

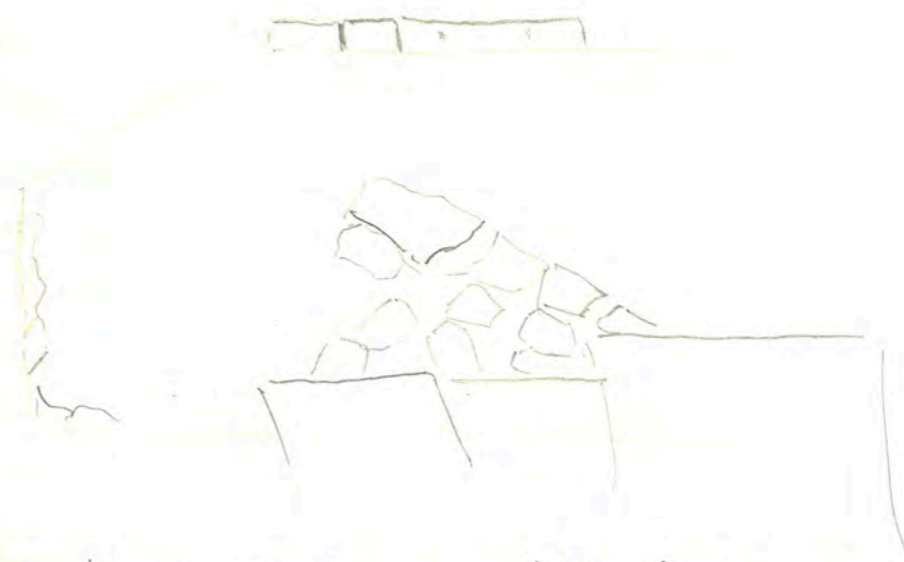
9.30 am. Within stratum 3 (whitish with limestone chips)
a series of rough stones begins to appear. They form perhaps
the corner of a square. There are larger blocks on the outside
with smaller stones in the middle.

These blocks are cleared a little for the moment and work
proceeds.

10.40 am. Tr 1 E (3) a small bronze pin or needle.
slightly bent in stratum (3); 30-40 cm N of the corner
of blocks sketched above. 87.002

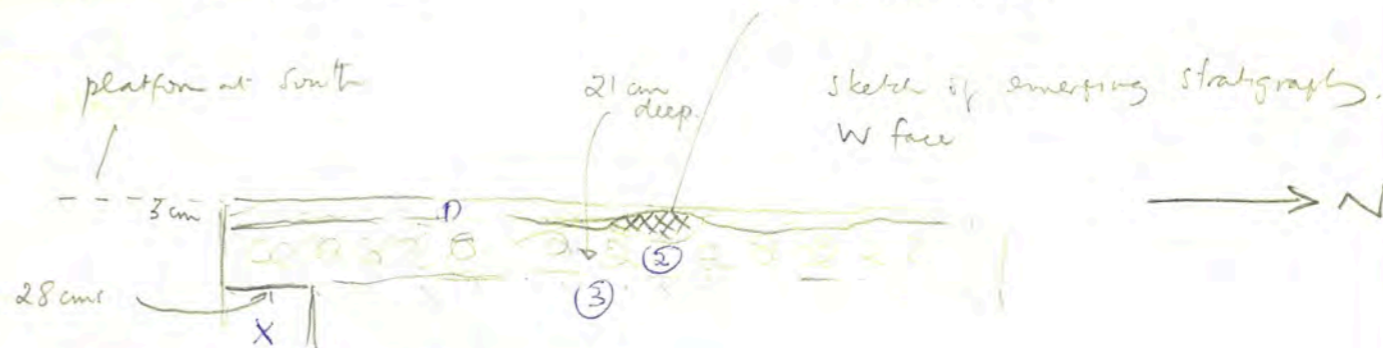
- (1) is a thin layer of top soil
- (2) is a fine brown soil with much larger blocks of limestone
- (3) is a whitish powdery deposit with small chips of limestone

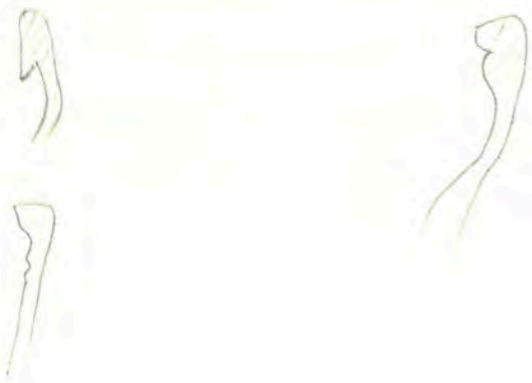
9.5.87 Tr 1 W [2] (6)

doz frags coarse ware sherds light buff clay.
rim frag. red brown coarse ware

3 rim frags small bowls weak red or brown glaze
1 wall frag partially painted ware

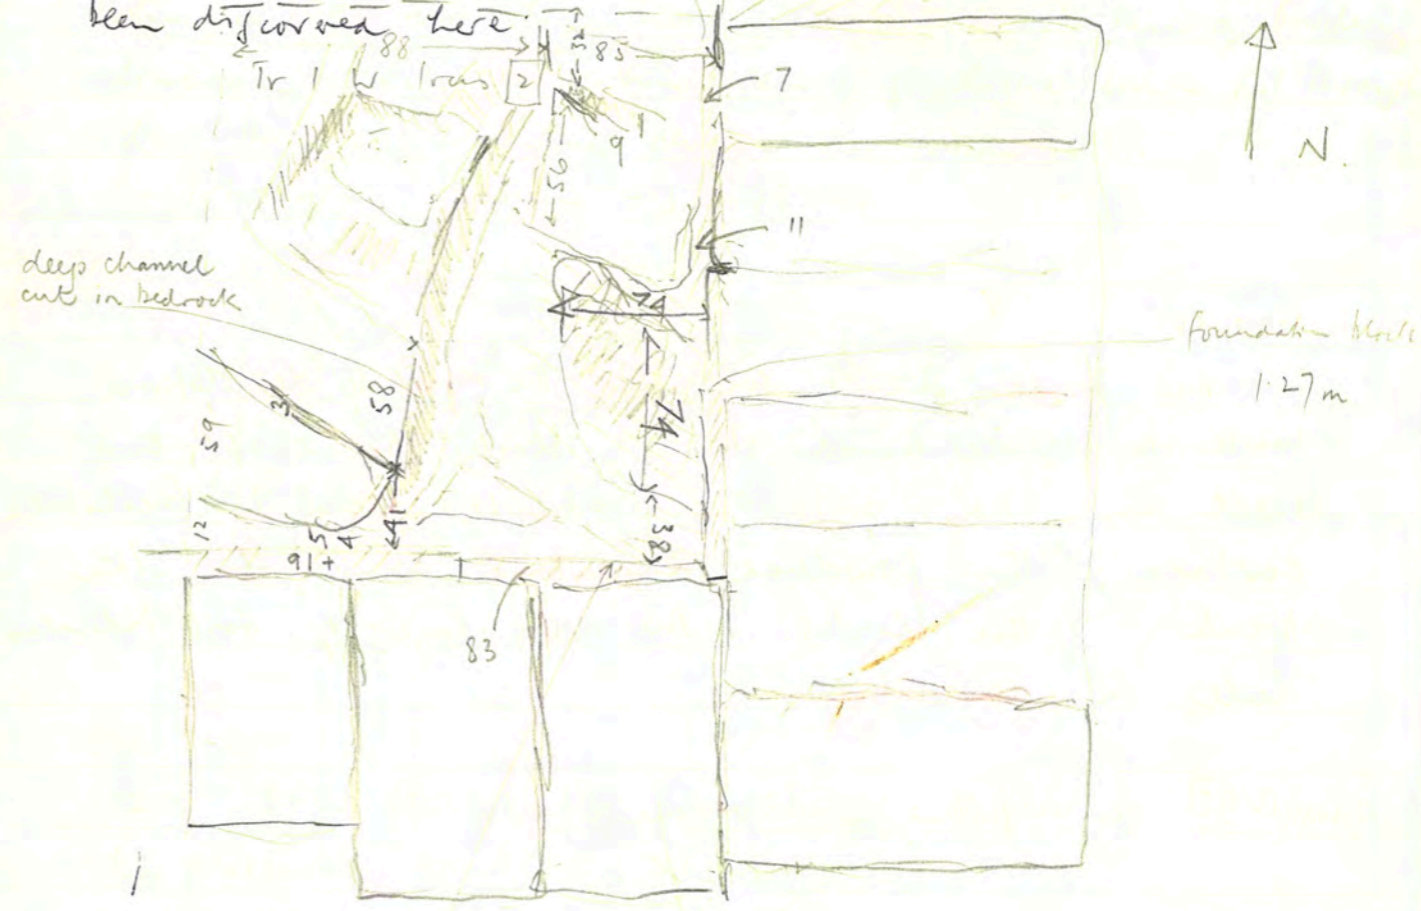
blackened area.
 Beneath the platform on both the E and S side of the focus, the foundations are consist of 2 large blocks on each side

This foundation continues beyond its join with the E face of [2]

The bedrock appears to be blackened at a point near the W face of the platform. However no amounts of carbon have been discovered here

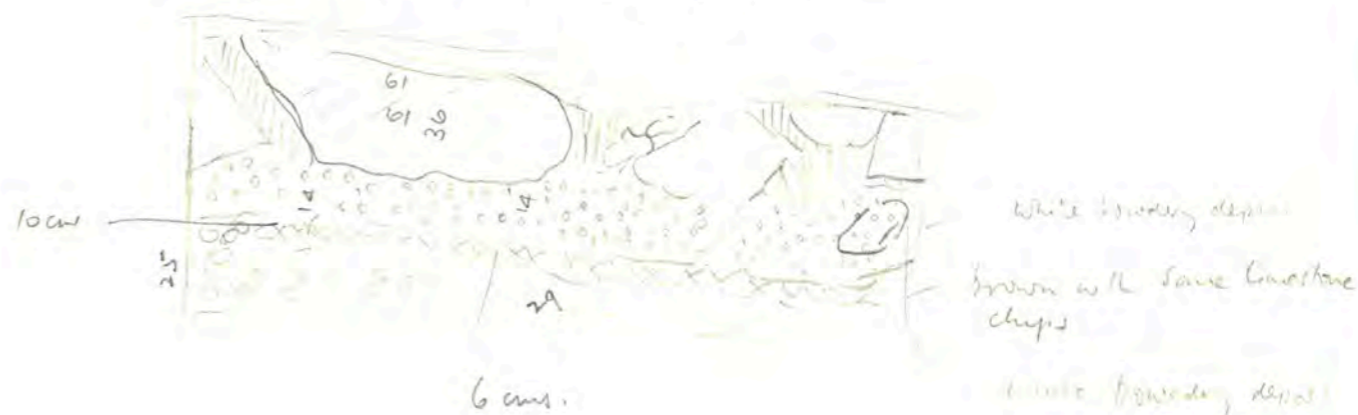
Tr 1 N

What I had supposed to be bedrock at the N of the platform are actually several more foundation blocks which look as though they could span the whole distance of the gateway. Immediately above these blocks is a thick stratum of powdery limestone which has a thin deposit of light brown soil through it. There are limestone chips in the brown soil. The total of the stratum is 49 cms.

12.15 B+W photographs of this section = N wall of [3] opposite the platform = Roll 5, 23-25
also colour photographs also from S = end of Roll dated 10.5.87

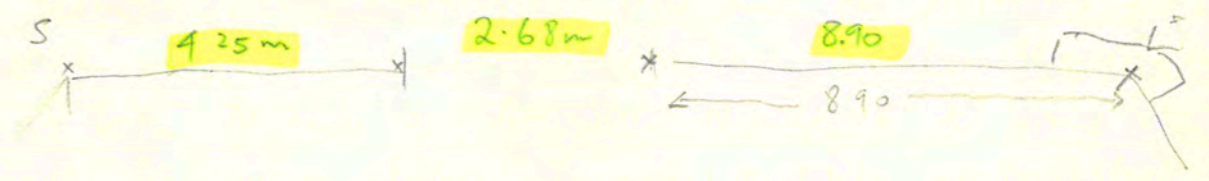
East Face of NW Tower.

Note the gateway is not in the cut

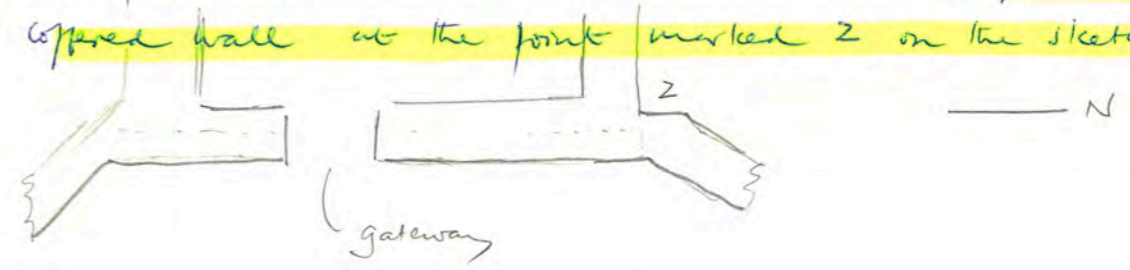
At N the diagonal curtain, at its outer face does not touch the tower immediately, it turns through 135° and runs parallel for a short space to the axis of the NS copped wall at the point marked Z on the sketch.

The gateway is indicated on the plan and on the previous sketch is placed off centre towards the S. This is reasonable because the approach to it from the citadel or the rest of the city must be from the south. Note that to the E of the tower is a deep quarry with steep sides on the S and N and the caves on the W. In fact at the N of the quarry the rock cuttings indicate that the curtain wall was placed immediately above the vertically cut face of the quarry. Therefore the only approach to the tower from the E would have been on top of the fortification wall.

The join of the curtain wall to the tower is not the same at N as it is at S.
