MAIN GATE

SUMMARIES OF NOTEBOOKS - DAY BY DAY

PJCS summaries
of MG books: '89

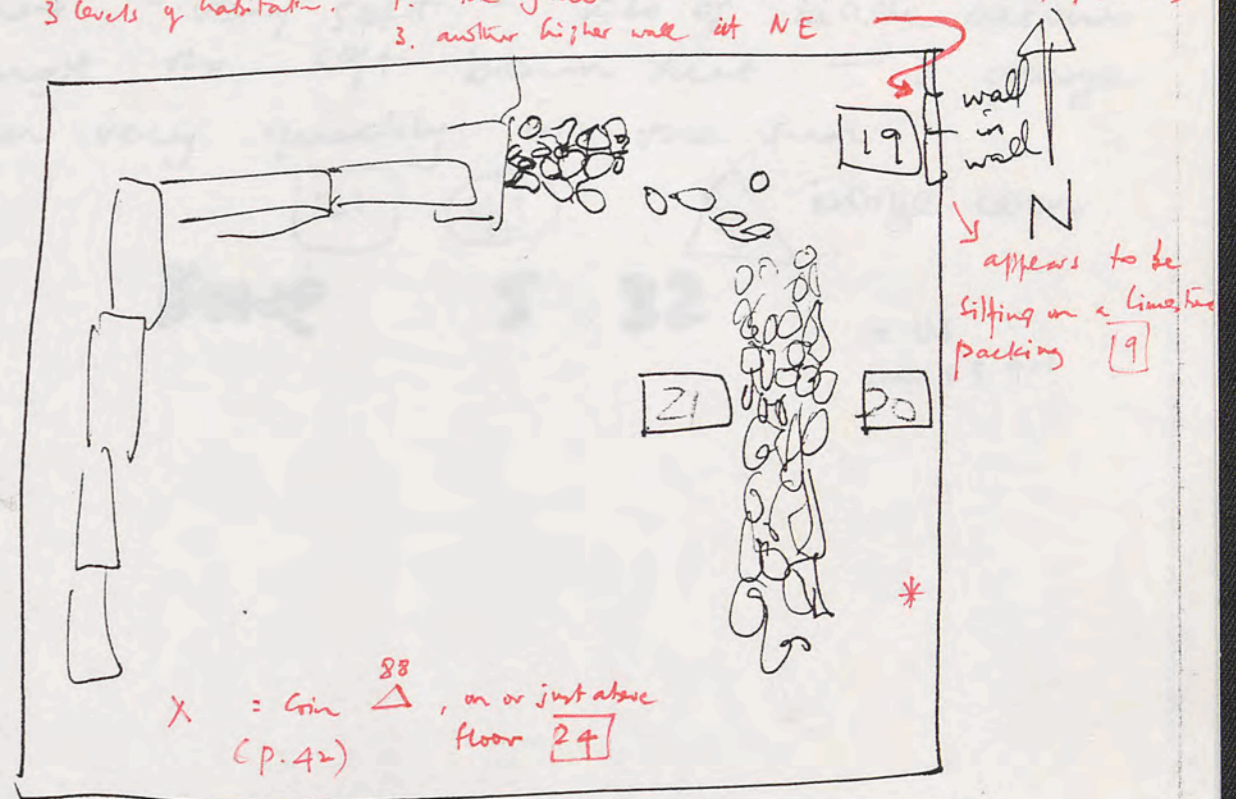
P. 42. 3 levels of habitations. 1. the gate 2. rubble wall + dump of pottery 3. another higher wall at NE

Looking at EMG-1 I can see a wall in the east baulk - running north south. It appears to be sitting on white chips of limestone type packing locus 19 - not in whole trench, only in north-east corner. - it also varies in thickness. It is very thick in north-east corner - possibly 30 cm - (not completely excavated)

* S end of wall 10 cm wider than N. top: medium to small stones + bits of red soil

The turn in the tower wall is very nice and the stone at the 3rd course on the corner is possibly drafted 5 cm down - it is difficult to tell.

There appears to be rubble leaning up against the north-south running part of the wall - I originally thought it was a wall but I cannot see clearly

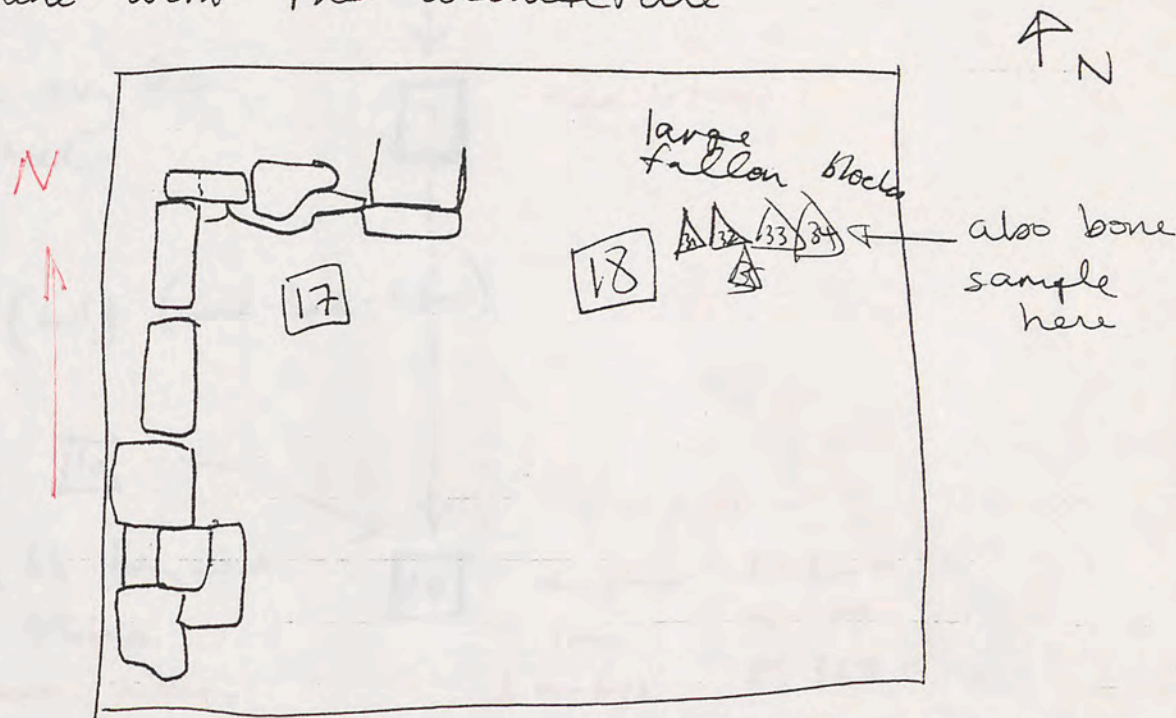
This trench very confusing. I don't understand why locus [17] and [18] are at same level in trench. The dividing line isn't clear, but is pretty much in line with the architecture

removing the large fallen blocks from

N-E corner of trench. - black, red & brown dirt - not soft - not limestone, alot of pottery, alot of bone - Jack has identified as possibly a cow. S 27

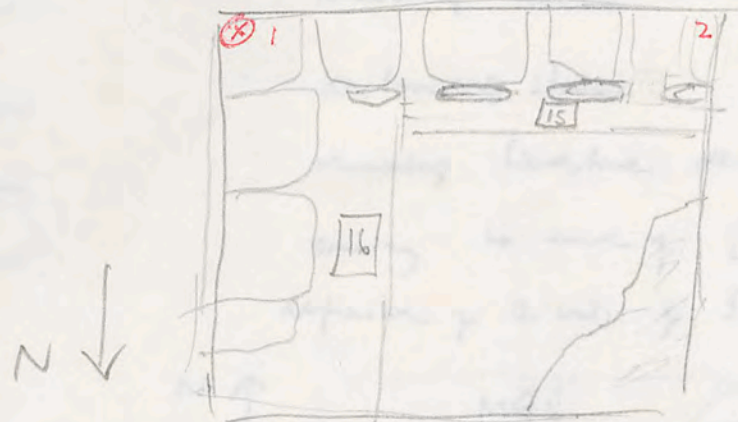
foundation trenches

elevation 2-4-89

(X) = highest stone in trench

1. 45 cm

2. 105 cm

foundation trench 15 narrower than 16

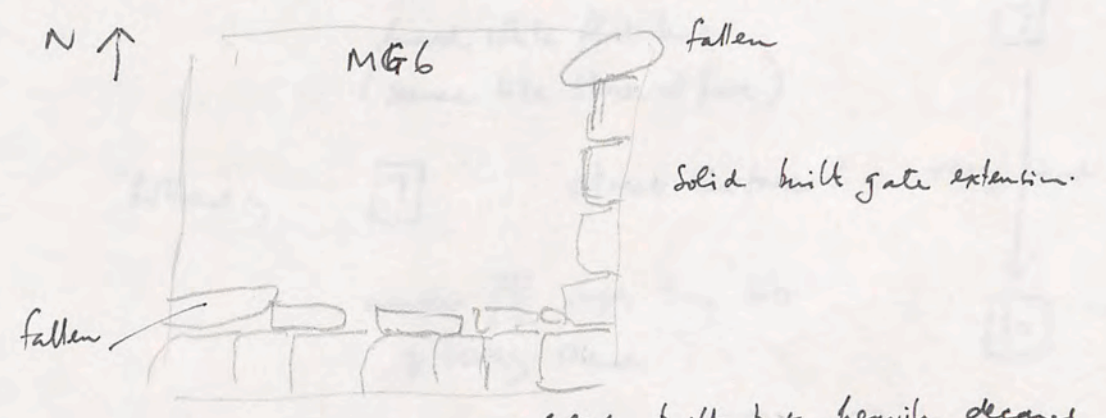
Solid built but heavily decayed
 Limestone plaster is better preserved. faced by smaller stones - not exactly the same as those of the north gate extension
 very fragile: only a 'cladding'

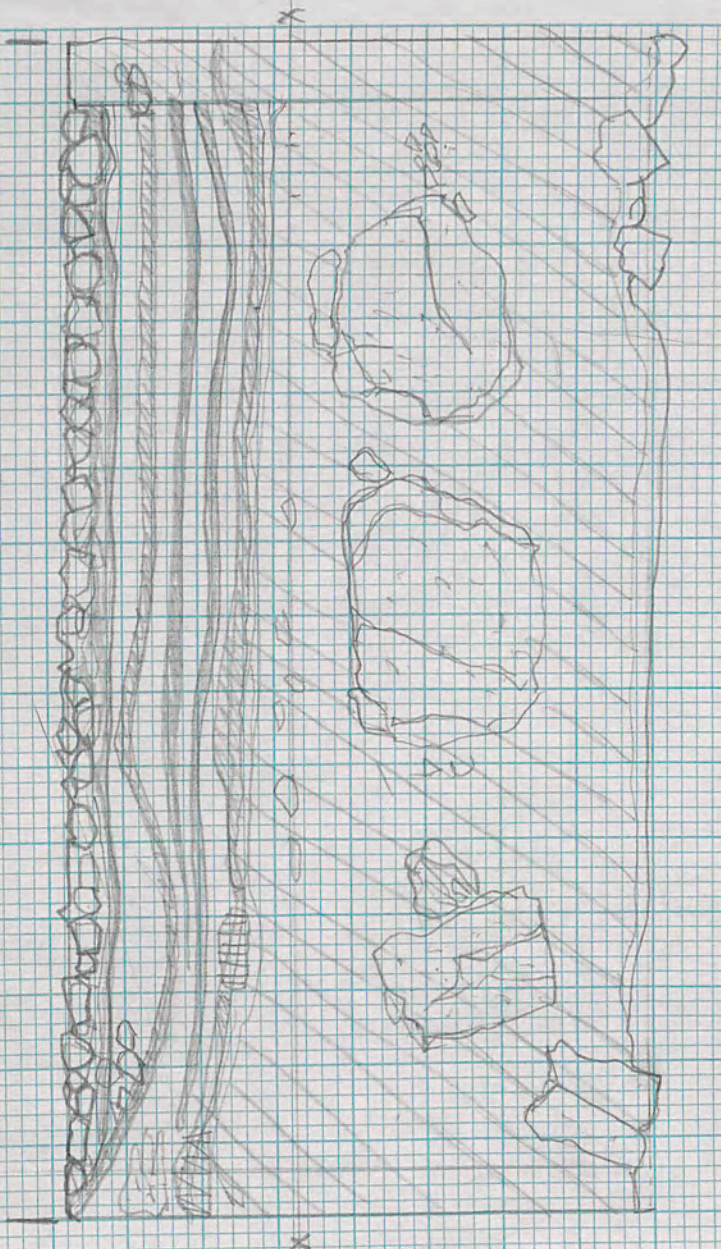
5TH SECTION 1:25

- ▨ PLANK
- ▨ LIMESTONE POWDER
- ▨ UNK. USE
- ▨ CHALK
