MAIN GATE

22 April - 13 May 1990

F. J. CONNOR	BOOK 1
JEBEL KHALID	1990

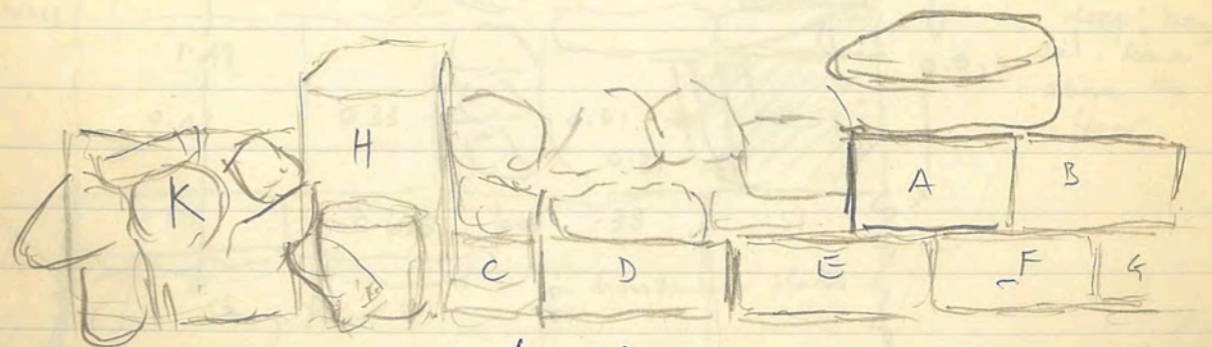
E wall of Stoa in 364/4 from W

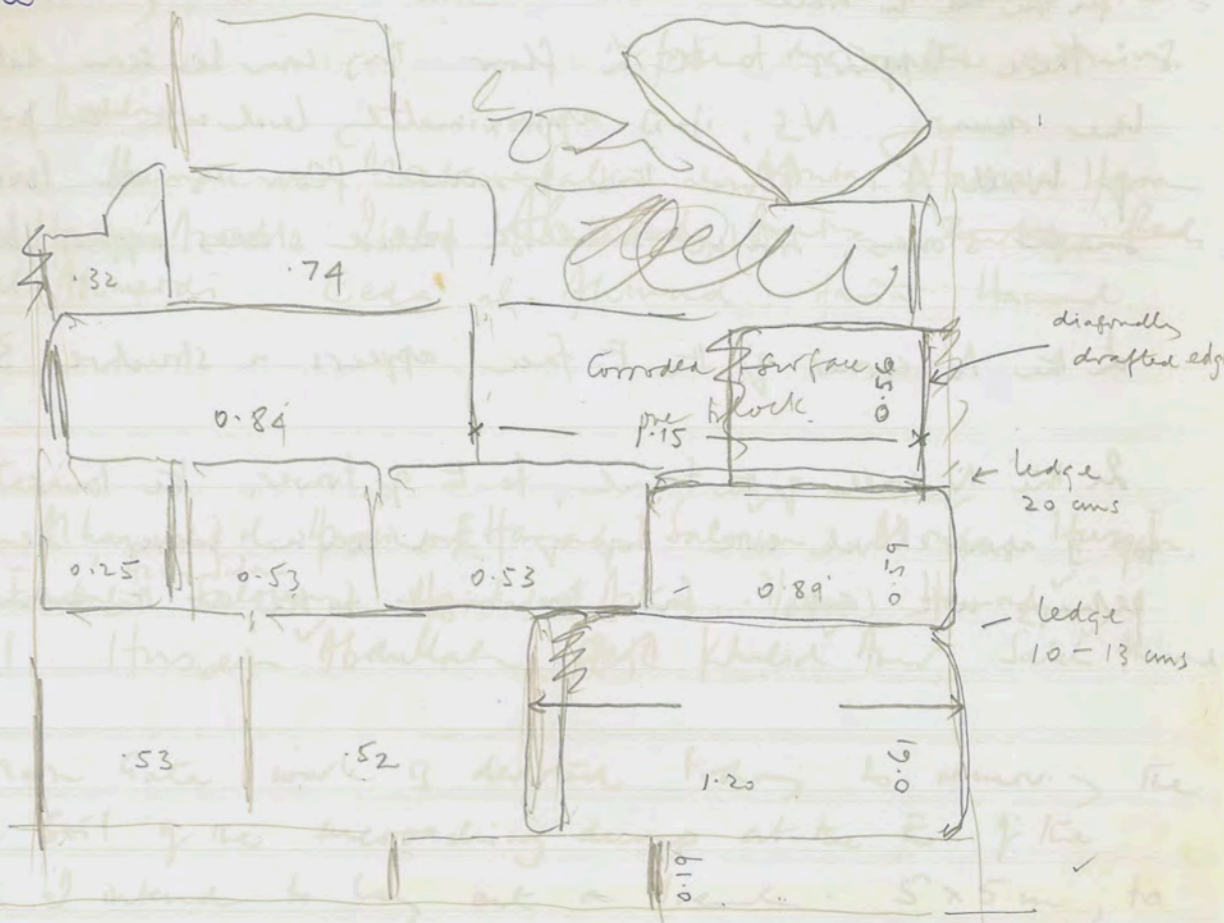
Main Gate
Wall X

interlocks
Keying for
laying of stone

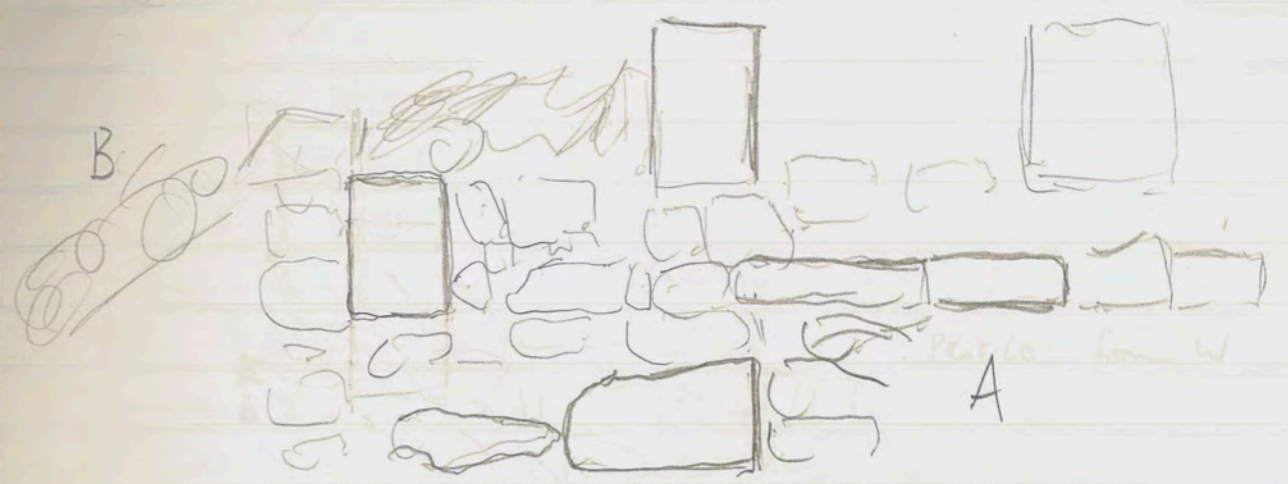
NW corner = 179/4 - 179/7

The wall B rests on a depth of soil, approximately 0.63 m from the lower floor excavated in this corner of E4 (?)
 Wall A continues to this lower floor excavated in this small section (C) c 0.44 below level of courtyard with circular stone
 there is a reddish stratum above a substantial gray stratum, then light brown soil mixed with small stones and some fragments of pottery

Wall D, which has been presumed outside House 2 is constructed similar to A. There is a doorway. Since Wall B is built on soil, perhaps A and D were once part of a single wall + belonged to the same house and B is a ^{later} division of the courtyard. Note depth of doorpost Y it rests on the rubble wall which rests on 1st level floor

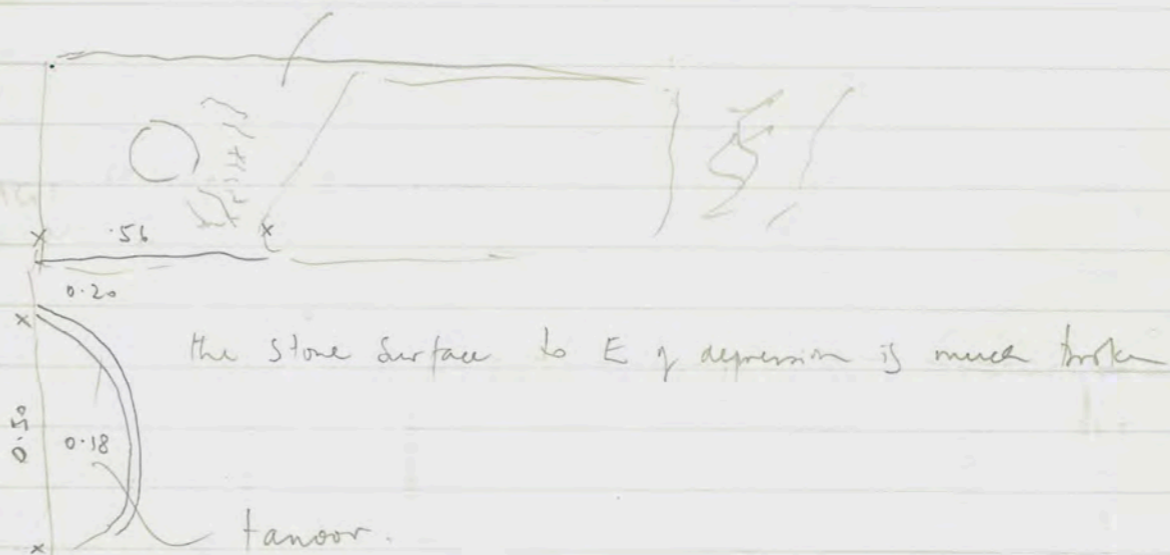
difficult to tell whether this is one stone

Radi points out that the N wall, at the point where there is a 'break' in the 'bench' filled in with 3 roughish small blocks, is not as carefully made as the rest of the wall to E + W. It may have collapsed and been restored with less skill. Radi sees the 'break' in the bench was made in mud plaster.

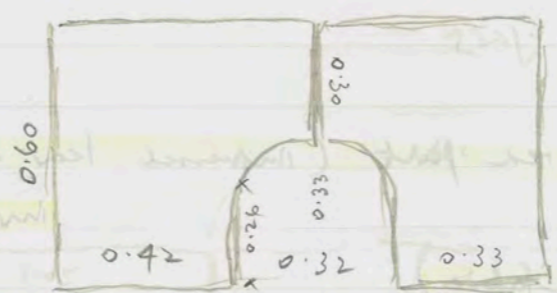
7.30 a small shallow basin begins to appear in front of the drain. The drain has a rounded top.

in the E 'bench', at join with S bench is a hole which also looks like a drain might have to excavate deeper

At E of this drain along the wall is a narrow stone 'bench' this 'bench' is also located along the E wall so far as we have excavated. The bench is 0.30 m wide. The bench continues W of drain also though this is not fully excavated

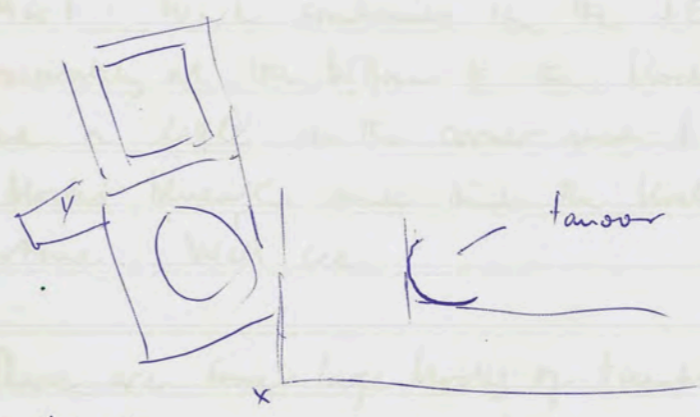
x = corner

and on the interior of the corner (in the later occupation) is a tanour. The small room in the SE corner of the courtyard could have been built at the same time as the subdivision. Note that the door between Room 3 and the courtyard which we suggested last year was a later addition to the wall is substituted for the door a little to its W which we originally thought belonged to a different house. Originally it could have been the entrance from the courtyard (which at that time extended further W) to Room 3 which as I have described before (bench, tanour) also extended further W. It is interesting to note that the only EW wall to go down to bedrock is that in D3 — except for the low wall to W^{S?} of cistern which is built on bedrock. The wall with the corner (see above) clearly runs over this S wall. The S wall of 208/9 ∴ belongs to the original occupant. We can see again the floor built up with an frag soil + rubble in EW placed stone at the cistern is also suggested to be support for the floor level.
