EXCAVATION RECORD BOOK. 2.  
JK DOM 1995. Sarah Myers.

JK DOM  
123/2  
8/10/95

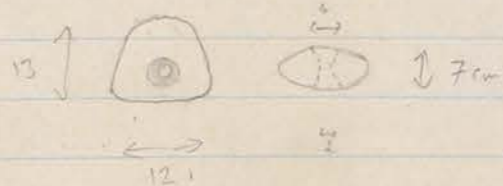
10:30am. Object 31. Basalt stone with hole pierced through.

found in wall A near to intersection with wall C.

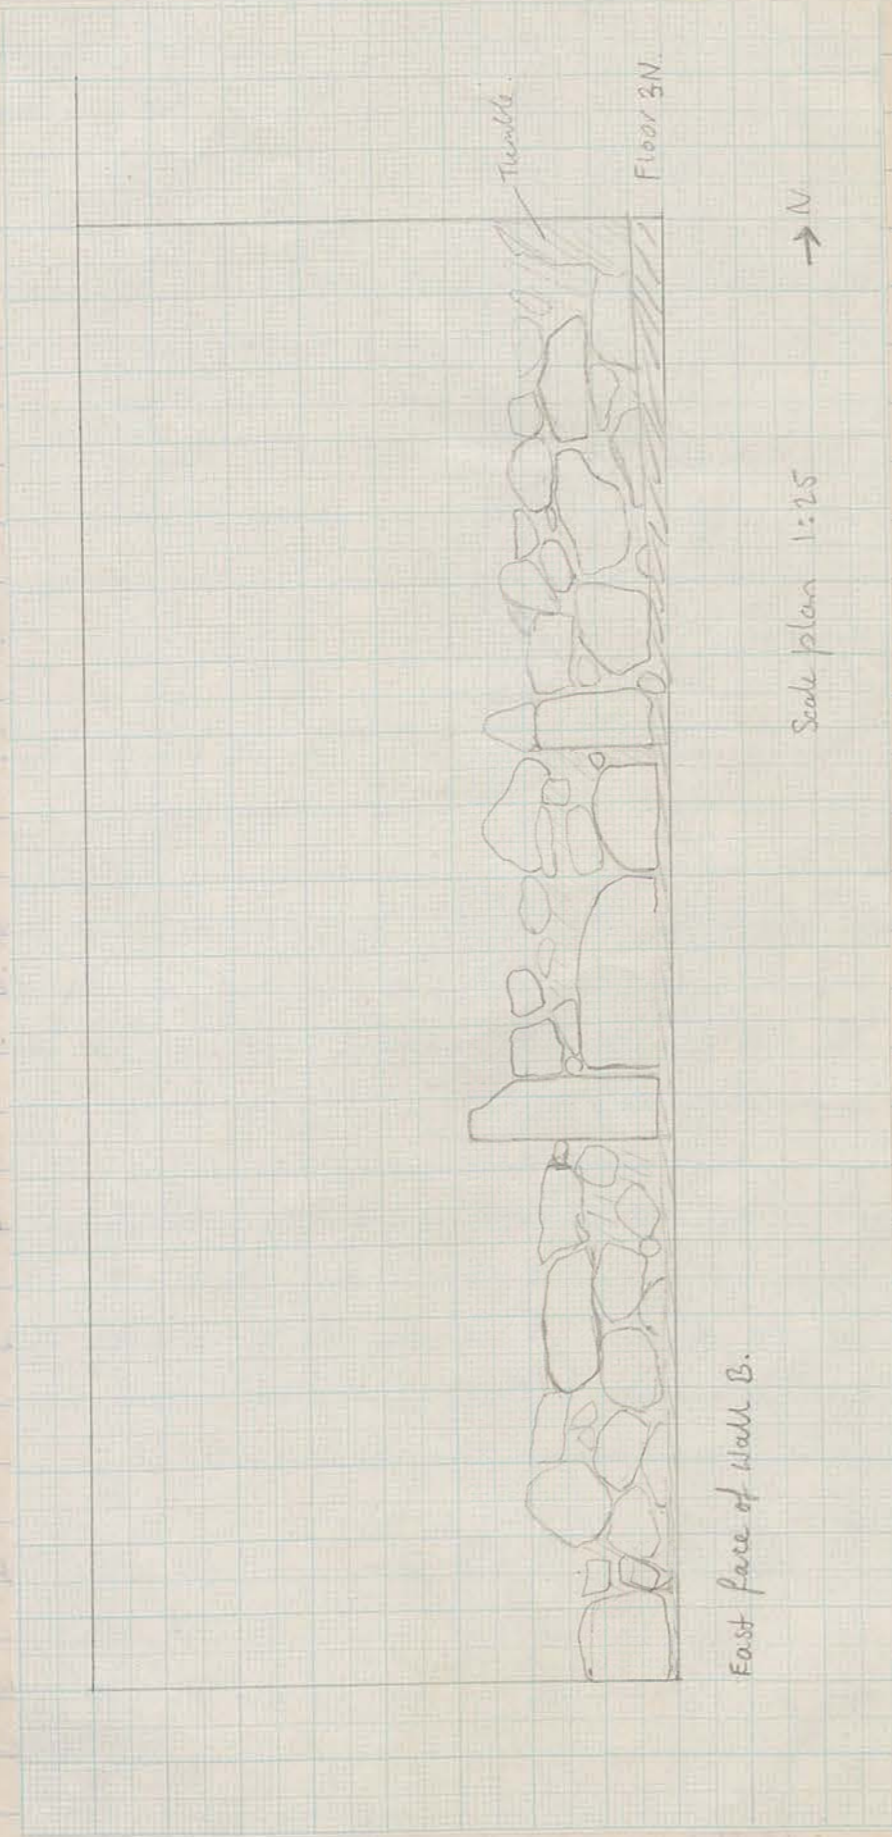
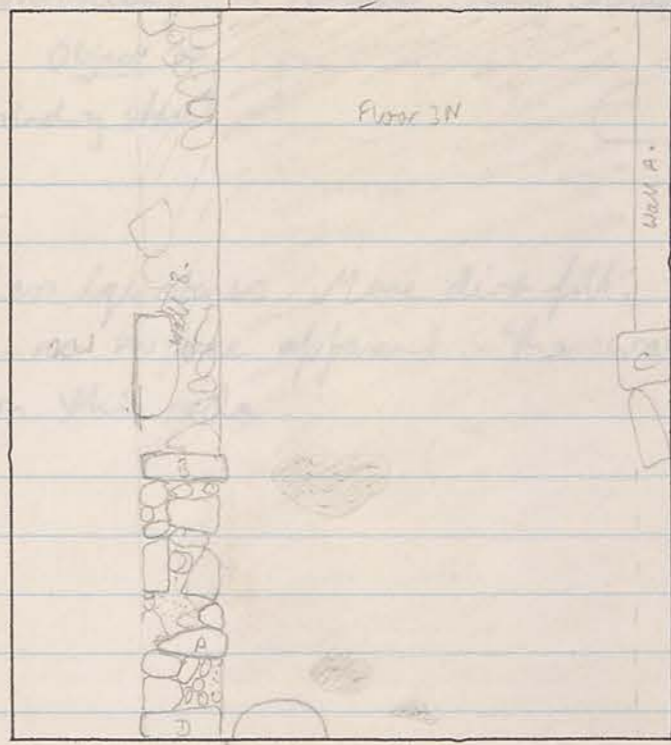
Fill 2W

6:00am. Removing tumble from W. side wall B. Now calling this level 2W. because below topsoil. Hope to define the outside face of the wall, and see the structure of the wall between rocks A & B. which were thought to be a doorway.

7:00am Many large stones same type as those from wall B. Not much pottery - none intact as yet. The wall B. is between 60cm & 70cm wide. There is no doorway!

8:00am. Wall B. is very solid, several very large stones. Removed the stones which protruded from the wall between <sup>1st</sup> stone A & B. to see wall. I figured this had slid from the wall. The rocks behind are rather uneven. There is a large rock (against the silt bank) crossing the wall Rock D. See section opp. pg.

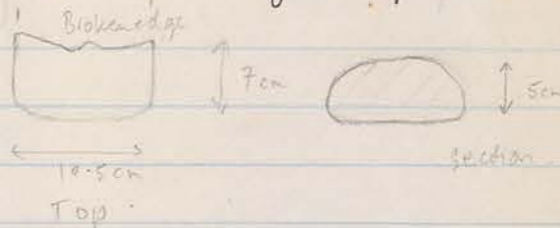
Object 30

Basalt grinding stone?

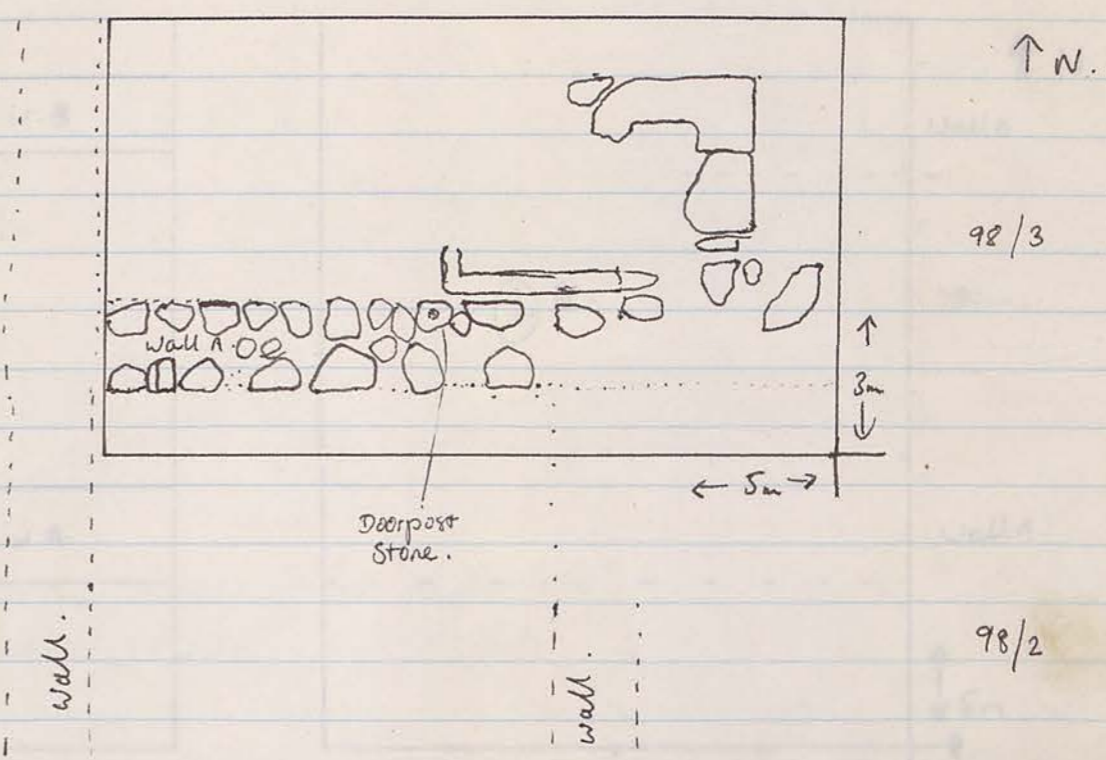
6:00am. Continuing to remove soil from between surface stones. Possible wall appearing running E-W in SW corner of locus: Wall A. Cistern in NE corner. Possible surface on east side level with top stones. Only about 4cm below surface.

8:00. Removing the hardened dirt around east side of cistern. I don't believe it relates to the cistern as a floor, but may be a recent surface of impacted dirt.

9:00. A long narrow stone lies beside wall A, <sup>against</sup> on the NW face. It runs across the <sup>south end of the</sup> cistern. At its eastern extent it forms a corner. It may be some sort of boundary wall for the cistern.

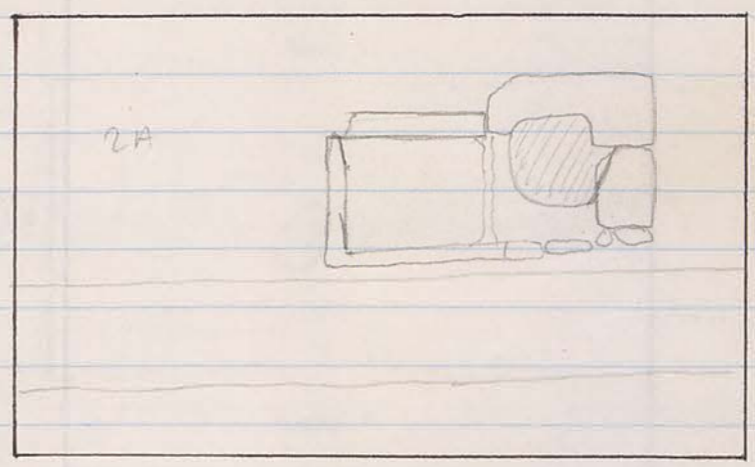
Rocks moved from W. side of cistern have exposed a ~~small~~ holding basin. I will call this area locus C. There were some bones removed from here, and some pottery. The bottom of the basin is appearing. It is carved from stone.

One large stone shaped into a dip forms the base. A stone stands behind backing against wall A. It is 40cm high from base. Another stone forms the West wall of the basin it stands 40cm above the base. Another stone lies across / forms the North wall, but it is only 4cm above base. It is like a step. There is a floor surface to the north of this which is 13cm above the steps.

9:30am. Cleaned basin beside cistern. Apparently water was drained into the basin first and then into the cistern. This allowed the silt to drop and be held in the basin before polluting the water. The floor surface to the north of the basin is probably part of the drain.

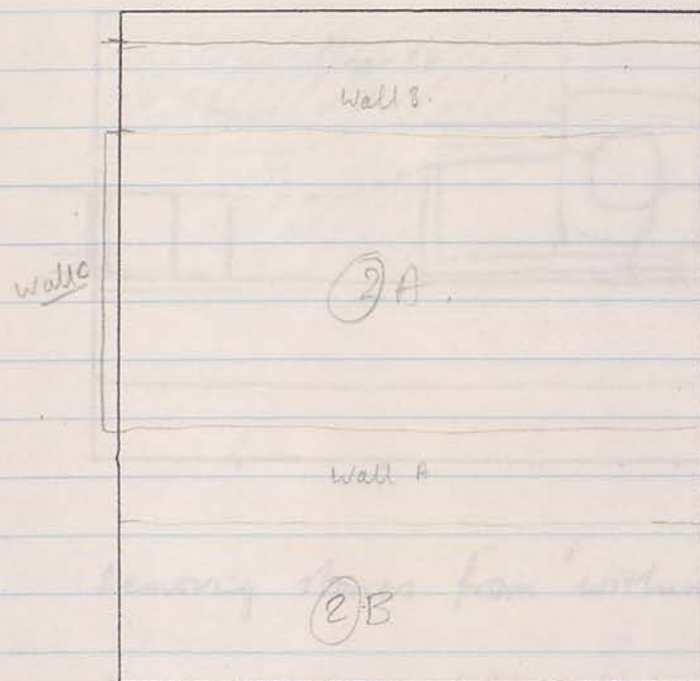
6:00am. Removing collapsed stone & fill from 2A.  
Defining inside faces of walls A & B.

7:00am Removing baulk carefully to expose walls  
A & B and whether there are doors or walls hidden within.  
Wall B is now clearly the extension on wall B in 123/3.  
as it curves back in line with it.

A wall has appeared in the baulk! Just inside the East  
face of the West. Baulk. It runs from Wall A - B.  
I will label it Wall C. It may be a secondary wall  
blocking this corridor because the stones do not appear  
to interlink.

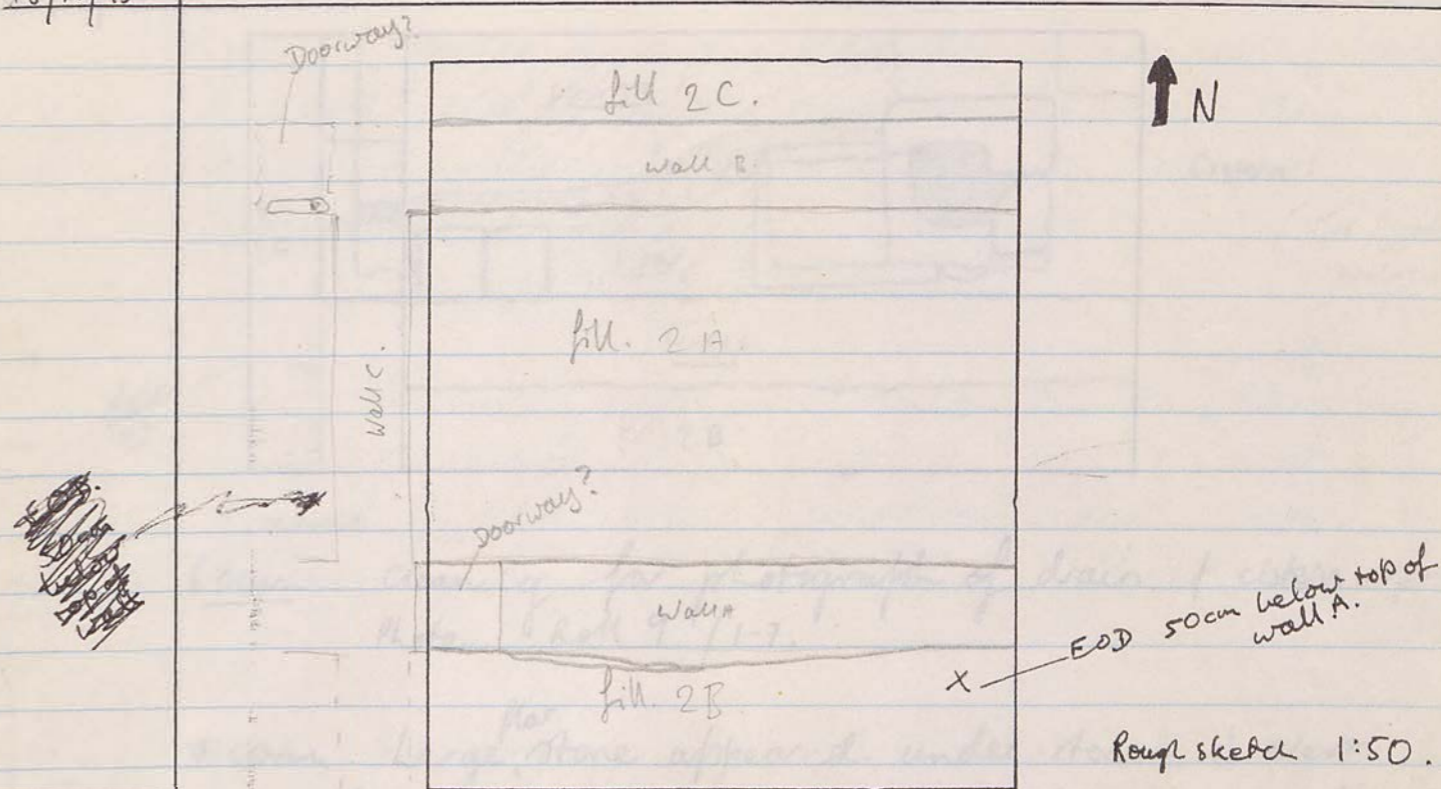
6.00am. Removing fill from south side of Wall A. = 2B. Contains fallen stones and dirt and some sherds. Wall A is leaning south. It is broken at its east end.

8.30am. Wall A now clear at eastern end. 60cm wide. Some large stones have slid to the south - in the middle of the wall making it appear very wide here. I will leave these for now. Wall C is also 60cm wide. Wall B. also leans heavily toward the south. (top courses of stones flat) and appears very wide in the middle. This accounts for why I thought it did not line up with wall B in trench 123p. to the west. There are two breaks in the wall which may have been small doorways <sup>see plan.</sup>

Removing fill from north side of wall B. = 2C. to define north face of wall. Northern face quite clear & straight. Fill contains fallen stones large & small, dirt & few sherds.

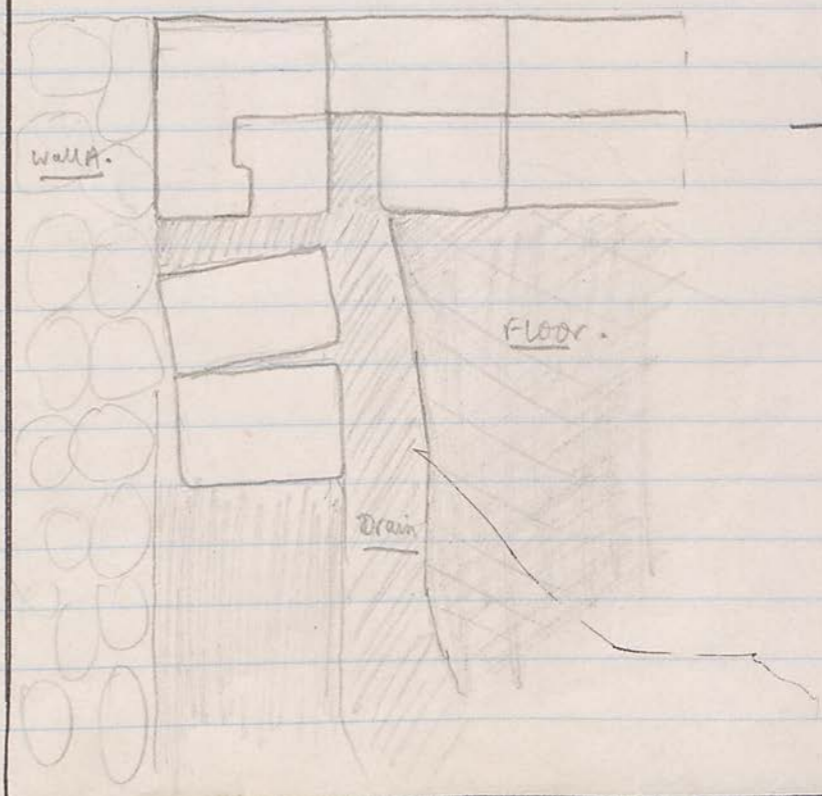
Section doorway  
looking West.  
Shows drains  
through stones

7:00am. Large <sup>flat</sup> stone appeared under stones in West  
bault - possible doorway. Removed stones over doorway  
to reveal three large cut stones of threshold. There is  
a second drain running under the threshold beside the  
first stone (south end)

View  
Top of doorway  
& drain.
