# A4 NOTE BOOK

HEATHER JACKSON 1996  
BOOK 3

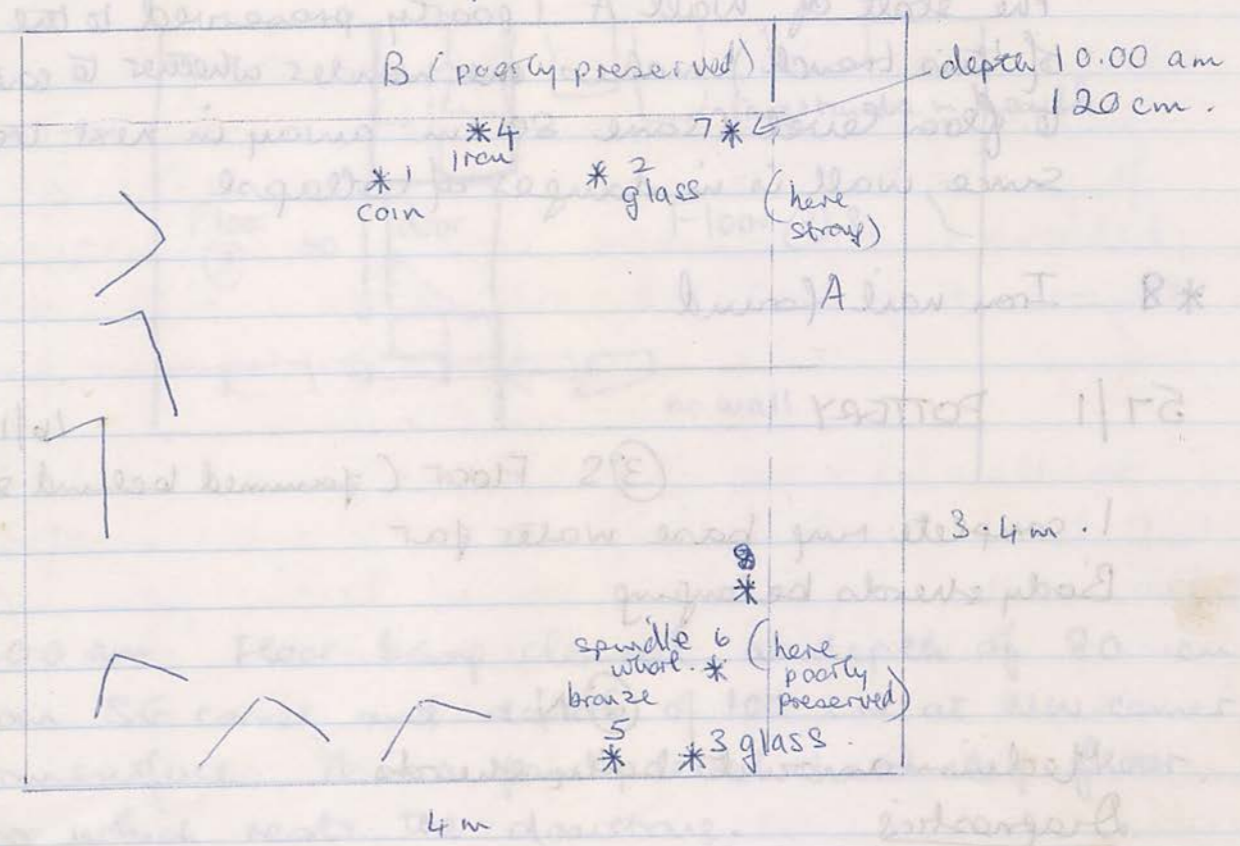
5/11  
100/3  
13/1  
15/1  
125/3  
SG

6.00 am Continuing to excavate (2) - a deep spit involving much tumbler. Some very big stones apparent in NW & SW.

\*1 6.30 am. Large bronze coin found at depth of 100 cm in loose soil between large stones.

8.00 am. South face of wall B at last improving at depth of          cm. from NE corner.

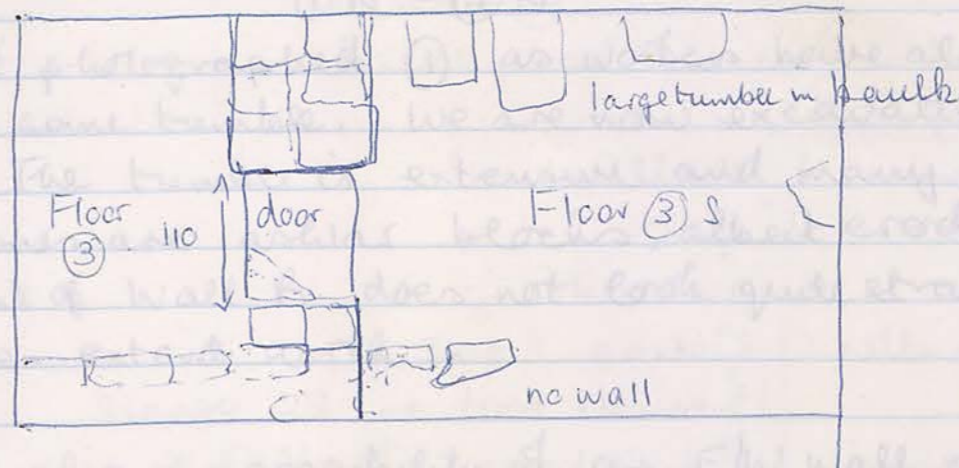
57/1 (3)S and (1)N

6.00 am. Floor being cleared at depth of 80 cm from SE corner and depth of 100 cm at NW corner from surface. It is a fairly level hard clay floor, on which rests the doorstone.

6.30 am. Cleaning down for photograph - then we will excavate the northern half from (1) to see what happens to the N/S wall B.

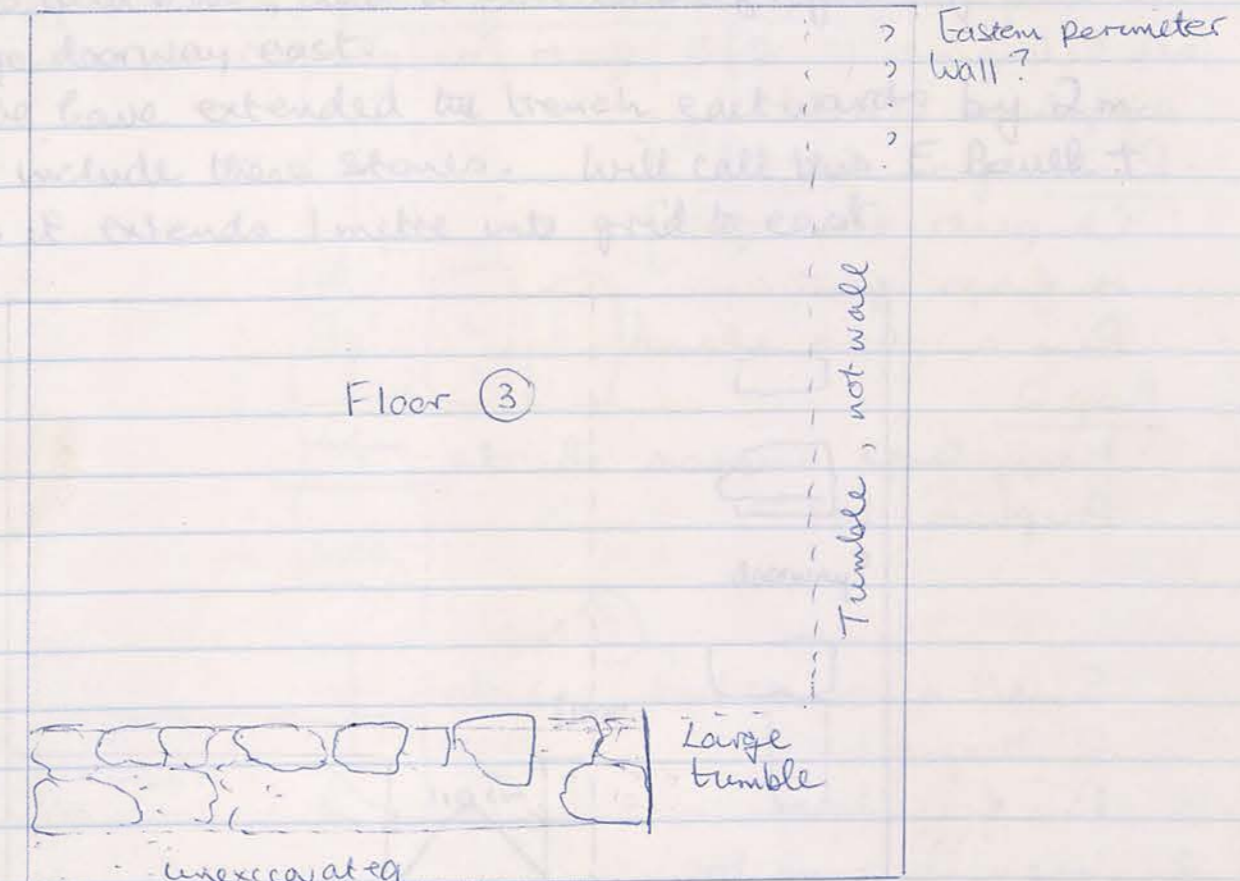
6.00 am. Clearing trench to floor seen yesterday for photograph.

7.00 am. Cleaned down & photographed:  
φ Floor Roll 4 CP 8-9.

Now excavating "doorway" and further investigating the non-existence of the eastern perimeter wall.

7.30 am. While excavating large tumble in SE corner we find Wall B does indeed end at | to make a doorway. The large stones in the tumble here may be part of the upper structure.

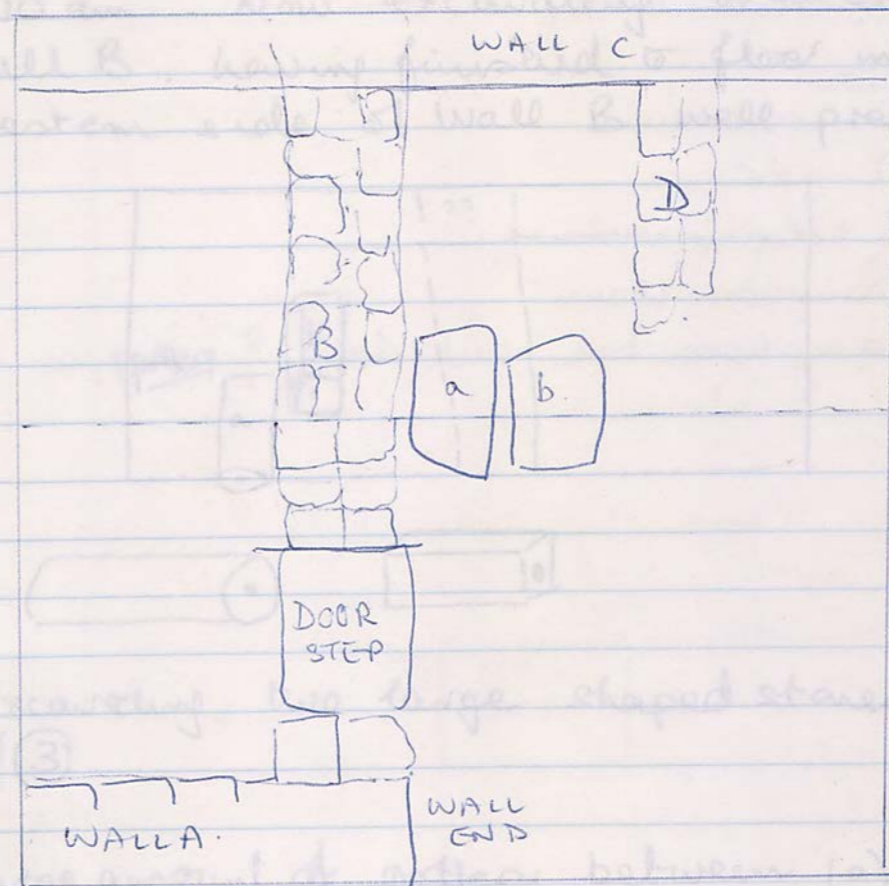
57/11 (3)

6.00 am Continuing to excavate (3) 57/11 (2) N now (3) N.

Still to see whether Wall B (a little crooked) is bonded with Wall C, which may be southern perimeter wall of northern insula.

A very close wall D seems to form a small alcove about 1 metre wide. It also remains to be seen whether this is bonded to C or is a later construction.

Have removed large tumble stones (a) and (b) from this locus - they rested on much soil and may have fallen from the door or end of wall B which contains many such used across the southern end face.

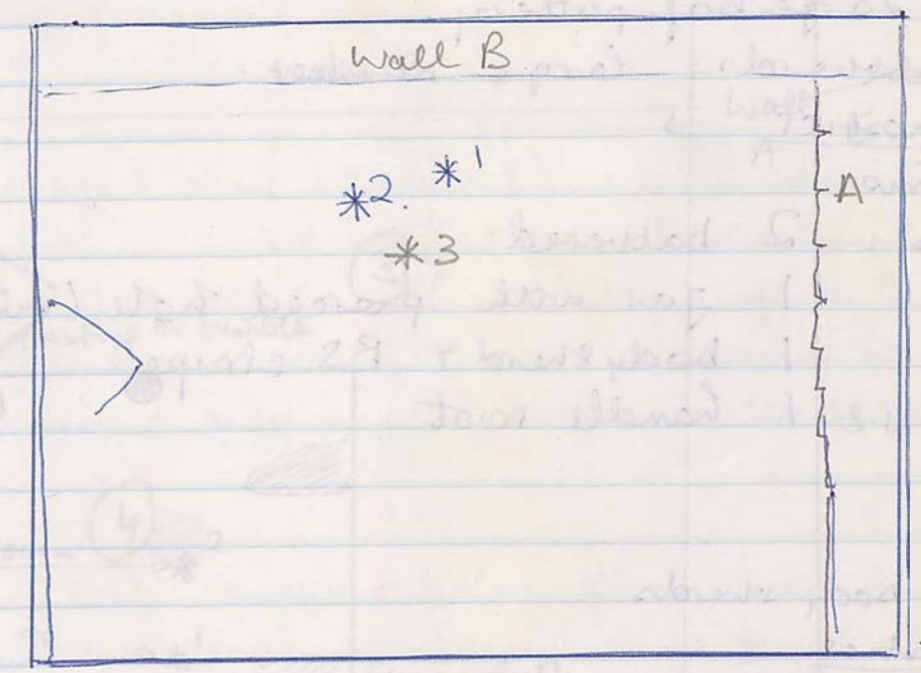
Clearing to level reached in trench to south.  
Still much tumble, causing some concern under  
Wall B which is liable to collapse if tumble  
is removed.

End of day: Nearly cleared to level reached in east  
of trench to south - both trenches without cross  
walls E/W other than Wall B in this trench.  
This confirms a very large room on this side of  
the basin entered by door from basin.

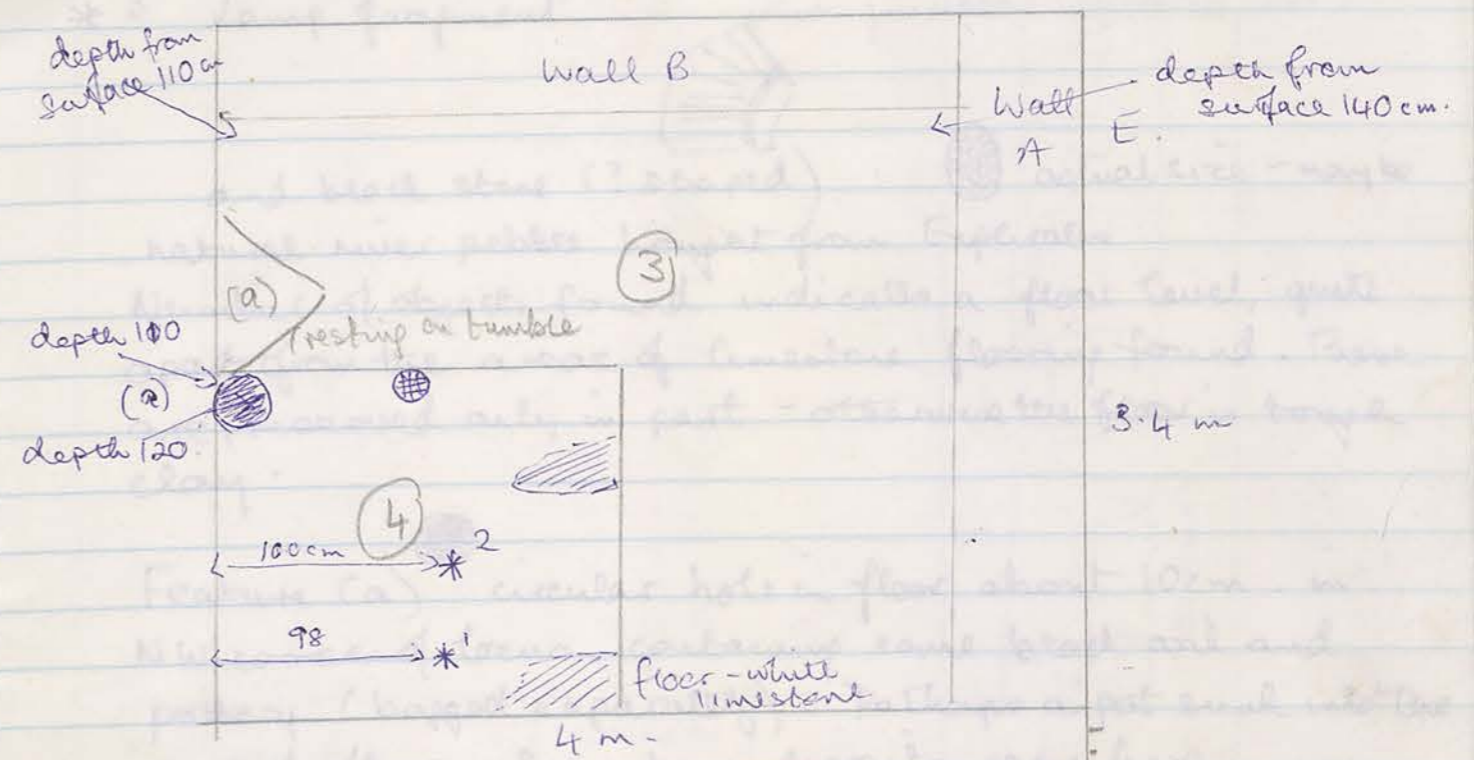
15/11 19/10/96

5.30 am. Finally clearing (3). In case of collapse from Wall A (eastern perimeter) and Wall B (poorly preserved at top), we will proceed to excavate (4) to floor only in a smaller area. Since there are no structures apart from Walls A & B, this is purely to confirm the continuance of the <sup>lower?</sup> floor level seen in trench to south. Wall B has 2 well-preserved courses above level/spit (3) and is presumably strong from there to bedrock, as its north face in 15/2 shows. There is no point in excavating it further.

7.30 am. Signs of limestone floor at spit (4) at depth of (120) cm. (see // on plan.)

actual size - maybe natural river pebbles brought from Euphrates. Number of objects found indicates a floor level, quite apart from the areas of limestone flooring found. These are preserved only in part - otherwise the floor is tough clay.

circular hole in floor about 10cm. in NW corner of locus, containing some black soil and pottery (bagged separately). Perhaps a pot sunk into the ground floor. Some bone deposits near here

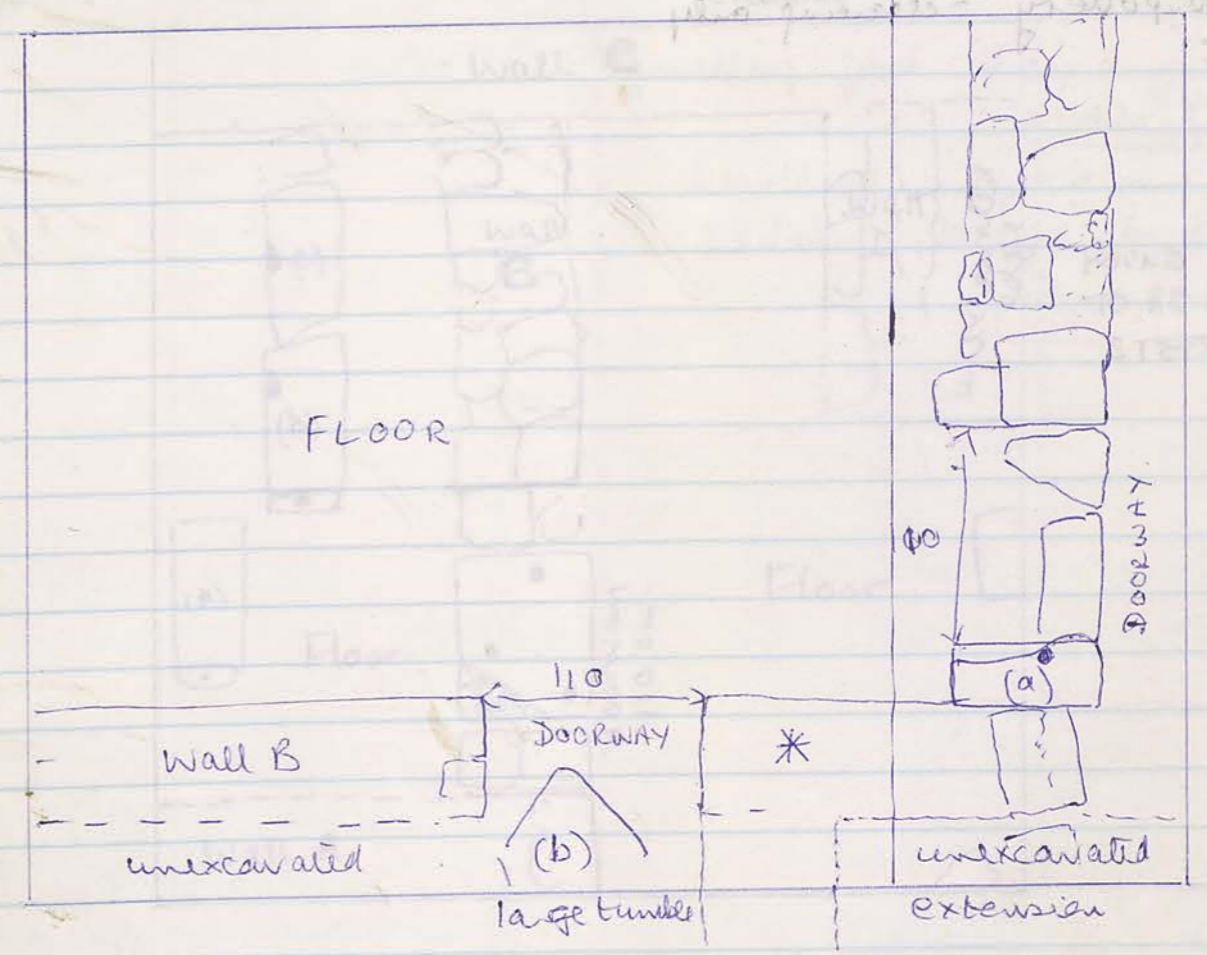
100/3

Cleaned down and workers moved to new trench 125/3, although when Hussein returns I want him to excavate the narrow strip between baulk and Wall B. We have not gone down to bedrock in this trench.

The perimeter wall, in a straight line from south, at \* turns a corner and extends to doorway excavated in extension to east.

Observation: this is not a main doorway (only 110cm) on the lines of the major doorways in southern part of insula. It does not have one solid doorstep or even two regular ones side by side. Although doorstone (a) is shaped

(much eroded) as the "better" ones are, the doorway may be secondary - a re-building taking the perimeter wall out.

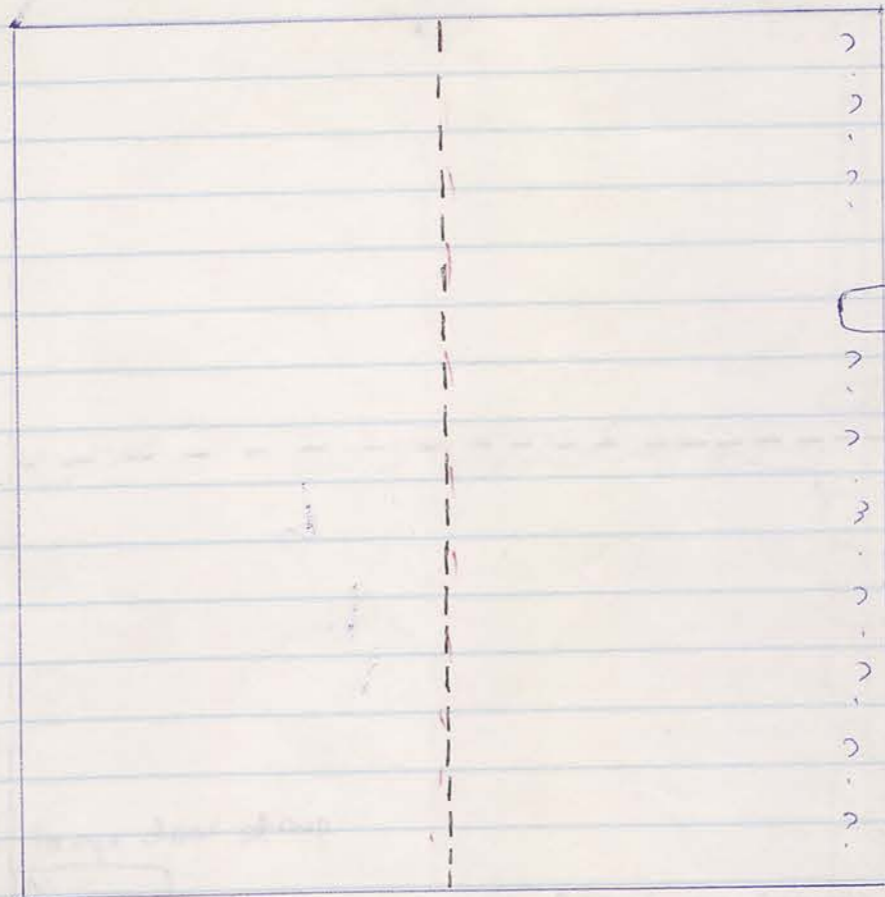
125/3 ①

line of perimeter wall?

6-30 am. This trench is being opened to confirm position of eastern perimeter wall in a straight line to north of the perimeter wall in trenches to south. This is particularly important since in 100/3 (finished early today) the perimeter wall seems to take a dog-leg out to east. Apart from protruding stone (a) there is no surface feature apparent. Stone (a) may be a door stone.

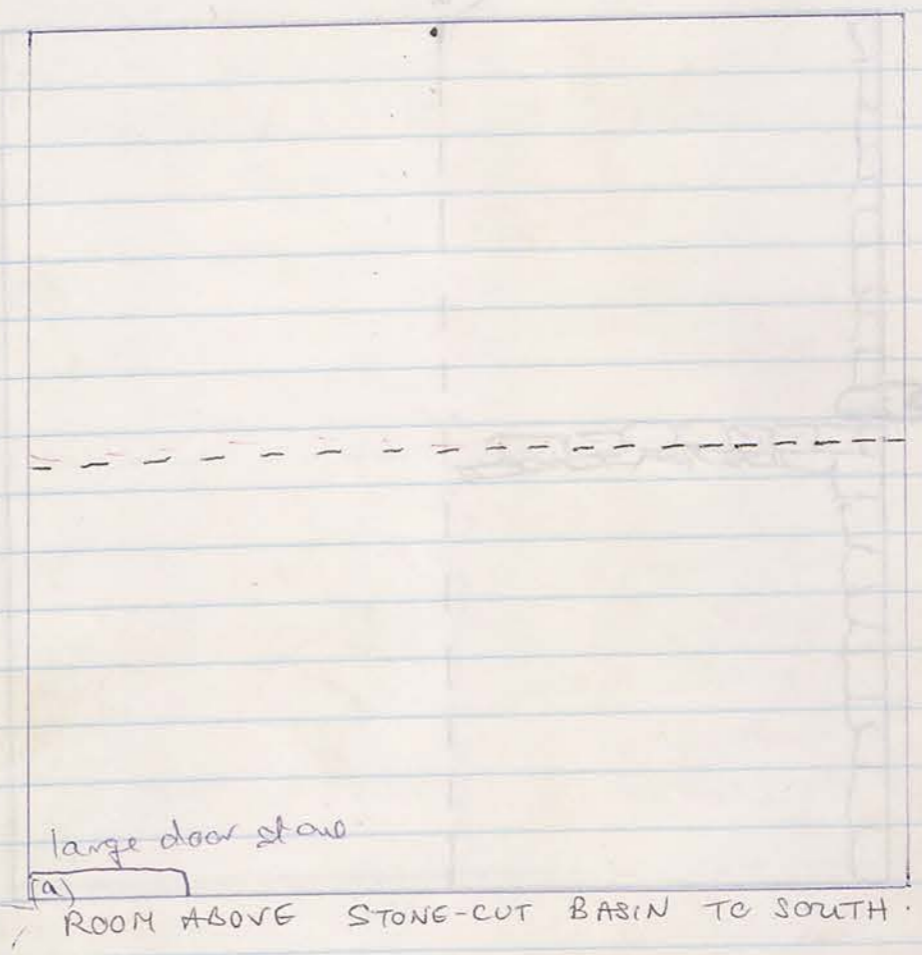
6.30 Team transferred from S7/1 to open this new trench, intended to investigate area to north of large room above stone basin. The excavation of a large doorway into this northern area makes it important to find out the extent of this house to the north.

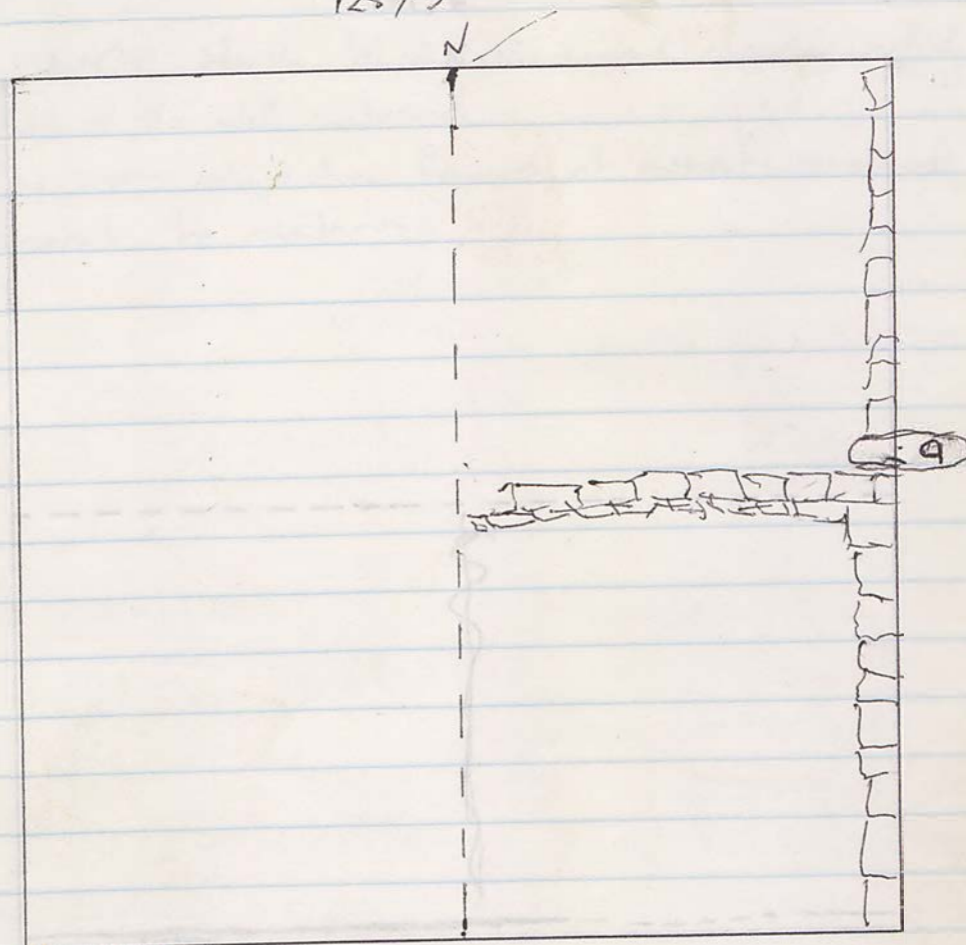
Level 2 - Work on eastern half commenced.  
 Wall revealed along eastern bank  
 also uncovered, a wall running  
 east/west approx. half way up trench,  
 south of protruding rock (a).

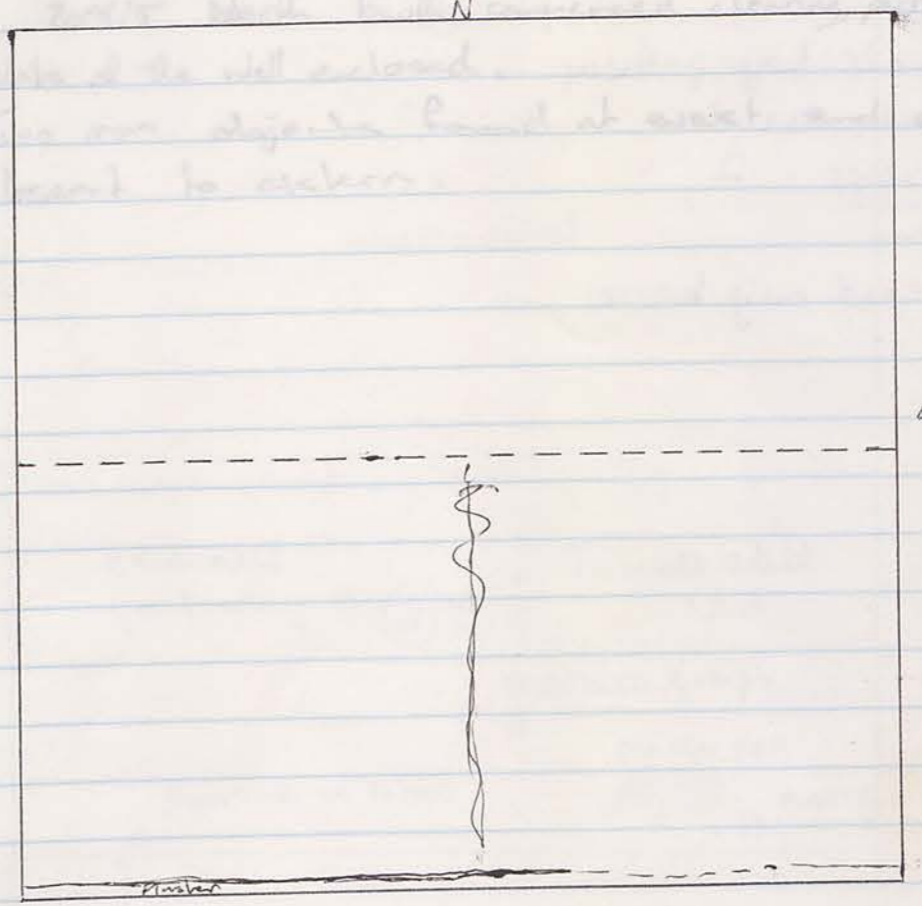
Level ② Work commenced to expose area north of southern wall.  
 Plastered wall exposed & recovered along the  
 southern wall. Plaster observed is in good condition.  
 Recovered <sup>with soil</sup> for observation & instruction by Heitler.  
 Sml piece of bone coloured plaster removed to spoil.

Many fragments of plaster: red, yellow, black,  
 white.

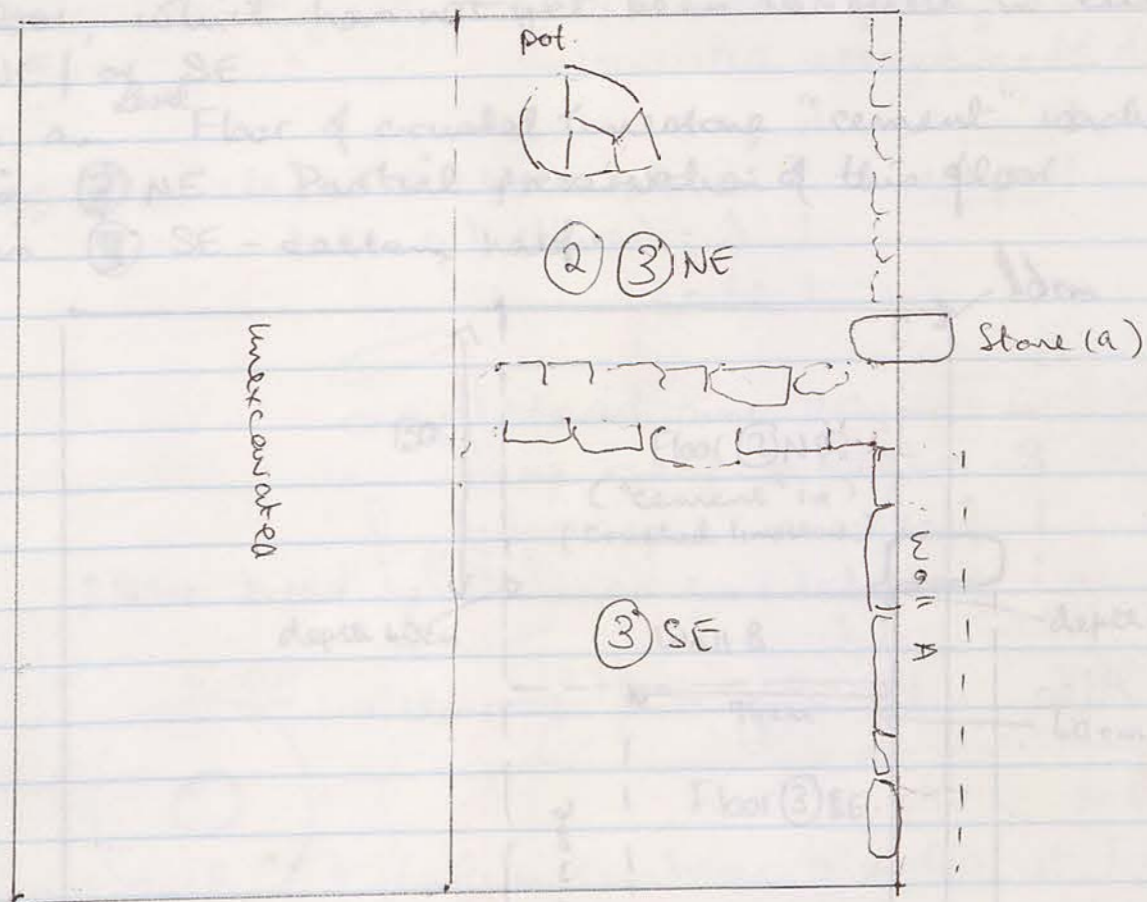
(3) E/NE

6.00 am. Yesterday this eastern section confirmed the continuance of the eastern perimeter wall and found a possible wall E/W across the trench, meeting the perimeter wall at Stone (a) which I still suspect is a door stone? Today we excavate in (3) NE, to look at this possibility.

7.00 am: Remains of very large jar found in (3) NE as shown above. Photographed in situ Roll 4 CP. 30-31.

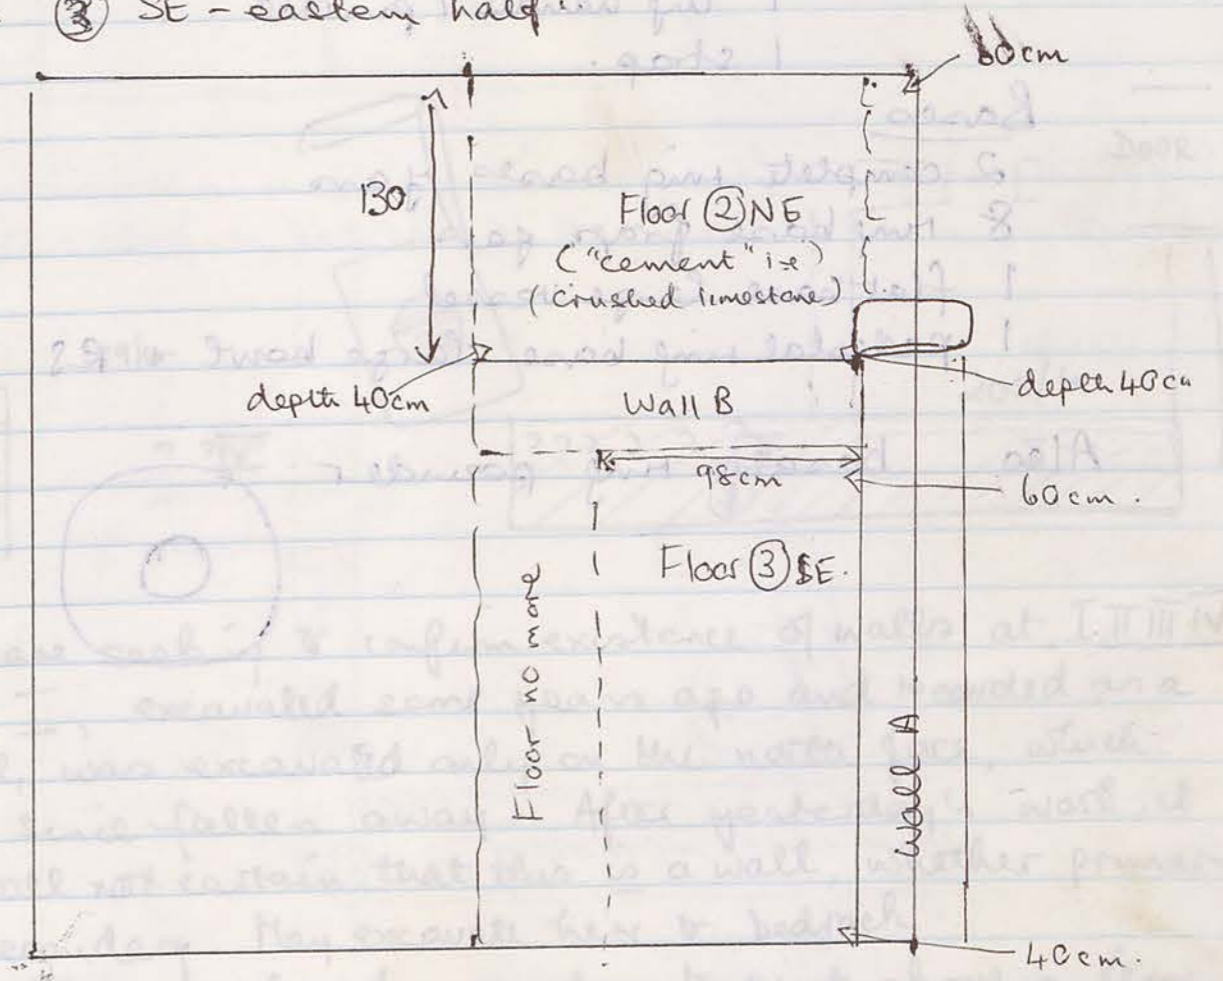
8.15 am. <sup>Level</sup> Floor of crushed limestone "cement" reached  
 2 NE in ③ NE. Partial preservation of this floor  
 in ③ SE - eastern half.

9.45 am. Photographed cleaned floor in ③ NE  
 Roll 4 36-37 (CP).  
 Now excavating this floor to investigate foundations  
 of Wall A, Wall B, and doorway.  
 Large rectangular stone just under floor near "door"  
 Wall B from doorway south, is defined clearly.  
 I do note that these beautiful door-step stones are  
 fully 165cm in length (3 stones joined), but at  
 the north end the wall intrudes on to the door-step  
 and a vertical door stone being in place.

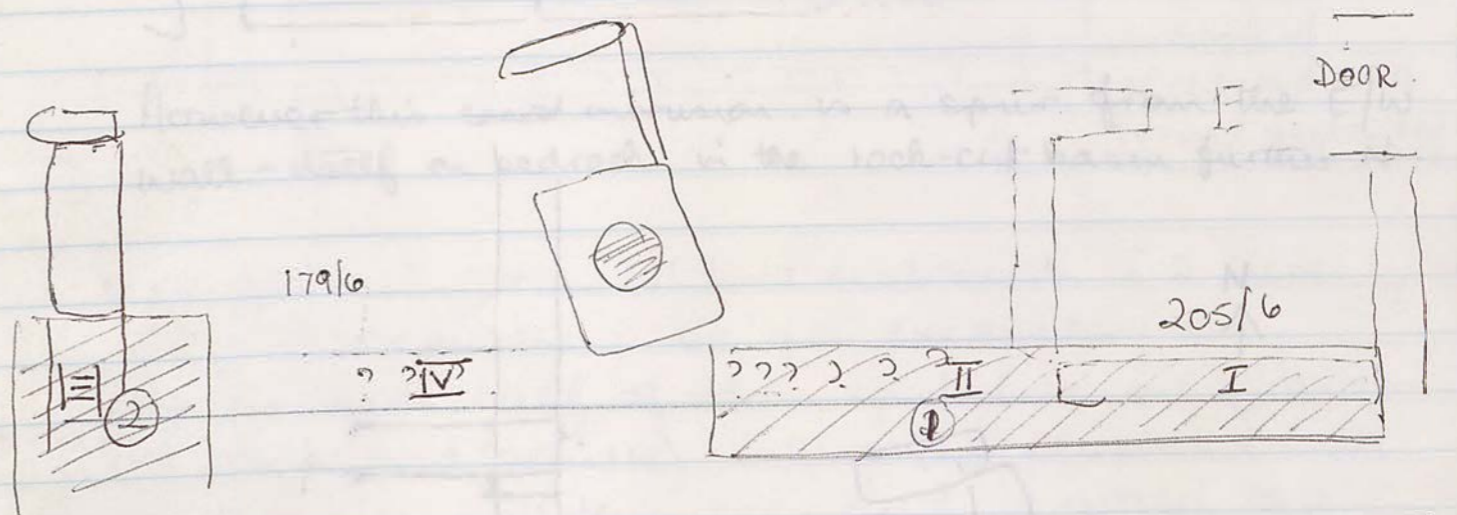
1. Cistern courtyard - E/W wall to south
2. " " " unexcavated area beside doorway

We are seeking to confirm existence of walls at I, II, III, IV.

- 1) Wall I, excavated some years ago and recorded as a wall, was excavated only on the north face, which has since fallen away. After yesterday's work, it is still not certain that this is a wall, whether primary or secondary. May excavate here to bedrock.
- 2) Wall II was found yesterday to exist above a floor higher, at a level approx the same as the floor in the cistern courtyard (above the drains). It is not quite in the same line as:
- 3) Wall IV now being excavated E/W across the cistern courtyard adjacent to & south of the cistern.
- 4) Wall III from doorway south, is defined clearly. I do note that these beautiful doorstep stones are fully 165cm in length (3 stones joined), but at the north end the wall intrudes on to the door step without a vertical door stone being in place.

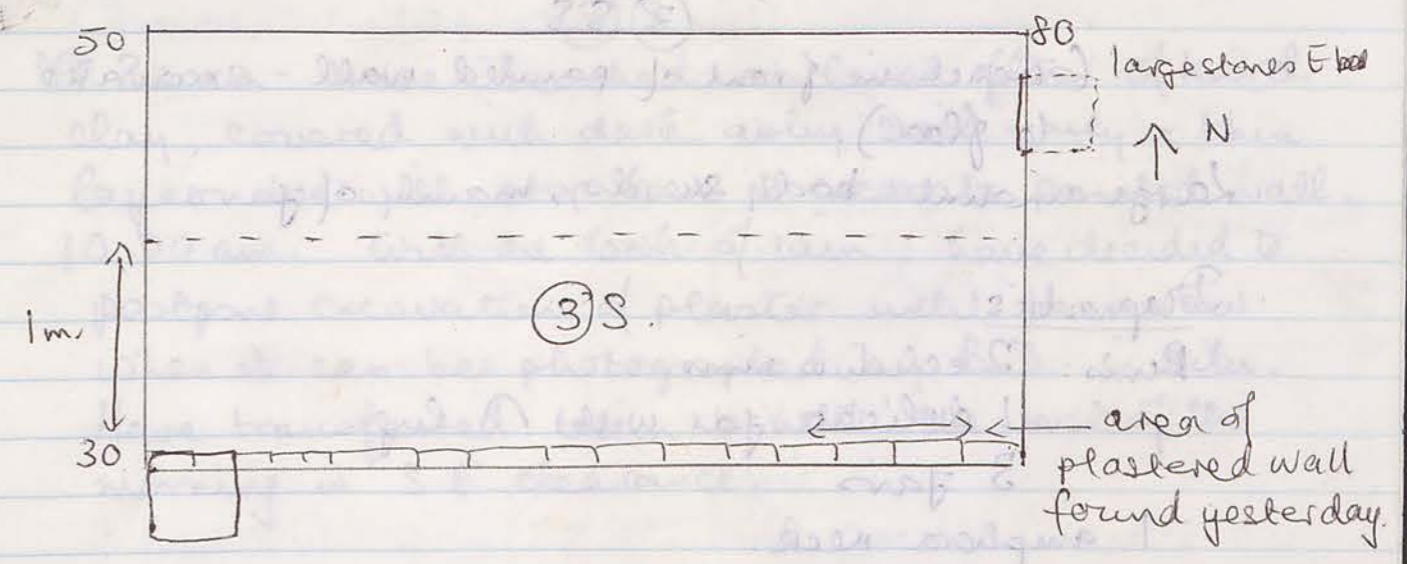
15/10/96 (3) S. 21/10/96

6.00 am. In view of time restraints (2 more days of excavation) we are excavating only the southern half of this spit (i.e. one quarter of whole grid square), along the plastered wall, in order to get this seen and recorded this season

6.30 am. the soil here is tough and clayey, suggesting a floor - if so, it is higher than the floor excavated at base of plastered wall in 15/9 yesterday

In SE of this spit there is still some plaster backing for the cornice (found yesterday), but as yet no more plaster, suggesting perhaps that the plaster was on a floor.

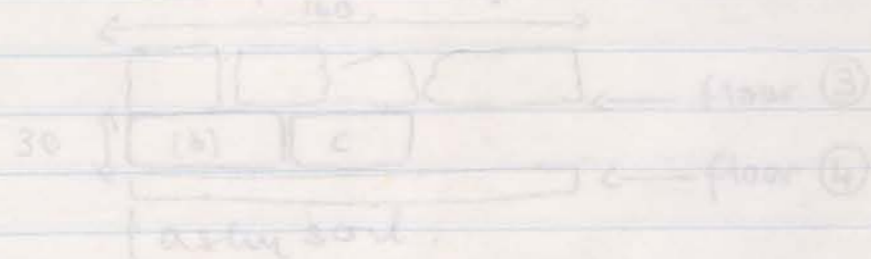
Section of north face of wall B

6.00 am. Greening in NE corner. Weather may be too hot to stop. During excavation yesterday, we found another floor 30cm below floor (3).

Upper floor: limestone "cement"  
Lower floor: hard clay

Beneath the second floor is much ashy soil. We will excavate to bedrock to ensure foundation of wall A is on bedrock.

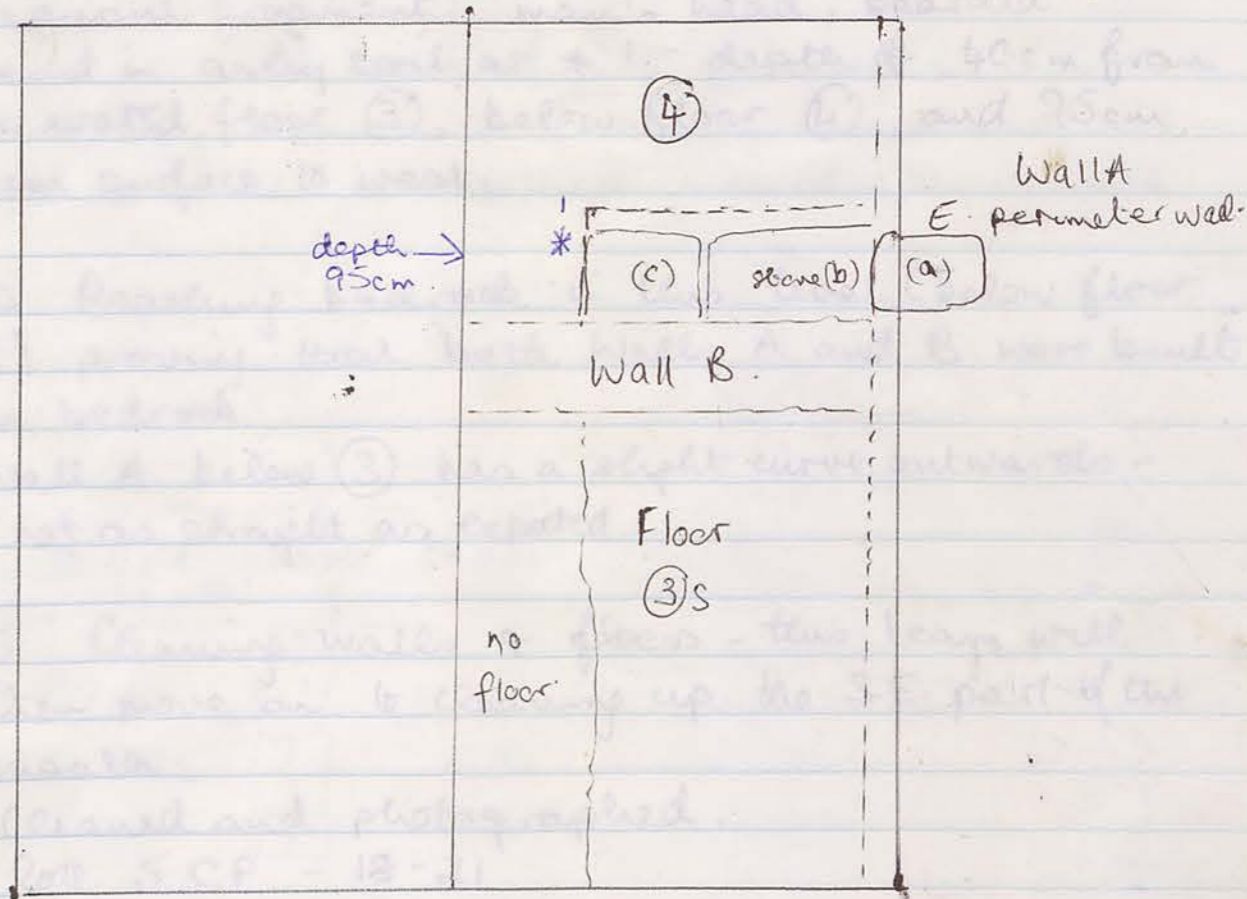
125/3 (4) NE

6.00 am. Excavating (4) in NE corner. Weather rainy so may have to stop. During excavation yesterday, we found another floor 30cm below floor (3).

Upper floor: limestone "cement"

Beneath this second floor is much ashy soil. We will excavate to bedrock to ensure foundation of Wall A is on bedrock.

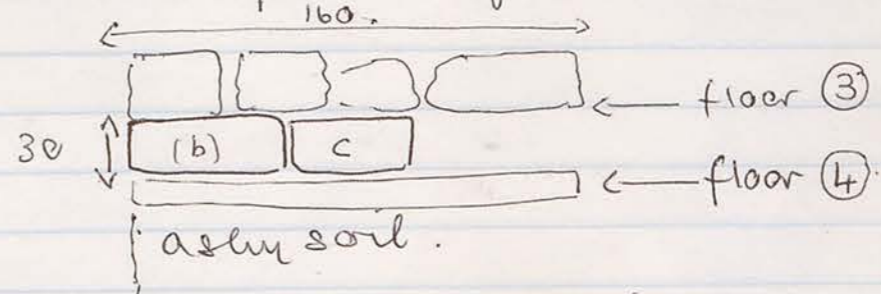
Section of north face of Wall B

Lower floor: hard clay.

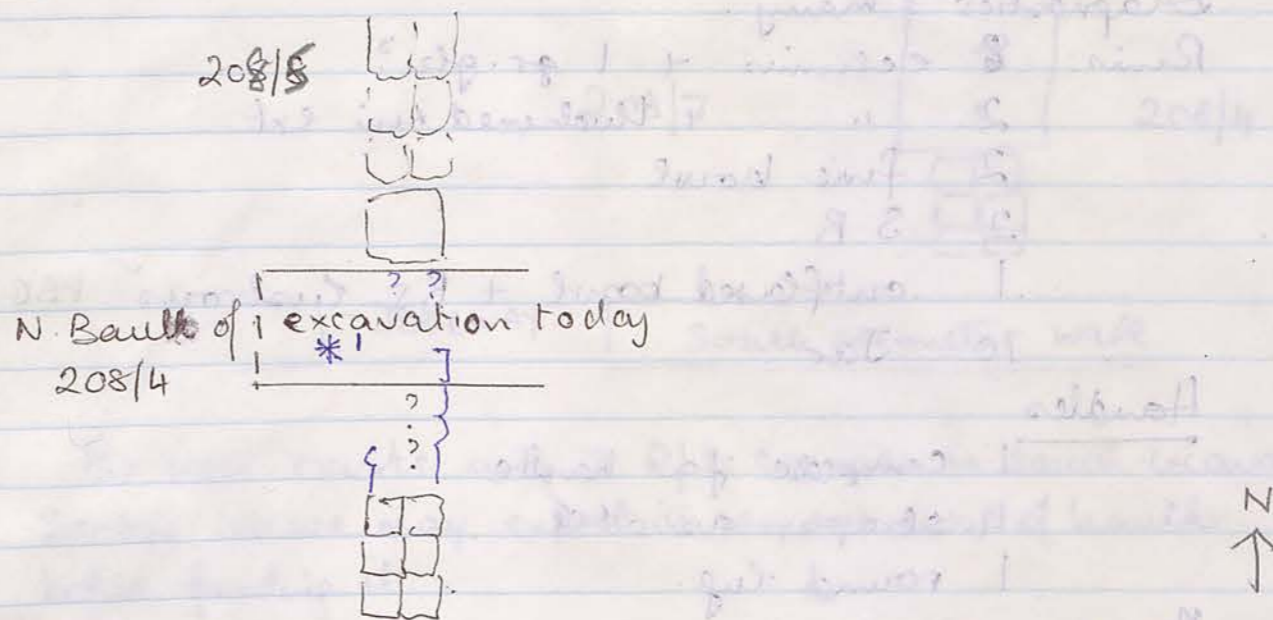
N. Bank of 208/4 removal

- to clarify continuance of scanty remains of N/S wall to south, where there is a clear N/S wall

8.30 am. line of wall found to continue north as shown in blue

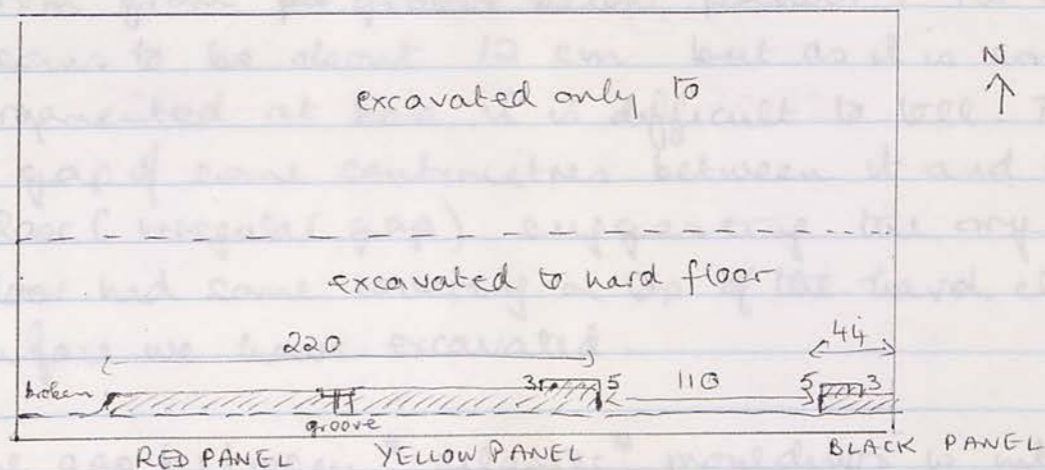
15/6

Returned Abu Hamid's beam to this trench to expose the plastered wall to south.

When fully exposed, the longer section to west was found to extend for 220 m, fragmented at western end near W. bank, but at eastern end, finished off with a moulding "pilaster" projecting 3 cm from rest of wall and cornered 5 cm. A similar feature was found after a gap of 110 cm, to east, bordering vertically the black panel seen there, fragmented after 44 cm length.

For drawings see HS's graph-paper and BR's drawing (24/10).

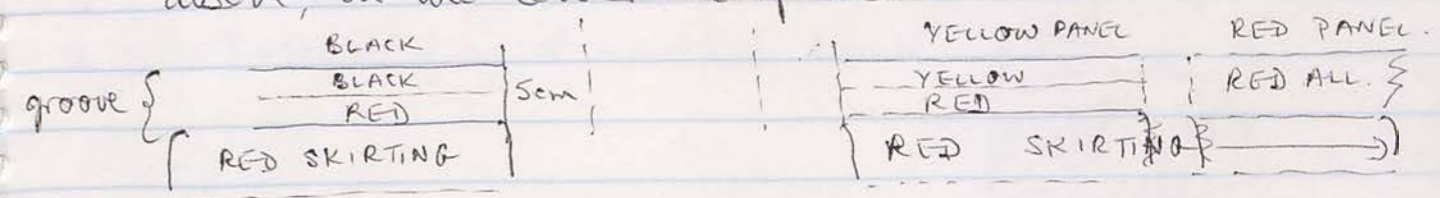
The longer section consists of a red panel (frag. to west) and a yellow panel (complete width 94/5 cm) divided by a 1 cm. deep vertical groove with vertical line in its centre.

Beneath all panels is a 5 cm <sup>necess</sup> groove horizontally painted in the top half the same colour as the panel above, in the lower half red

Beneath panels and groove is a red skirting, projecting

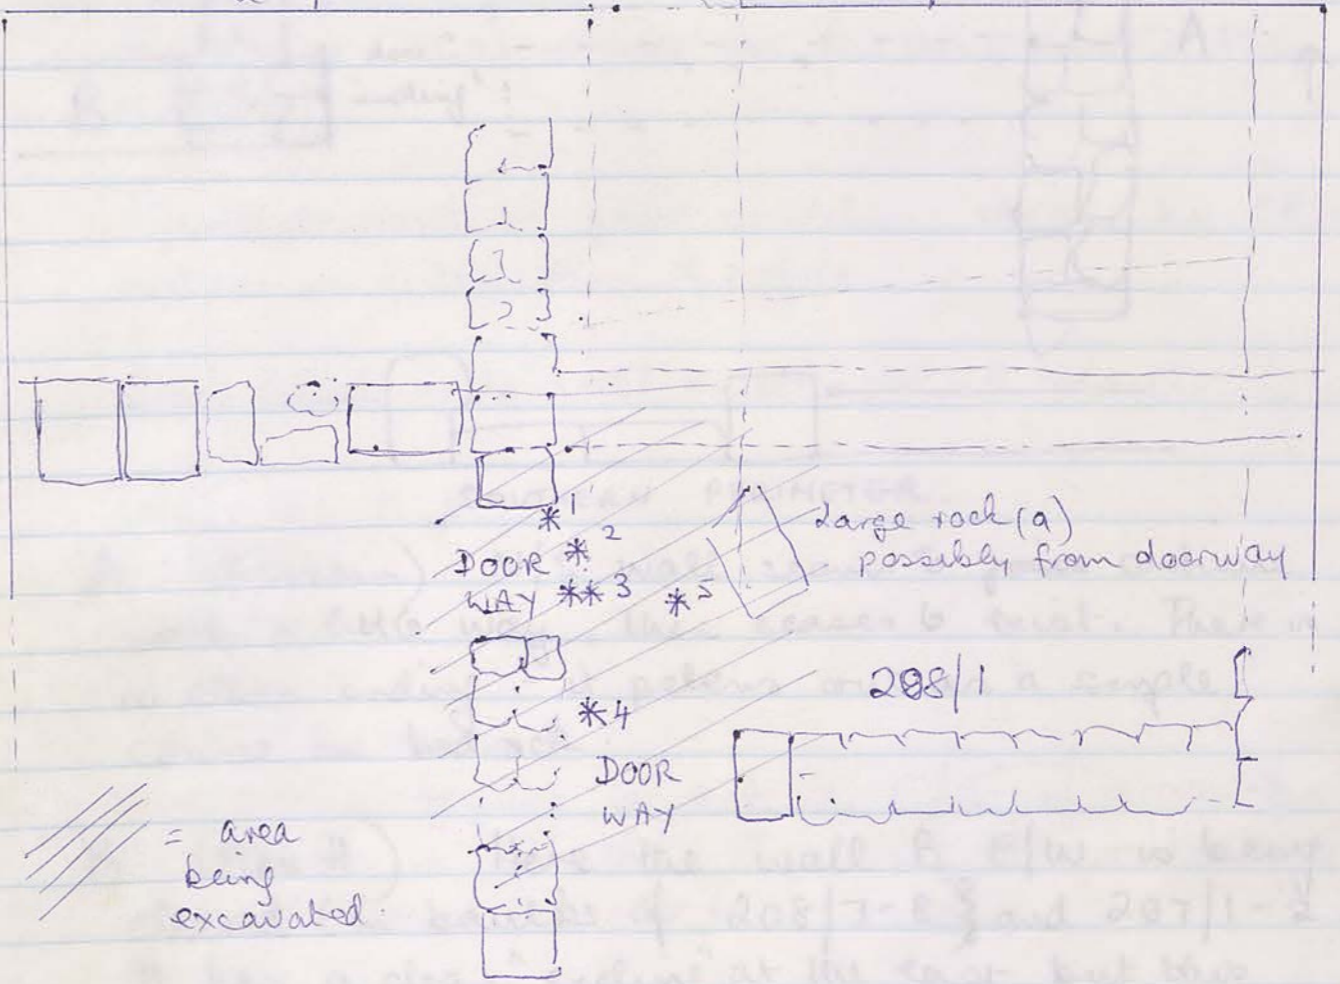
\*1 Iron nail found in newly excavated gap in wall, thought to be a doorway. Large worked stone (a) may be from this doorway. Width of doorway ..... 100 cm. - on bedrock.

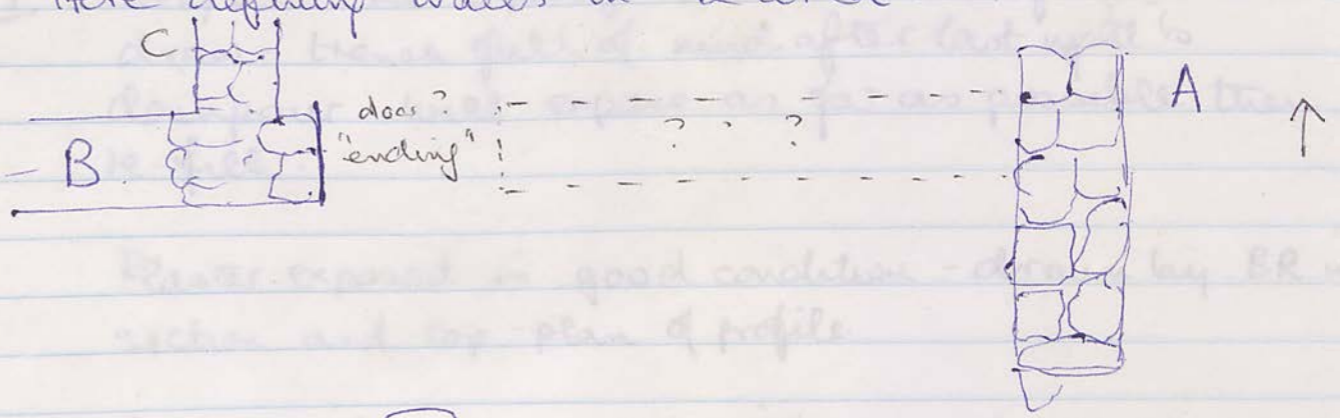
SOUTHERN PERIMETER.

A: (Hussein) N/S wall seems to ~~join~~ continue north a little way, then ceases to exist. There is no clean ending - it tapers out as a single course on bedrock.
