Jebel Khalid 2000/2

Field Record Book

B22

Name.....	BILL CLARKE + VICTORIA CRAPPER
Trenches.....	AREA B TRENCH 22
Dates.....	14/04/2002 -

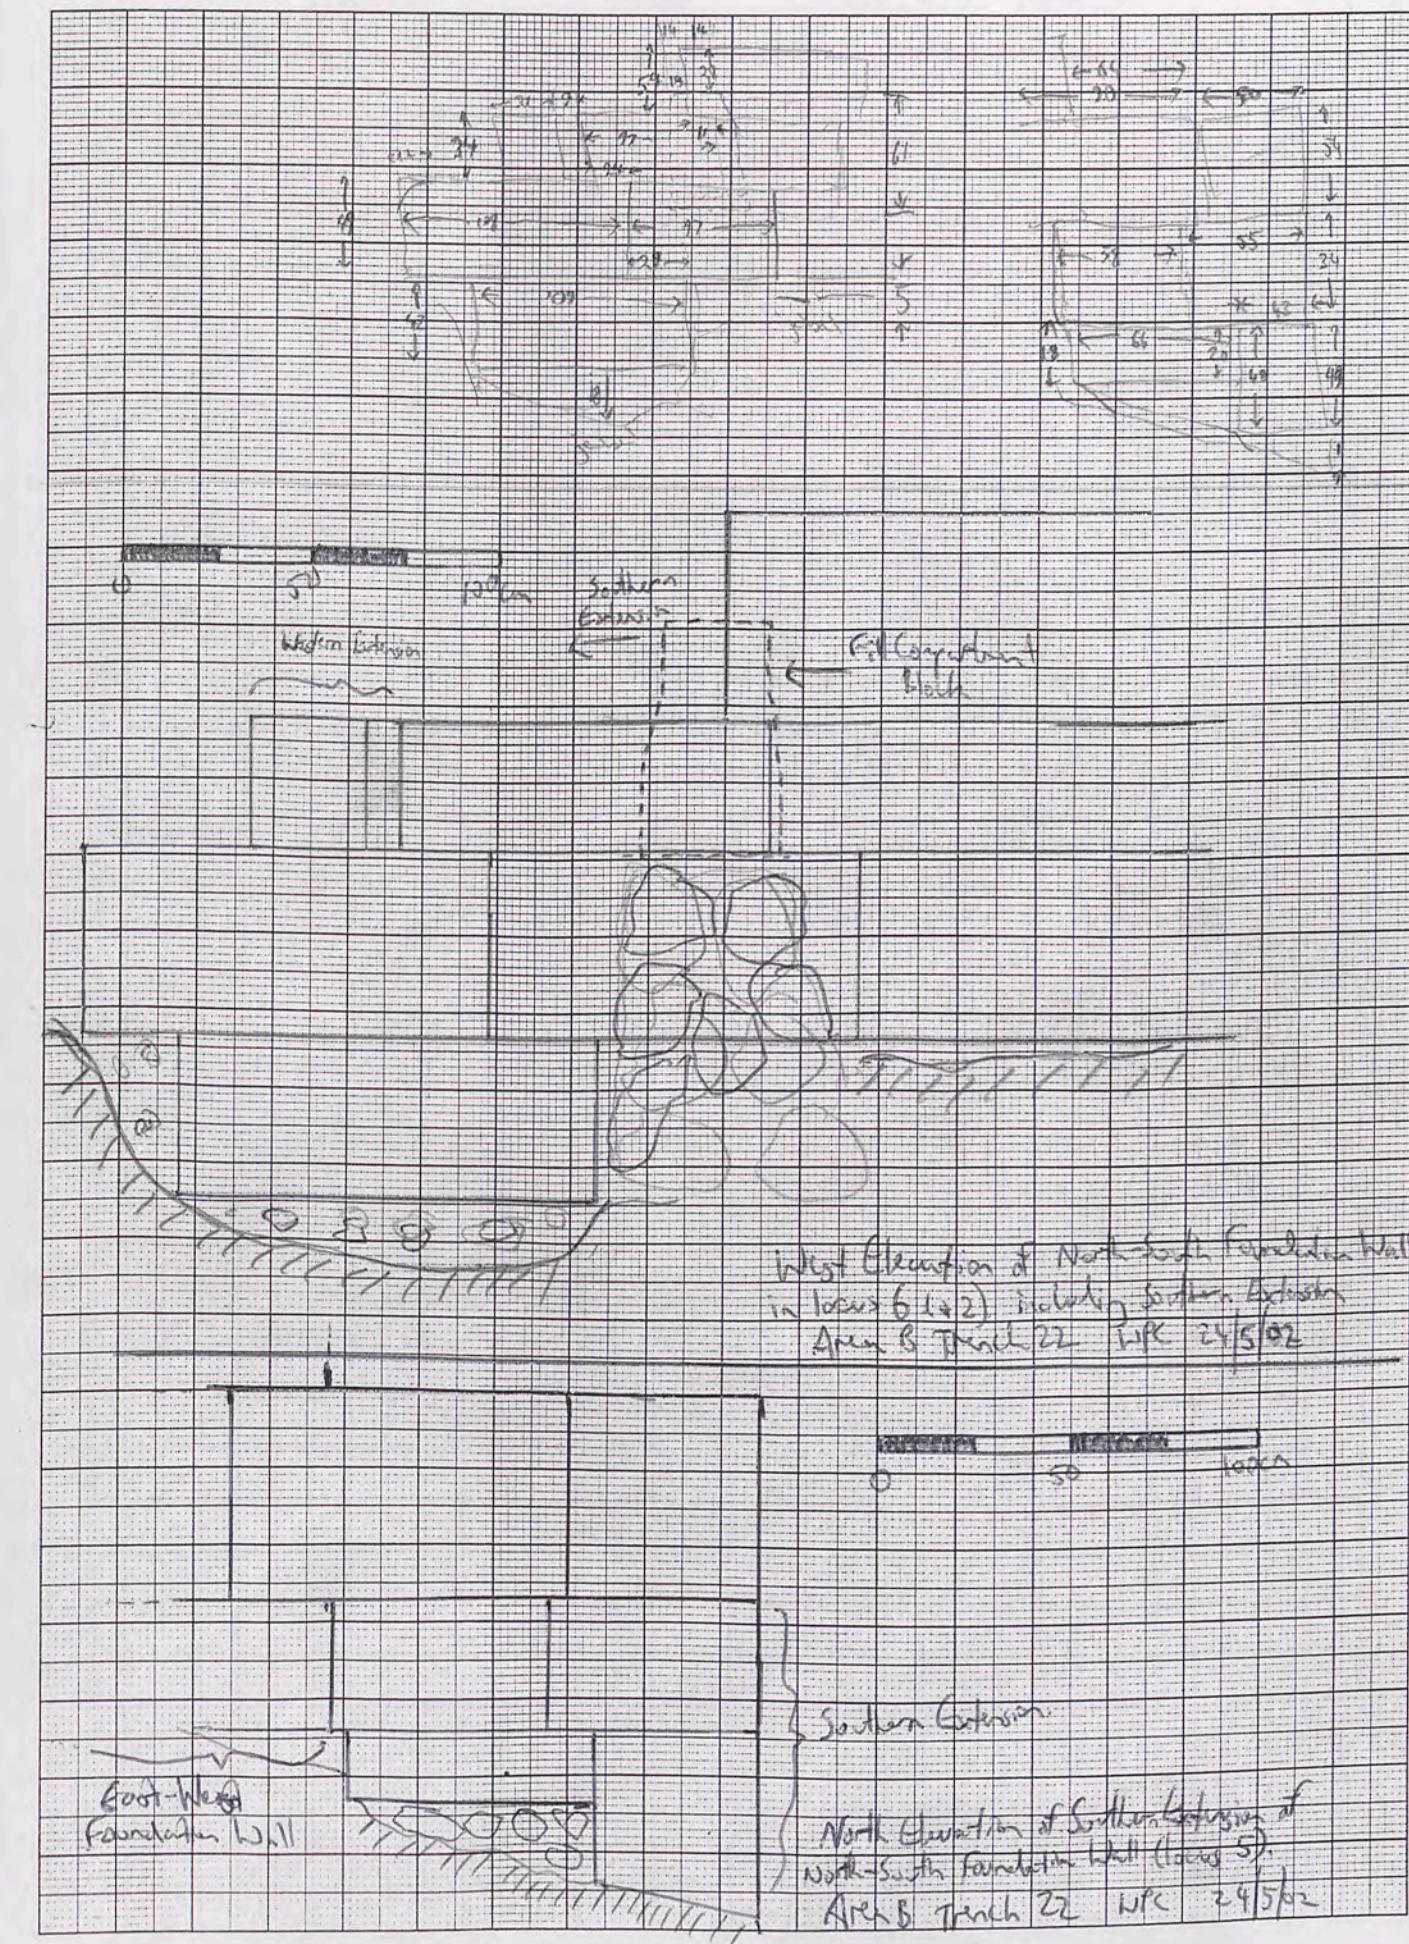
See elevation of the Southern Extension of the North-South Foundation wall. Corresponding elevations for the rest of the walls are on pages 30, 34 & 44.
