Jebel Khalid 2000

Field Record Book

Name..... HEATHER JACKSON

Trenches..... 74/2, 74/3, 75/8, 75/9, 75/3, 75/6-9
..... 75/9-8, 56/2, 57/7, 57/8, 74/9, 57/4

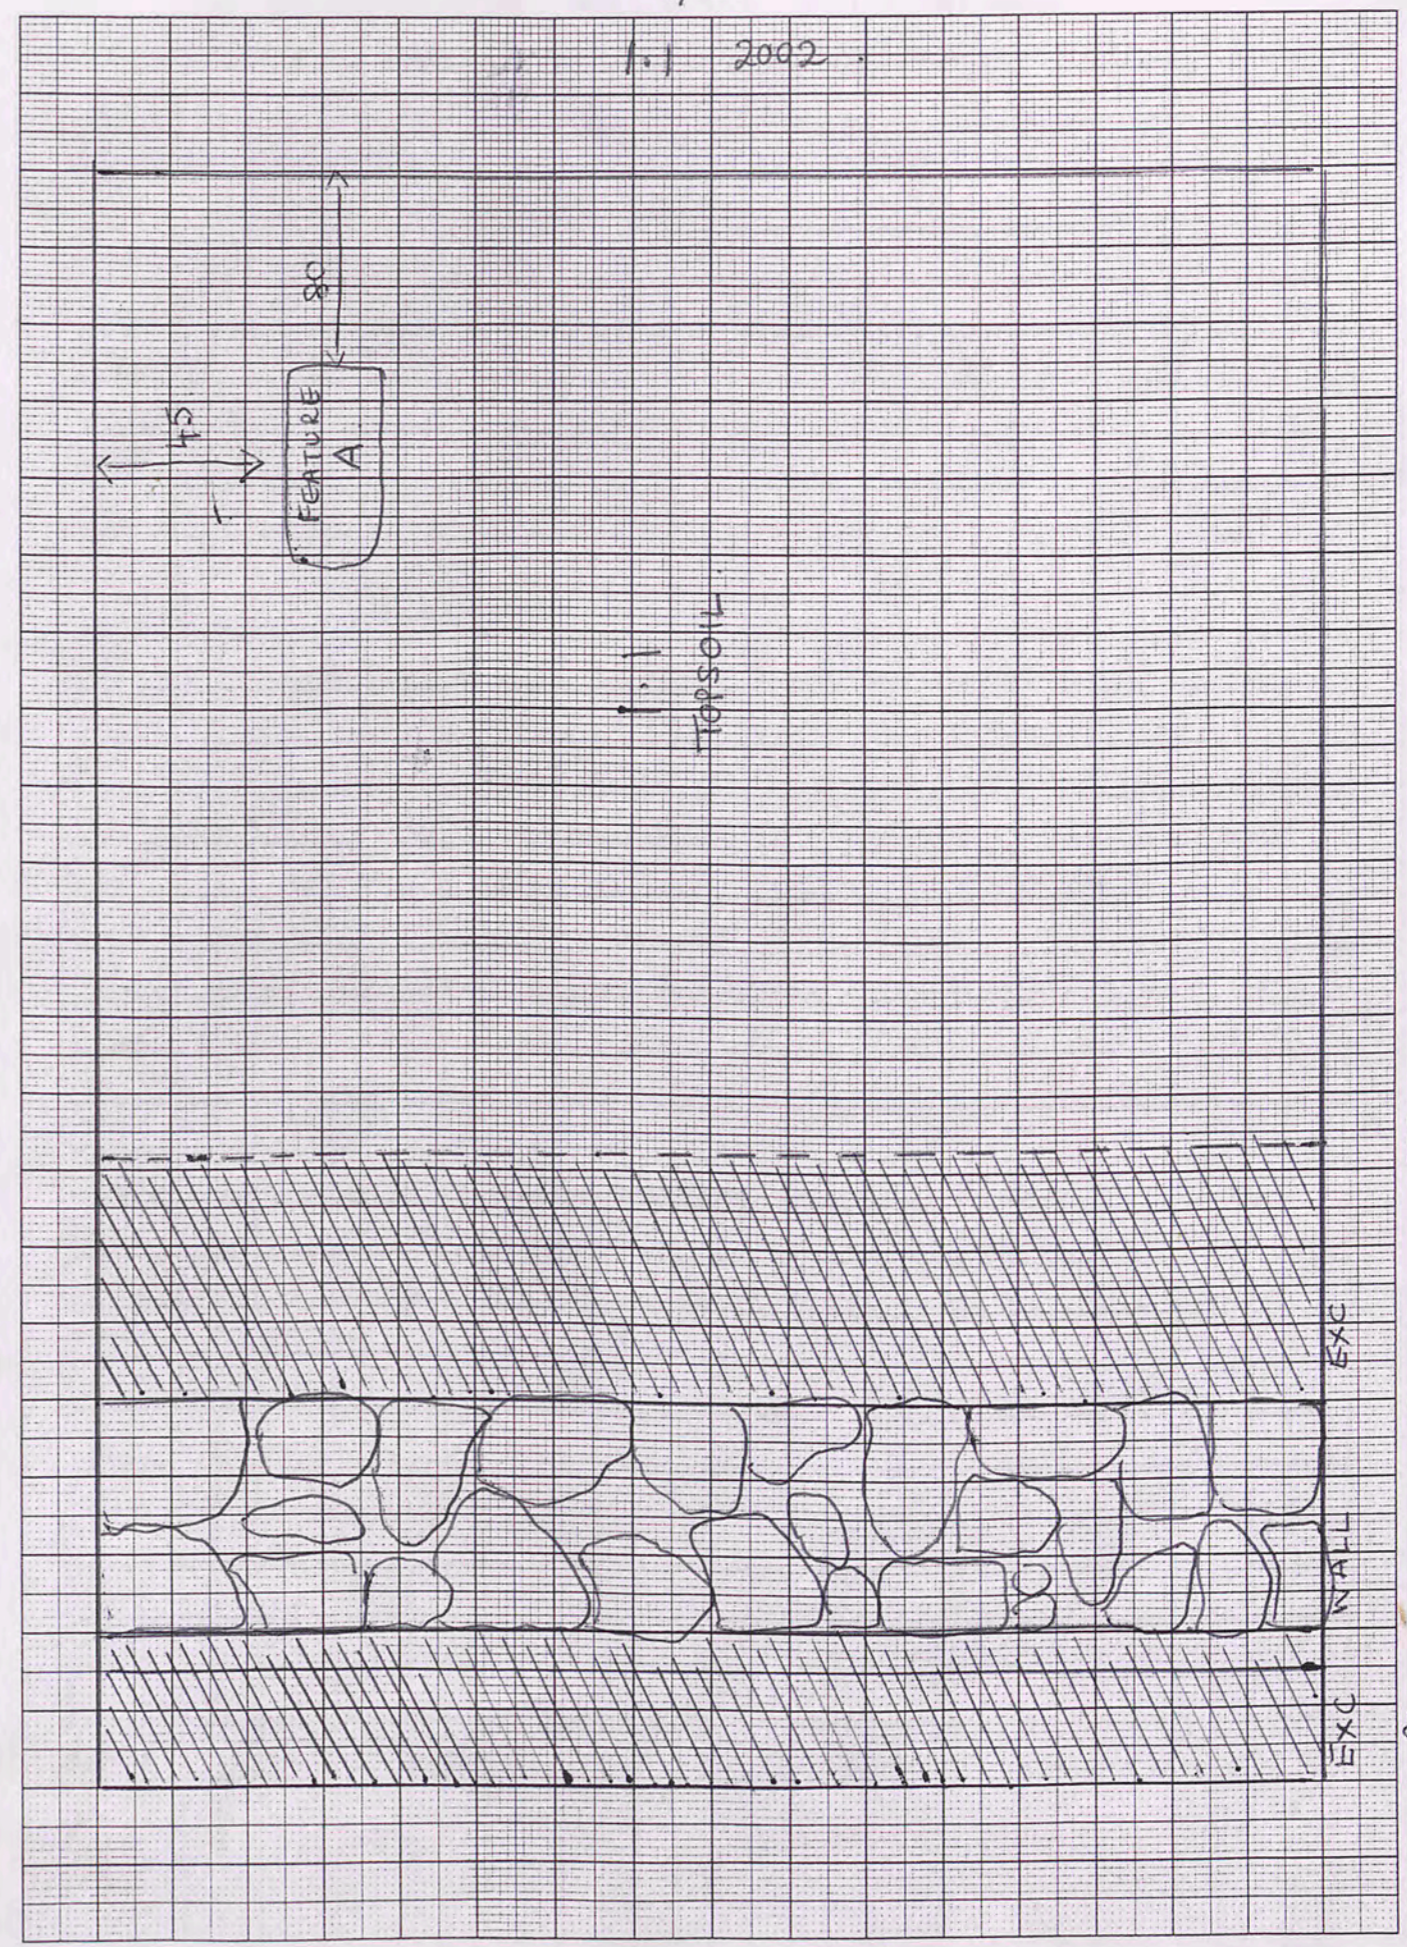
1.1 2002

Context	Report
1.1	Continuing to excavate the topsoil. Will sweep down if the rain allows. The prominent doorstone stands 76 cm high - is 60 cm long, 50 cm wide. In the baulk to the East of it is a very large worked stone visible on the surface. I feel this may be the other doorpost stone, ex situ. Swept & photographed HJ 1/31-30
1.2	Tumble removal from the whole of locus 1. Rainy / showery conditions make it difficult. Tumble is large and heavy. For plan see 17/4/00.

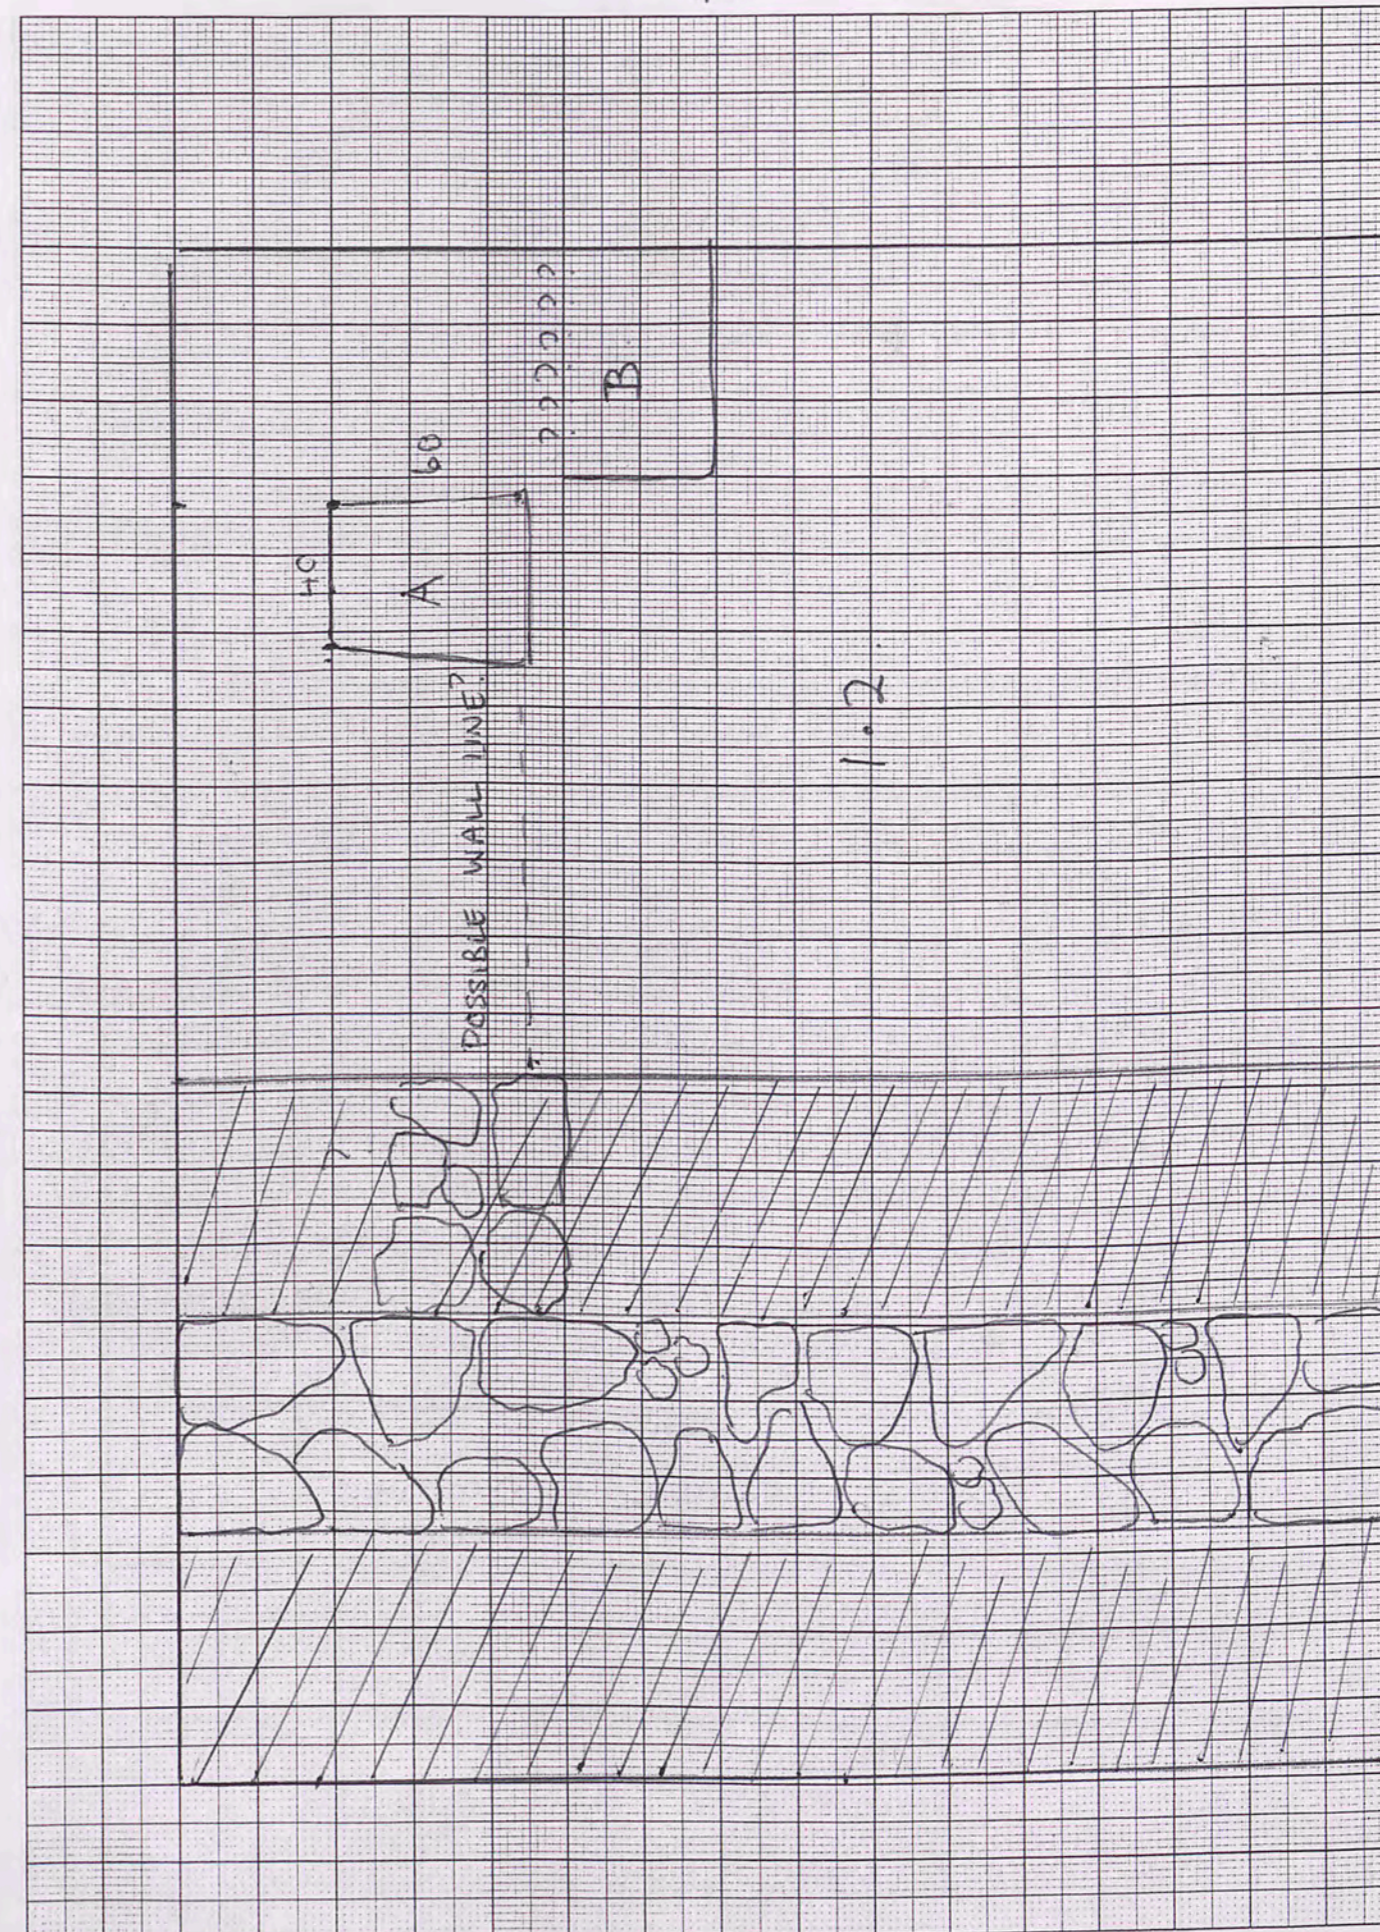
74/2 1.2

1.2 Rainy, muddy conditions rendered this a half day only. Still moving much large tumble resting in soft (and muddy) soil. By the end of work, we had reached the wall line indicated in the North. There is certainly a promising place here but I am still unsure of the wall's existence, which is surmised from the position of the tall door stone (Feature A)

A large rectangular worked stone, lying flat, is found in the vicinity of the "doorway" but to the South of it. The threshold stone ex situ?

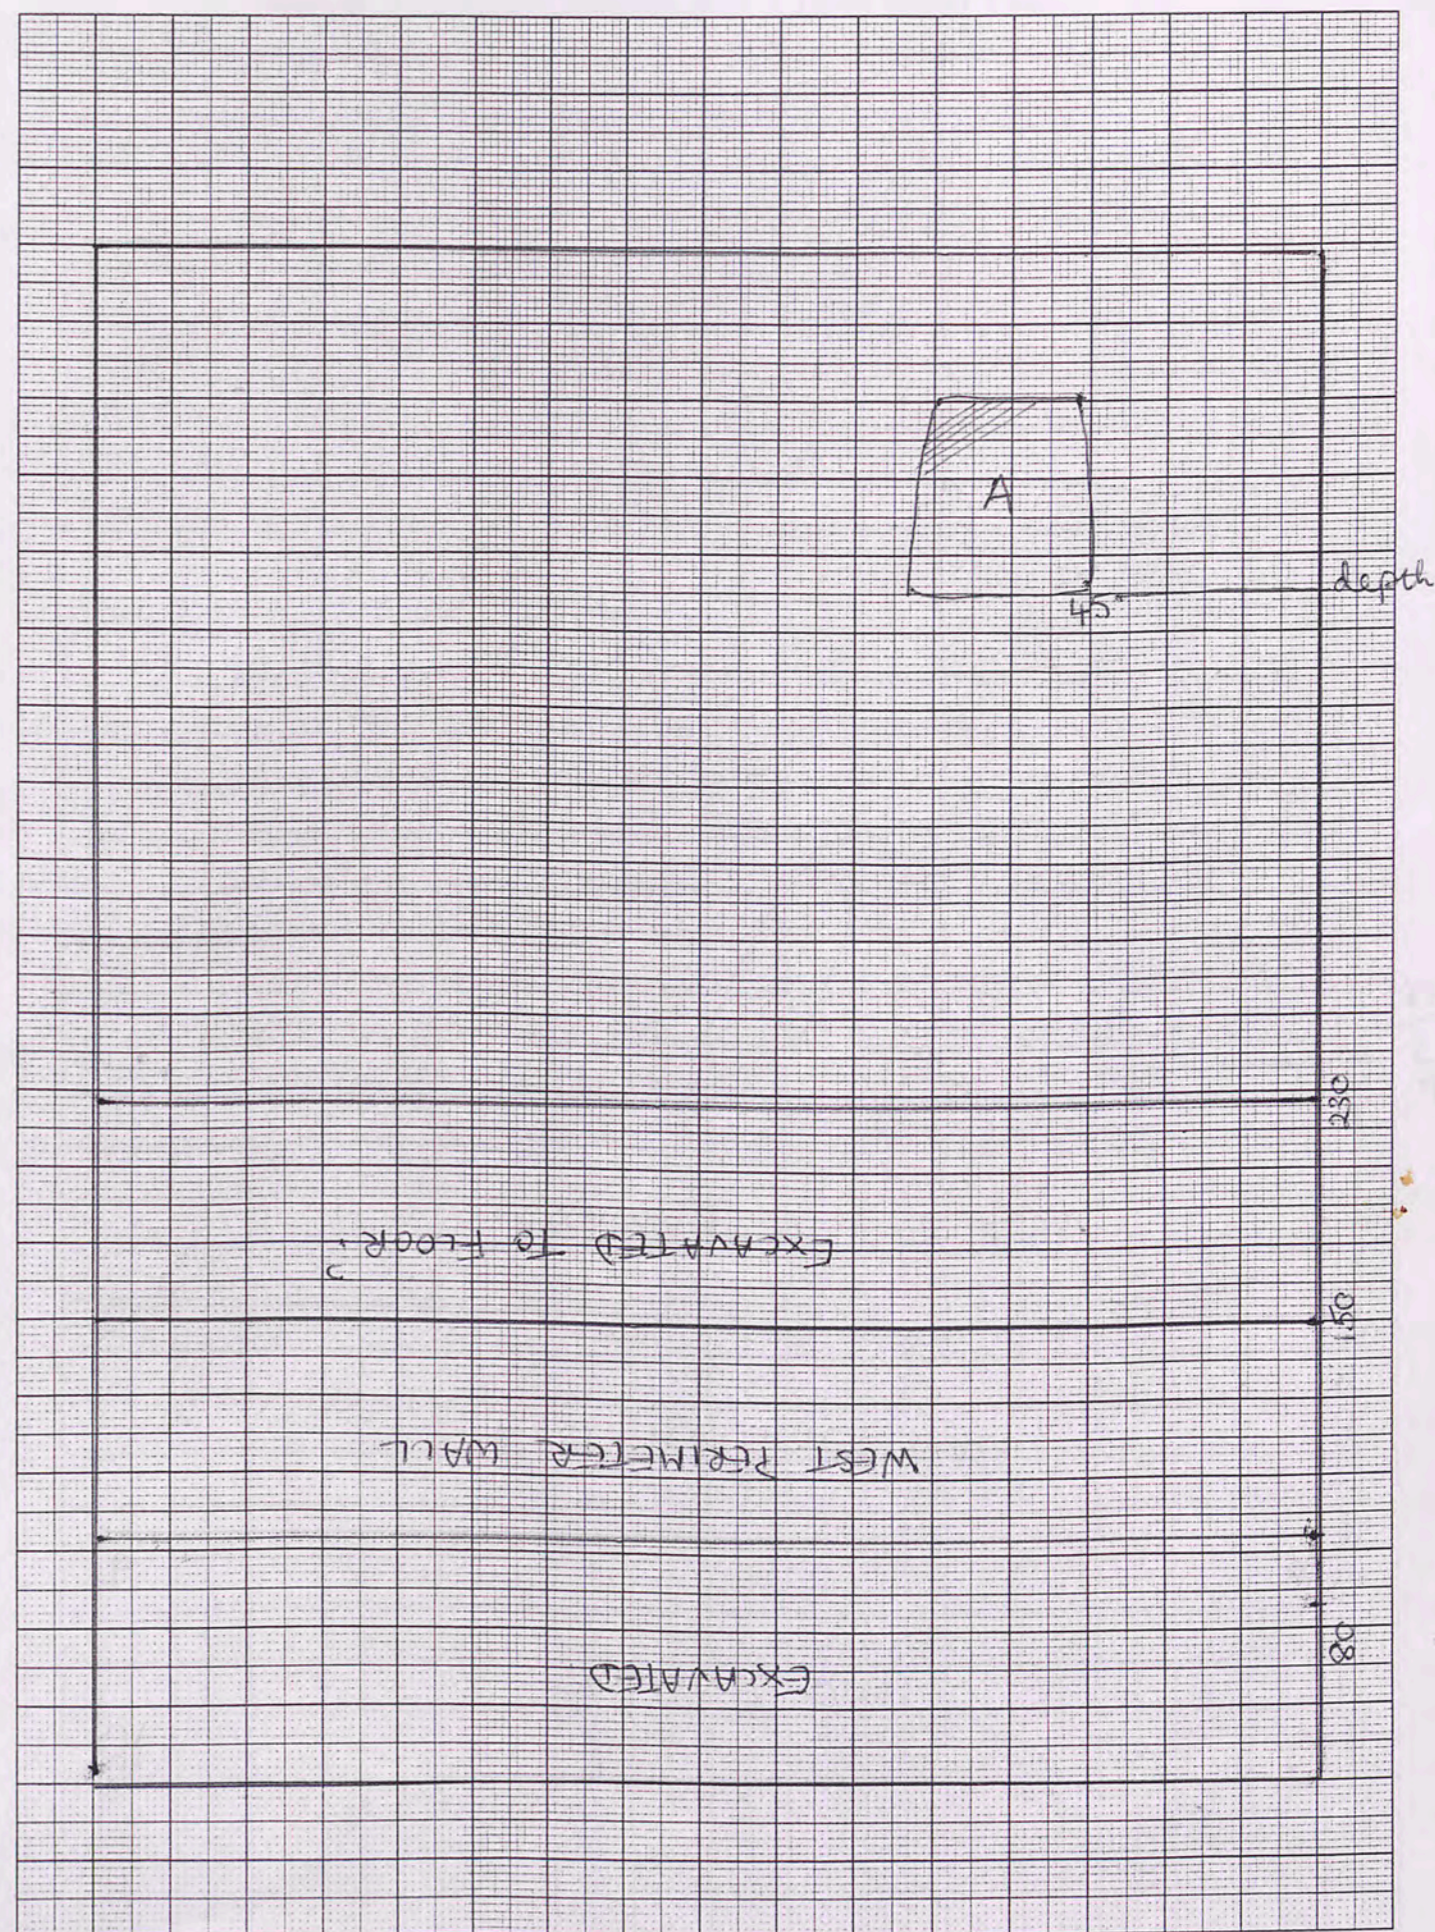
THIS PLAN INCORRECT - SEE NEXT PAGE. 1mm Squares

Context	Report
	Weather improved.
1.3	A new spit south of the "wall" excavated yesterday. The locus is now reasonably level, although still full of tumble. This means that, because of the slope N/S, the southern end of the trench is excavated only to 5-10cm from surface. Against the south face of the now-revealed E/W wall we have reached a depth of 75-80cm from surface.
A	Feature A is the tall doorstone - 130cm tall to the base, which is now becoming clear.
B	Feature B is the rectangular stone, possibly a threshold, lying south of A.
C	Feature C is a fallen doorstone lying on the surface, partly in the bank. It is very worn but approx. 1m. in length (which would be its height) so it is very likely the other doorstone.

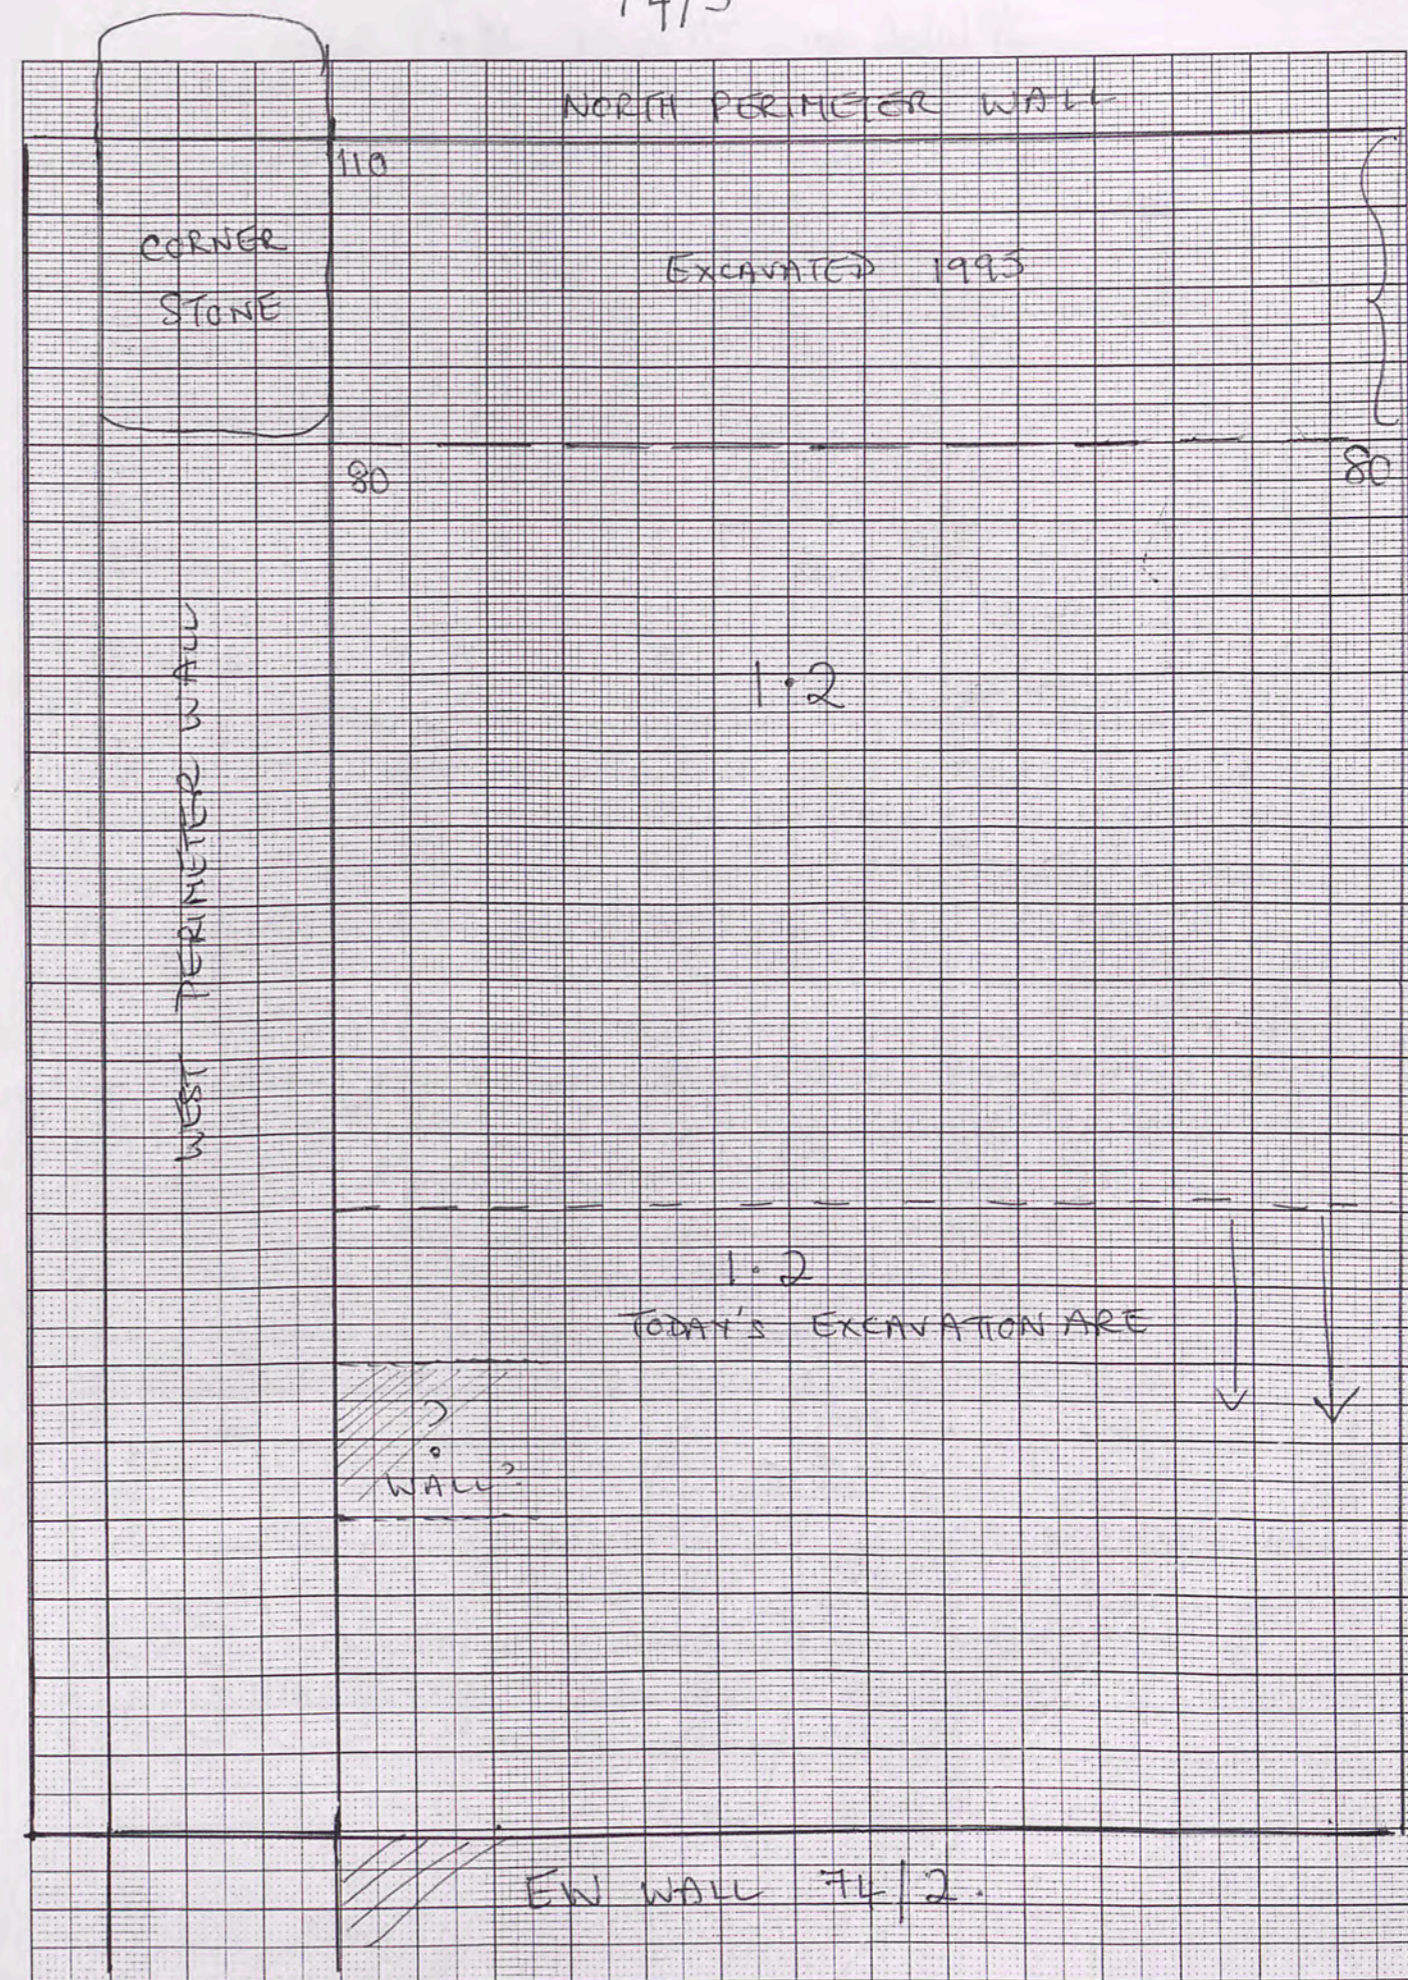
74/2 (Scale not correct E/W - see next page)

Context	Report
2.2	<p>Still excavating this very difficult locus which consists of very large tumble. I have not changed the spit number as the contents/character still the same i.e. tumble in loose brown soil, no pottery. In the North we are almost at the level reached in the 1995 excavation. In the South there is still a fair height of tumble as the presumed "wall" across the 2001 sendage was presumed to continue. I now think (a) it was not a wall (b) cannot be one so closely parallel to the E/W wall in the North of 74/2 (doorway). So we are now excavating this southern area.</p>

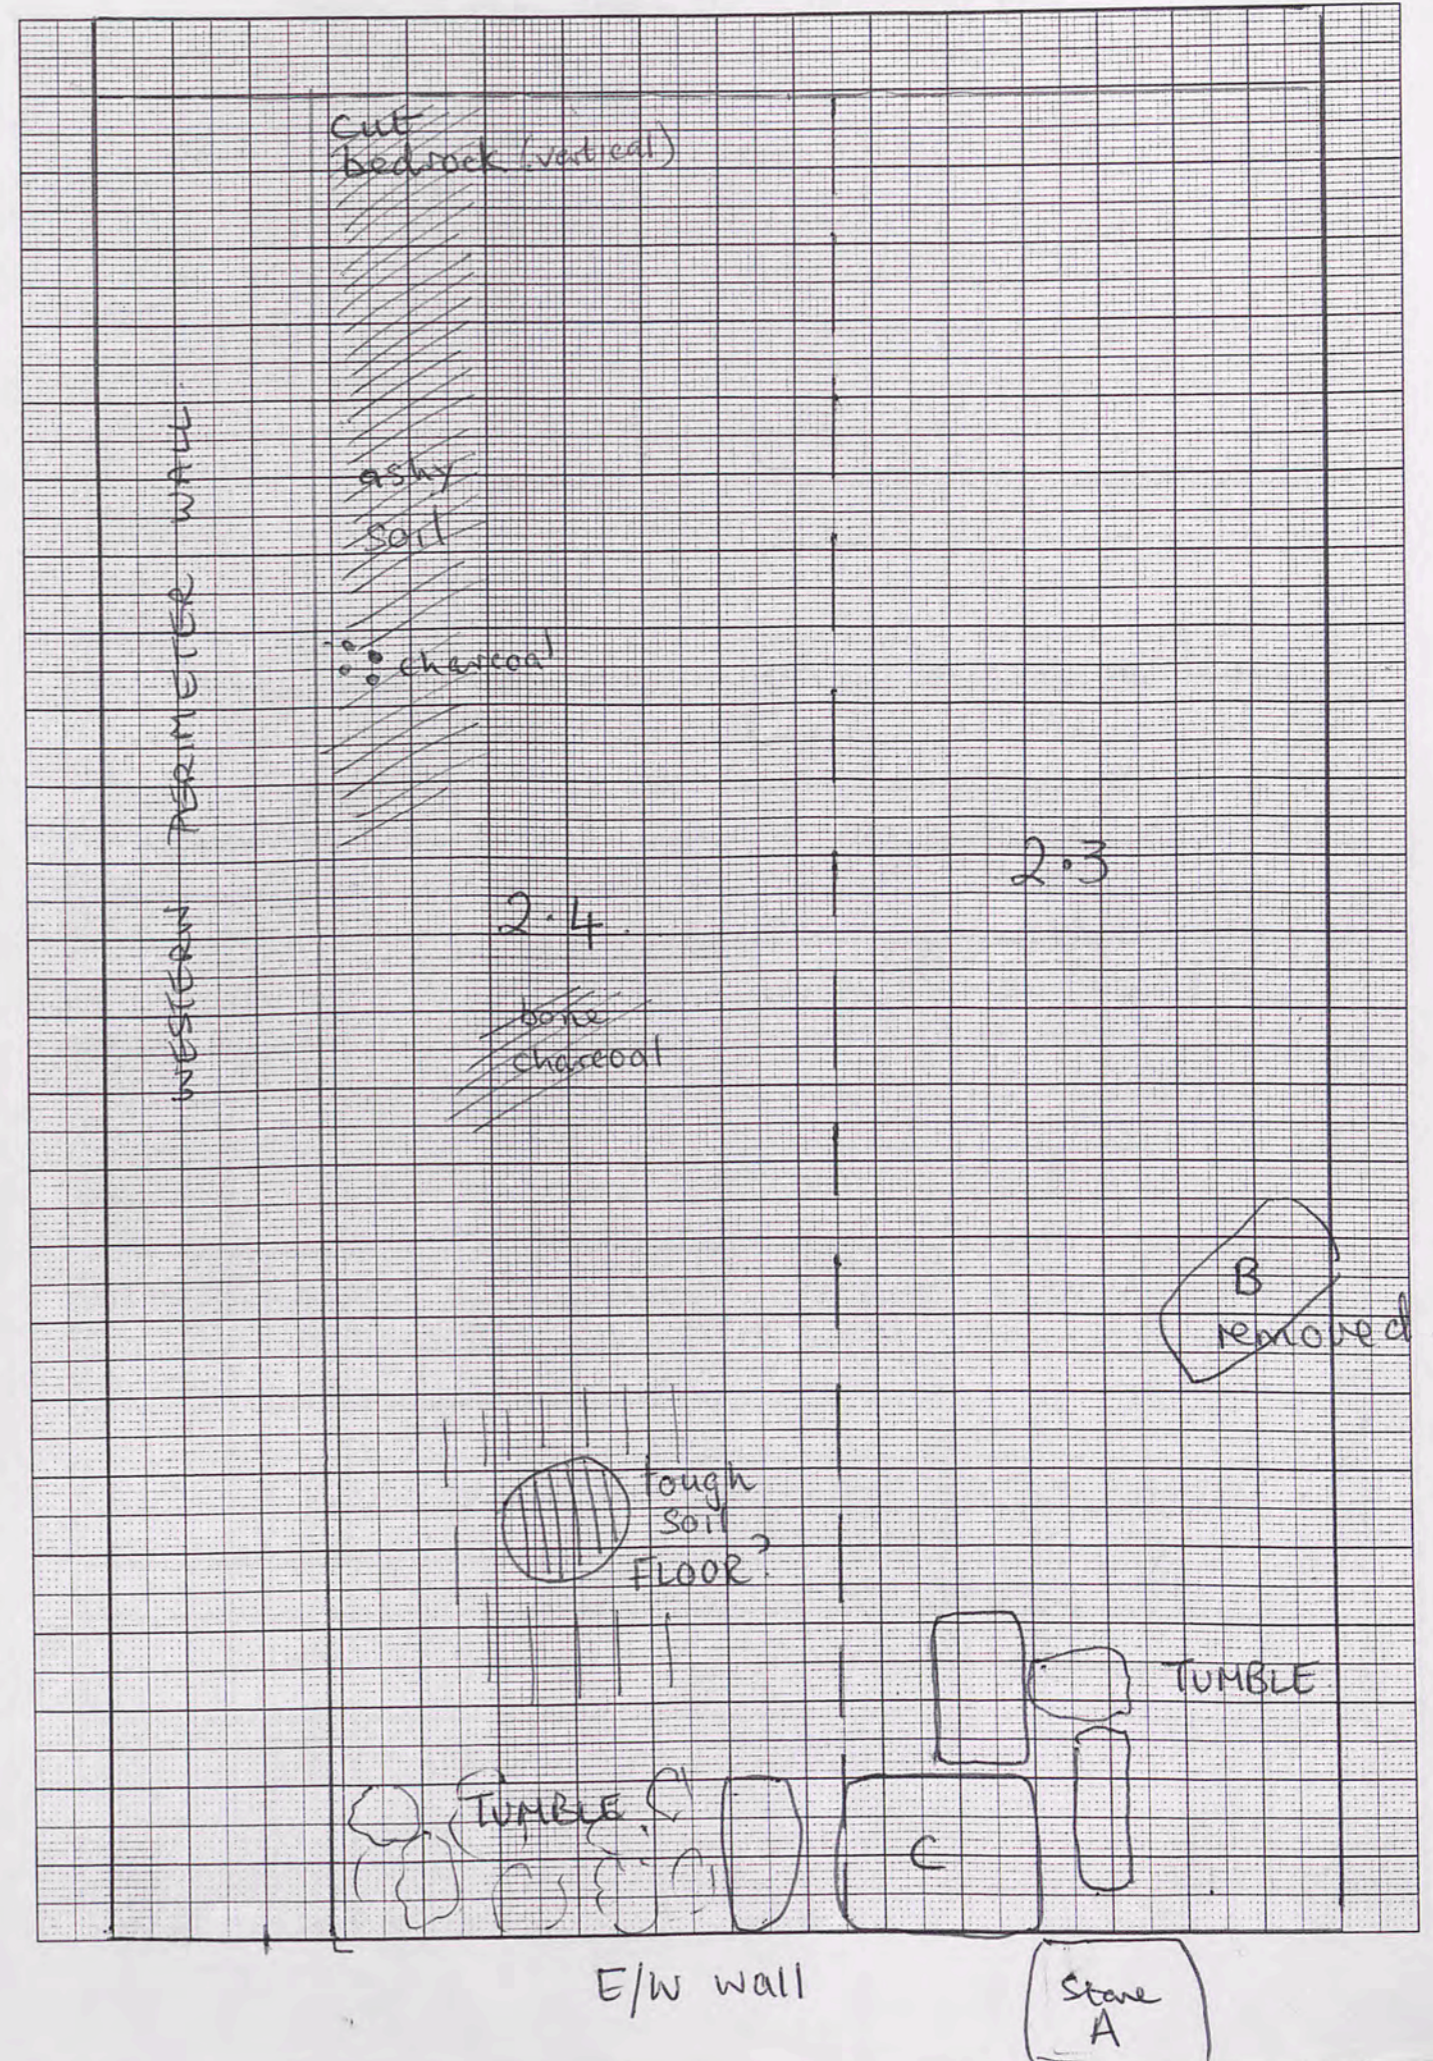
74/3 2.3 → 2.4

2.3.	Continuing to excavate this difficult locus and spit, which is still full of very large tumble.
	Conditions cold and windy, but dry, although the rain of yesterday has toughened the soil exposed.
Stone B	A very large door stone has been removed to rest on the East baulk. It was lying <u>ex situ</u> to the North of the doorway (see plan) on its side. It measures 73 x 50 x 20, with a bolt/hinge hollow on the narrow side.
Stone C	Stone C is of the same measurement. Have found a patch of possible FLOOR here (see plan).
	Charcoal from NW corner adjacent to wall. 170cm south of NW corner at 90cm depth. This comes from ashy patch of soil.
	In the NW corner an area of cut bedrock is apparent below the West perimeter wall.

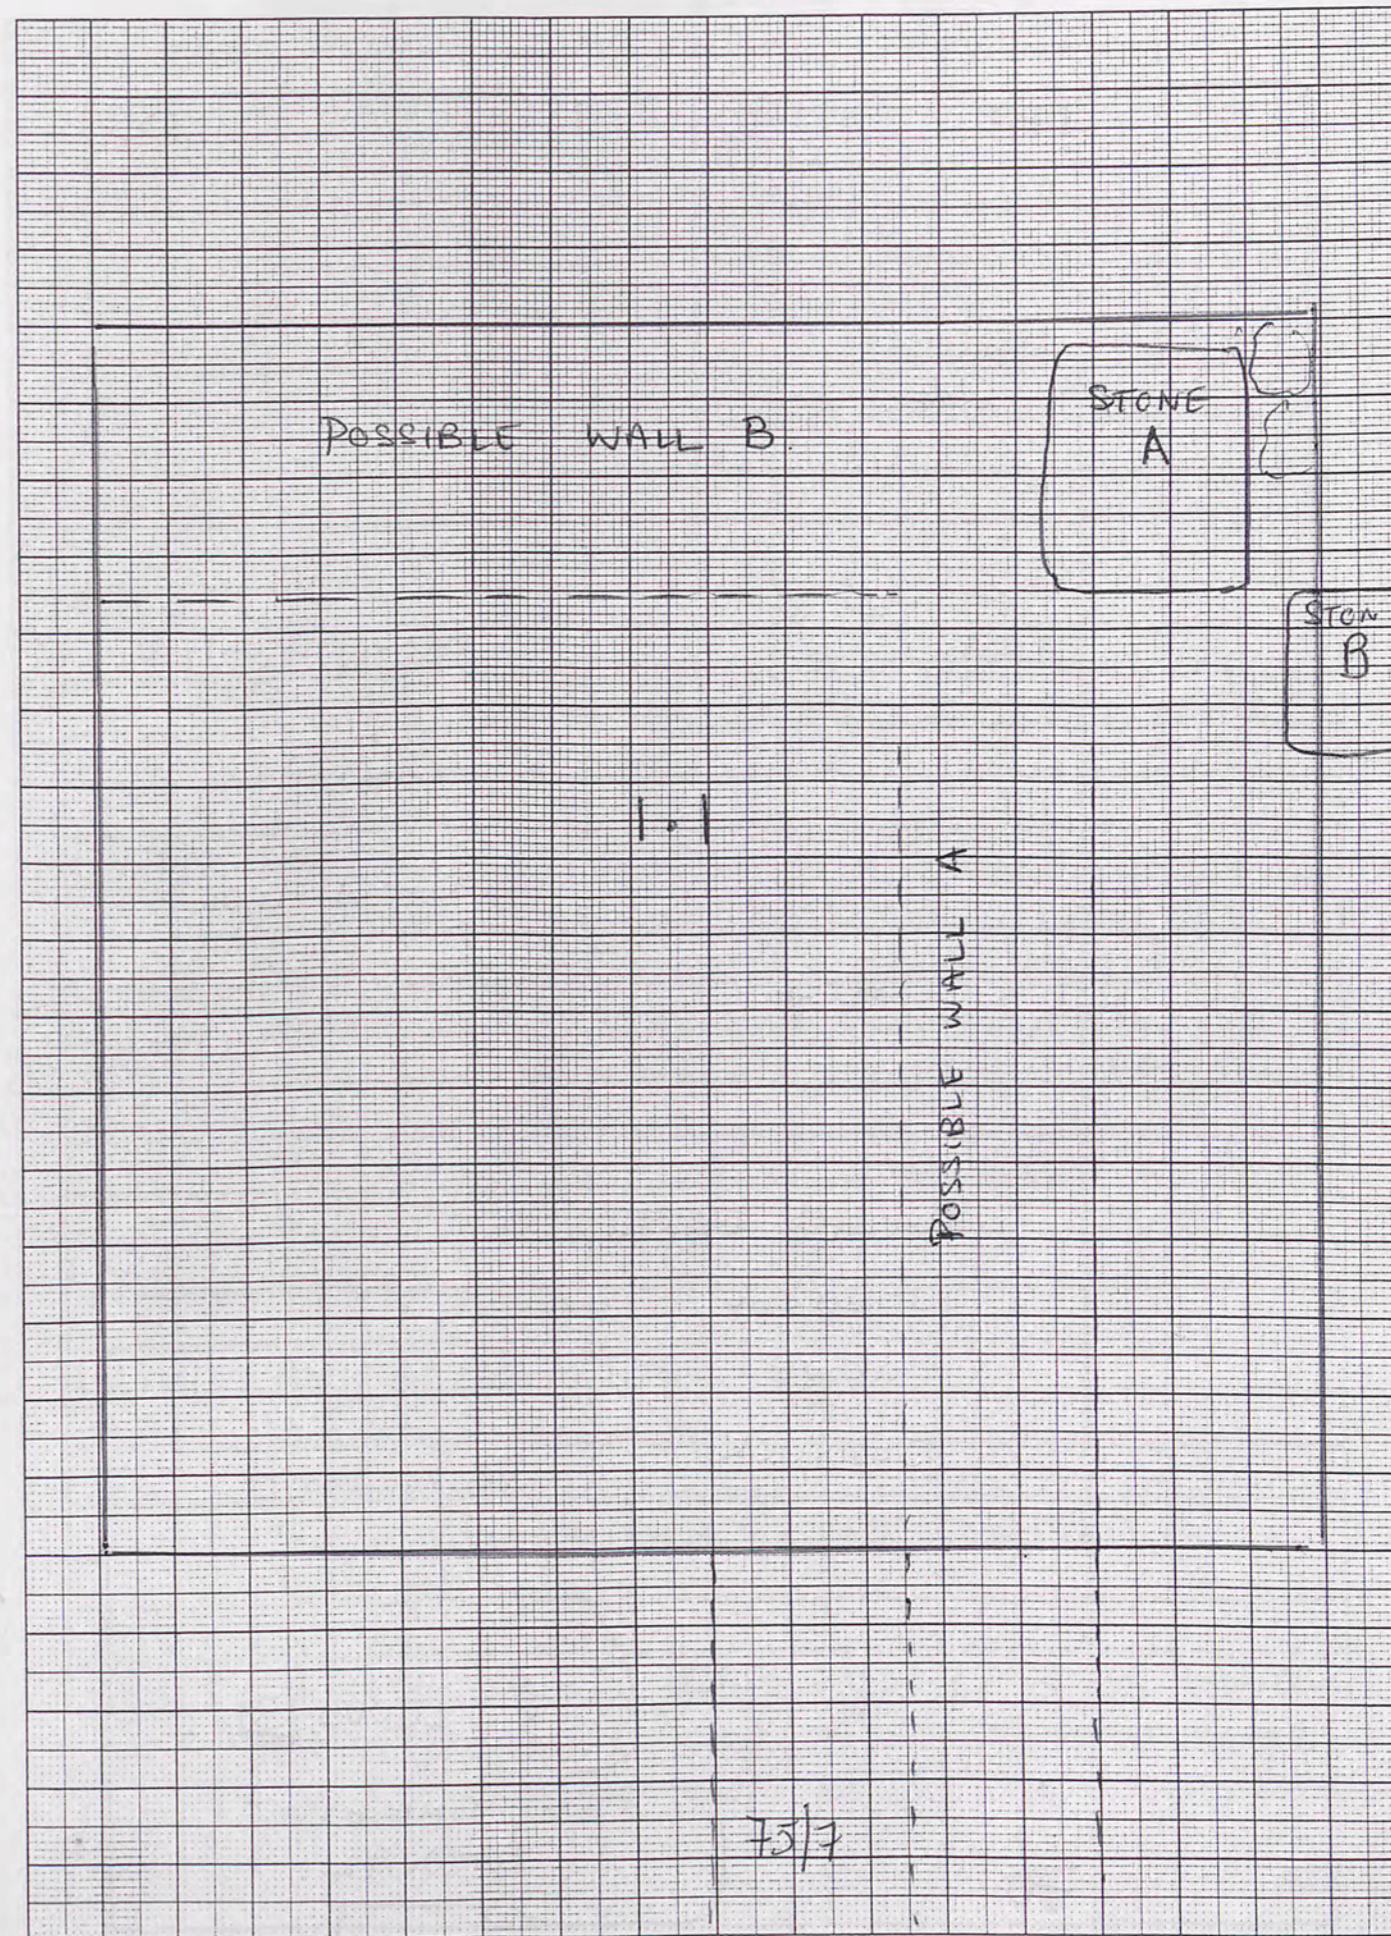
74/3 2.5 - 2.6

[2.5] Spit below floor in NW corner to find the extent of cut bedrock under the west perimeter wall. Here there is much charcoal and immediately two iron nail fragments, probably broken into the floor. At 10cm we find another floor surface below the above. An ashy patch appears against the North wall.

[2.6] At a further 10 cm bedrock.
 *3 4 frags of iron nail
 *4 loomweight.
 These objects were found together on bedrock.

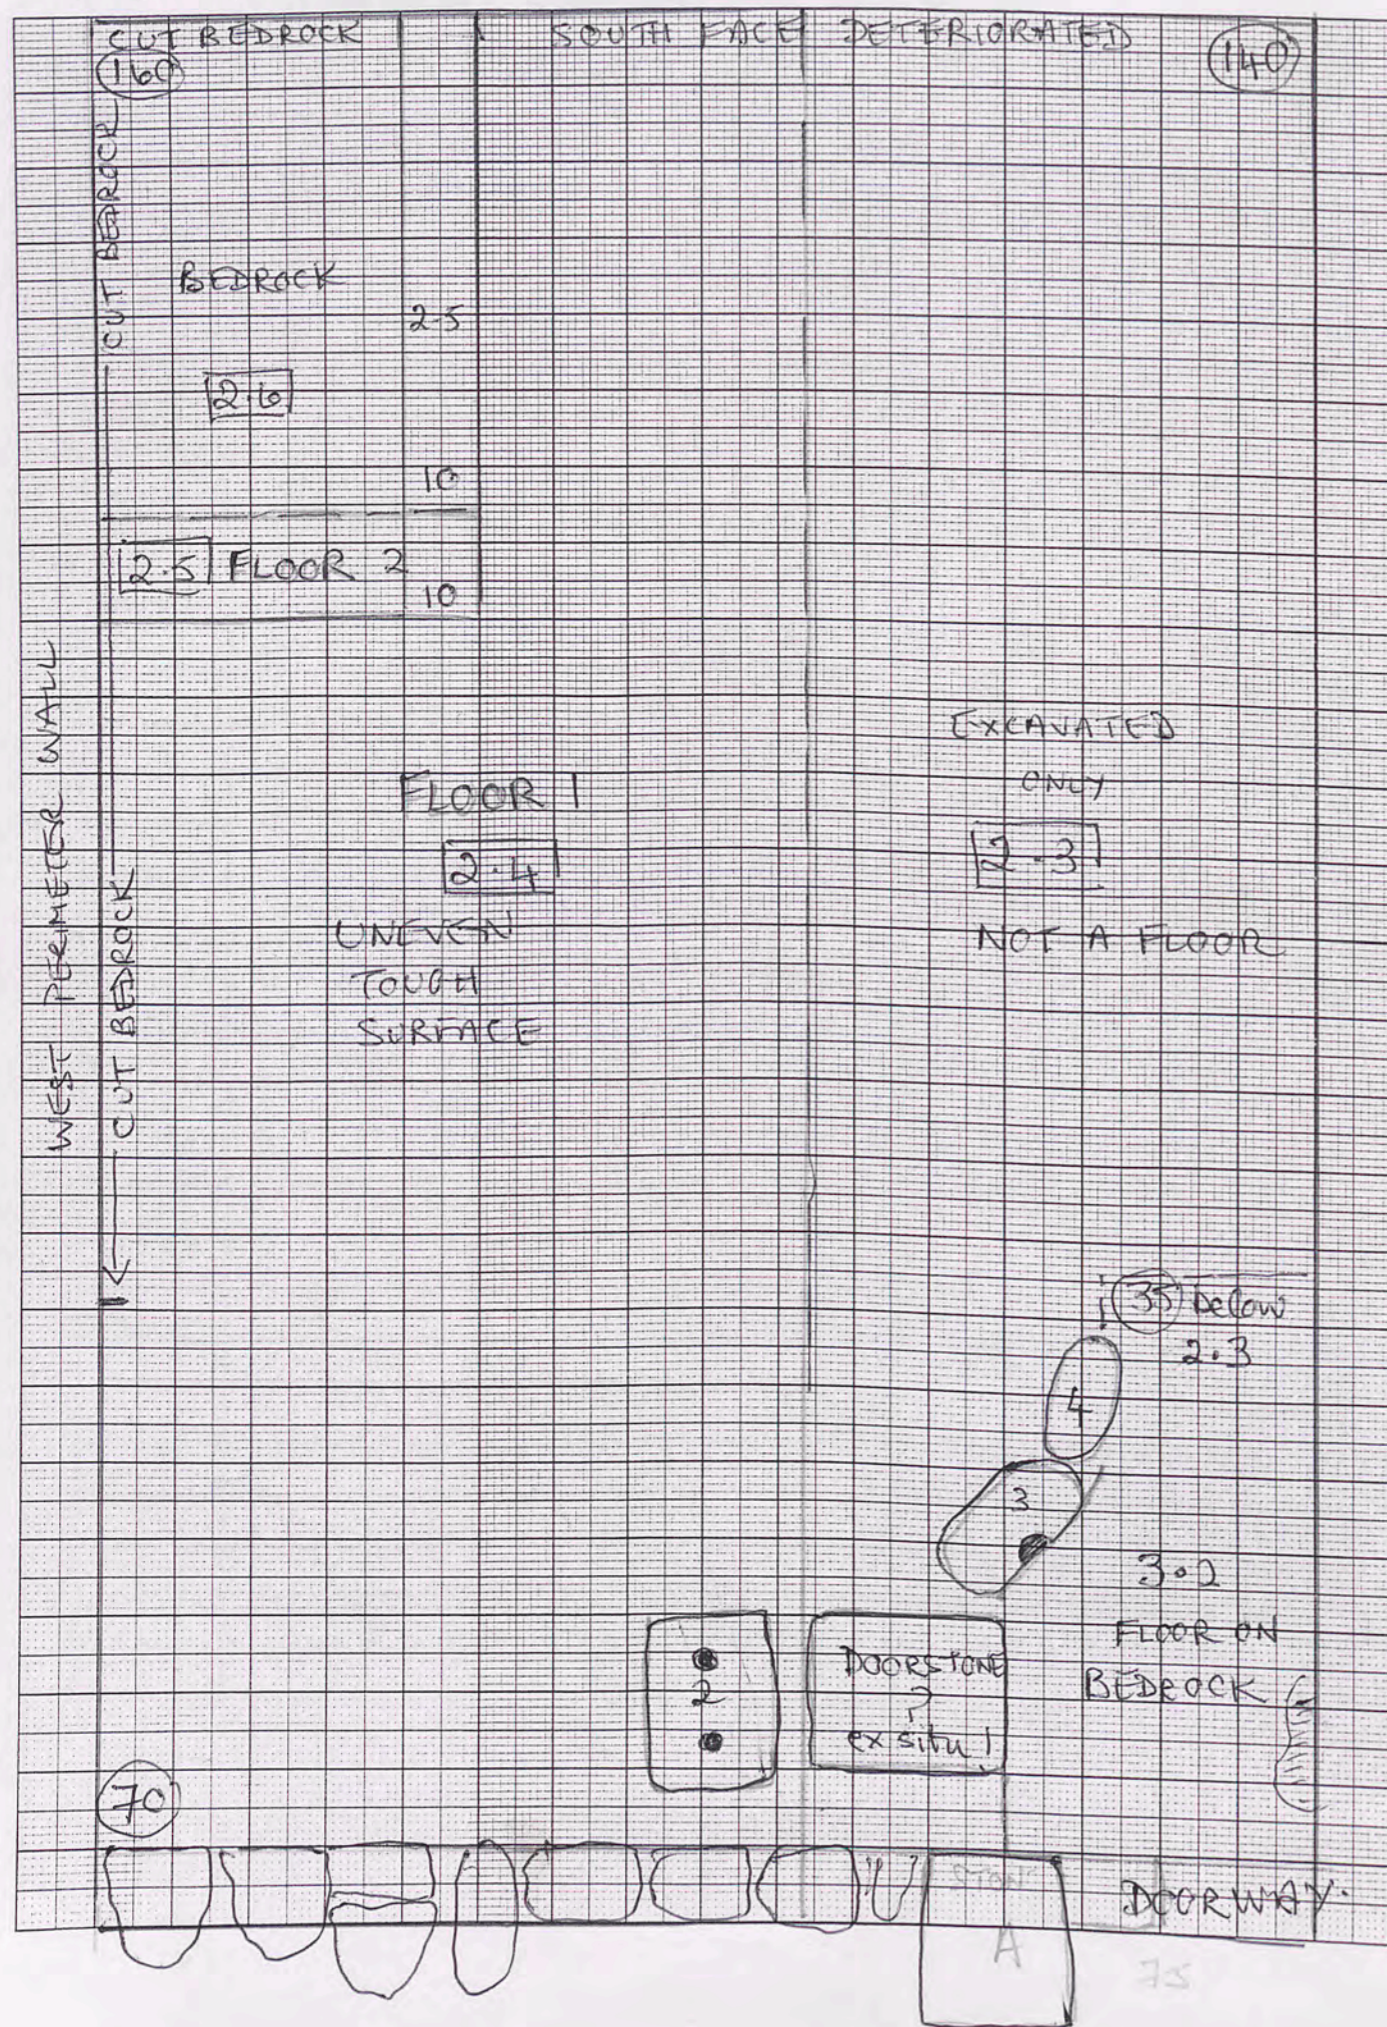
CORNER NORTH PERIMETER 74/3 FINAL

After cleaning the walls down, we are excavating a second spit in this doorway locus, to reach the base of the hollowed-out doorstone sitting presumably on a floor level which is lower than that found in 2.4. A patch of very black soil and burnt river pebbles is at the base of the hollowed stone. Some bone here
