Jebel Khalid 2000

Field Record Book

Name..... HEATHER JACKSON

Trenches..... 74/2, 74/3, 75/8, 75/9, 75/3, 75/6-9
..... 75/9-8, 56/2, 57/7, 57/8, 74/9, 57/4

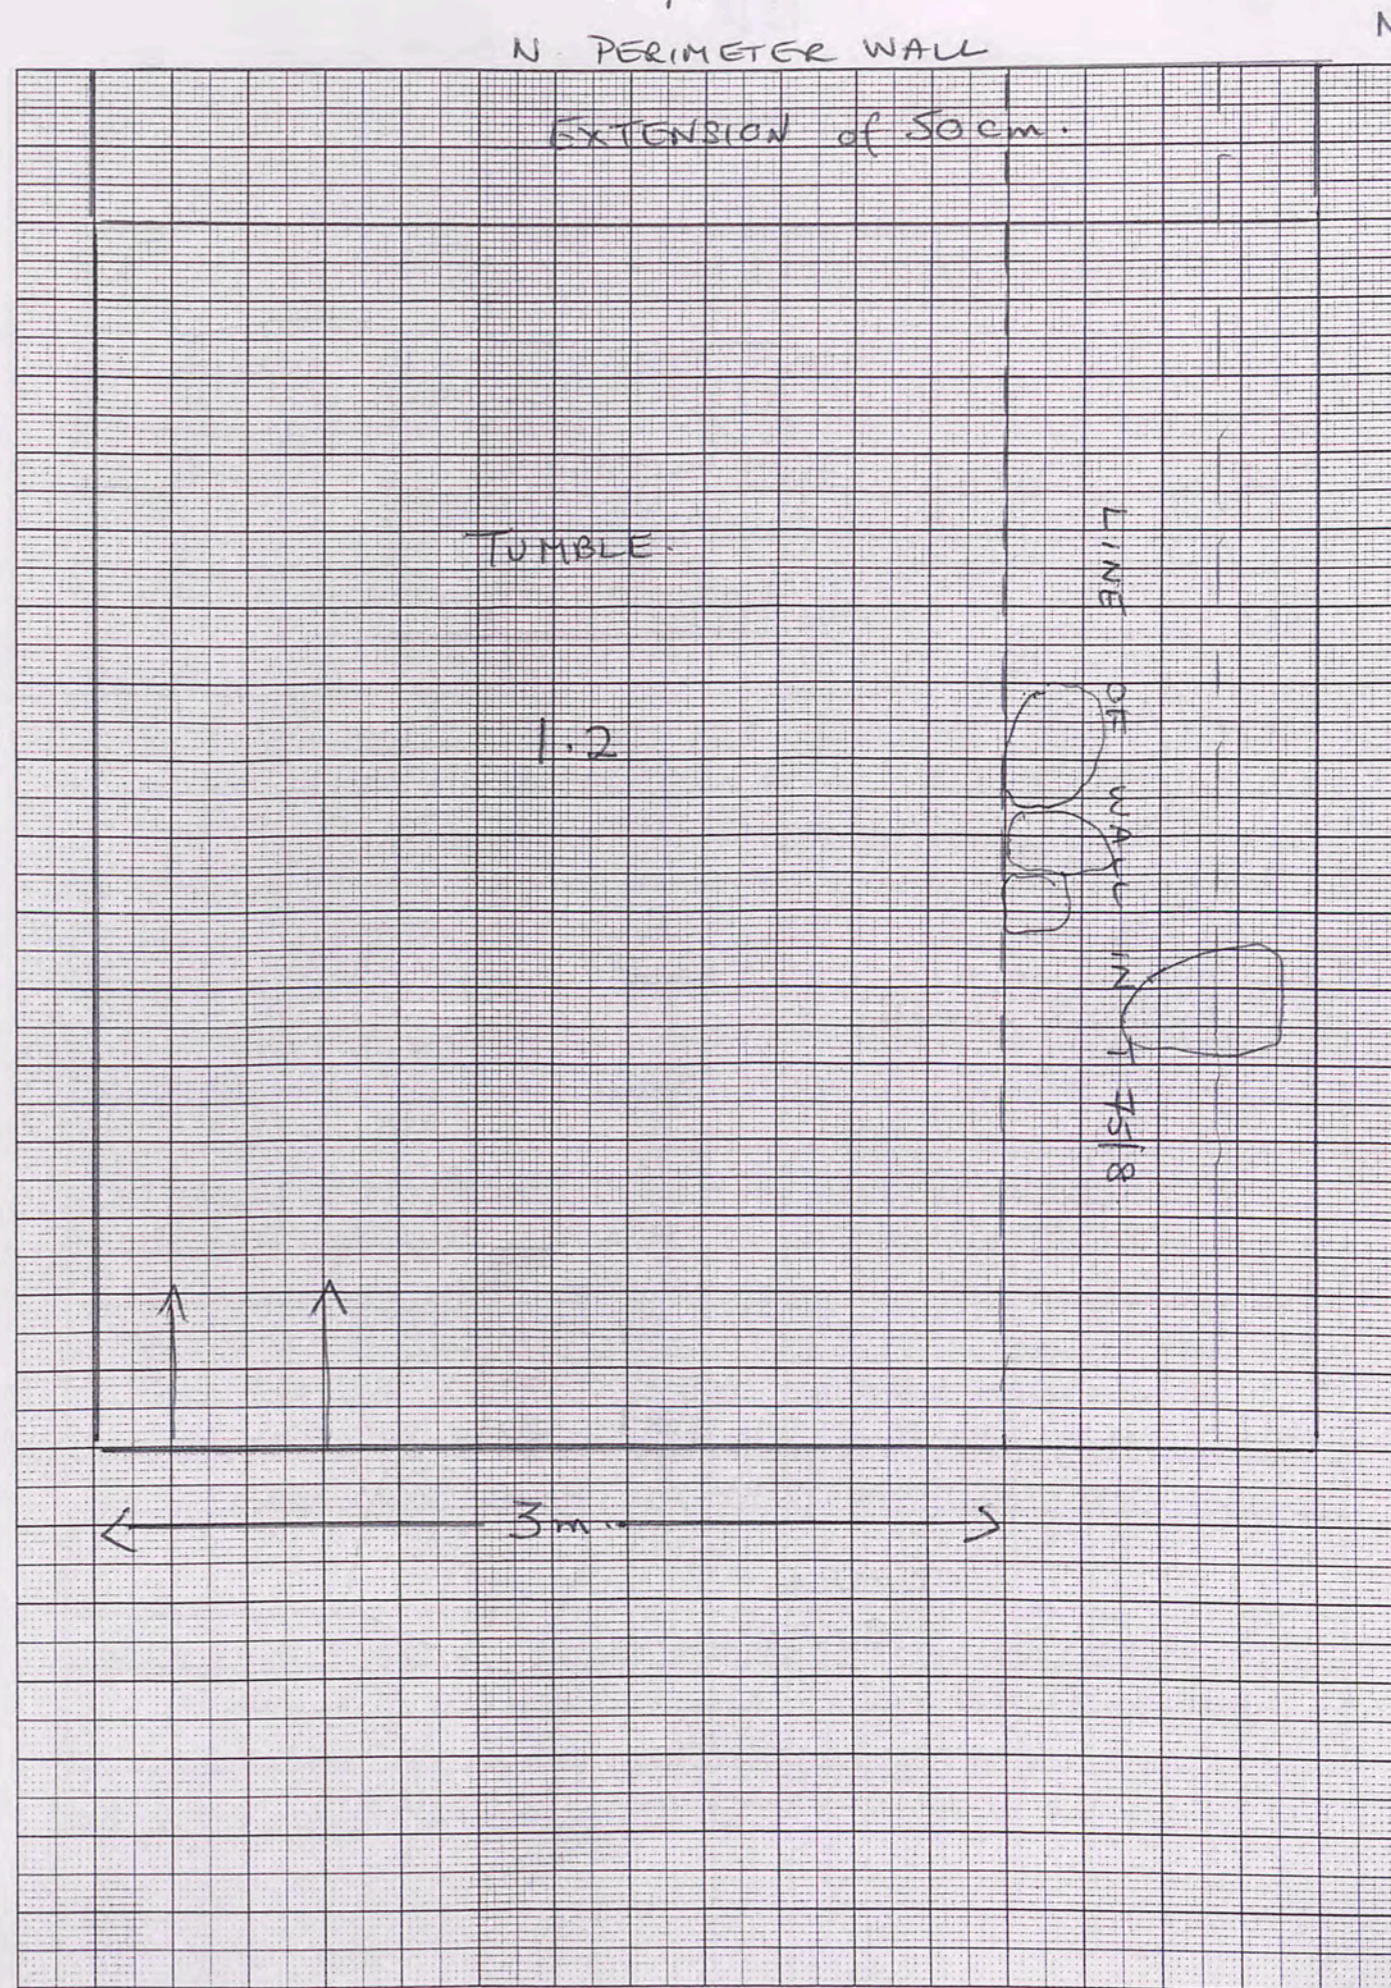
7518

Context	Report
2.2 East	Removing the muddy eastern half of locus East (2) to the same level as 2.2 West. This consists of a thick layer of loose brown soil, empty of tumble, whereas in 2.2 West there was a small amount of tumble. There is some tumble further East, obviously from Wall A. Wall A west face is now clearer and more regular.
2.3	Clearing bedrock spit below 2.2. A bedrock "shelf" (not yet clear whether cut or natural) has appeared along the south face of Wall B (E/W). Was it cut for the wall? If so, we may have removed some of the south face, or it has fallen? Unlikely - we are still in line with the E/W wall in T 74/2.
2.4	An area of very black soil in SE corner. Leaving this for later excavation but have collected ashy pottery (2.4)

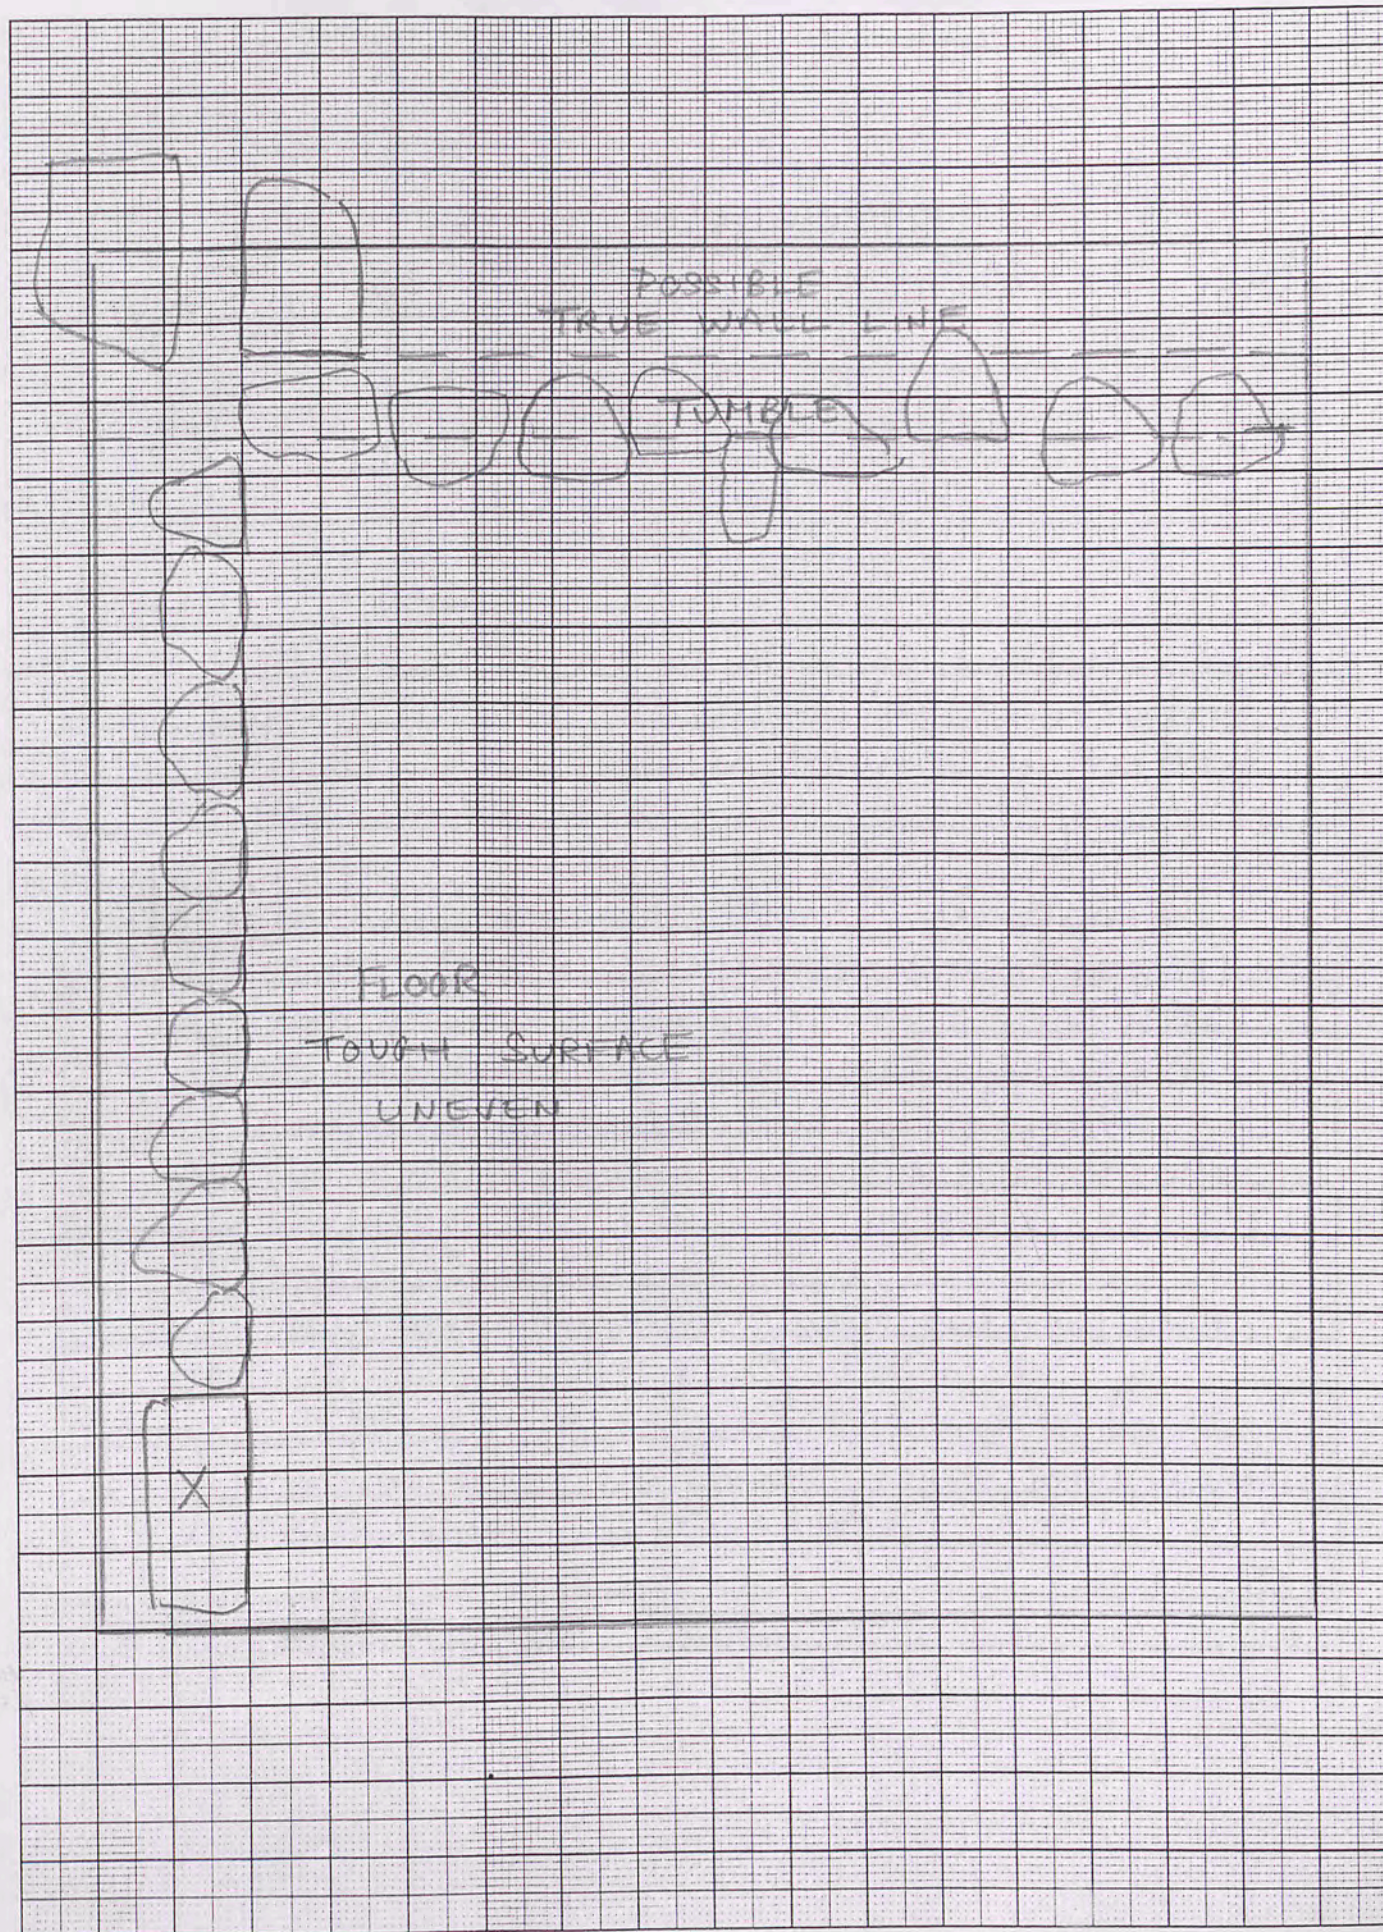
75/9 FINAL

Context	Report
1.6	FLOOR cleaned to a tough surface, but very uneven, at depth of 100cm in NW corner. The floor is tougher in the West than in the East.
2.1	We now excavate locus (2) which is the area left unexcavated in the East of the trench - unevenly 100 cm in width. It was left because we suspected a continuation of the wall N/S in 75/8. We work carefully to the East looking for a wall. The locus is entirely tumble, equivalent to 1.2. Two large blocks found side by side which may be part of a wall. Wall did not happen. Cleared to baulk.
2.2	Feature A: NE corner black tough patch
*1	Glass toe in Feature A
*2	" " " "
	Soil sample taken

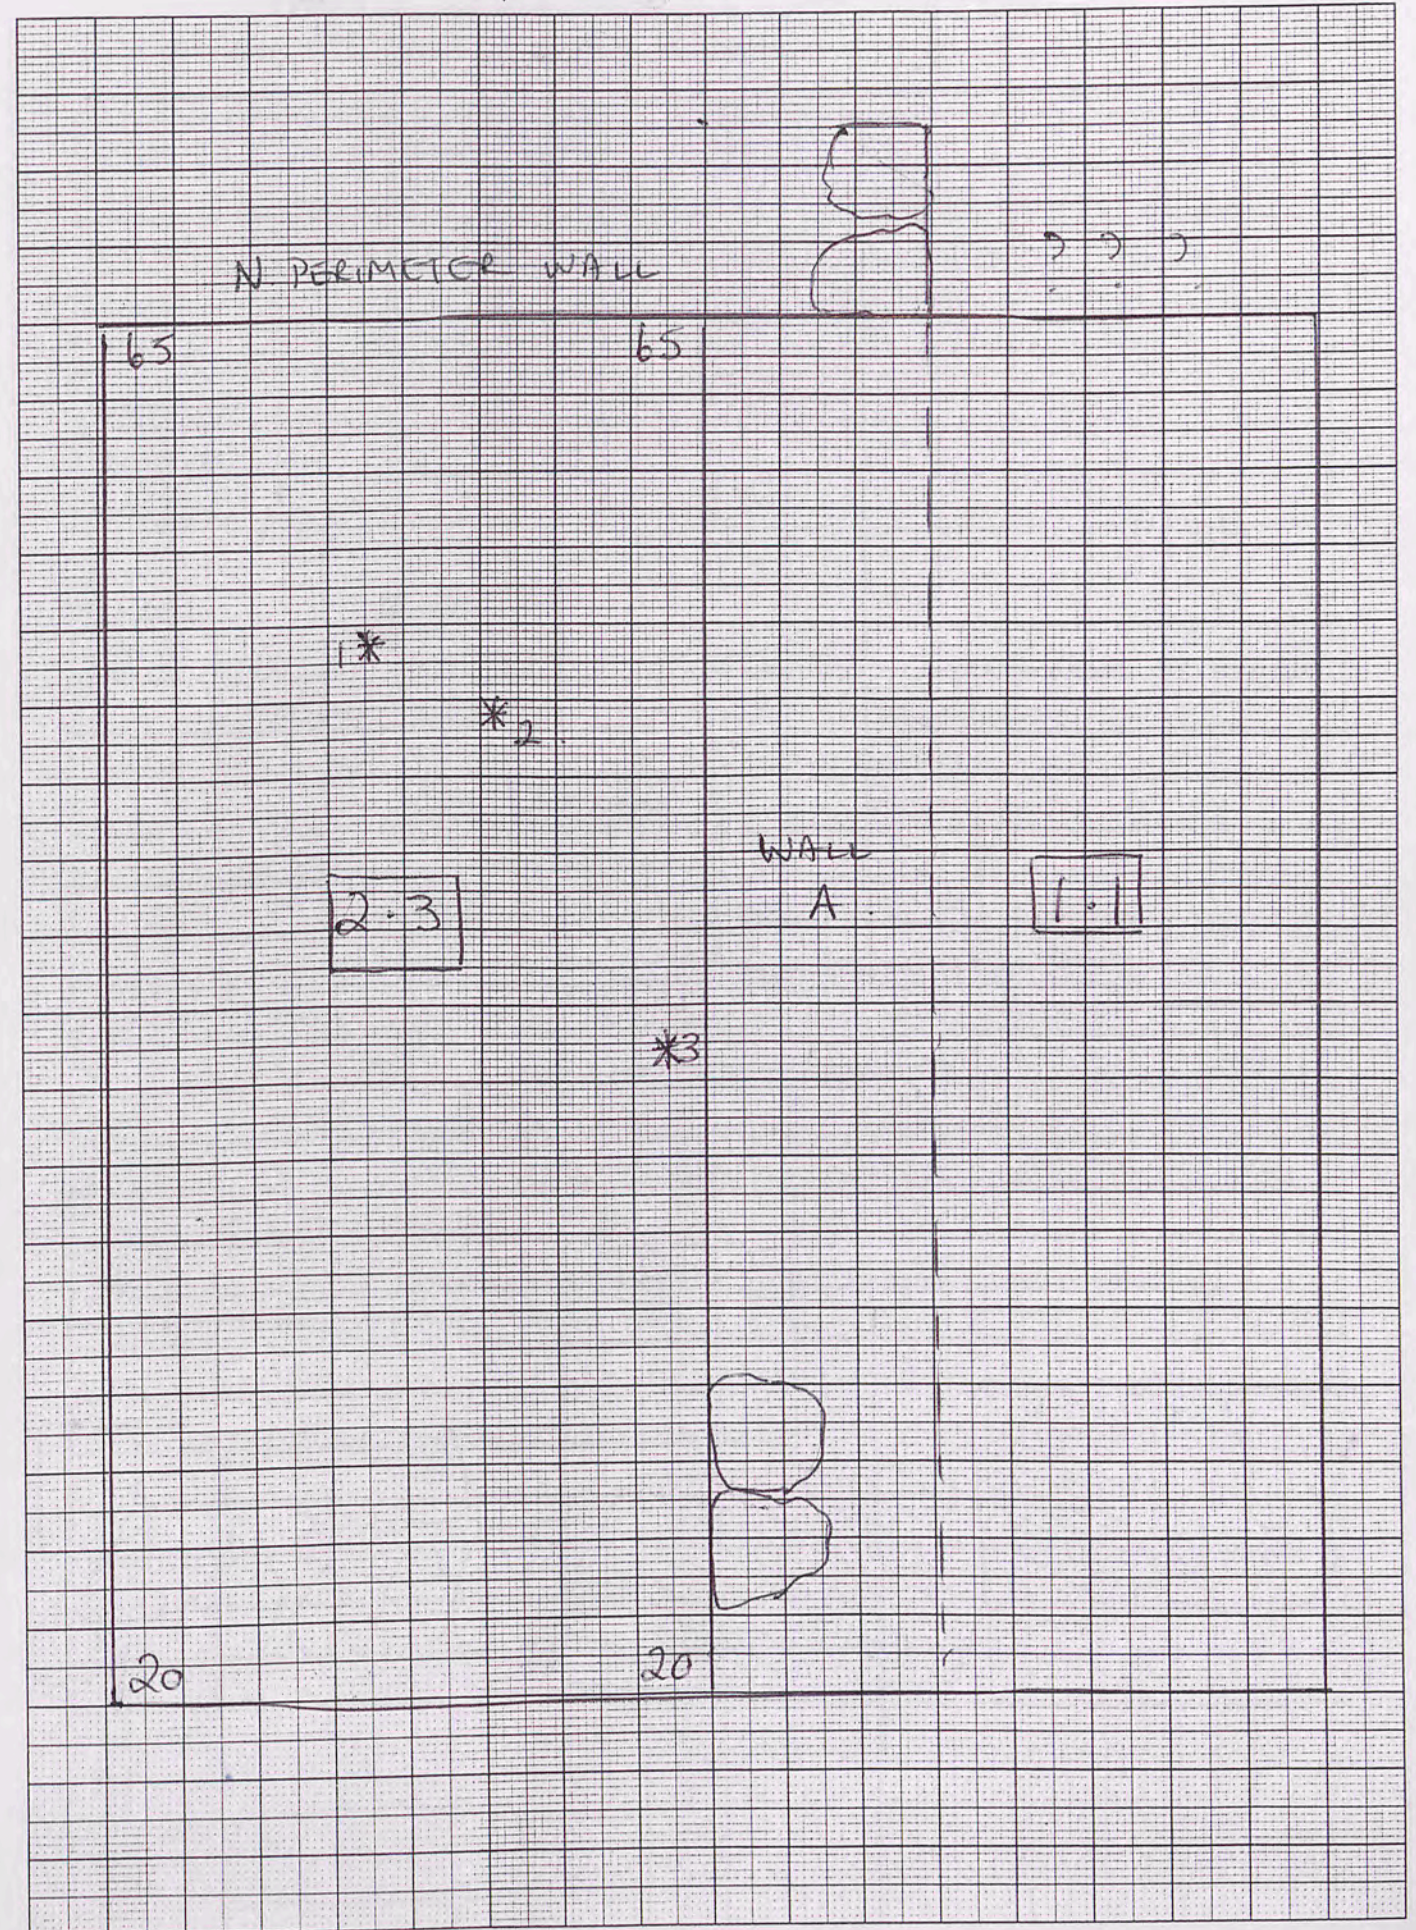
75/9 BAULKS

Context	Report
2.1	This locus is North of the doorways (3) which are temporarily abandoned at 3.2 in order to find a N/S wall, crucial to the interpretation / reconstruction of the doorways. There is no sign of a wall on either face of the bank. 2.1 is the upper stratum = topsoil and tumble.
2.2	Having cleared topsoil, this spit is removing the tumble, which seems to constitute the whole of the baulk contents. The existence of a wall now seems unlikely but we have to be sure.
* 1	Shell frags found between tumble
* 2	Iron frag " " "
	Still removing tumble - all resting ashen in loose soil - no wall.

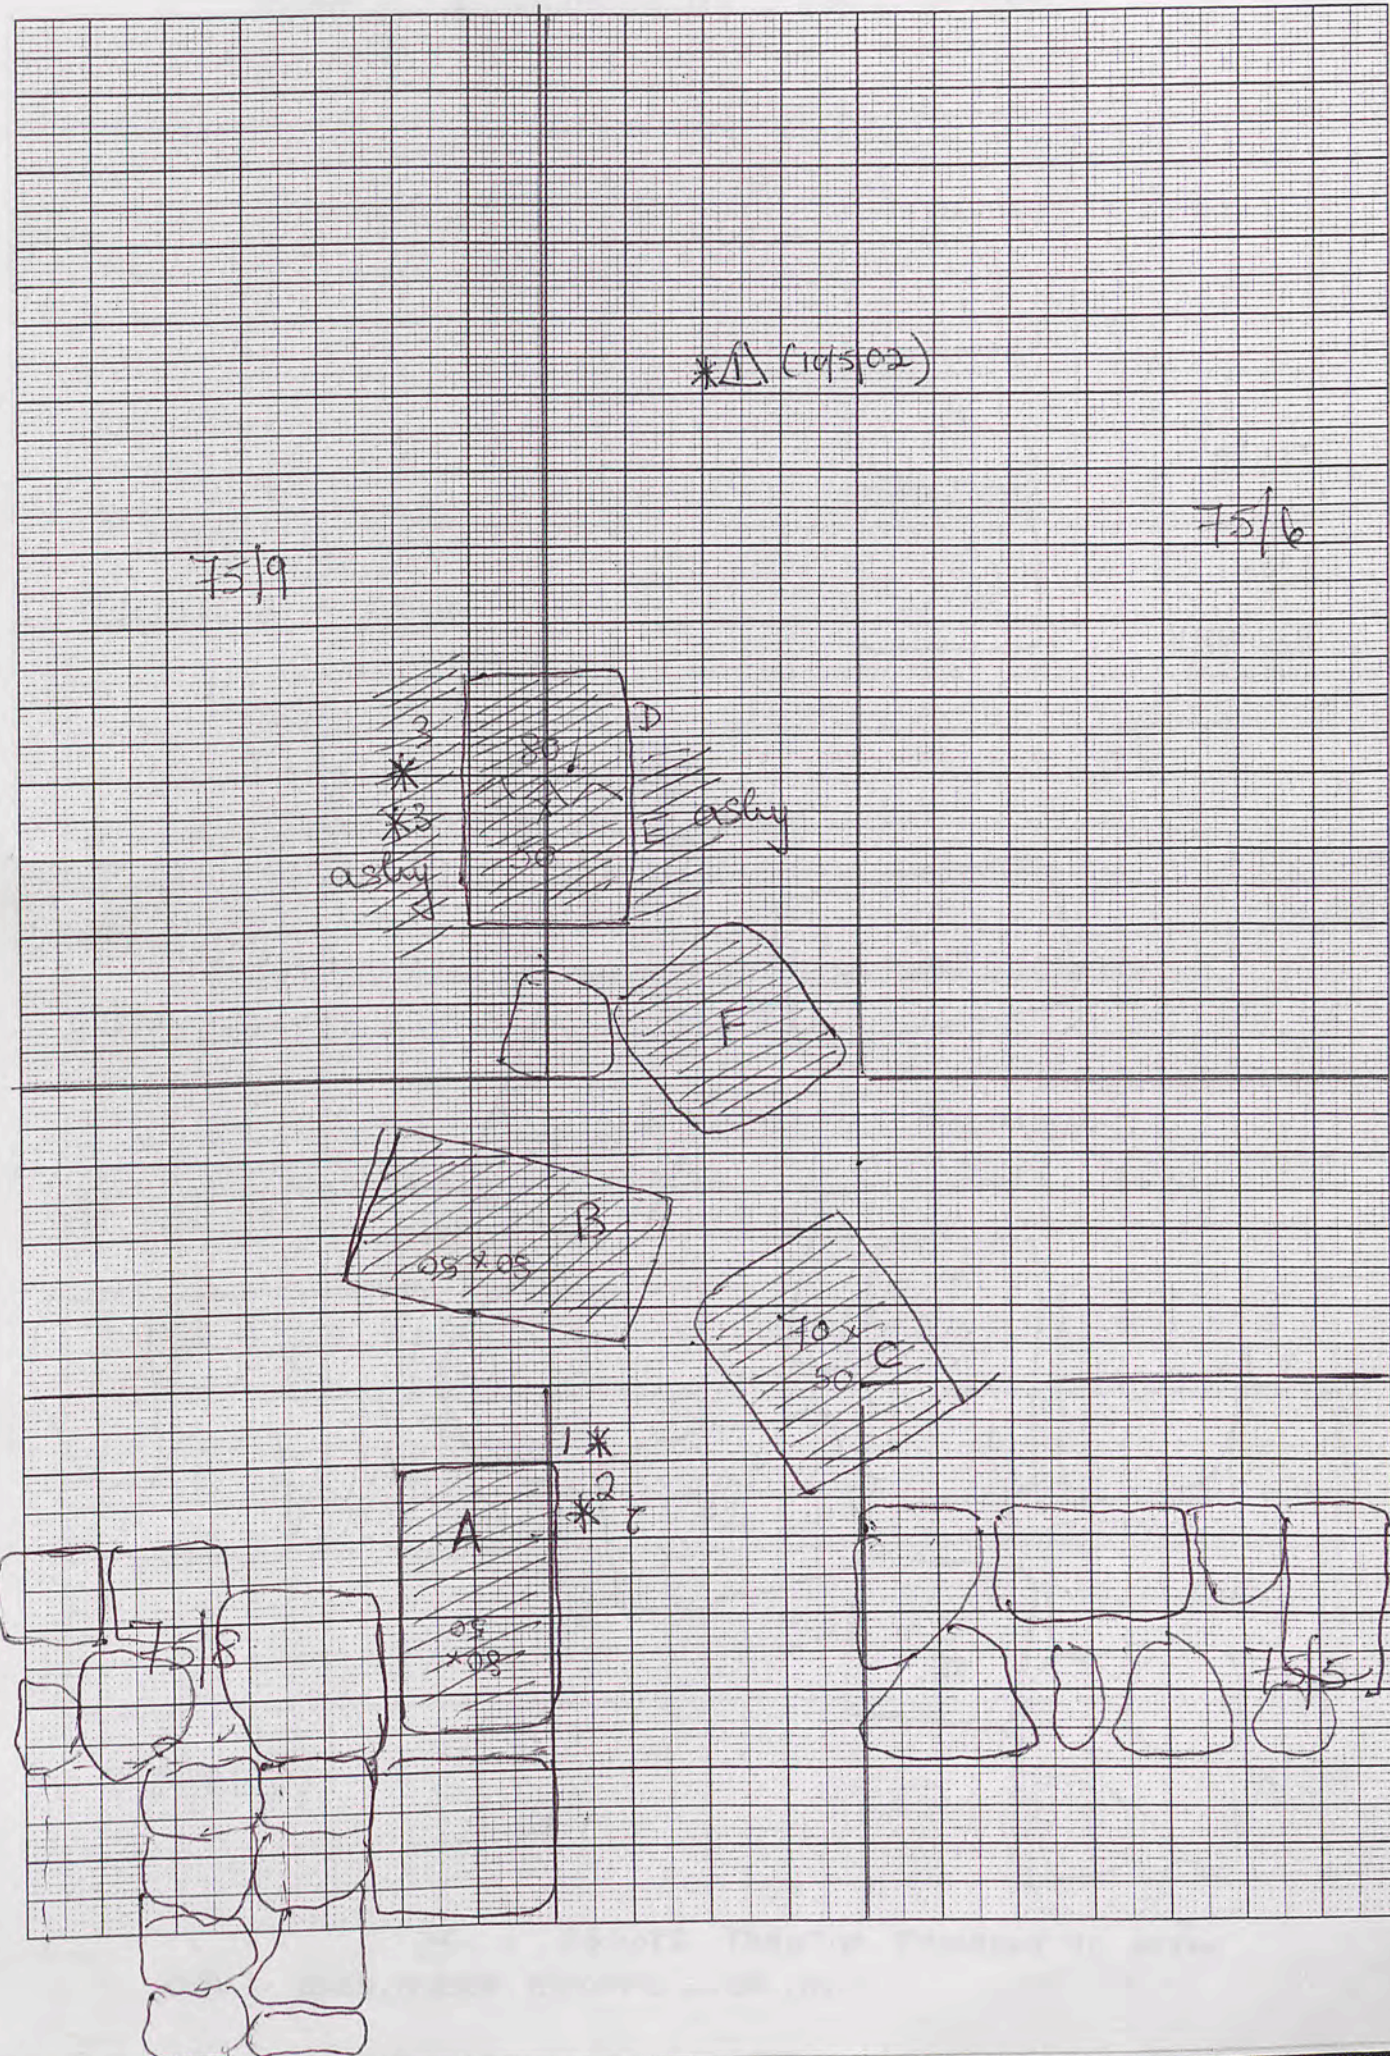
FINAL DOORWAY AREA
75/9-8 and 75/5-6

Context	Report
	FLOOR CLEARING: The baulk area between 75/9-6 had not been cleared evenly to the annular floor. This is now being done. Store D/E is the focus of a patch of very ashy soil. Noticed G07 handle of small jar in pottery - this on floor. 10/5/02 (Saturday) Continuing to clean floor of this large area x/1 Glass rim frag (bowl/cup) found on floor The ashy lens is very clear on the W. face of the western wall - the wall is actually burnt. No pottery.

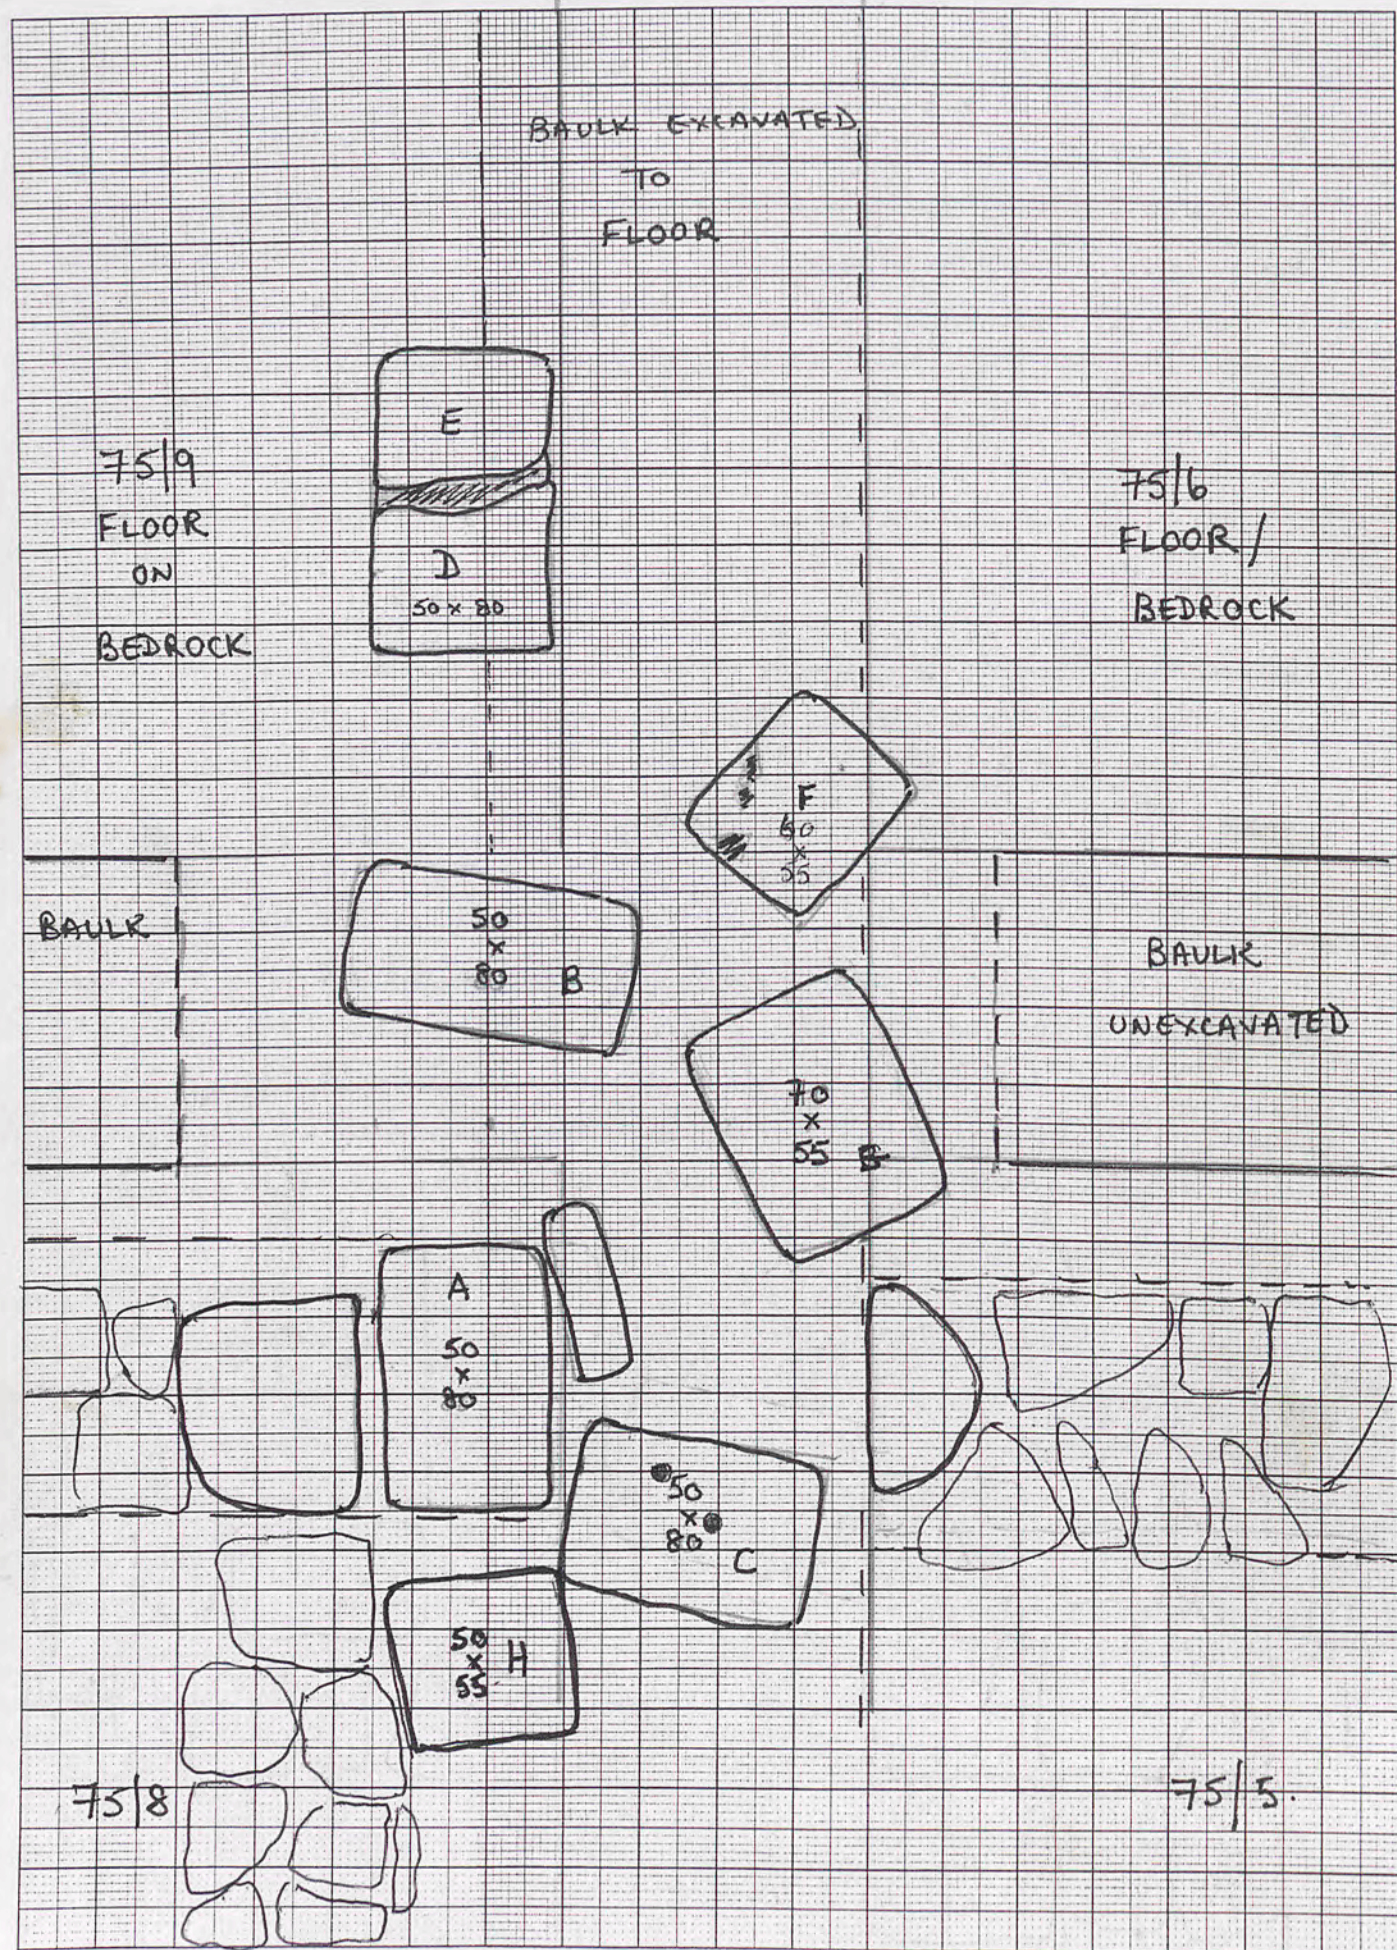
WIDTH OF DOORWAY WITHOUT STONES = 175
" " WITH 25cm STONES RESTORED = 125.

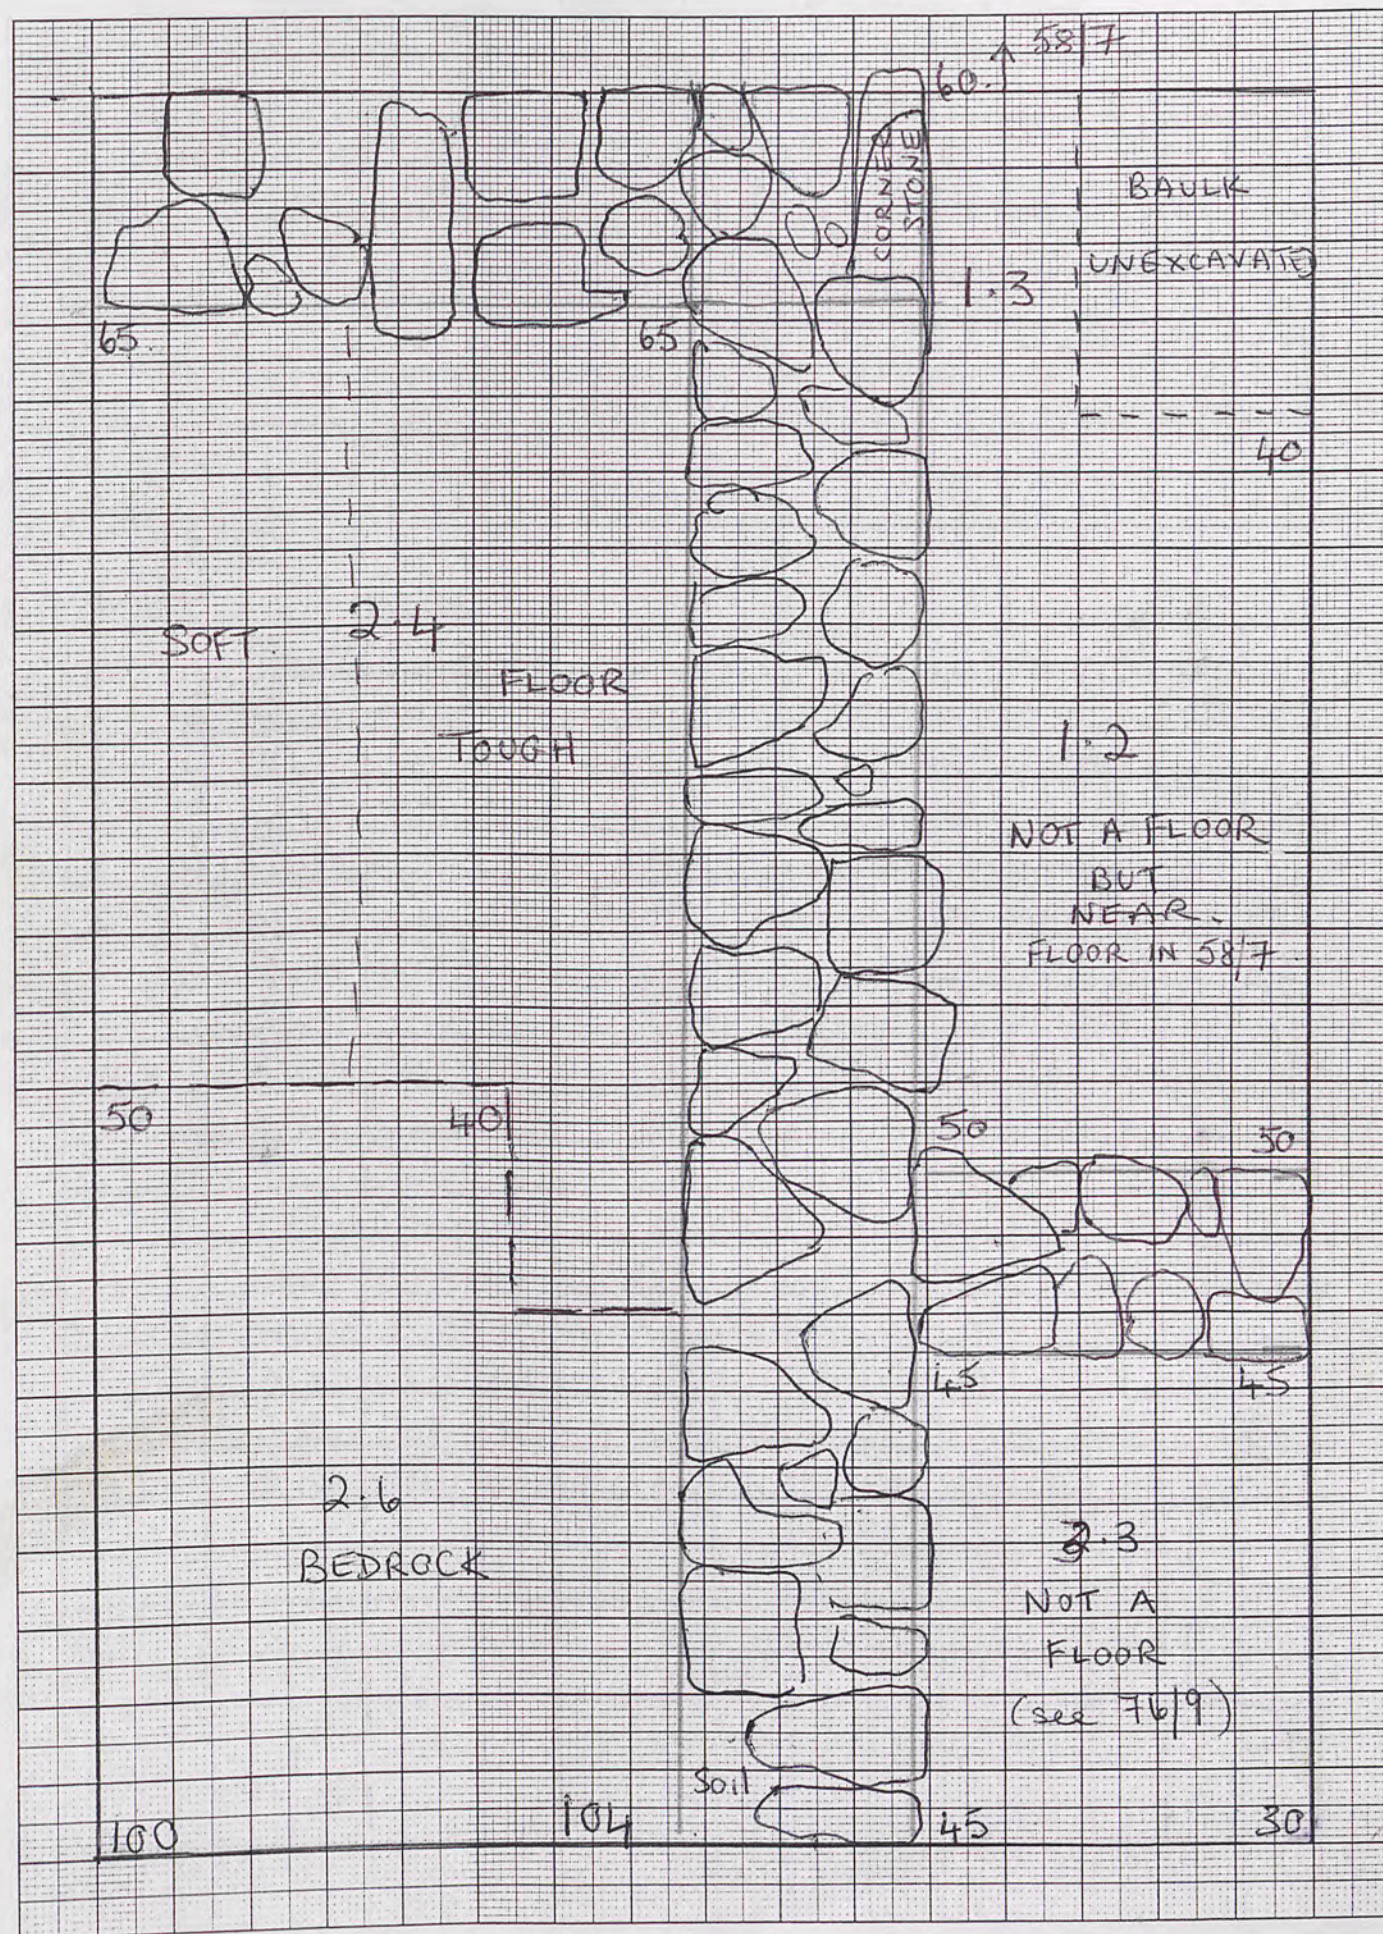
FINAL TOP PLAN 75/3

Context	Report
1.2	Today we finish this spit, which was extended to the North to include the NW wall corner, now clearly exposed. There is still, even in this small space, much large tumble in loose brown soil.
3.3	There is no point in excavating deeper, since, floor/bedrock has been reached in the same "room" in 76/9.
	Cleaned & photographed.
	For final report see pages after 13/5/02.

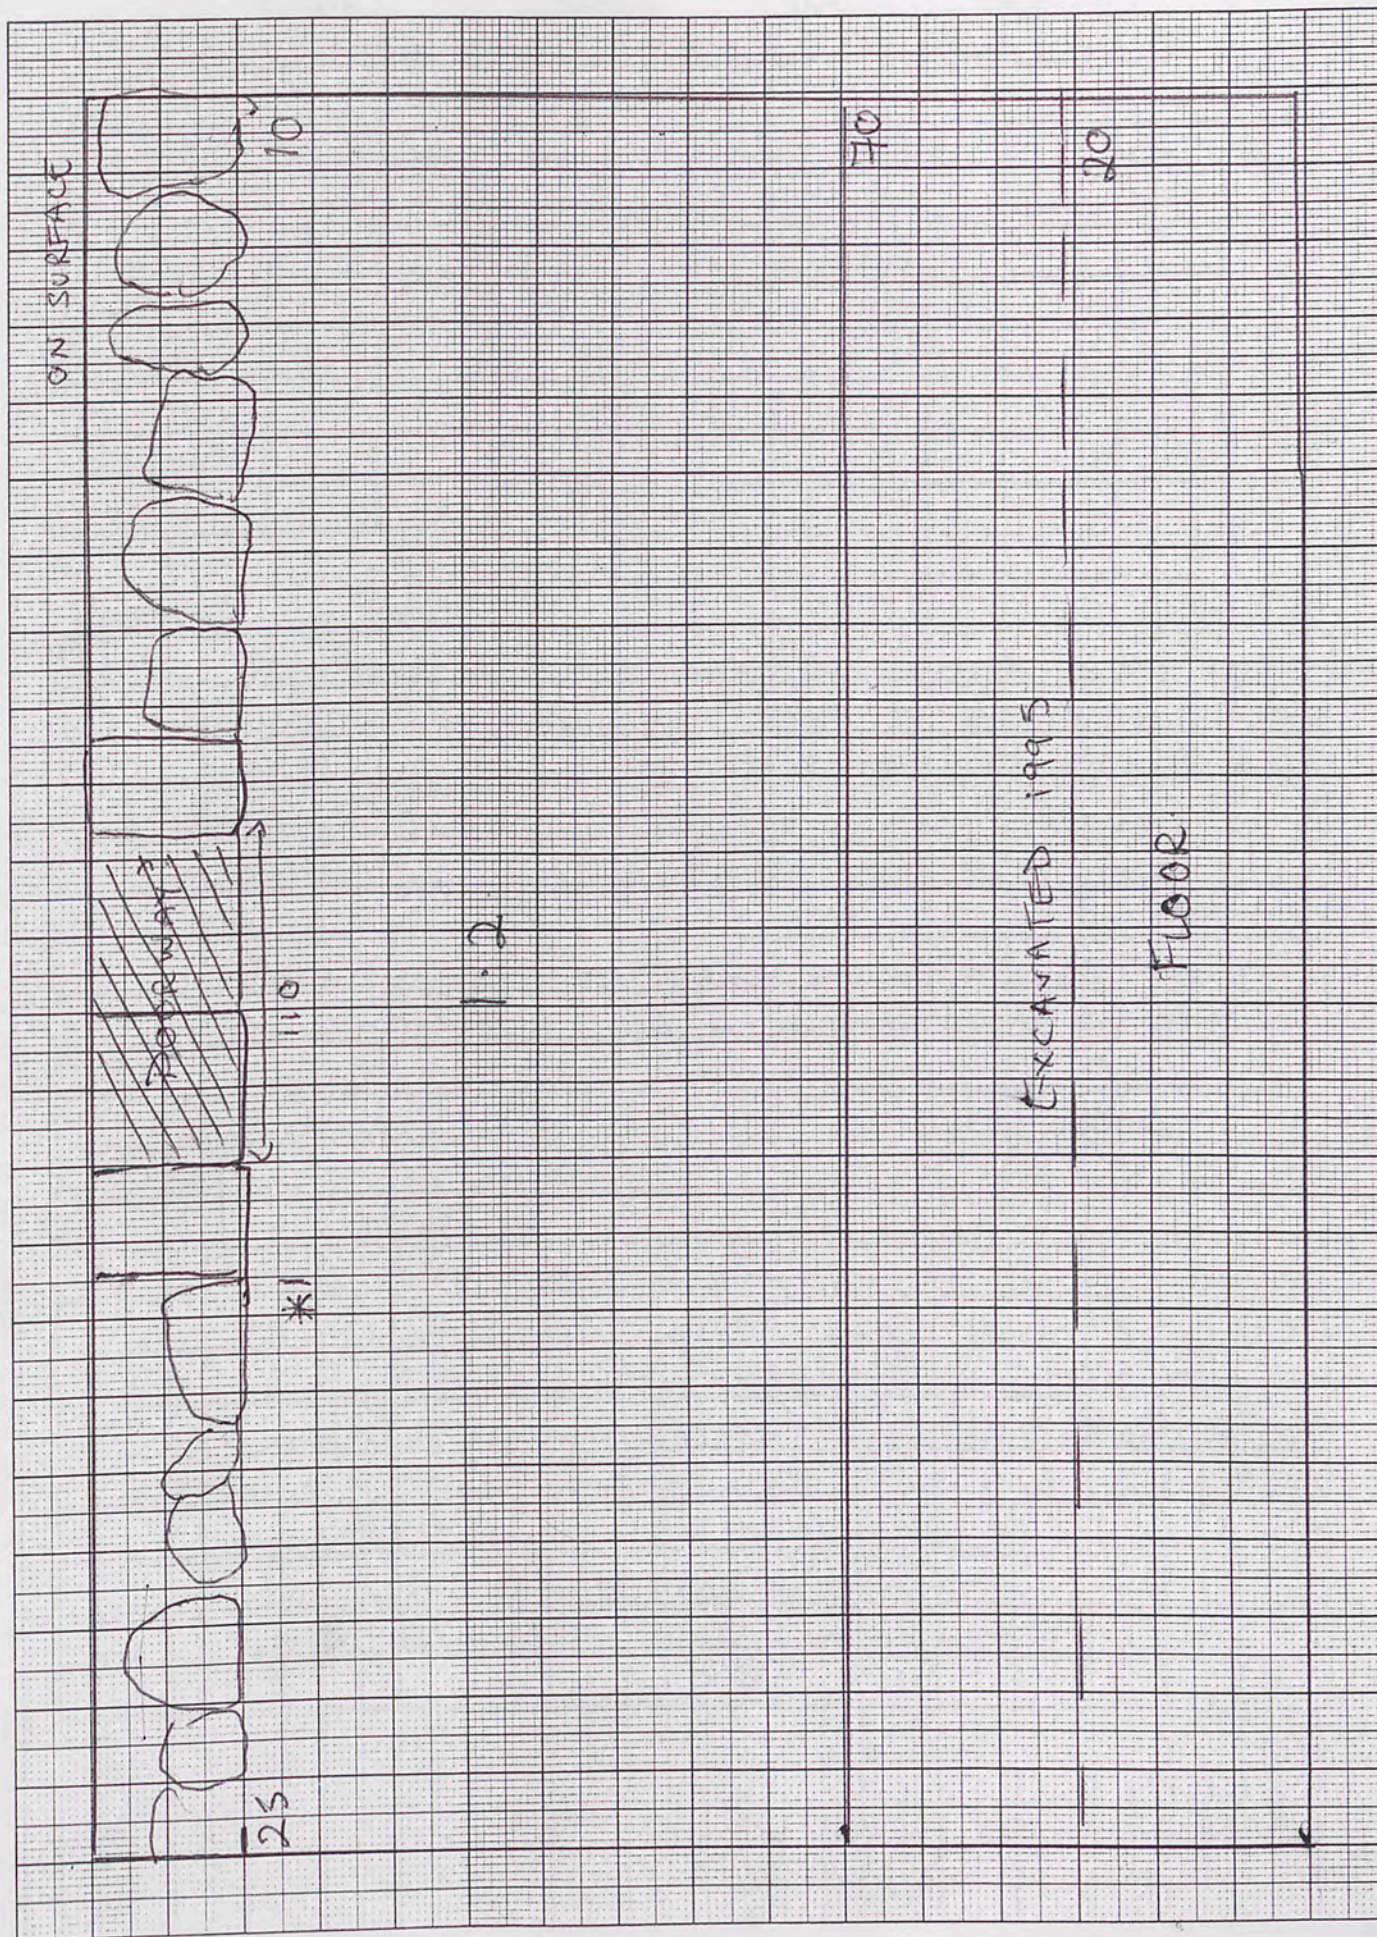
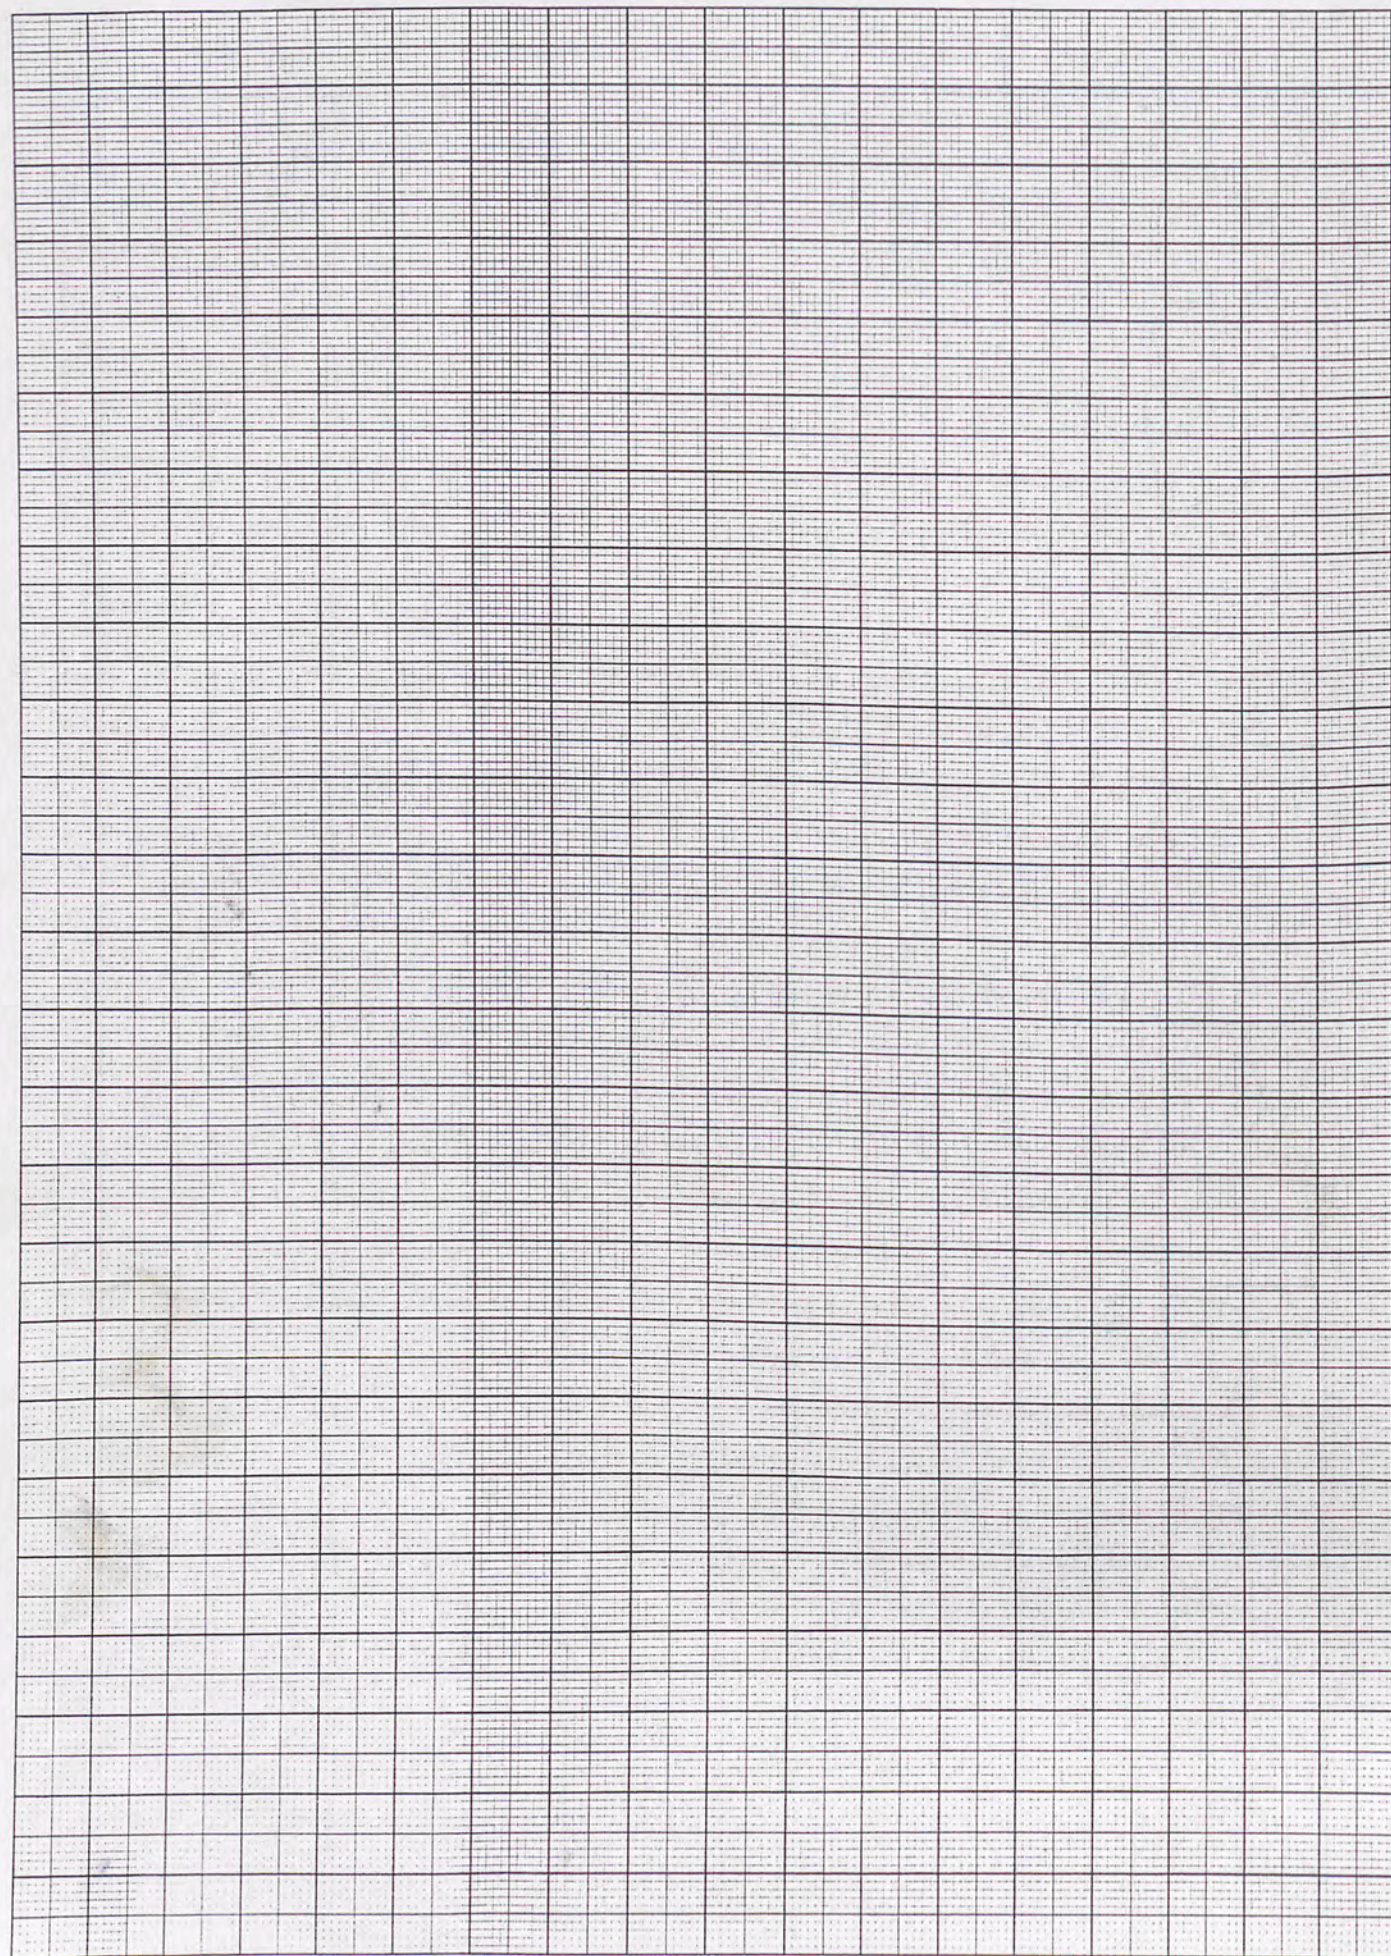
Context	Report
1-2	Continuing to remove tumble. North wall EW line clear, but no N/S wall apparent. The section apparent from previous excavation shows only tumble to an approx depth of 80 cm above floor found in 1995. Resting on some 20 cm of soil.
*1	Bronze spatula frag found adjacent to doorpost A (See plan) at depth of 50 cm. The doorpost stone is now exposed to a depth of 50 cm, giving it a total height of 80 cm.

NOT TO SCALE
