Jebel Khalid 2000

Field Record Book

Name..... HEATHER JACKSON

Trenches..... 74/2, 74/3, 75/8, 75/9, 75/3, 75/6-9
..... 75/9-8, 56/2, 57/7, 57/8, 74/9, 57/4

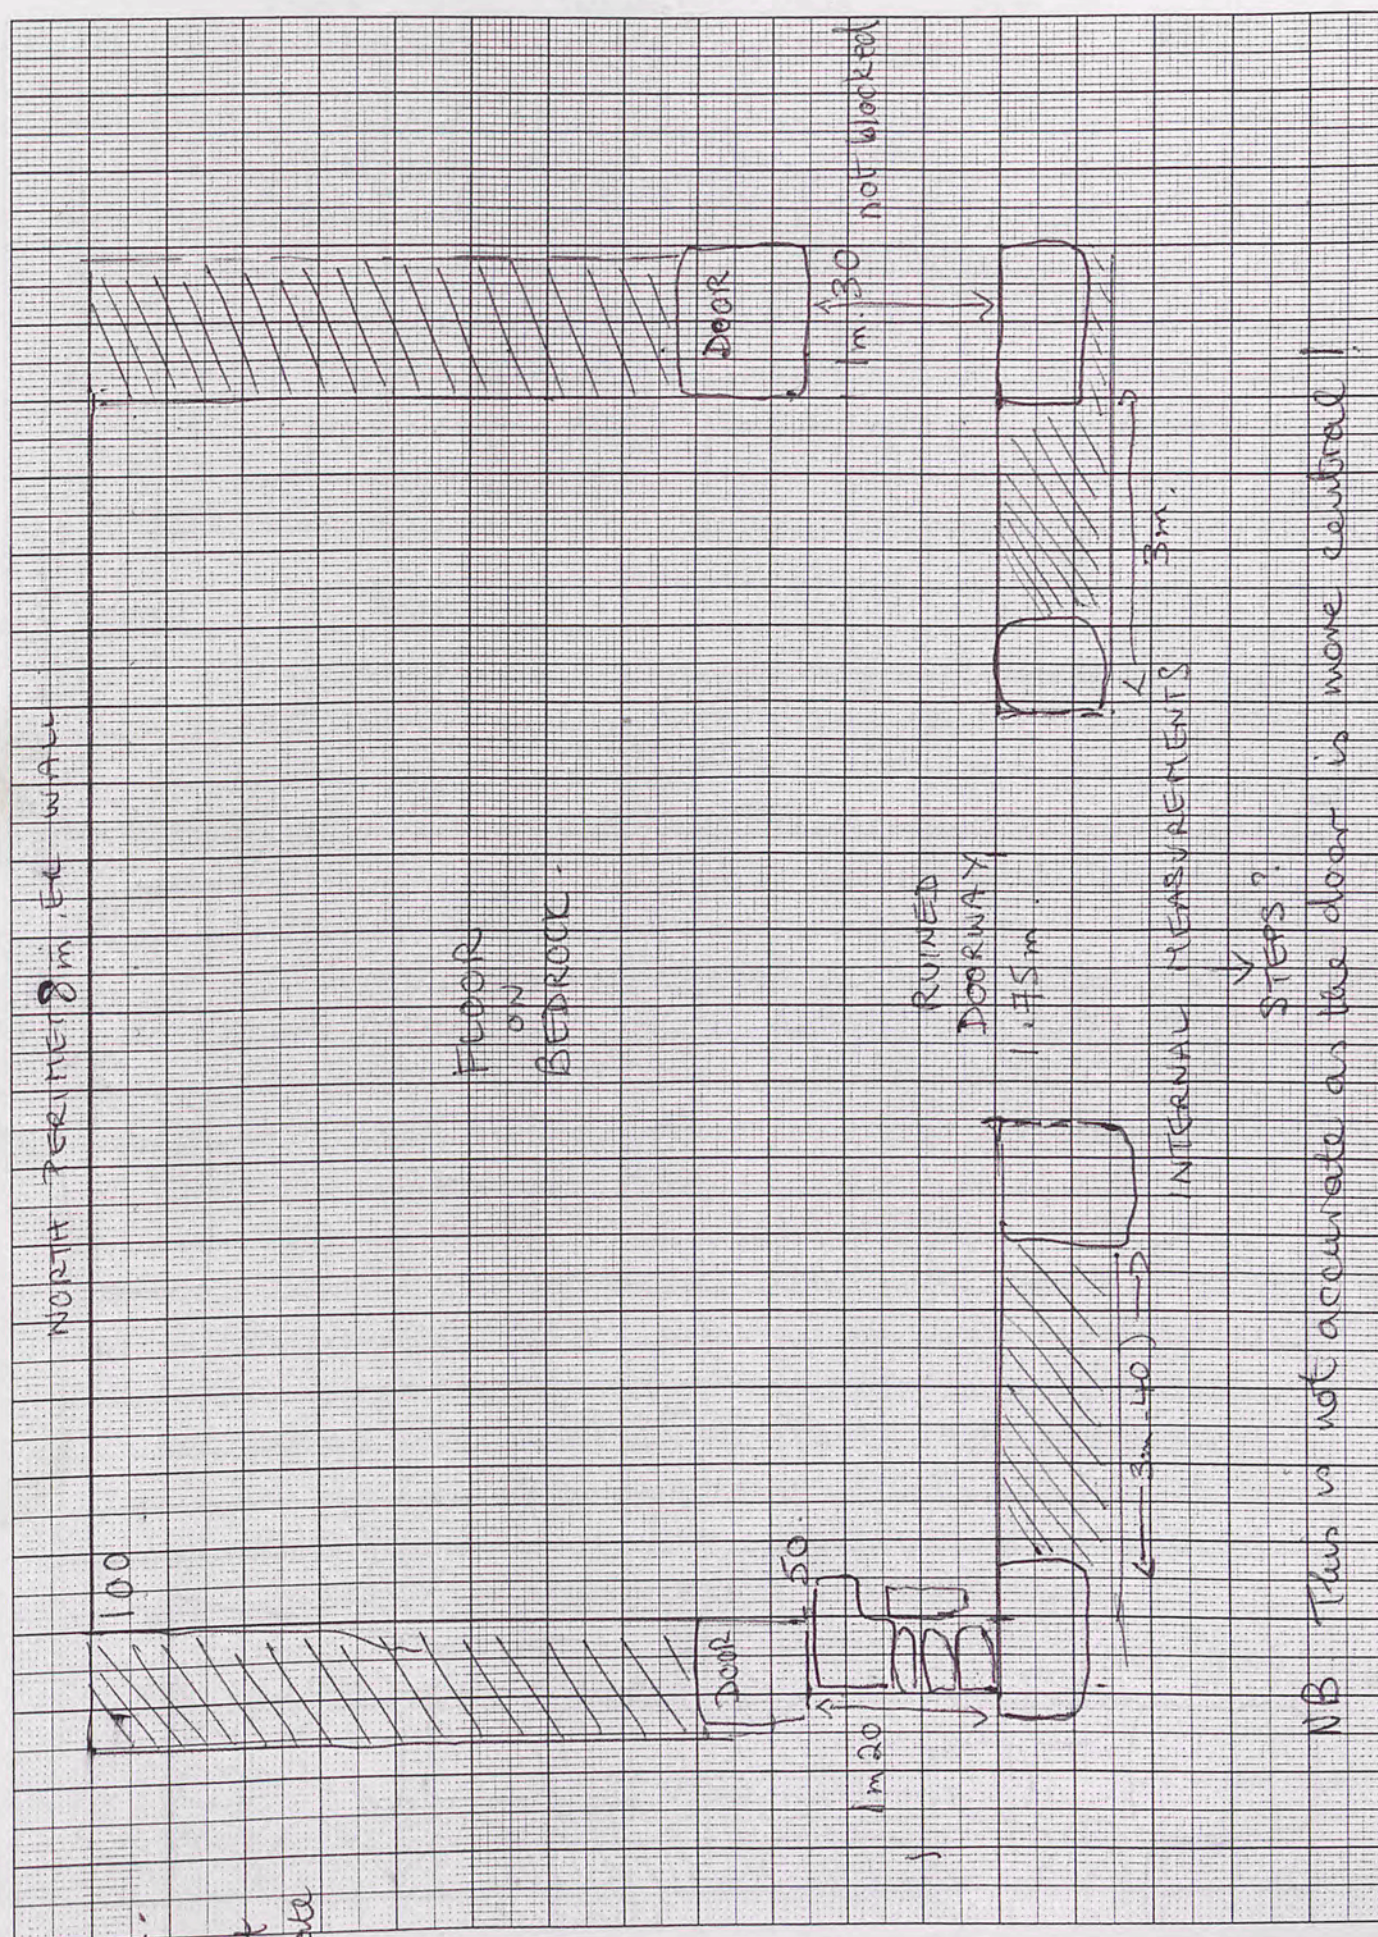
75/6-9
SKETCH ONLY

Loc 2	<p>The largest locus (2) in this trench is the eastern sector of a long (N/S) room East of the big room 75/9-6. It is a private room entered only from the west door (exc. JB in 75/6) which is wider than usual, so perhaps this is an elite room.</p> <p>Two levels of occupation were found. The primary floor was on bedrock - on it was resting a large worked stone - purpose? Between this and the secondary floor were found huge amounts of roof tile, which can still be seen in the baulks. Obviously there was some destruction of the roof before the construction of the upper floor - some 45 cm higher and consisting of a rough clayey surface, very uneven. This floor falls to the west. There is no tumble under it - only tile, smaller stones and soil, none of which looks like deliberate fill or packing.</p> <p>Walls A and B both good quality.</p>
-------	--

(3) This small locus forms the NW corner of a room East of the Masonry court (possibly was included in it). Here we only defined the walls N/S and E/W, which were both strong, and did not excavate to a floor, since it was found on bedrock in the adjacent trench 74/9.

8m x 6m

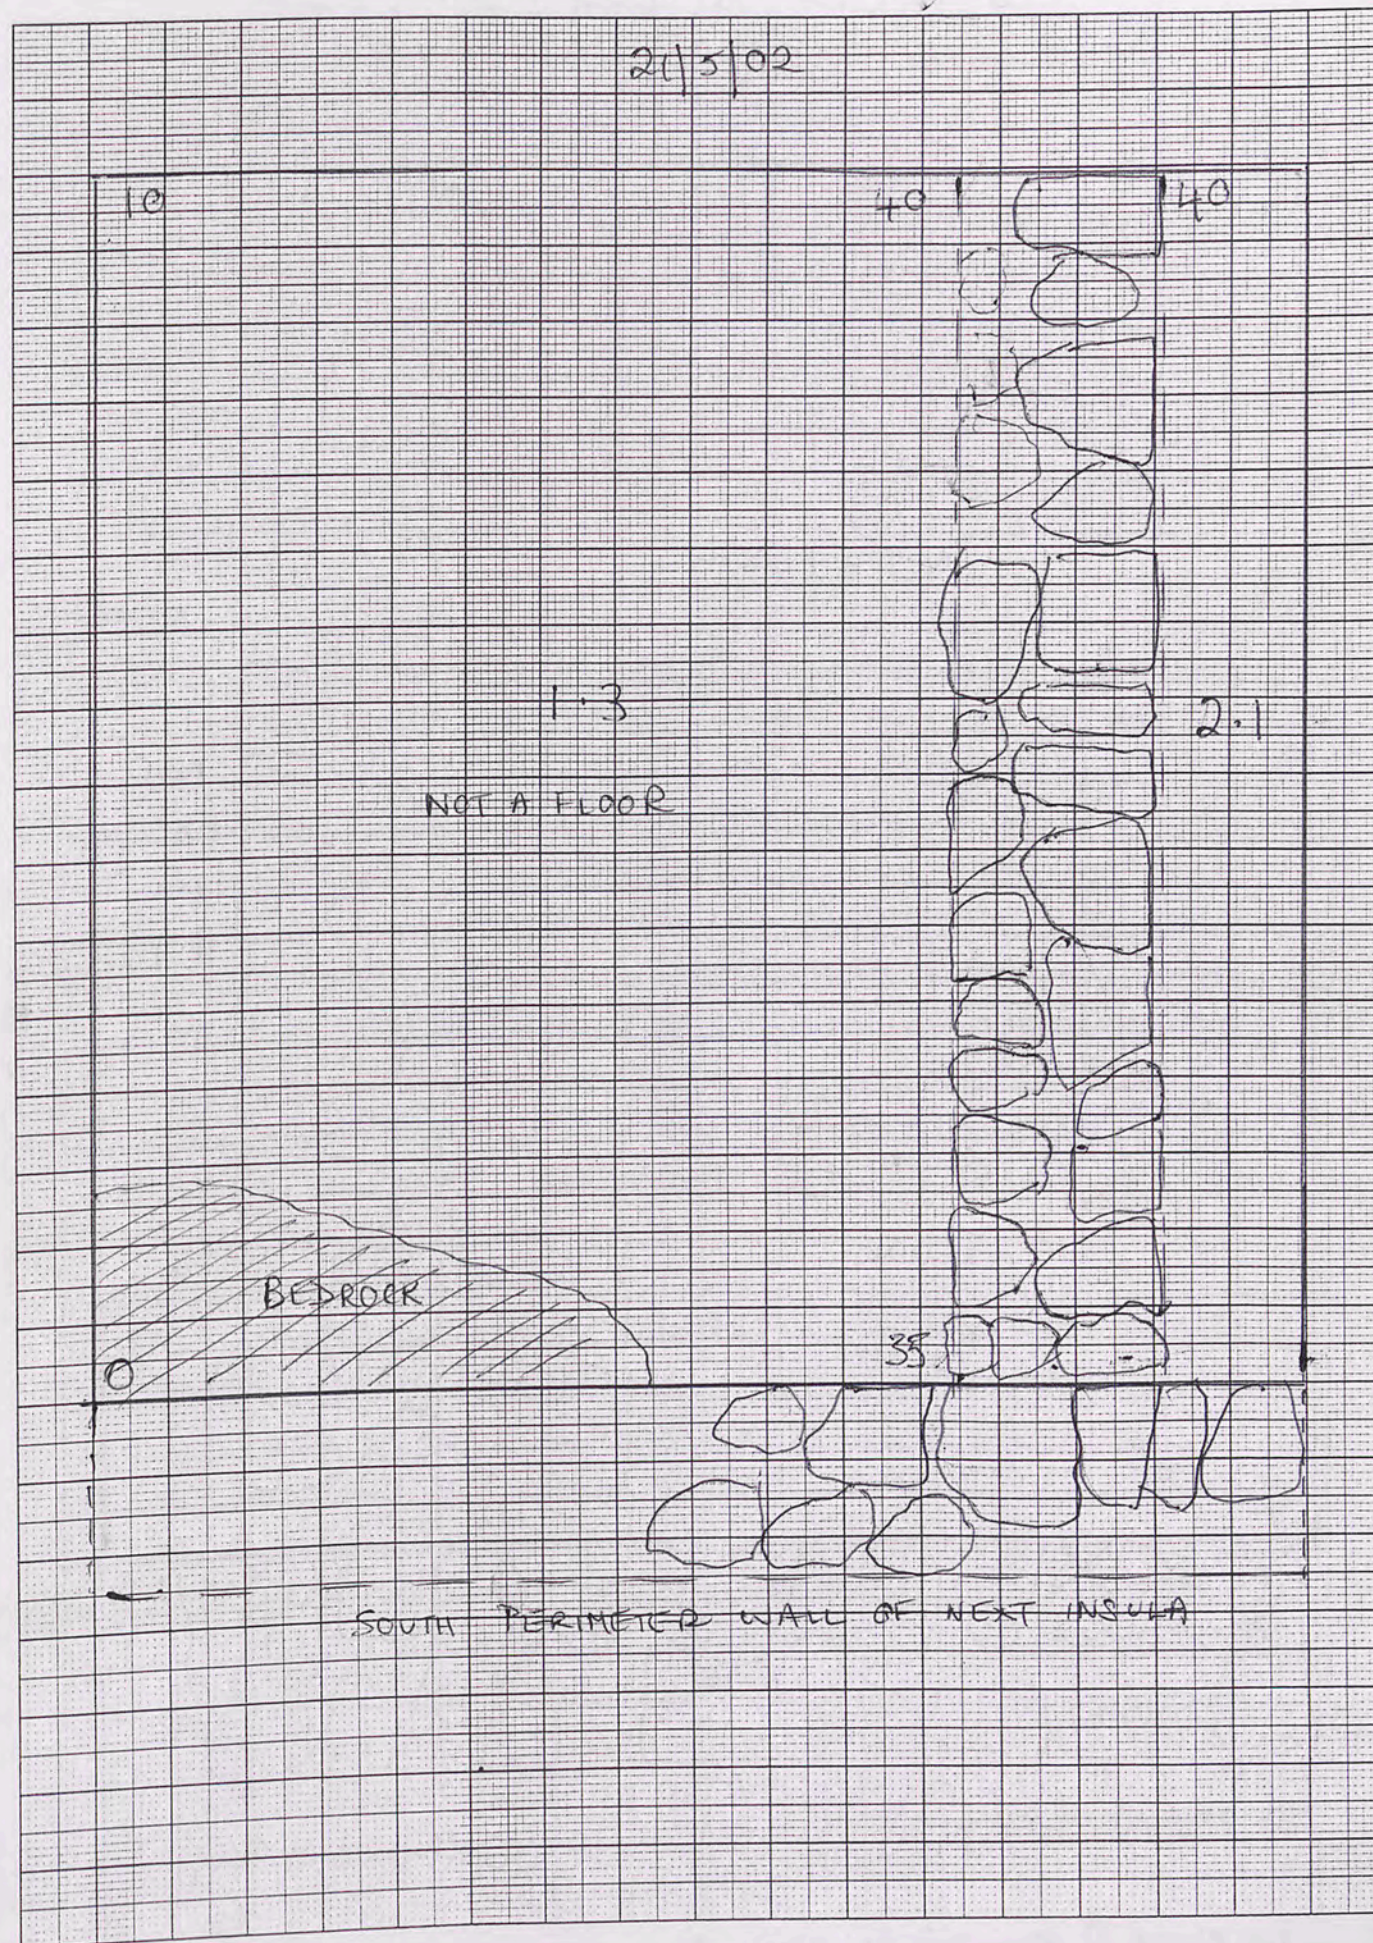
56/2

The purpose of this trench was to find any further traces of the south perimeter wall of the next insula, and any further structure to the North.
(a)	The south perimeter wall (as found in 1995) fails to the west on bedrock.
(b)	A reasonably strong and straight wall abuts it in the East of the trench, running N/S. There is still no sign of a CORNER in line with the NW corner of our insula. It is presumed lost to erosion or robbing. Excavation was taken to 25cm above visible bedrock and, on the west, level with existing road. If time allows, we may take a small sondage to bedrock just to confirm the primary nature of the N/S wall.

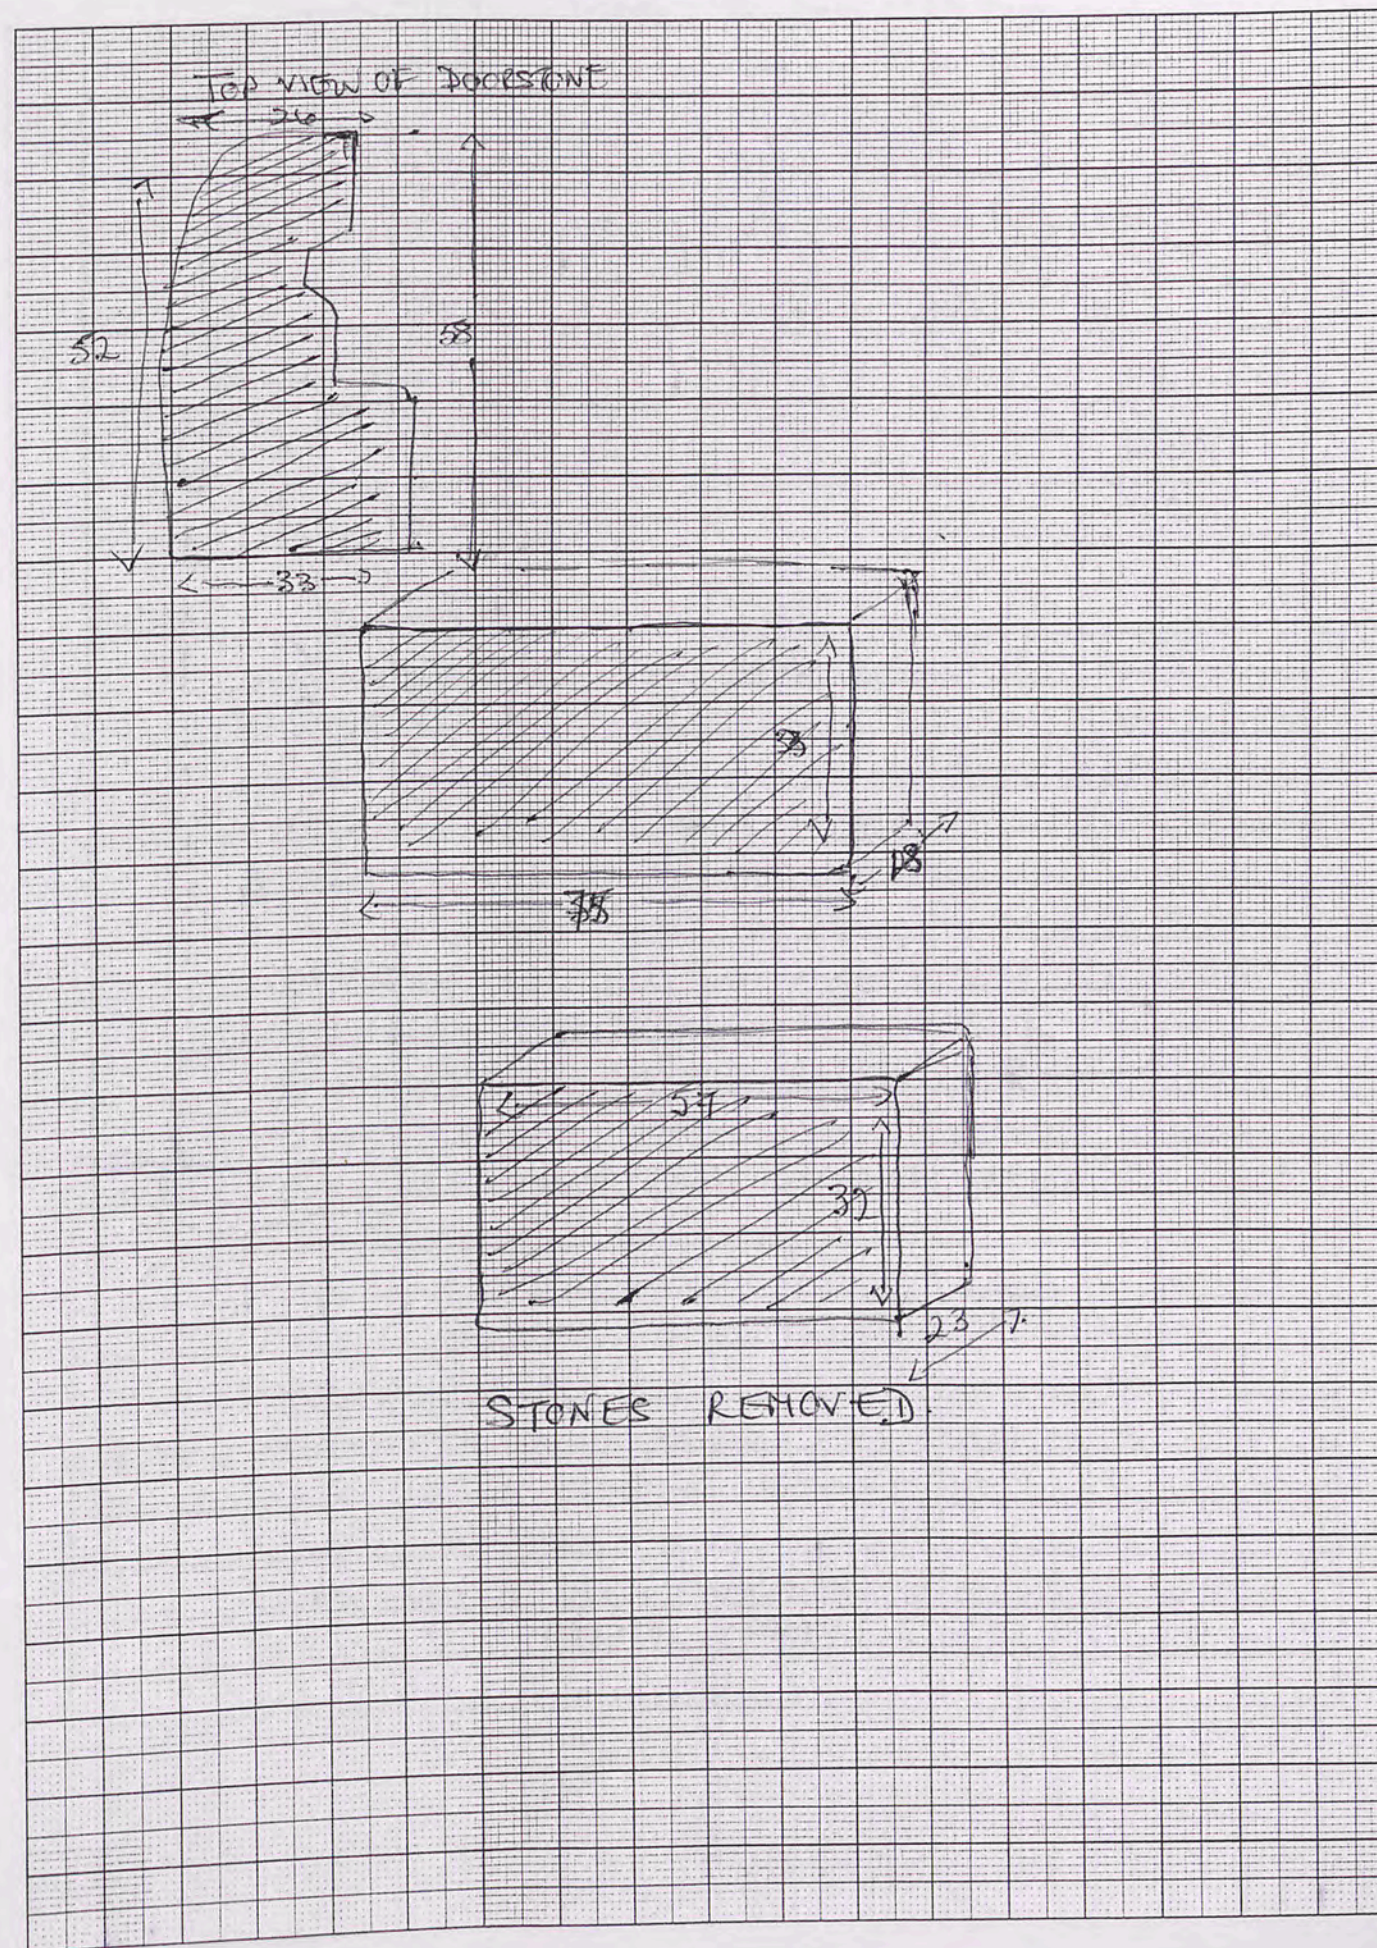
74/9

1.3	One team only now working on this trench since the eastern sector is empty of structure and we concentrate on the western walls & door
*1	Glass rim found under large stone (now removed) Wall faces are strong and even but I am still puzzled about the narrowness of the doorway, not yet fully excavated but not appearing blocked. From the corner of the dogleg - it is a full 6m across the "street" to the insula, which does not accord with the estimated 5m. street width. Now clearing doorway itself, having found FLOOR near and under the doorway.
	Last day
1.4	Am now excavating the soft floor in the NW wall corner, before cleaning up. Behold! a lower, older wall appears underneath the E/W wall, projecting approx 40cm to its South. We are following it East as far as time allows.

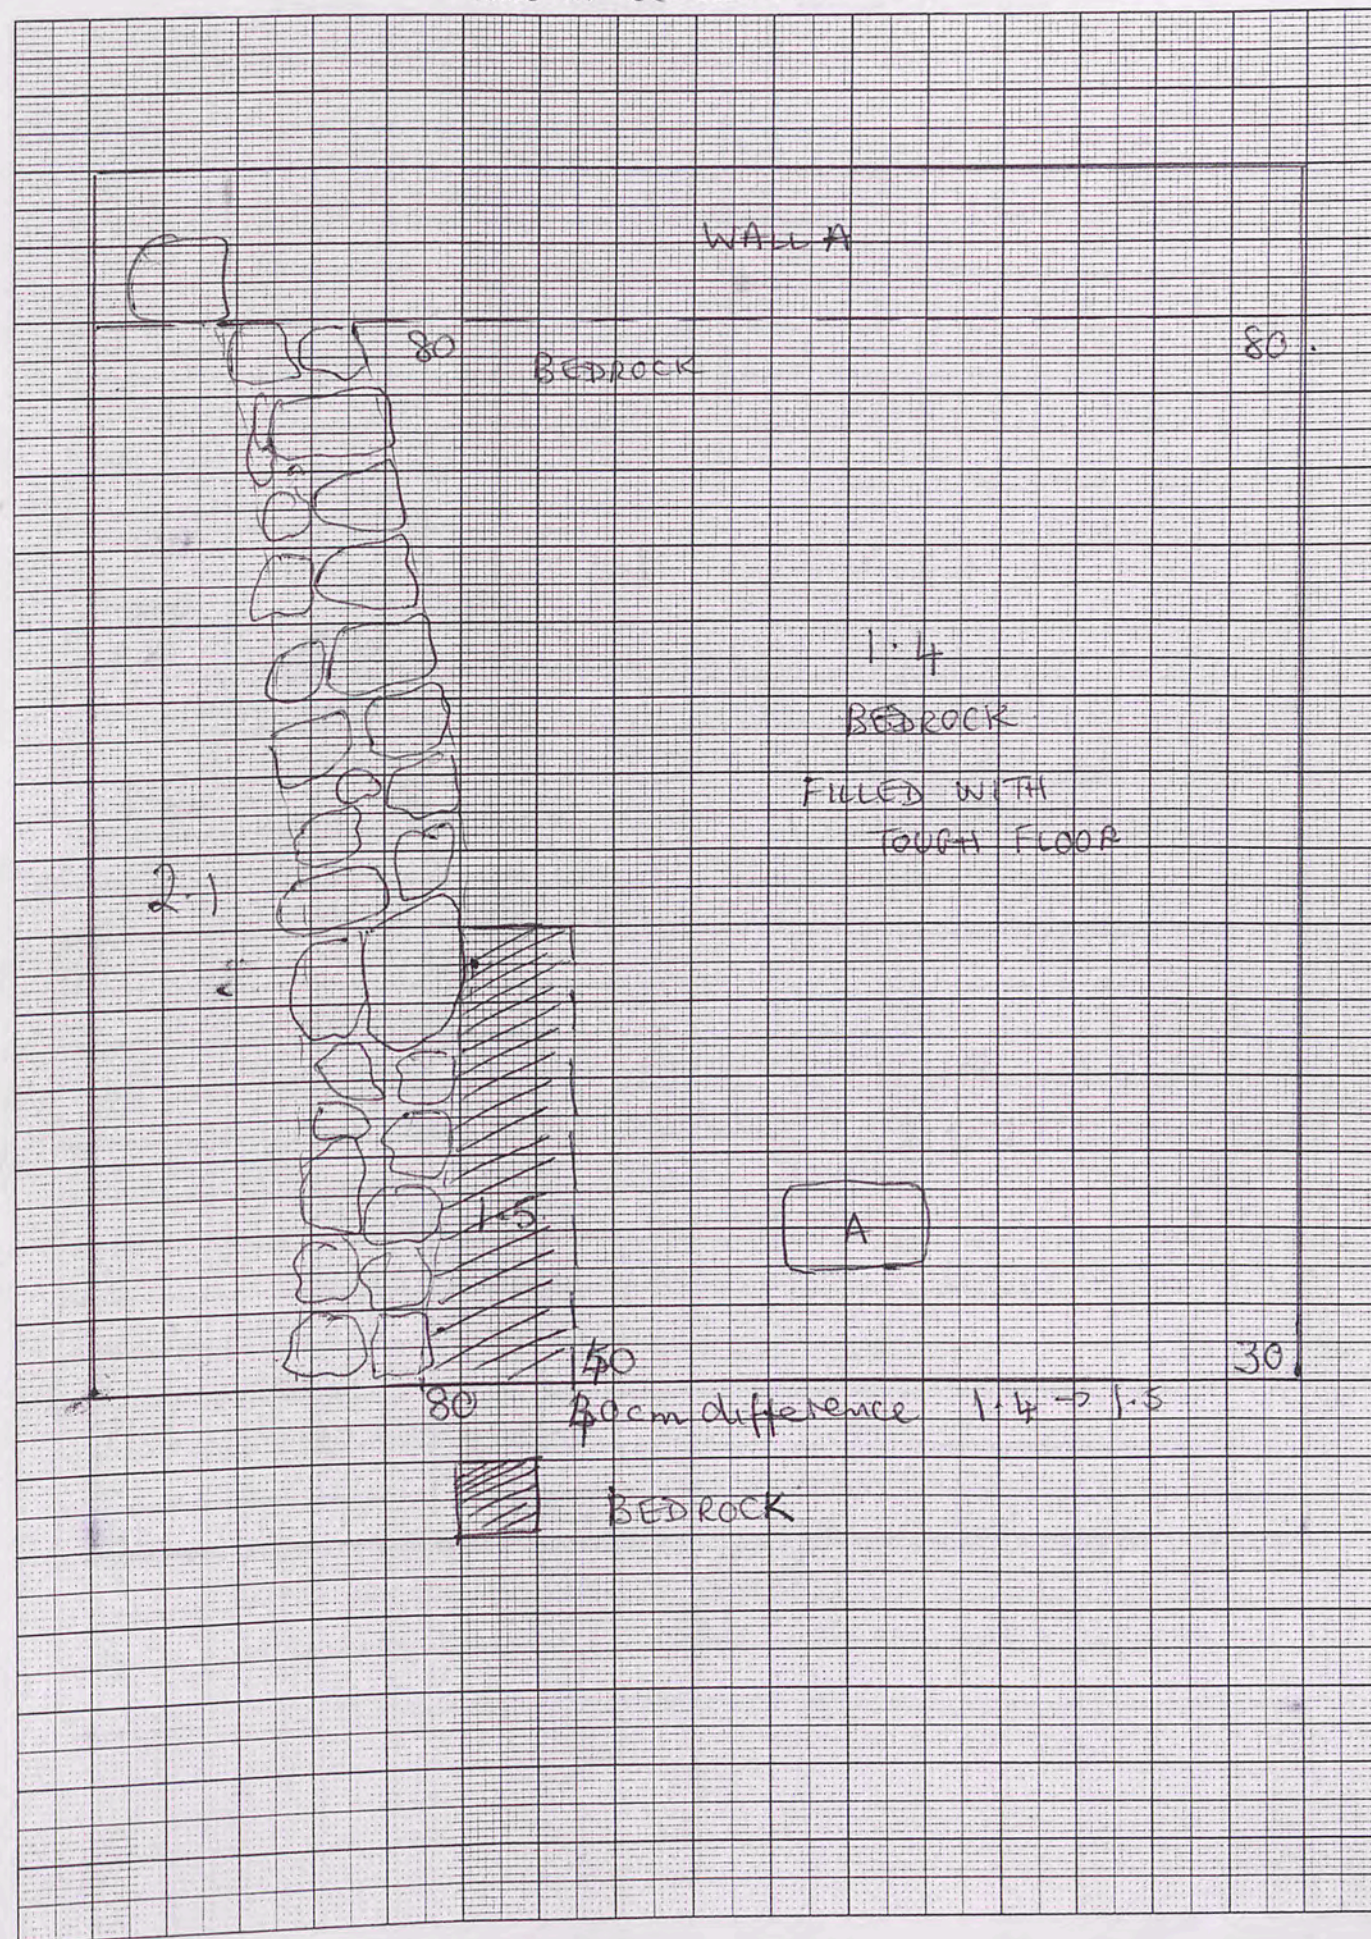
5718

1.3	Returned to this trench to excavate the northern portion which was left at 1.3. Clearing a spit to 1.4 along the N/S wall. Several large stones are revealed, sitting unevenly on the floor. In the NE corner: BEDROCK.
	<u>Last day.</u> Excavating 1.3 North 2: a sector west of yesterday's excavation will go to floor 1.4 seen in South, then clean up. If time, we will define the east face of wall A slightly - in the narrow space between it and the east bank.
*1	Coin found as indicated, small bronze, depth 67 from N. bank
2.1	Very narrow area east of wall A - just a 10cm spit to define wall
*2	long iron nail (possibly not ancient) at 10cm.

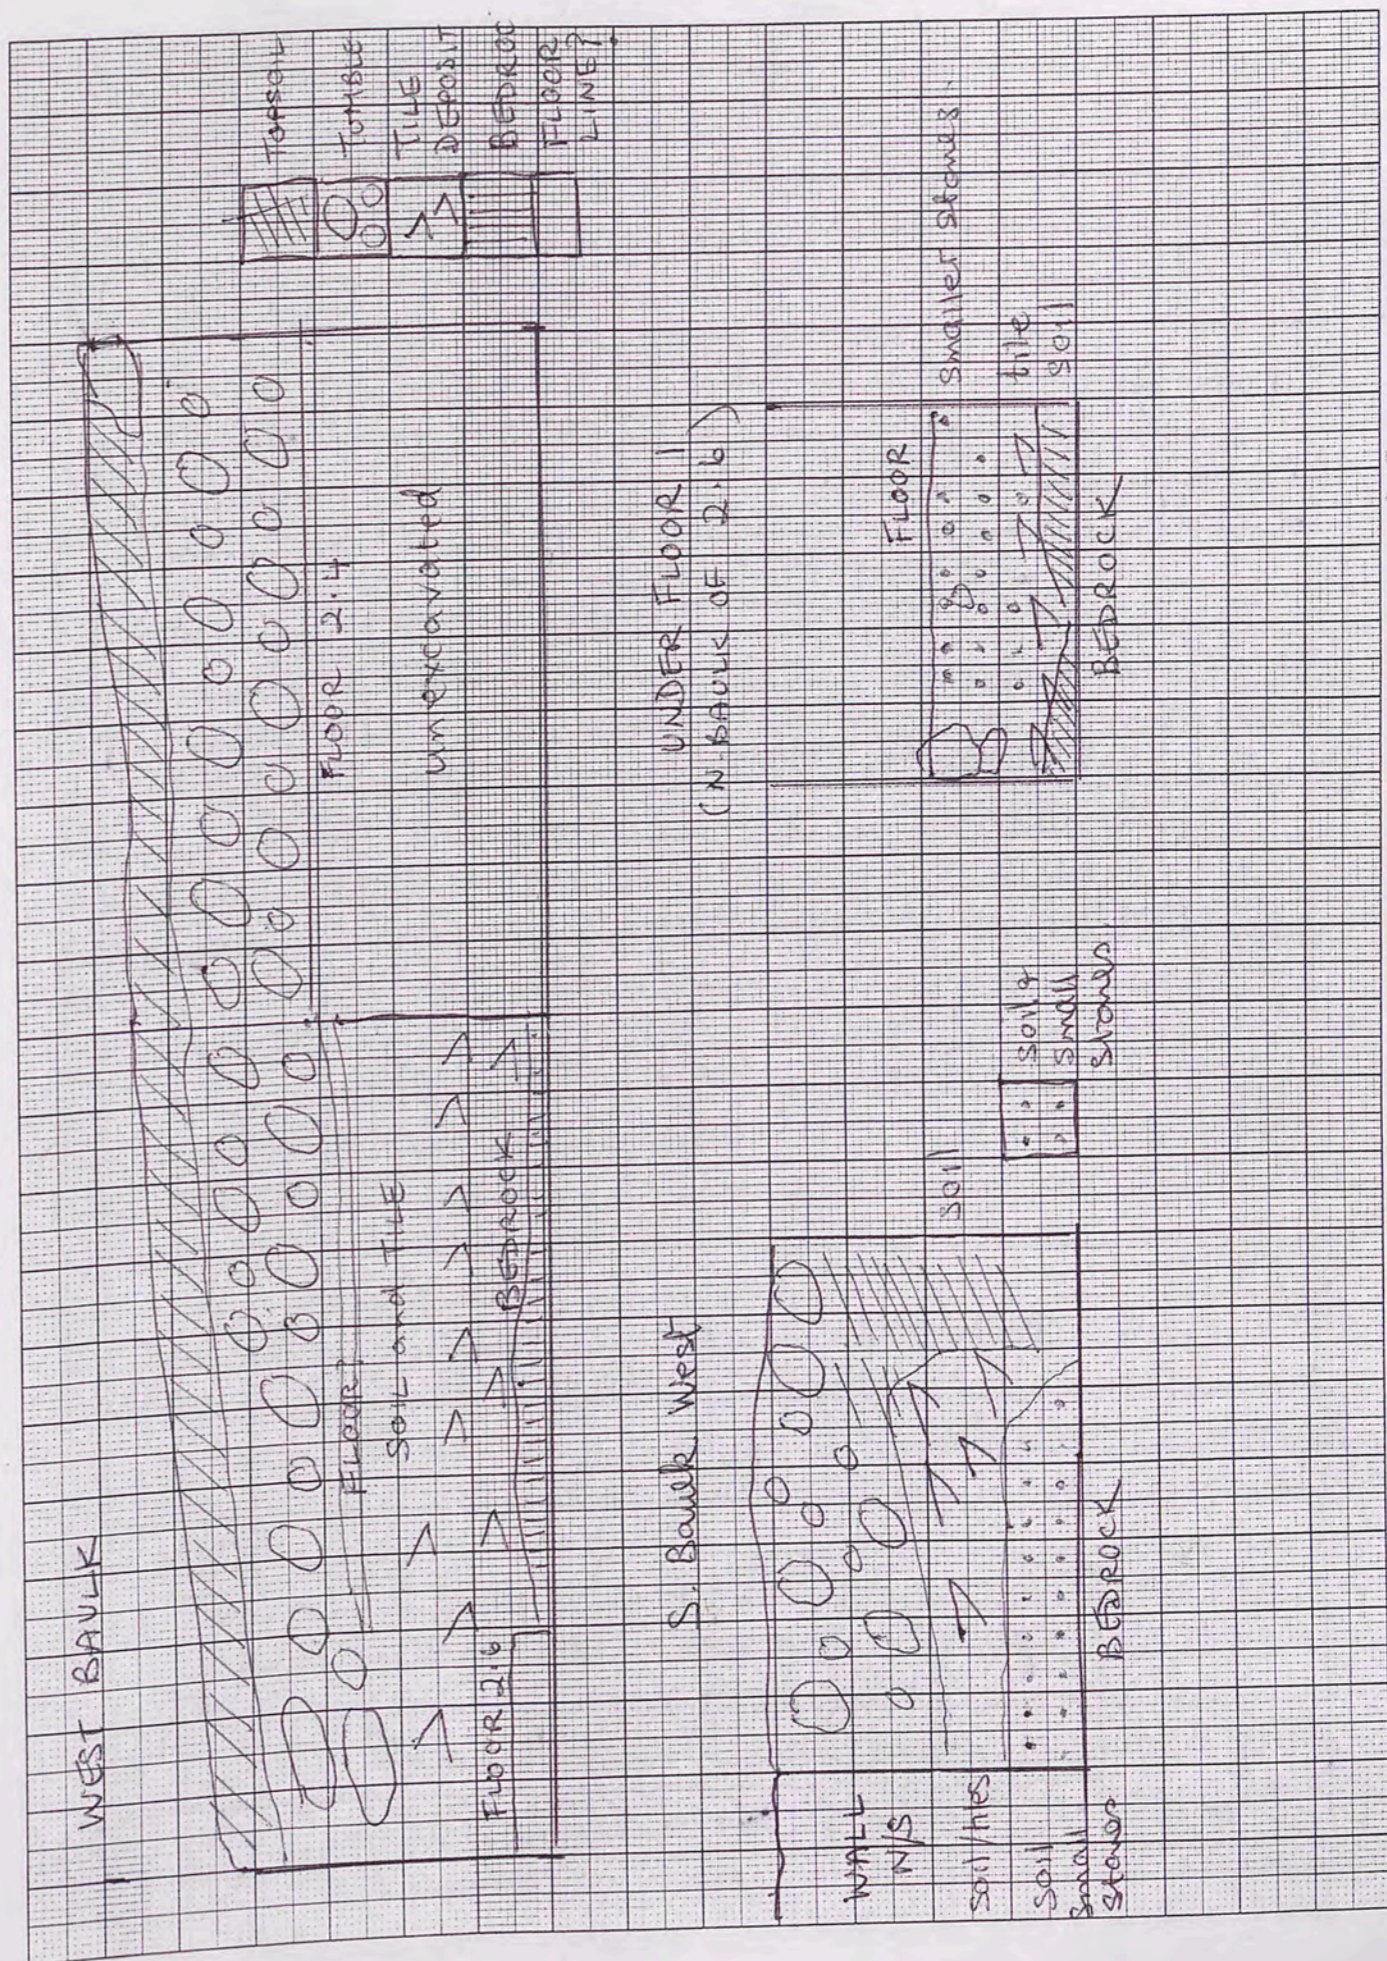
75/8
See also 28/4/02 plan

This trench is the northern part of the eastern courtyard, with part of a large doorway North into 74/3. The western doorstone still stands, eroded at the top but still 130 cm high. Walls: The N/S perimeter wall is in good order with 3-4 courses extant, and an average width of 75 cm. The E/W wall is also strong to the doorway but courses are not as regular. The doorstone rests on two courses, suggesting a step up into the next room. The step is not in situ but several likely stones are ex situ in the east baulk (especially *D and a stone *E not seen in top plan because it is under C). Stone C is a fallen doorstone, eroded but still a metre long across the baulk. on second thoughts, stone B may even be in situ as it is in the correct position. The estimated width of the doorway is 110 cm between doorstones (int.) Two such stones (E & D?) would be needed side by side for a step

and two more for the threshold

Occupation: only one floor, courtyard style. Small installation in NW corner for storage (?) would only hold one pot. Bedrock not excavated but seen to be near in adjacent trenches.
