# Jebel Khalid 2000<sup>2</sup>

## Field Record Book

Name.....NICHOLAS WRIGHT.....  
Trenches.....75/1, 75/2, 75/2-75/5, 76/3.....  
.....206/7, 58/8-58/5, 123/1 East.....  
Dates.....

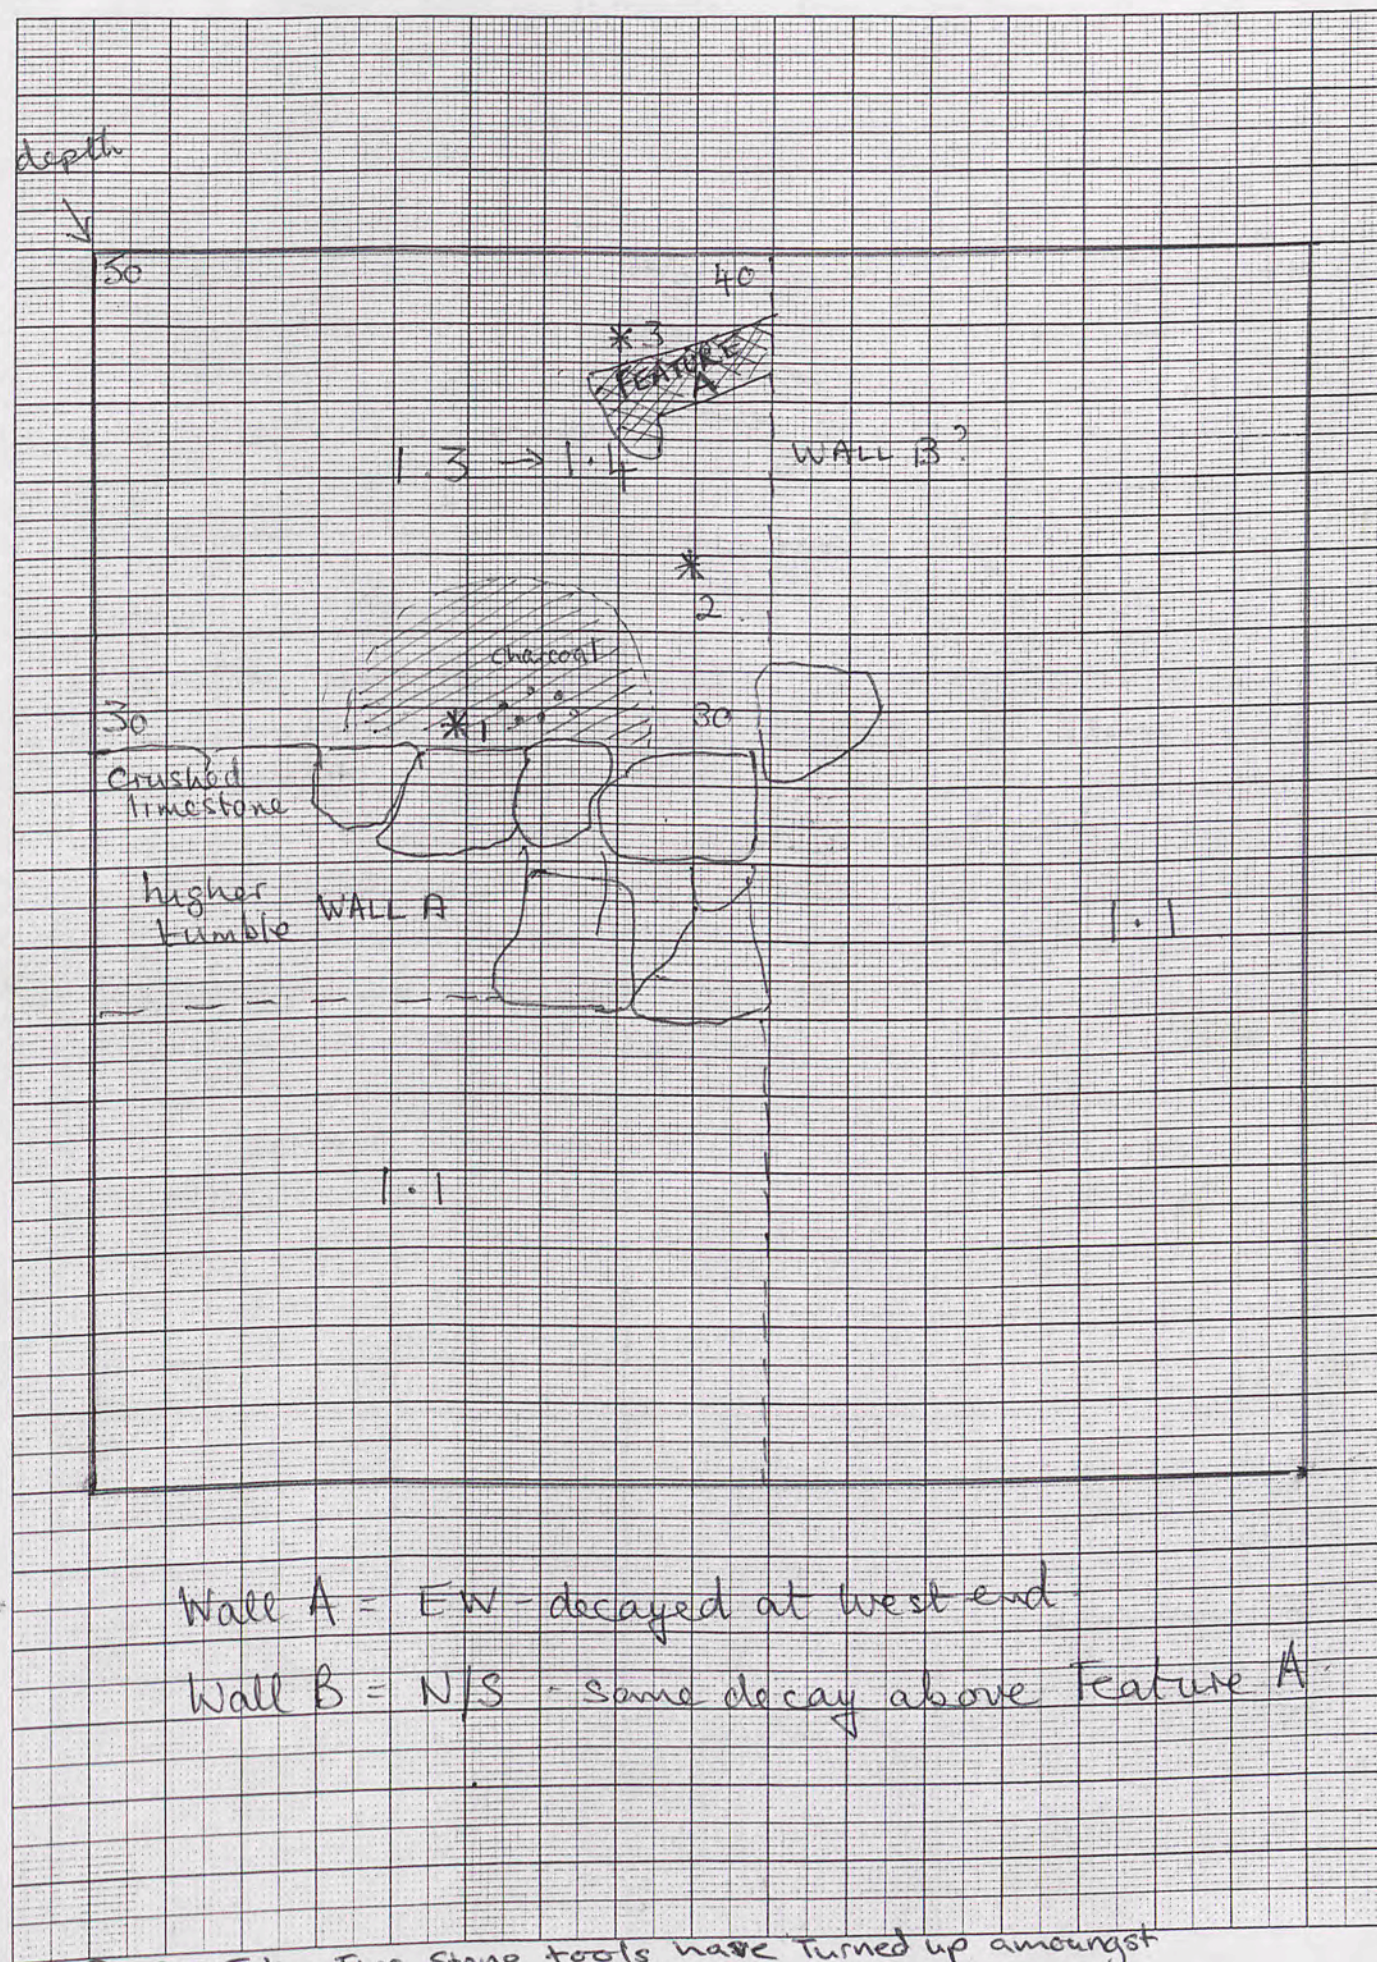
75/1 16/4/02.  
 1.3

Wall A = EW - decayed at west end

Wall B = N/S - some decay above Feature A.

Context	Report
1.3	This locus is below locus 1.2, which was entirely tumble. The soil is now soft brown loose, with the beginning of an ashy lens against the E/W wall. Here a few fragments of oven material have emerged and some burnt bone - some indication of a decayed oven. Also some CHARCOAL and a RIVER PEBBLE, possibly used as a pounder.
	Top First course of N/S wall now fairly clear, North of the E/W wall. The ashy lens is weak - confined to a circular area against the E/W wall (wall A).
*	A lump of metal was found in this area, depth of 30cm from surface of wall A.
1.4	A new spit below 1.3 - 20 cm.
*	2 fr. blueish glass
*	bead from soil in N. of trench

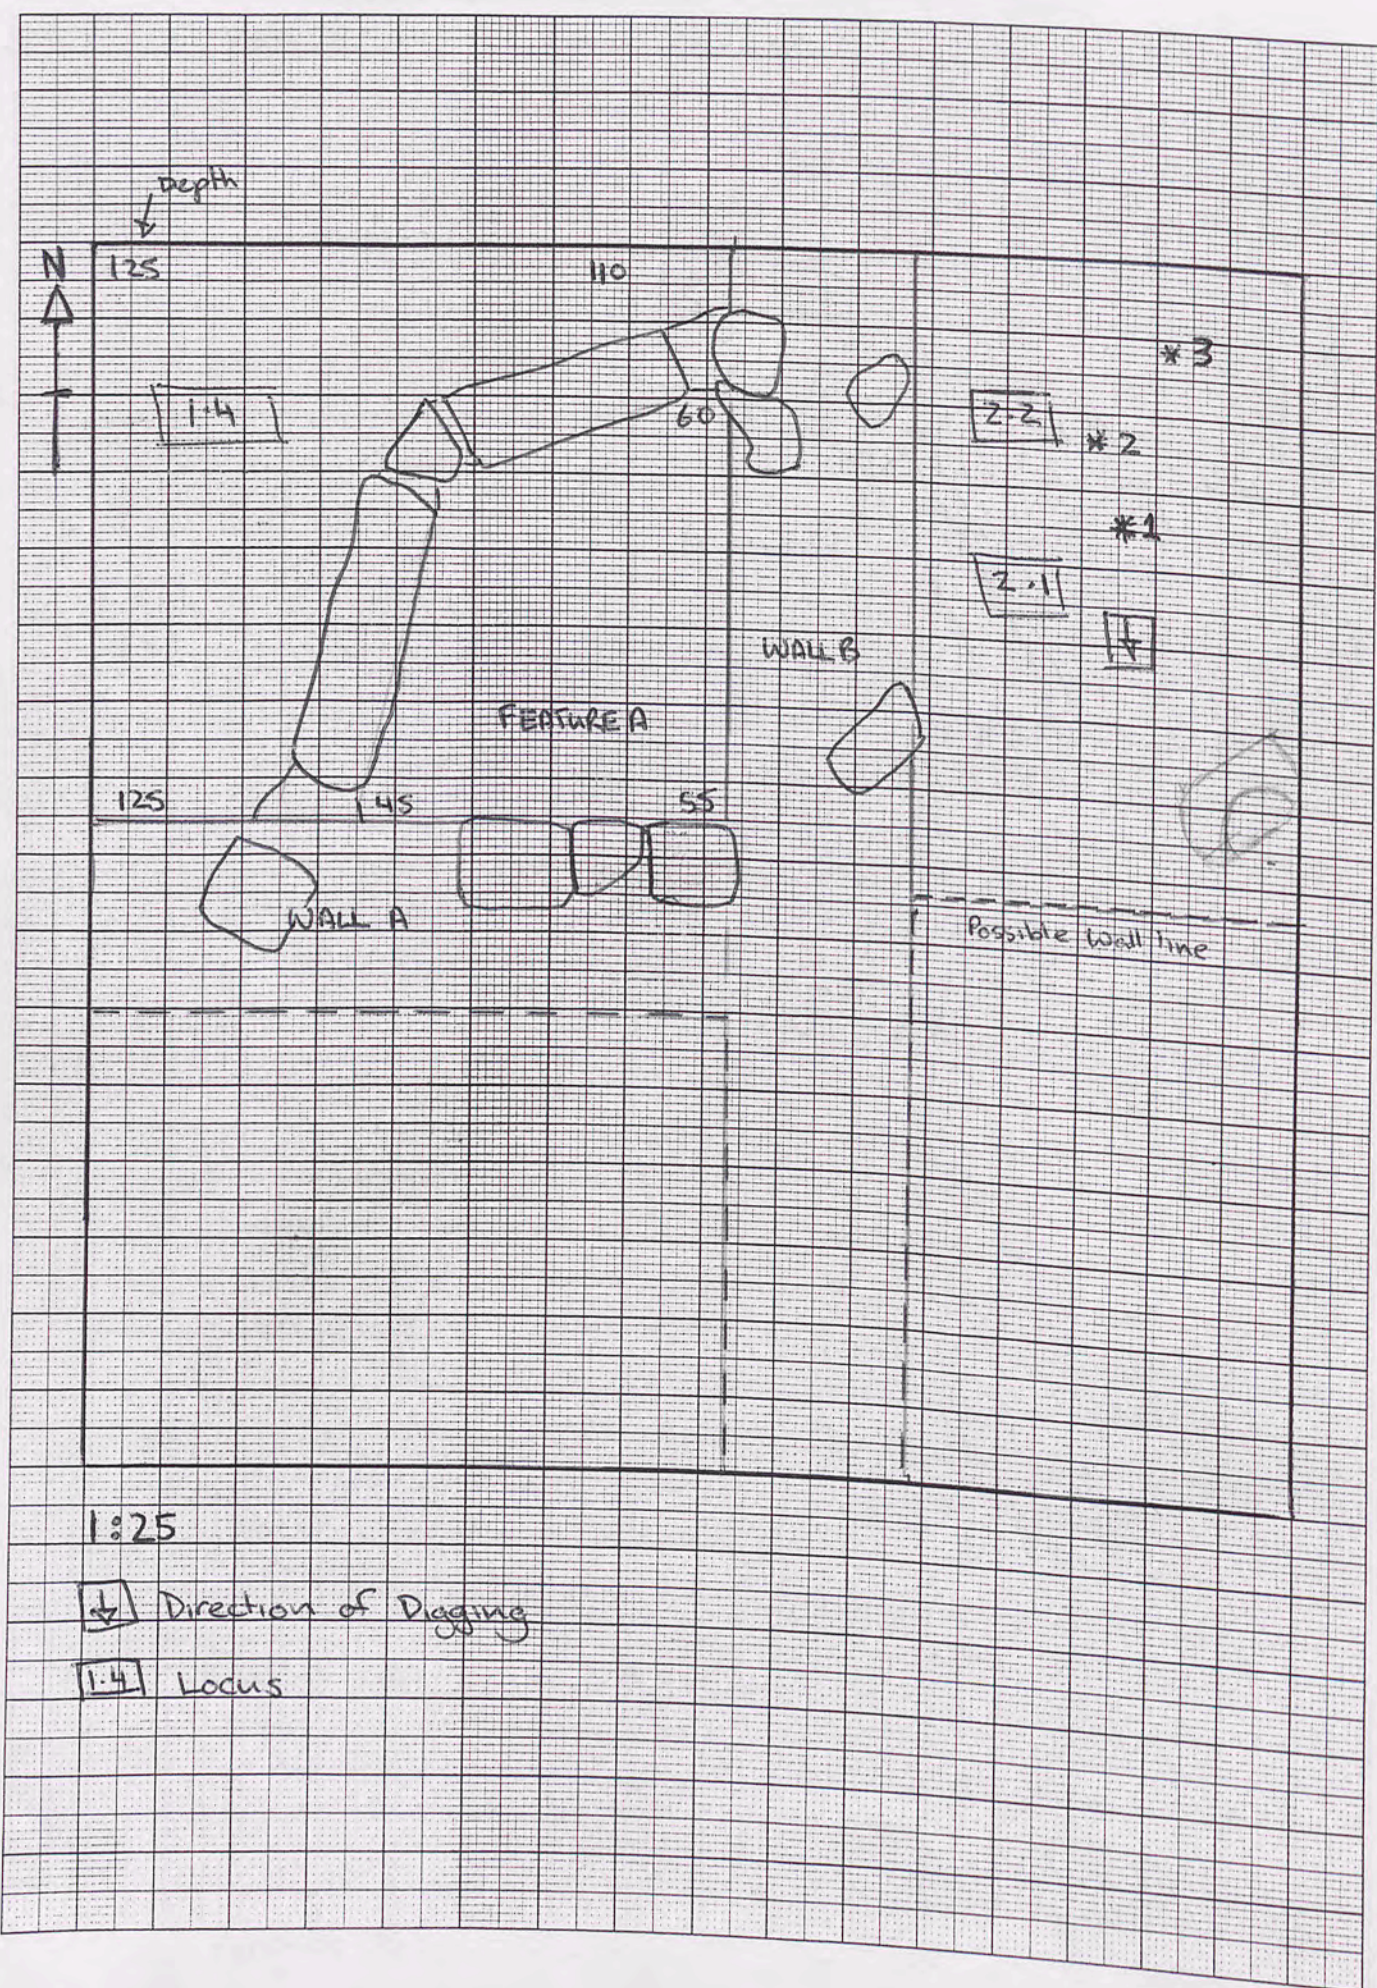
1-4	Immediately uncovered Objects 1 + 2 in the North East corner of Locus 1-4, just below where the basalt was uncovered yesterday. Object # 1 is a wonderful moulded Bowl frag - looks to show on the main panel, L → R an amphora, rearing horse facing left, winged Nike/Eros? facing left.
1-4	lots of tumble turning up in the SW corner of this locus, below the crumbly limestone wall
	2 large River Rocks uncovered, both ≈ 90 × 60 × 40 cm lying around edge of feature A
	2 Flat slabs of limestone have turned up, one on top of the other forming what looks like a rudimentary step - to be called feature B. They just fell apart. Second step was just tightly packed tumble. 1 slab still remains. 53 × 30 × 18 cm
	.. Feature B has been fully removed - Tumble?

Now looks as though there may have been a floor, corresponding with the top of Feature A + the charcoal - Ashy deposit found there ≈ 30cm below surface level.

Probable Floor ≈ 110-125cm from surface, 70cm from Top Feature A.

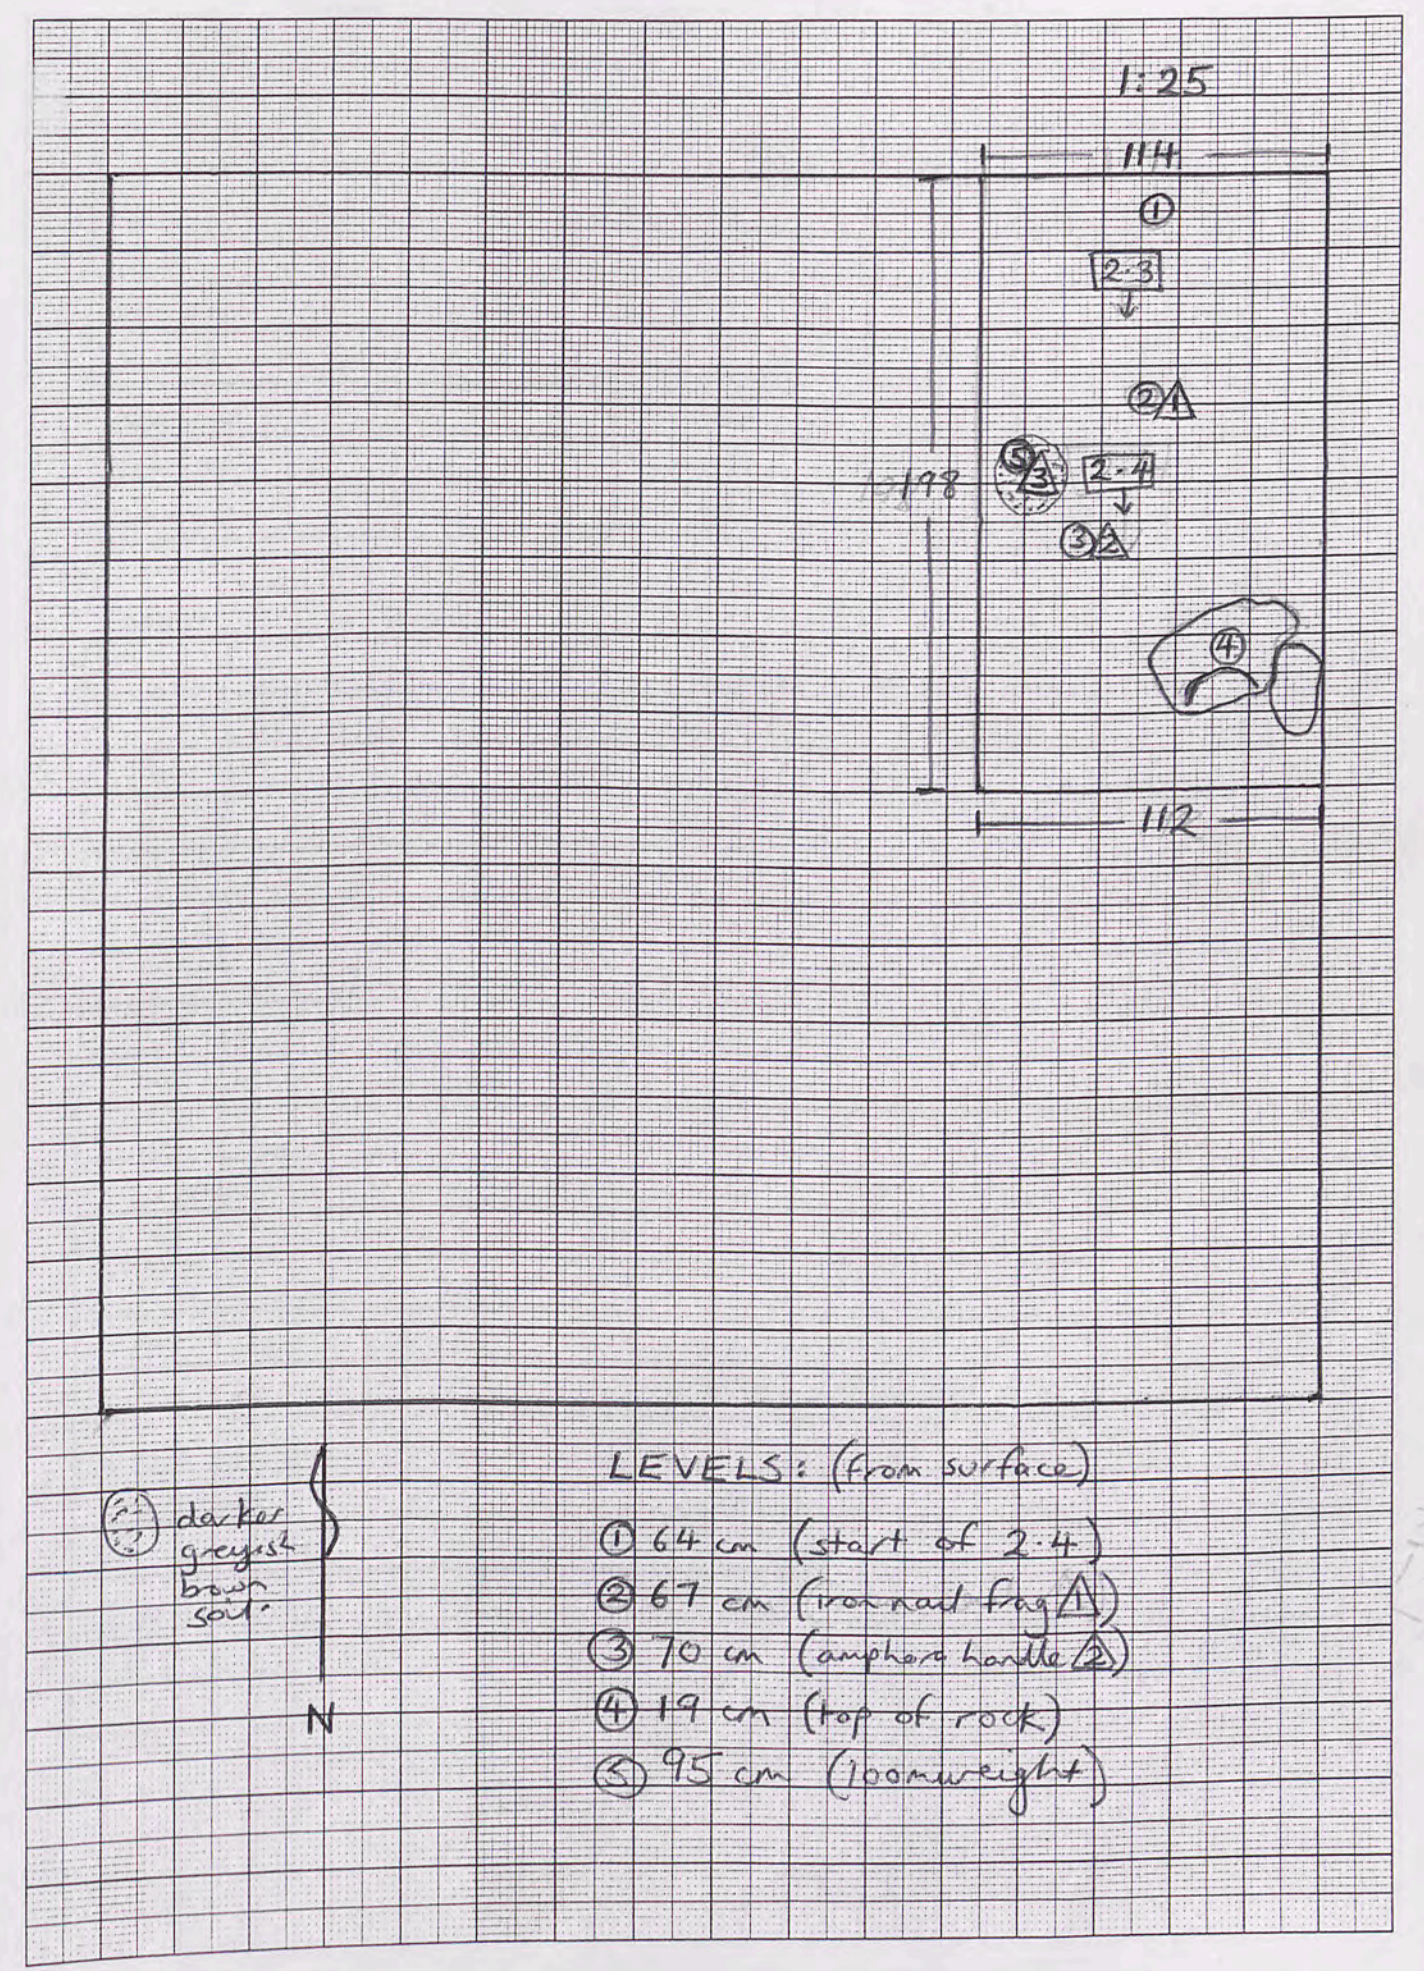
70  
170  
-120

Context	Report
2.3	Continuing excavation of area east of N-S wall. Pottery, bone in small amounts. Stone in southeast part of locus appears to be disturbed/tumble
2.4	Starting new spit at 64 cm below surface. Will pedestal stone to ascertain whether resting on floor.
1	Iron nail at depth of 67 cm
2	Lovely stamped amphora handle at depth of 70 cm. Removed worked stone as clearly ex-situ. Resting on a couple of smaller stones - apparently tumble rather than packing. Soil light brown crumbly throughout. Some bone emerging. Possible E-W wall east of Wall A is a definite wall. 2.4 gone to depth of 87 cm and courses still smooth & regular. Will continue down to try and find floor.
3	Loom weight found at depth of 95 cm. Soil slightly darker around it, but not ashy. Not enough for sample.

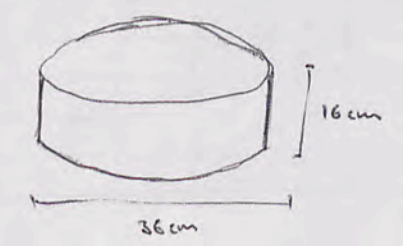
Clearing out Feature A, Soil Brown + crumbly just as rest of locus high proportion of Tumble.
○	Possible Column Piece, d=36cm h=16. Does not appear to be fluted at all.
	1 Whole + 2 half Querns are being cleaned up + left in situ. = 75 cm from surface.
	Floor level has been reached at the same depth as that of locus 1.4 Area has been tidied up for a photo.
	Soil Sample taken from floor around Querns.
Photos	BW2, 8-16 CS1, 4-7 frame 6 is a detail shot.

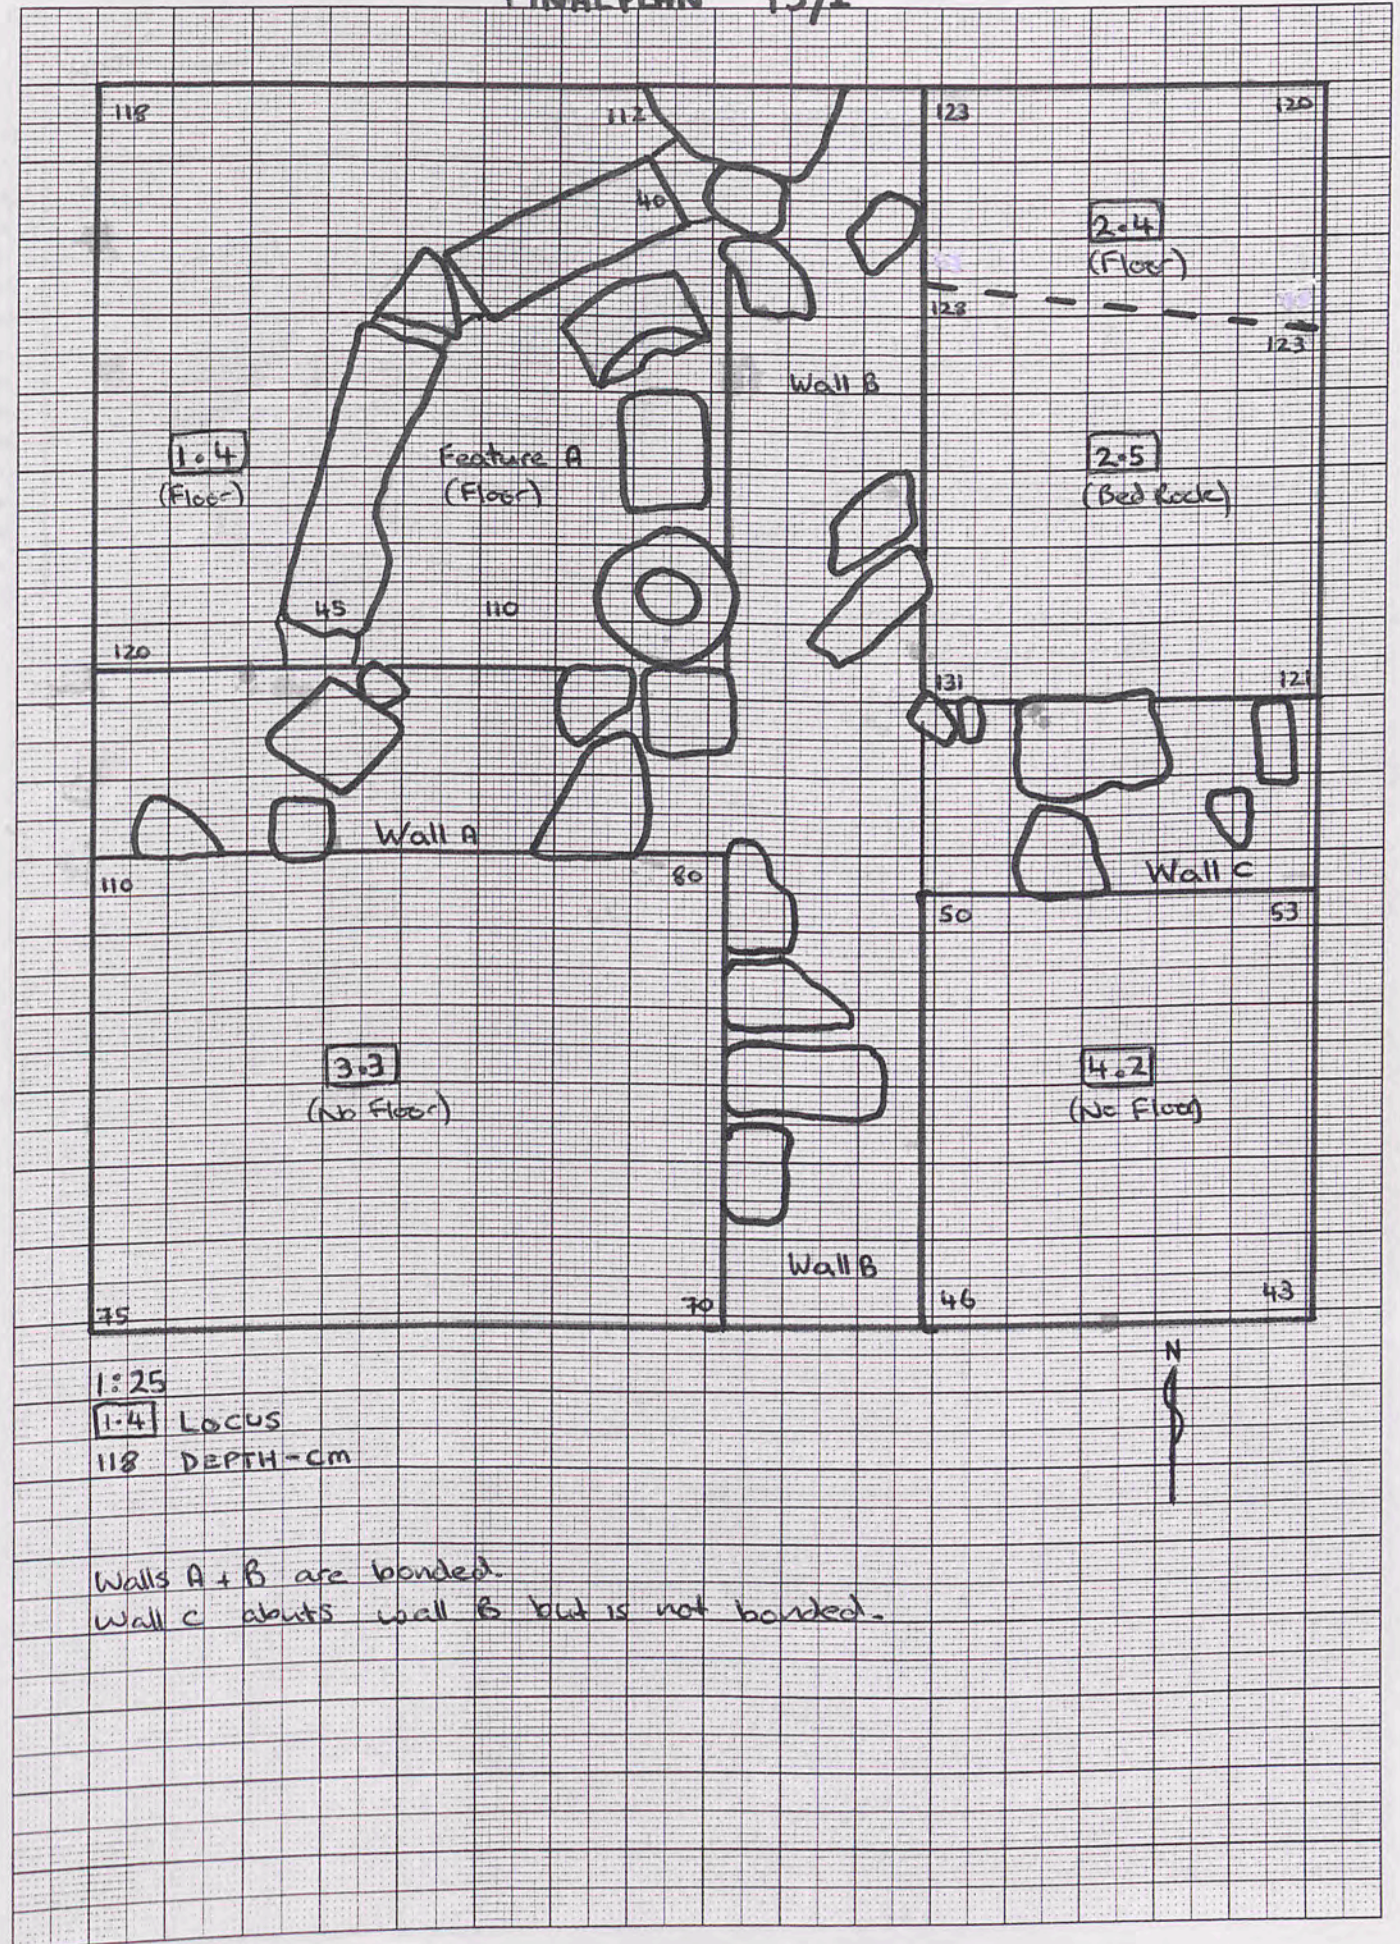
FINAL PLAN 75/1

1:25  
 1.4 Locus  
 118 DEPTH - cm

Walls A + B are bonded.  
 Wall C abuts wall B but is not bonded.

Locus	Context
Locus 1	The most complicated + interesting locus, the Western Baulk appears to indicate 3 periods of occupation which co-incide with what's happening to Feature A. The Grey Ashy Soil rest at roughly an even level with the top of Feature A. In this period of occupation, the Feature probably would not have been visible. Occupation level 3. The limey soil is placed to line up roughly with the base of the worked stones that make up the feature. Below these worked stones is a small layer of fill which rests on top of the floor level of 1.4. therefore, it would appear that there were 3 periods of occupation of this locus.

- Primary occupation - beaten earth floor, No Feature A
	- Secondary " - limey looking deposits, construction of Feature A from "borrowed" worked stone - Metope + Triglyph + Architrave. + the placement of the Querns in side.

- Tertiary " - by this stage the feature is completely filled and covered, + includes a piece of column. this is all covered by the ashy layer.

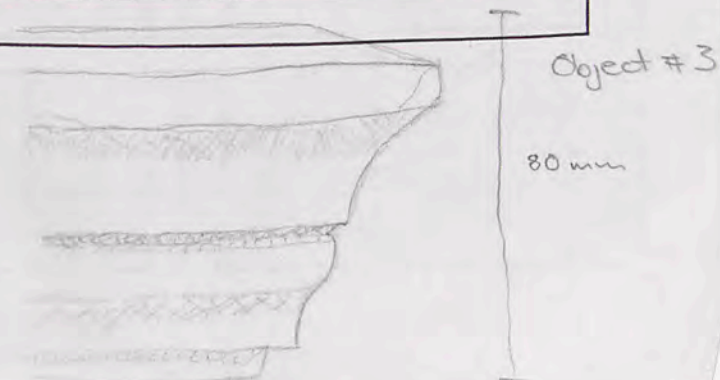
1-1	Day One of Baulk Removal.
*	1 - Glass frag in topsoil
1-1	Dug to depth 18cm in the S, 20cm in the North.
1-2	Day Two of Baulk Removal
	Chunk of Basalt 100x90x40mm Removed at depth of 40cm
*	2 - Glass Frag
*	3 - Worked stone - possibly a corner of Architrave
*	4 - Iron frags, not Nails.
1-2	Dug to Depth: 80 in the S, 75 above Feature A, 110 S of Feat A
1-3	Day Three of Baulk Removal.
	Proceeding as expected. Feature A of trench 75/2 - The low wall of worked stone continues (w) into 75/5 to meet up with a similar construction. - Small wall dividing Feat. A
*	5 horrid little Fig Fragment. Finger Prints on the Back/inside.
	Dug to Jewel. Cleaning For Photos.
	CS 5, 23-7
	BW 9, 23-31

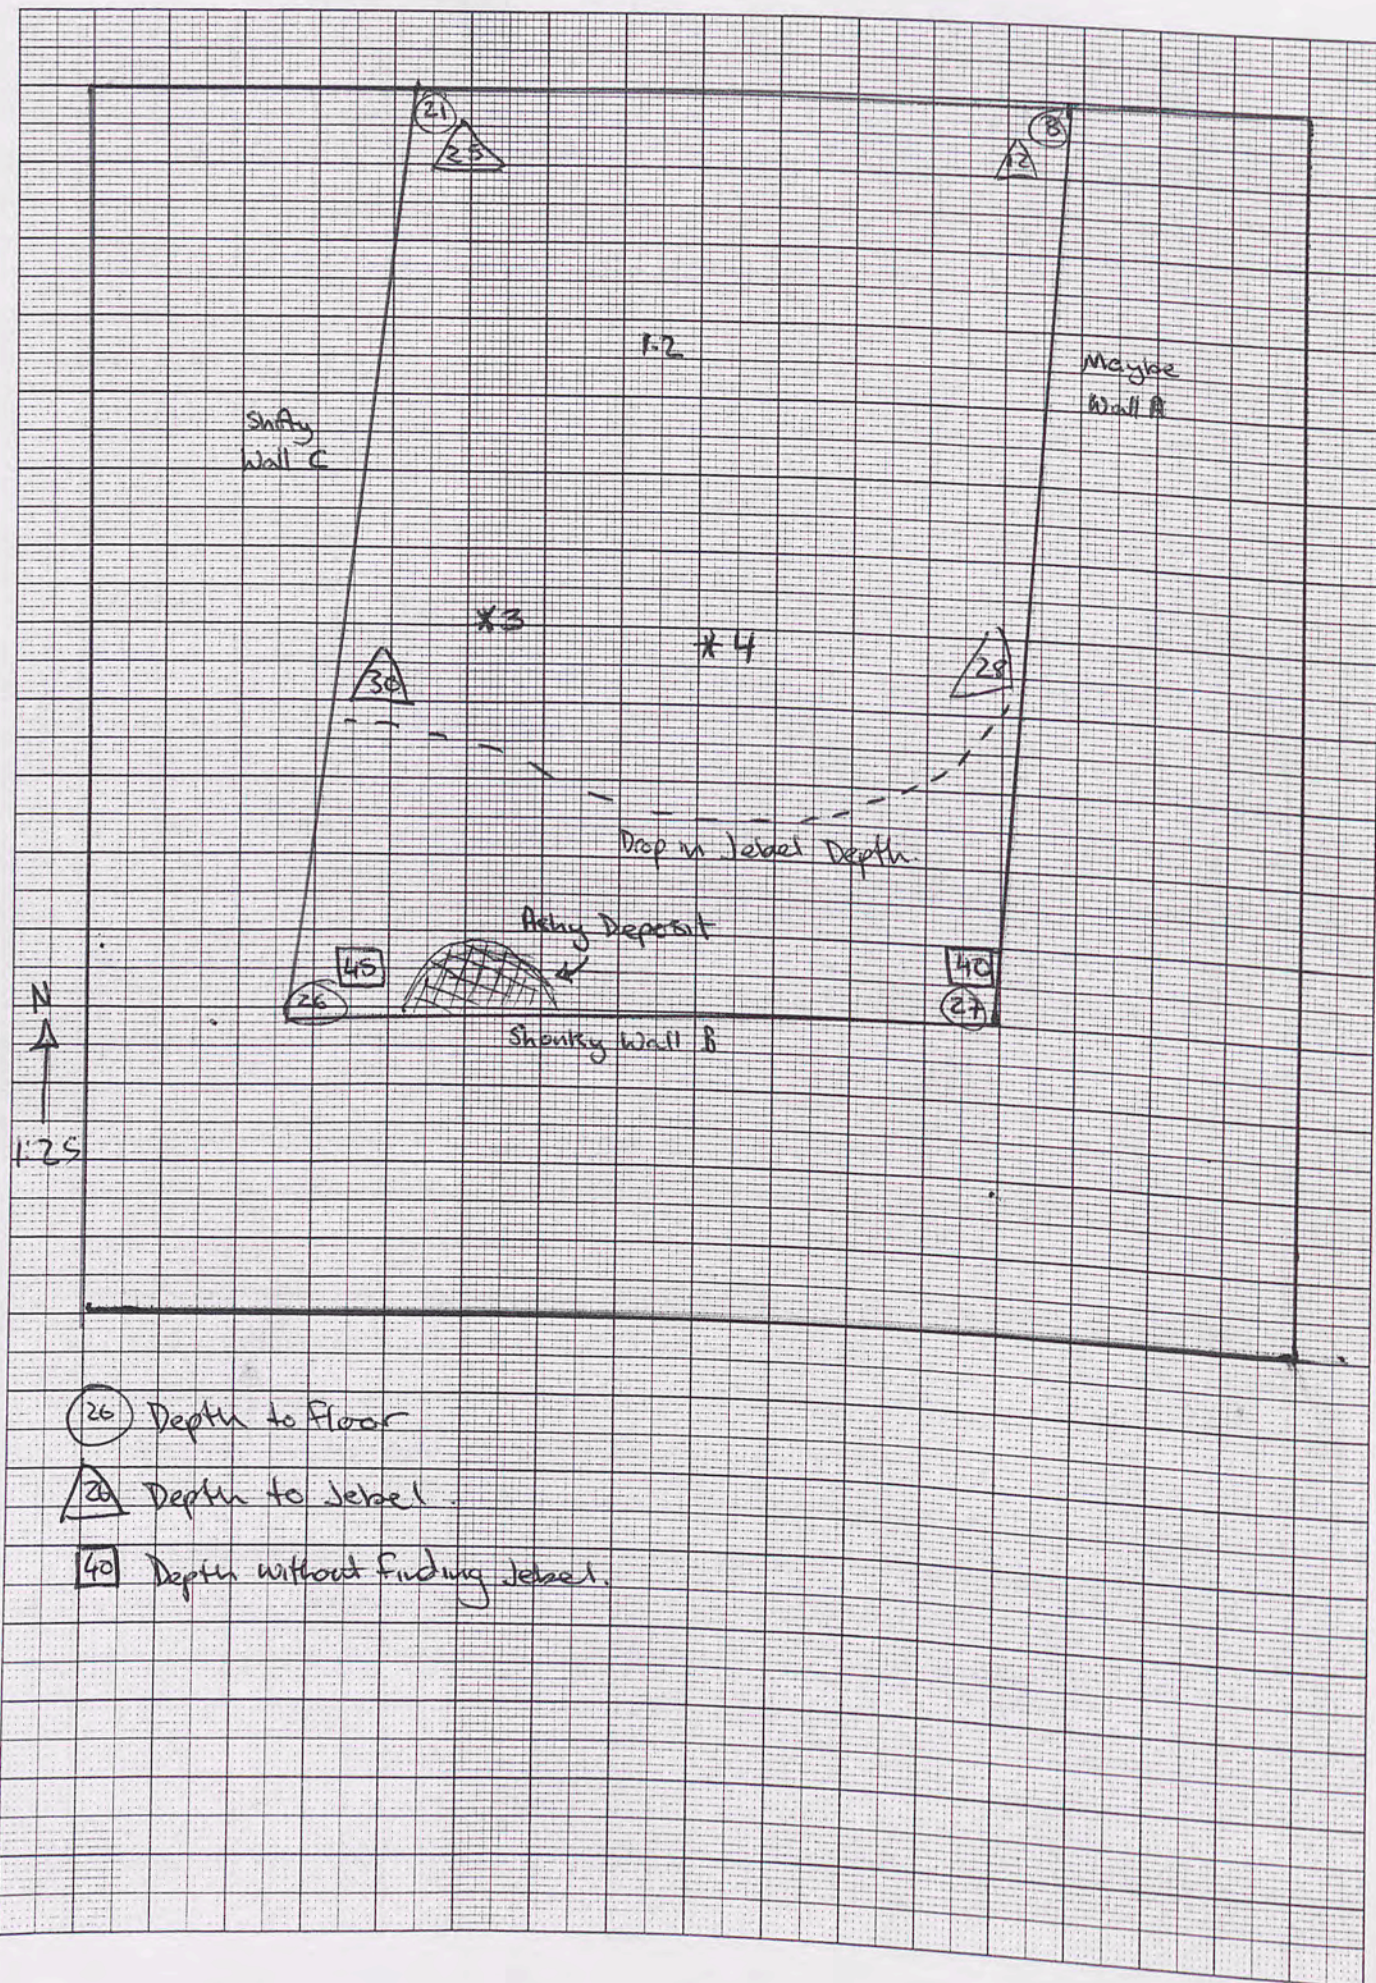
- ②⑥ Depth to Floor
- ②⑧ Depth to Jebel
- ④⑦ Depth without Finding Jebel

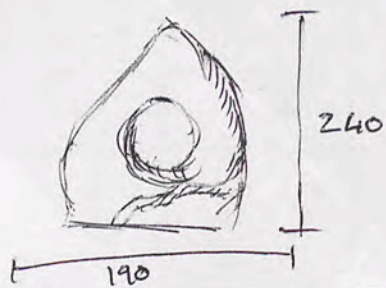
Stone Quern.

Context	Report
1-2	Tuesday. Sunny. All good. Removing tumble, checking out the scene, looking for a wall or two.
	The NS wall in the East, (Wall A), that can be seen clearly from outside the trench, may not exist in the Northern half...
	There appears to be a second NS wall roughly in line with the tall tombstone like rock (Wall B)
	The E edge of Wall B is exactly 500cm from the Wedge of the external wall of the opposite Insular. Distance of Wall A to Insular - 368cm
	Wall B looking like joining up with Tomb/door stone.
	Stone Quern depth 30cm.
#1	Fig Fragment. little figurine head. Seems quite worn. depth 50cm
