Jebel Khalid

DQ T27

Field Record Book

Name... Chloë Smith
Trenches... 27(DQ), T5(Areas), T10(Areas), T16(Areas)
bank T9 South
Dates... April - June 2006

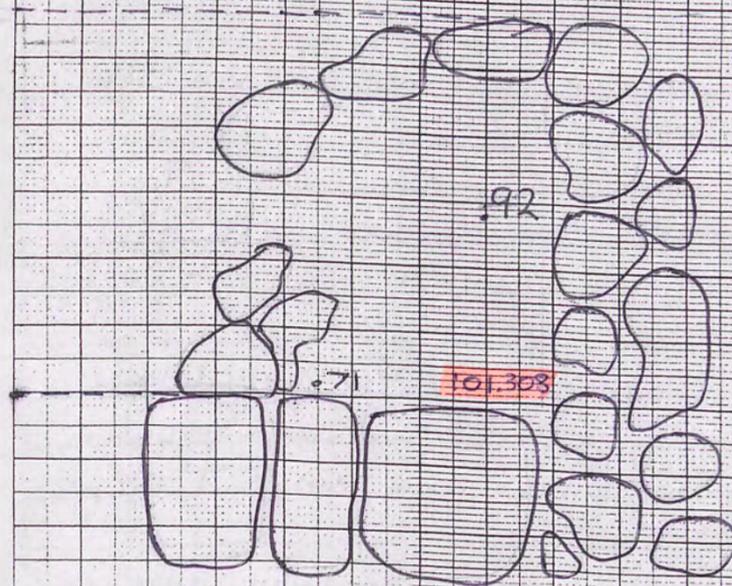
Feature A, 2.3

Context	Report
L2.2.	clearing spoil from previous excavation (1996) want to excavate down to bedrock and perhaps find a third floor level. - object Δ found, perhaps worked stone handle? in layer of spoil so probably fallen upper level in baulk. - small pieces of charcoal found Δ also probably fell from baulk of upper level. - Curving wall uncovered enclosing SE cnr. seeding \rightarrow
2.3	- very large piece of pottery (40 cm length) Δ - probably a tile

Depth from upper floor - 29.61
elevation - 101.308
