# Jebel Khalid

Field Record Book  
2006

Name..... HEATHER JACKSON BOOK 1 .. 2006 ..  
Trenches..... DQ ..... 61, 66, 44, 46, 6, 23, 47, 29, 30, 40, 15, 20,  
..... AREA S 7 [2], ..... 12/21, 48  
Dates..... 24/4/06 - 16/5/06 ..... 81/89.

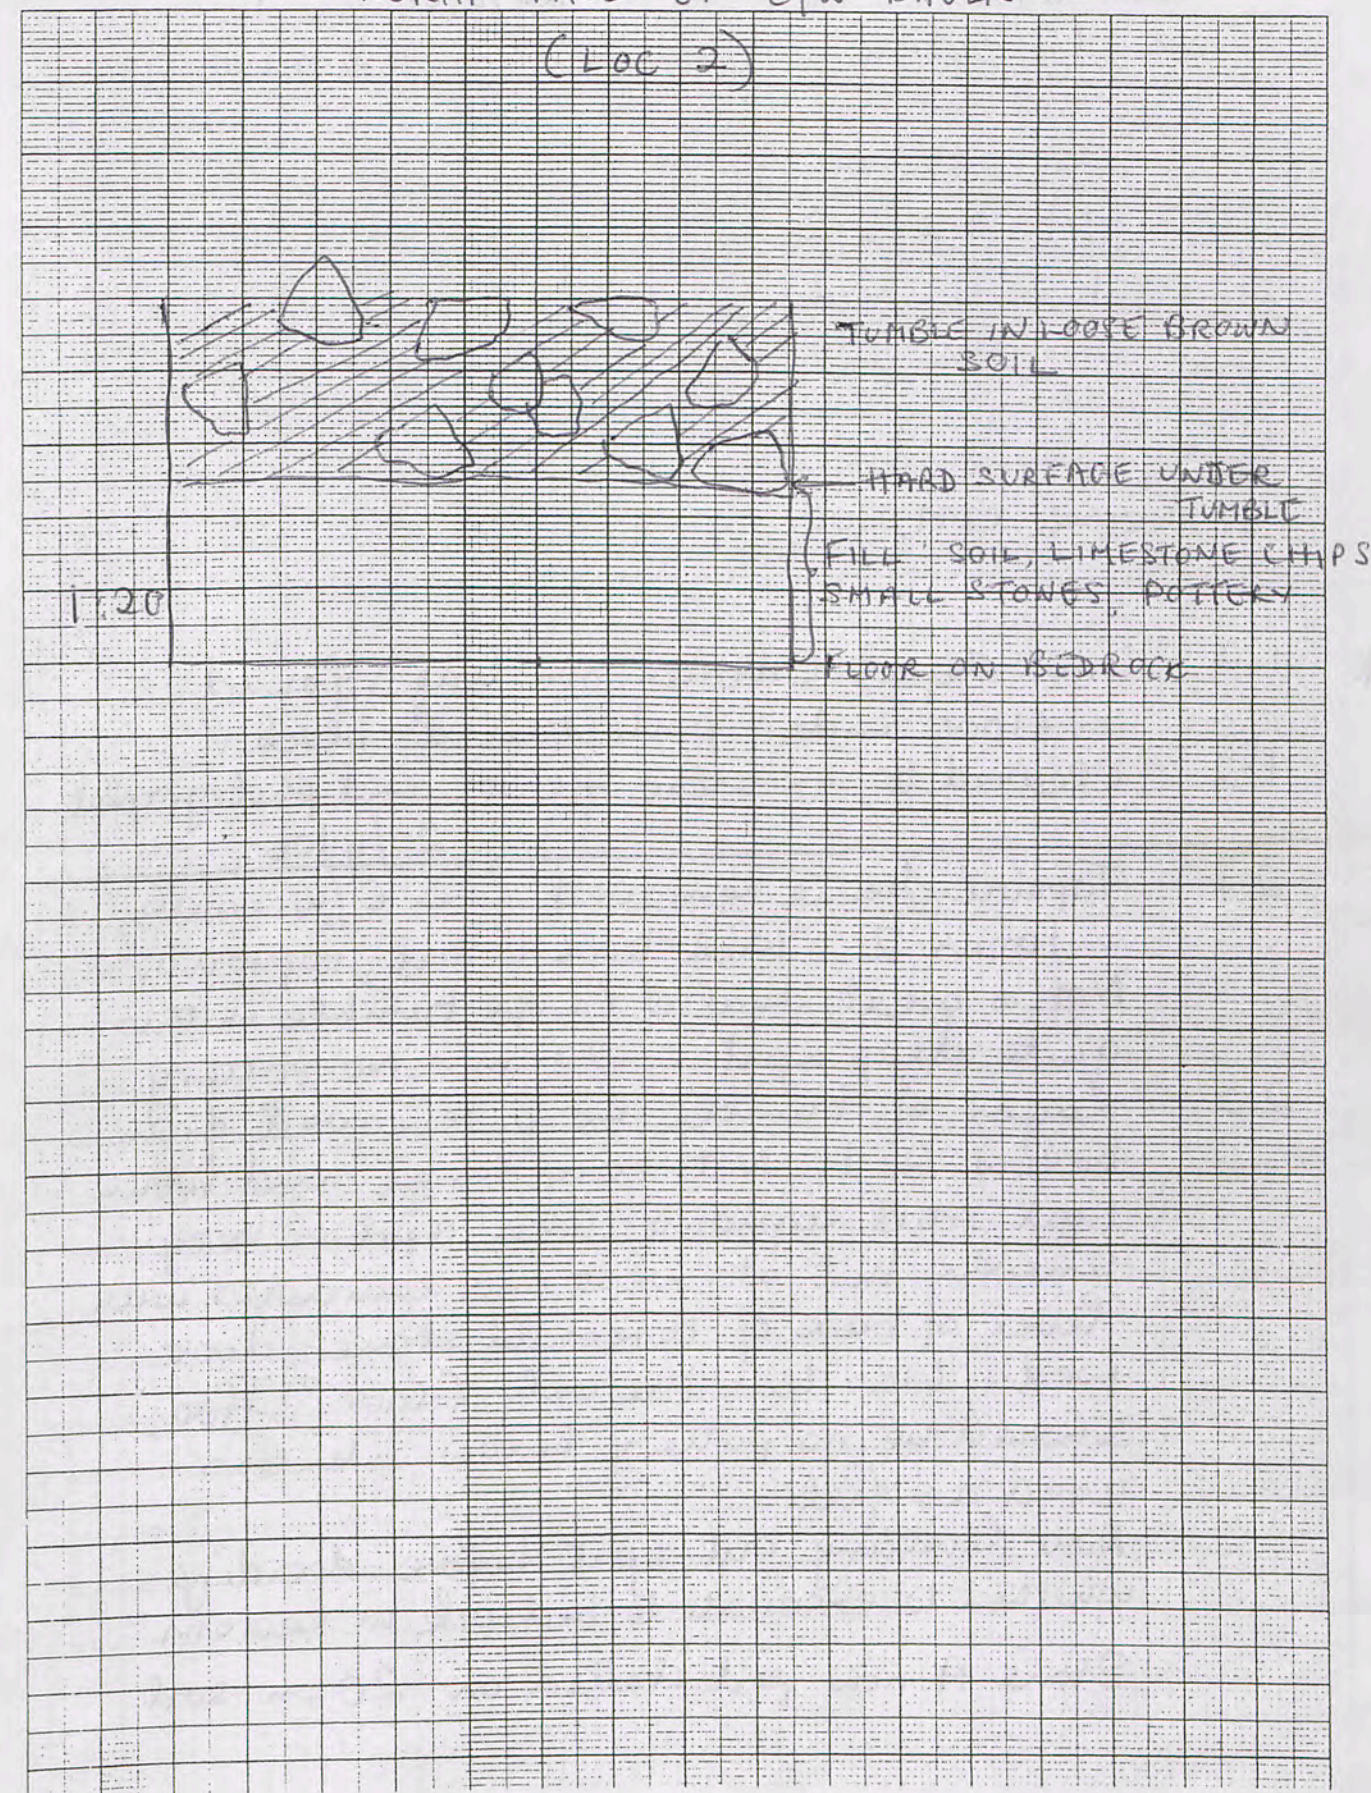
NORTH FACE OF E/W BAULK

(LOC 2)

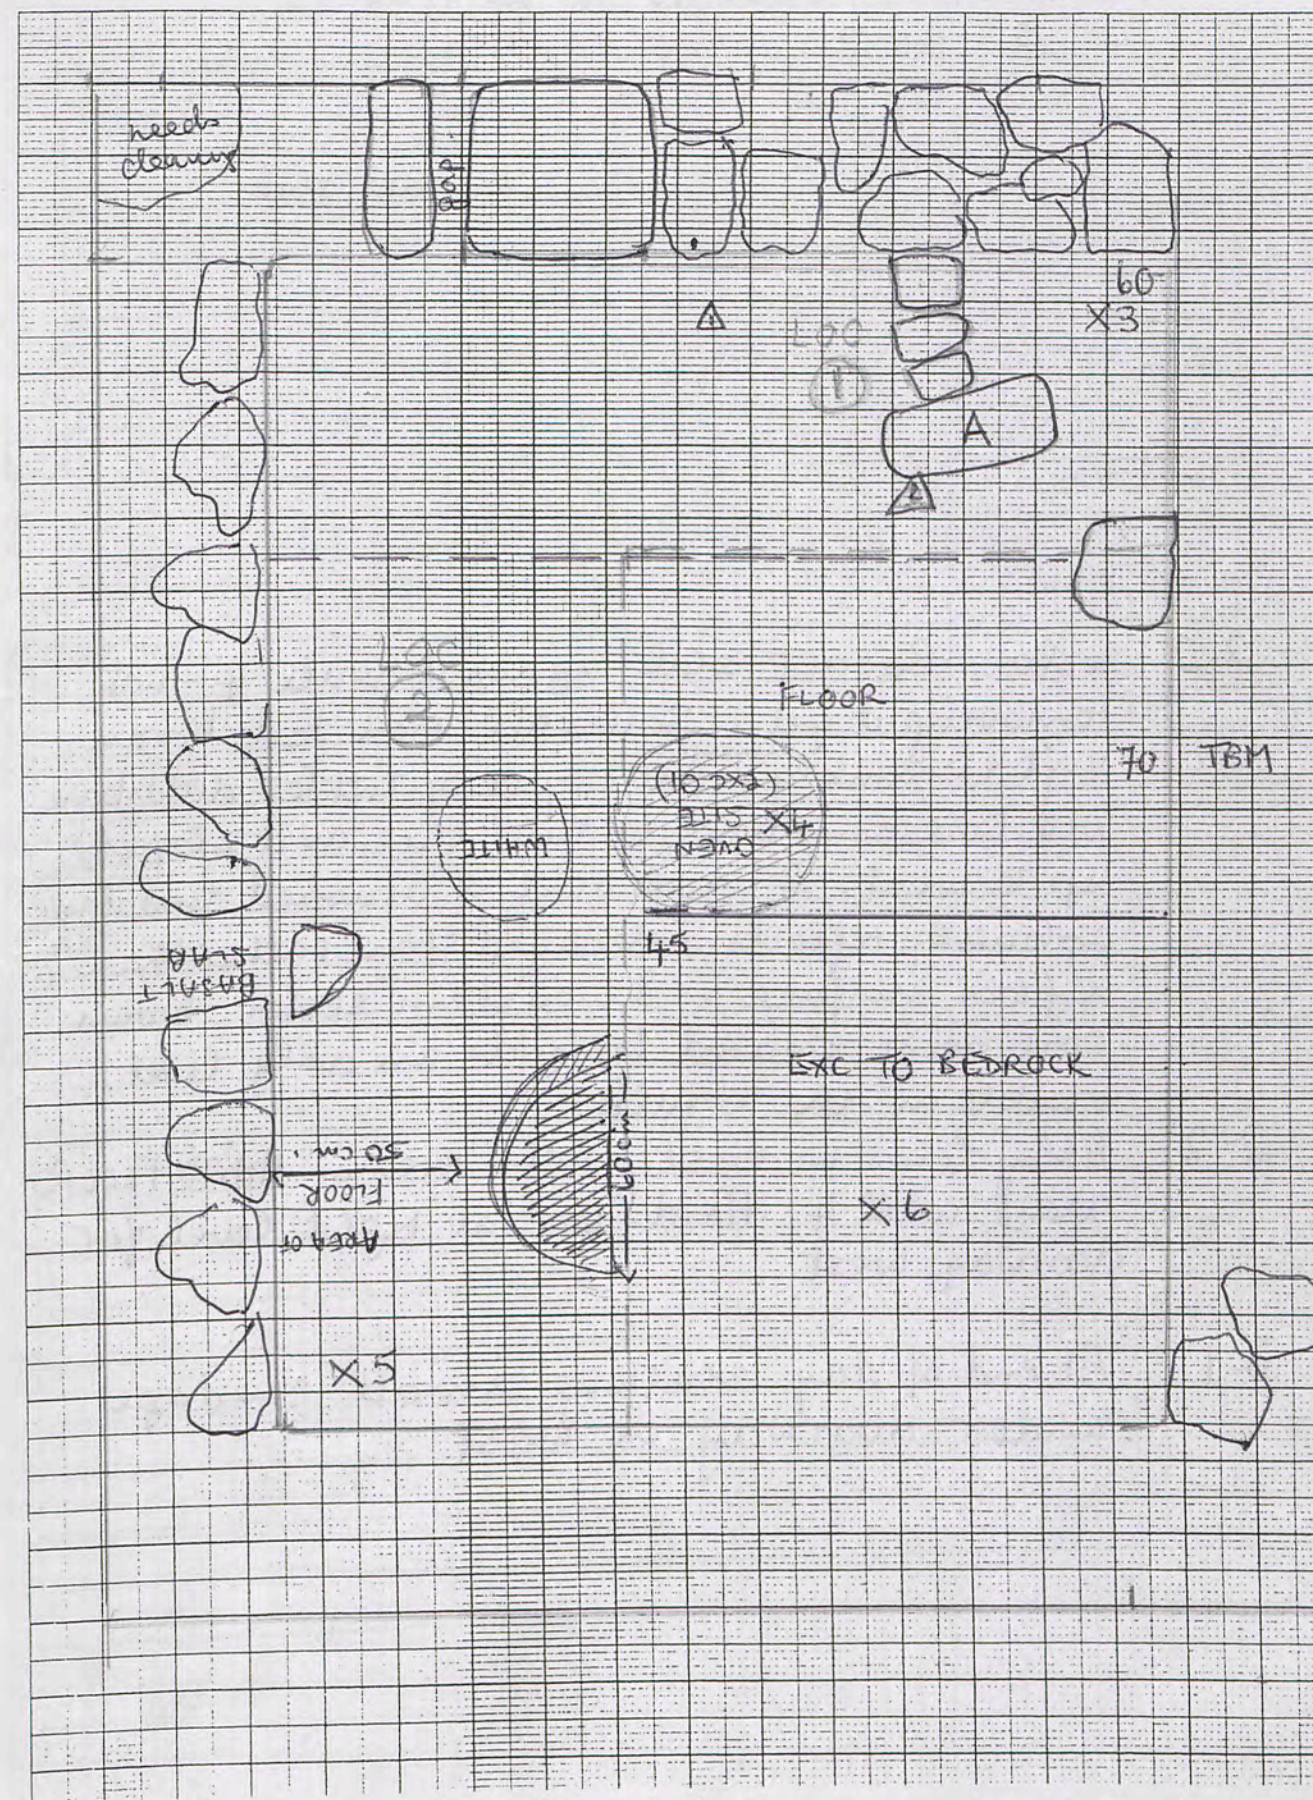
4A

△ 200 mm  
△ 650 mm.

top of A 5cm

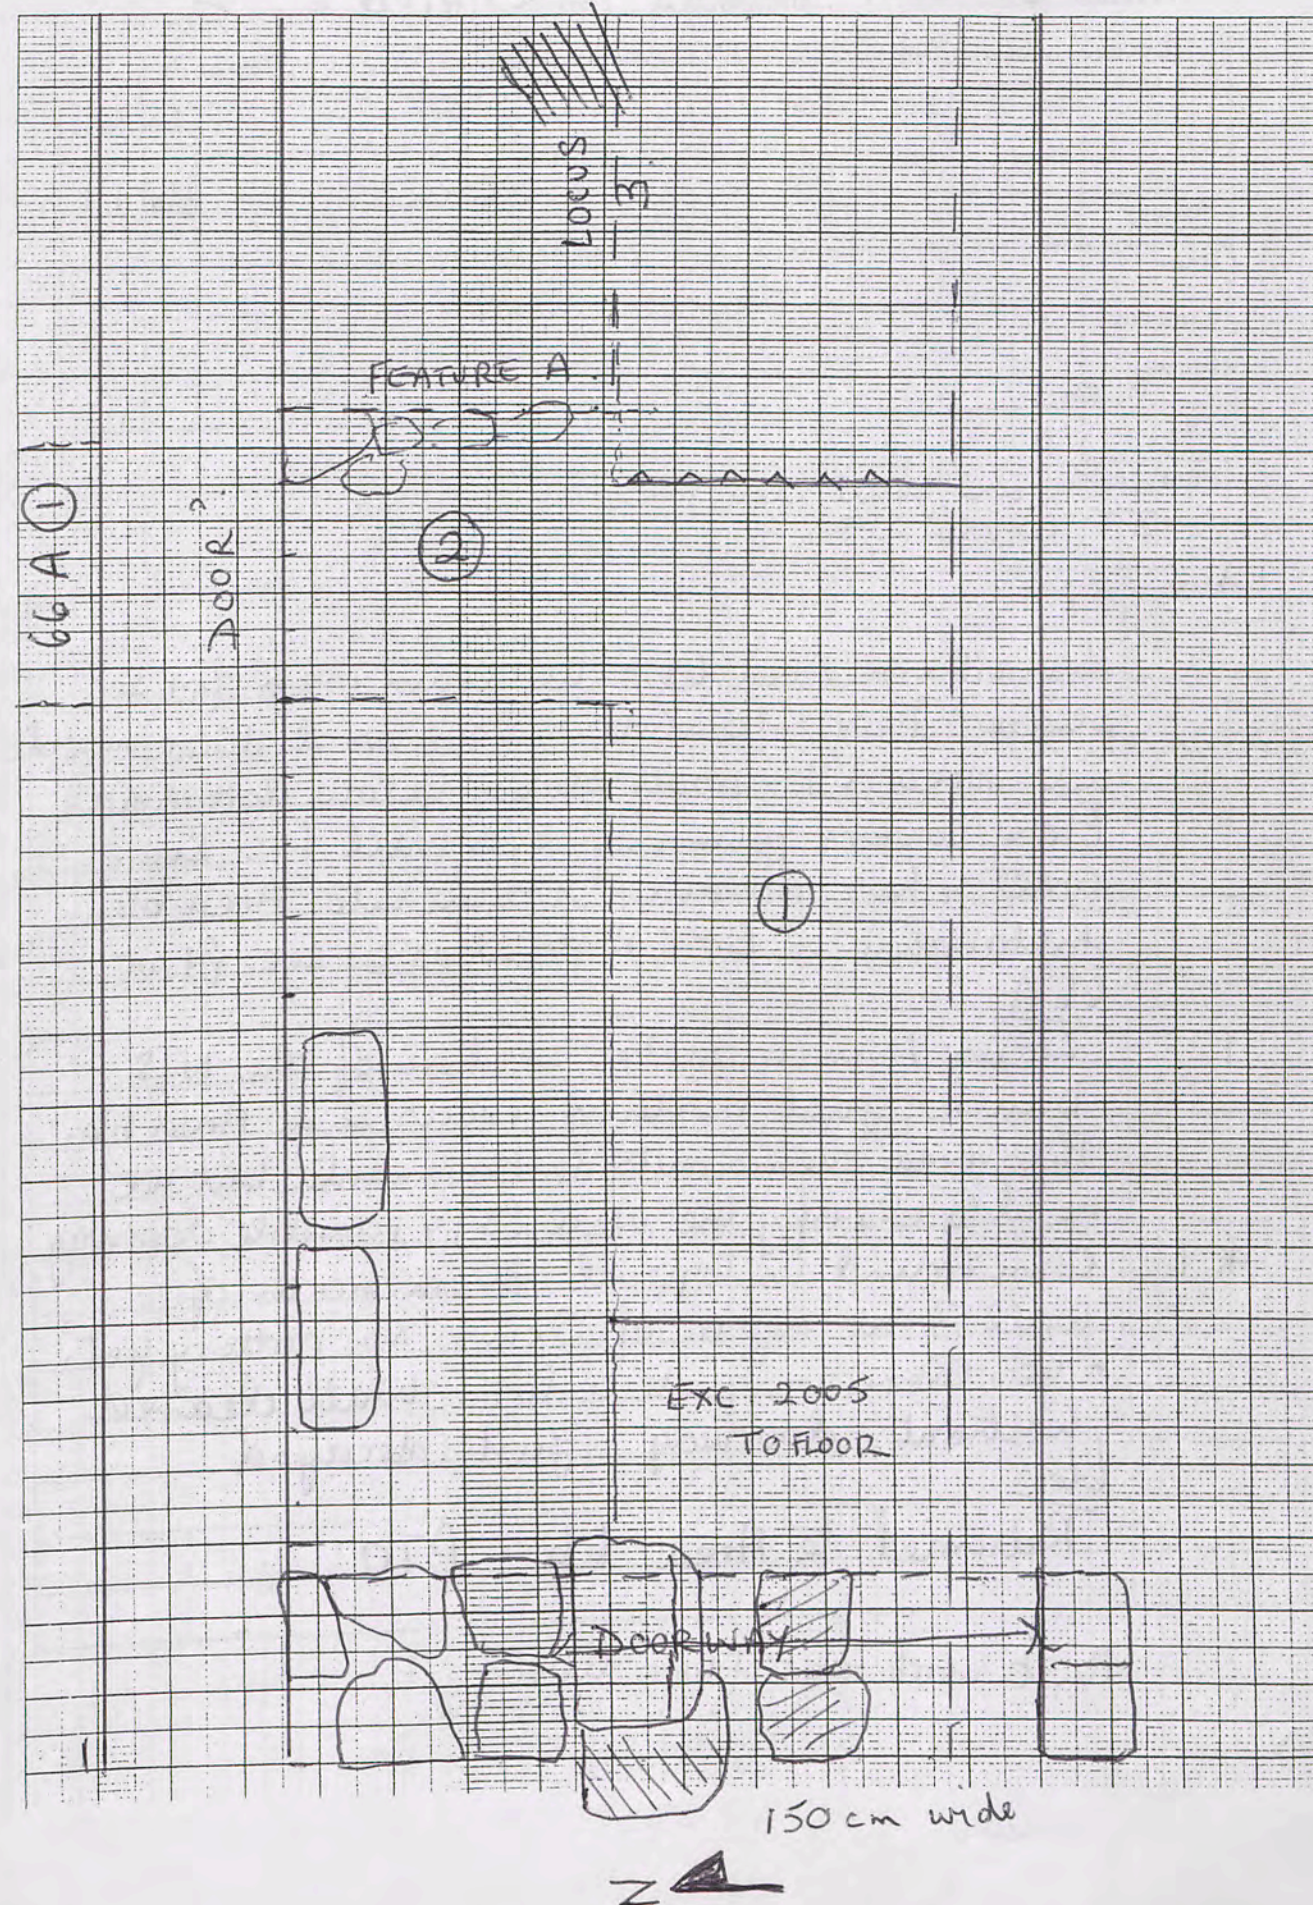
6A

| Context | Report |
|---|---|
| 1.2 | Returned to bank (1) (E/W) to start removing tumble, which is very thick and large in this locus. It is resting on the floor to a height of 75-80 cms, with rich brown soil between the rocks. Am now considering that the time-consuming removal of all this is not going to tell us anything new about Area 66 - there is unlikely to be an installation in the centre of the room. So ..... we will change focus? to external bank to north of locus 2 - this is locus (1) in 66A (area outside insula - not a room). |

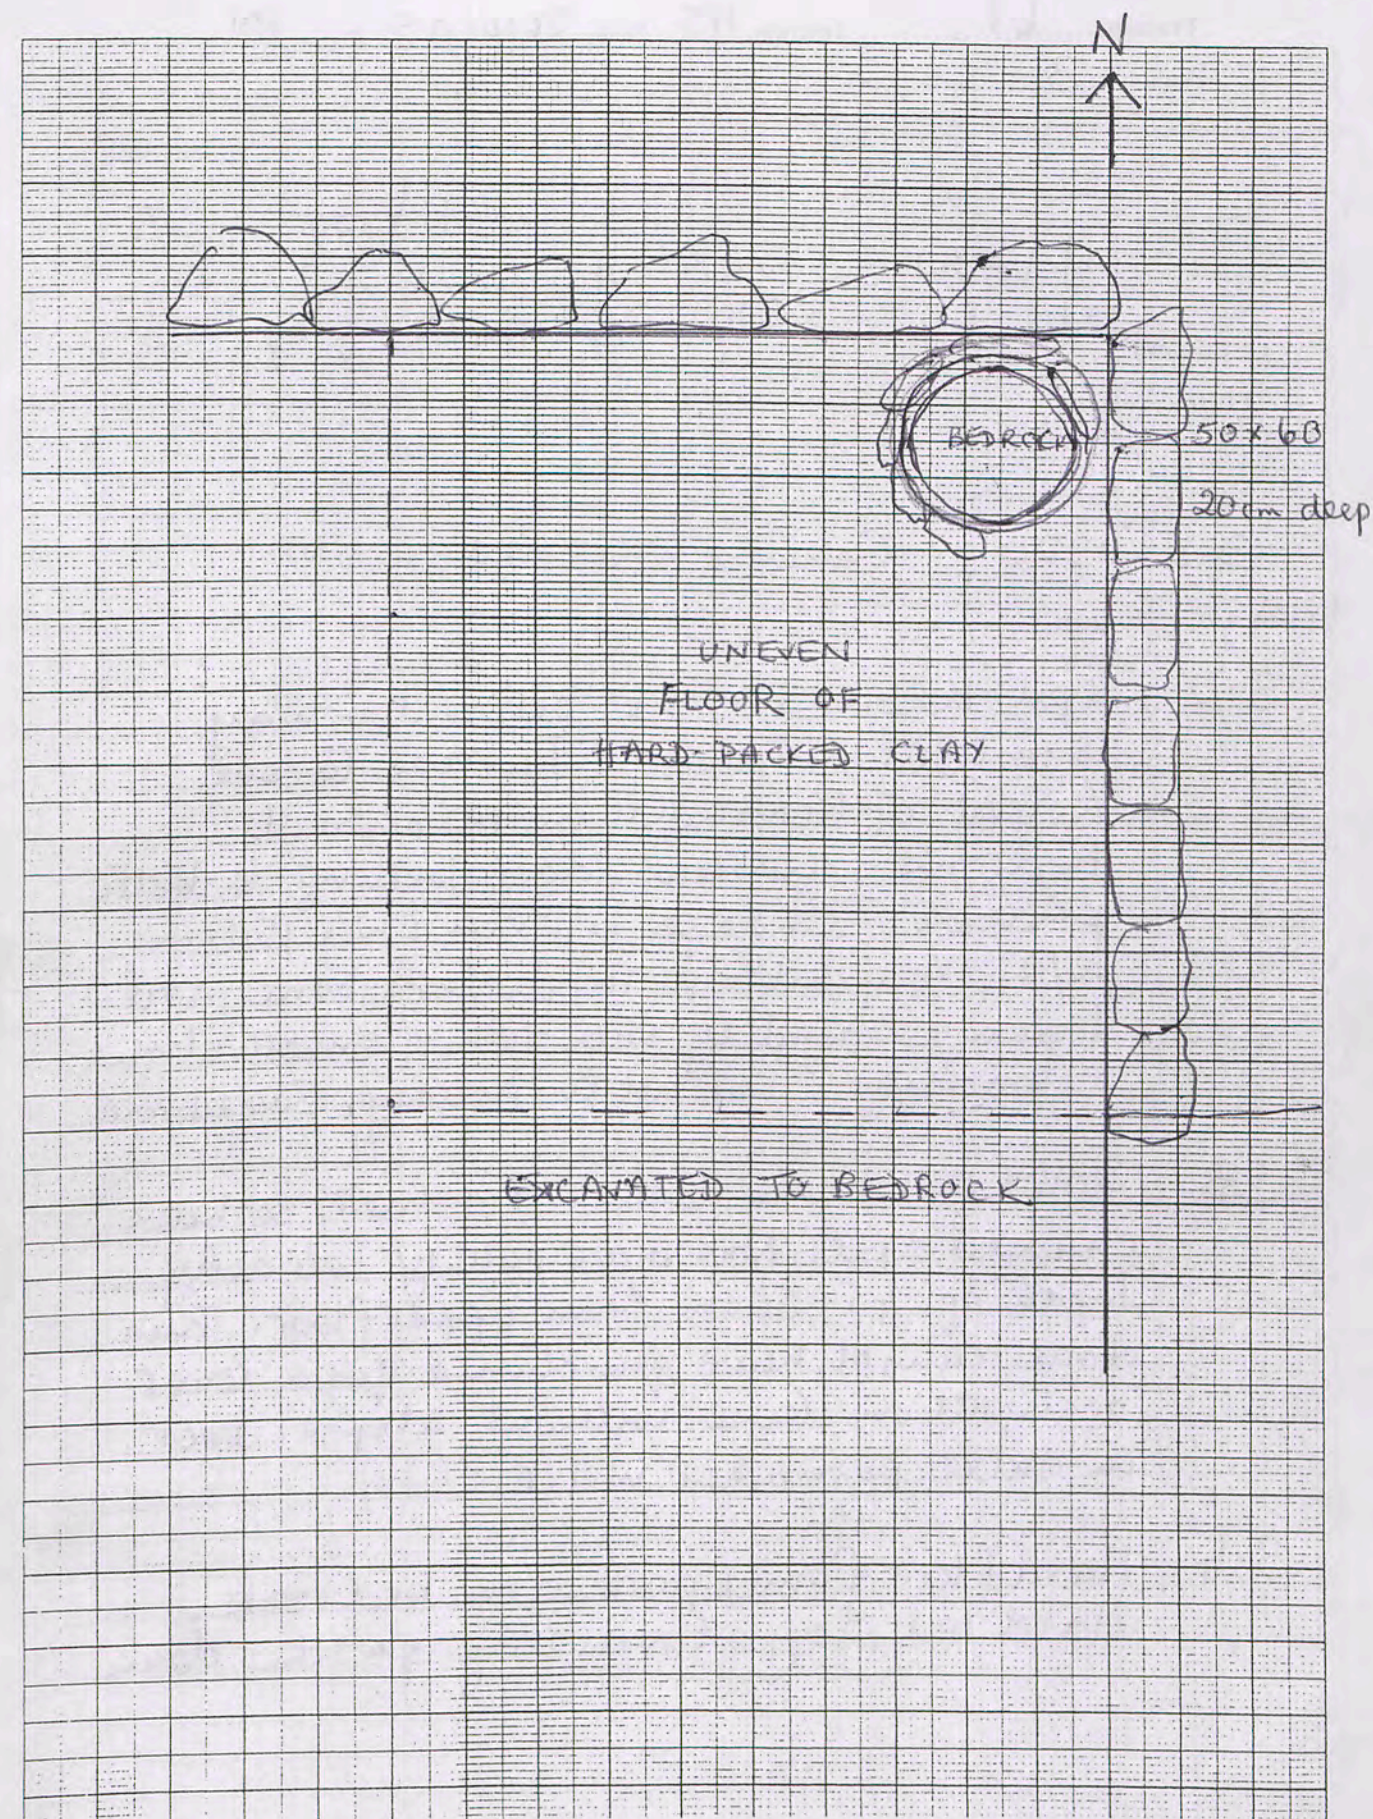
1mm Squares 9A

| Context | Report |
|---|---|
| F.A. | Tannur found in NE corner - fairly well preserved to a height of 200 mm. and surrounded/protected by stones at the base. Some bone from interior - no pottery. One large bone visible. Tannur same one found 2002. |

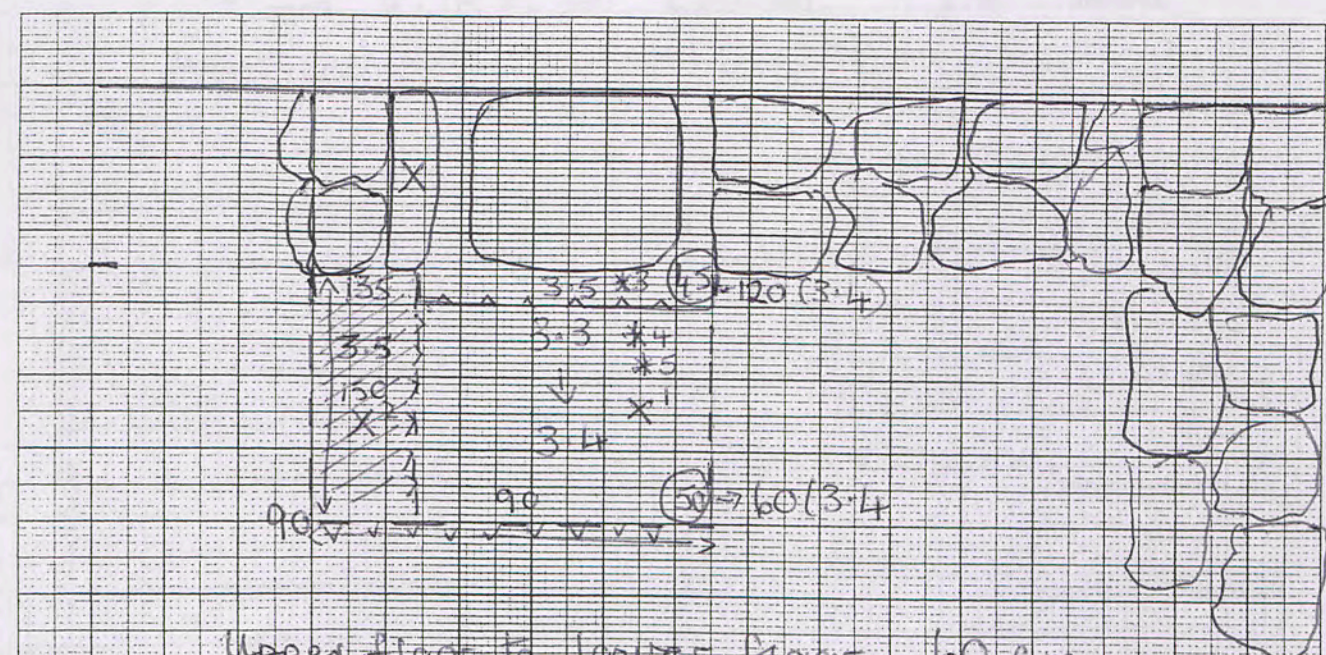
1mm Squares  
10A

Upper floor to lower floor 60 cm  
 Lower floor to bedrock 10 cm  
 Threshold to lower floor 70-85 (70 = base) cm  
 From surface X to bedrock 130 } bedrock  
 " Y " " 120 } slopes  
 Pit in centre sec floor diameter 110 cm  
 depth 20 cm  
 Upper floor to lower in NE 45-50 cm

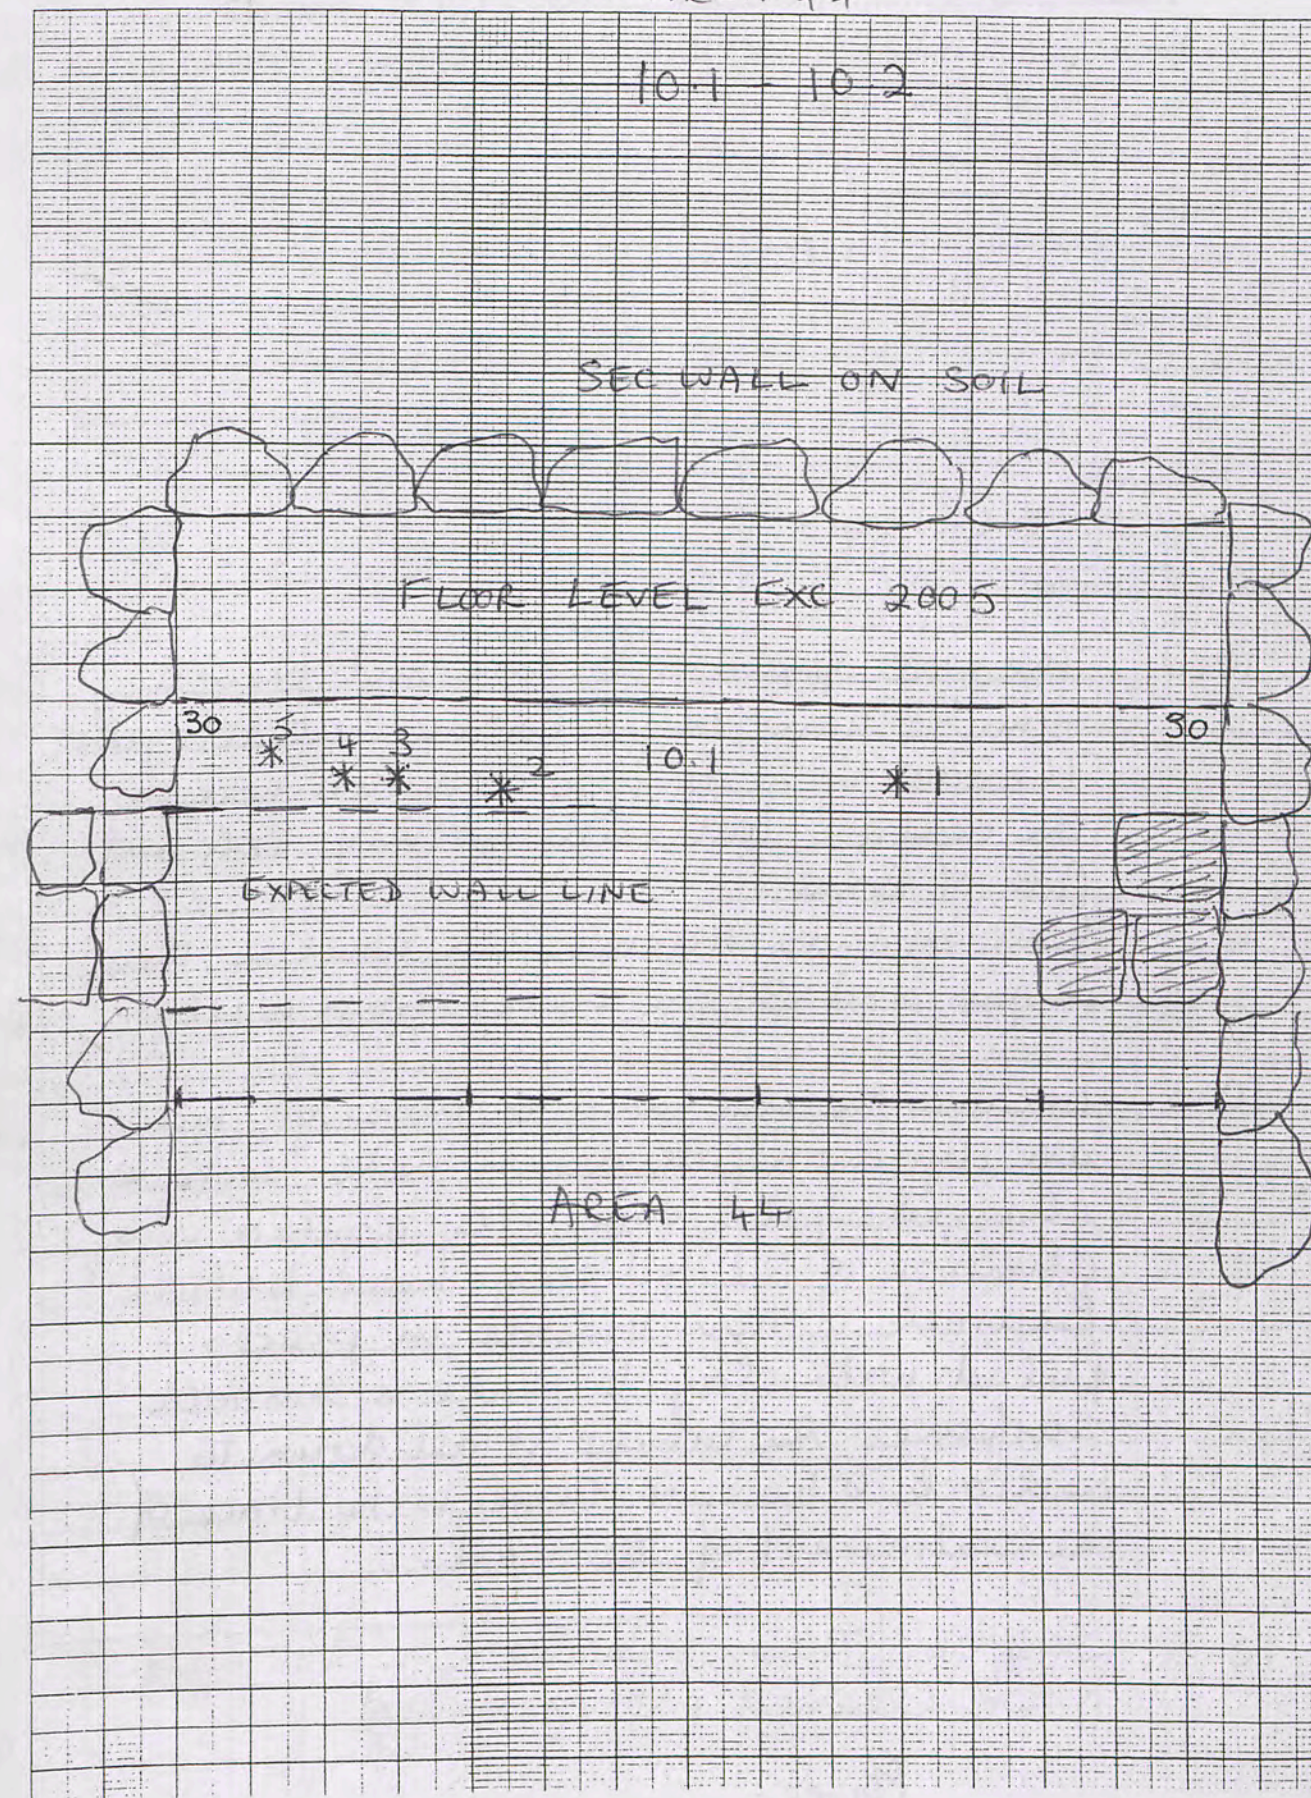
10.1 - 10.2

| Context | Report |
|---|---|
| 10.2. | The wall appears to fail mid-trench - must have been taken out altogether. The soil is quite tough brown here in the centre, but still pottery-rich and full of bone. Wall extends 110cm from wall 2, then a gap and 80cm braces from wall 1. |
| 10.3. | Because the mid-wall is missing, they are digging a little deeper here, so have changed spits, especially as there is a glimpse of the red clay (near bedrock?). Bedrock is now visible in places - filled with clay to make a smooth surface. Am taking it all down to bedrock to be sure there is no trace of the centre part of the wall. |

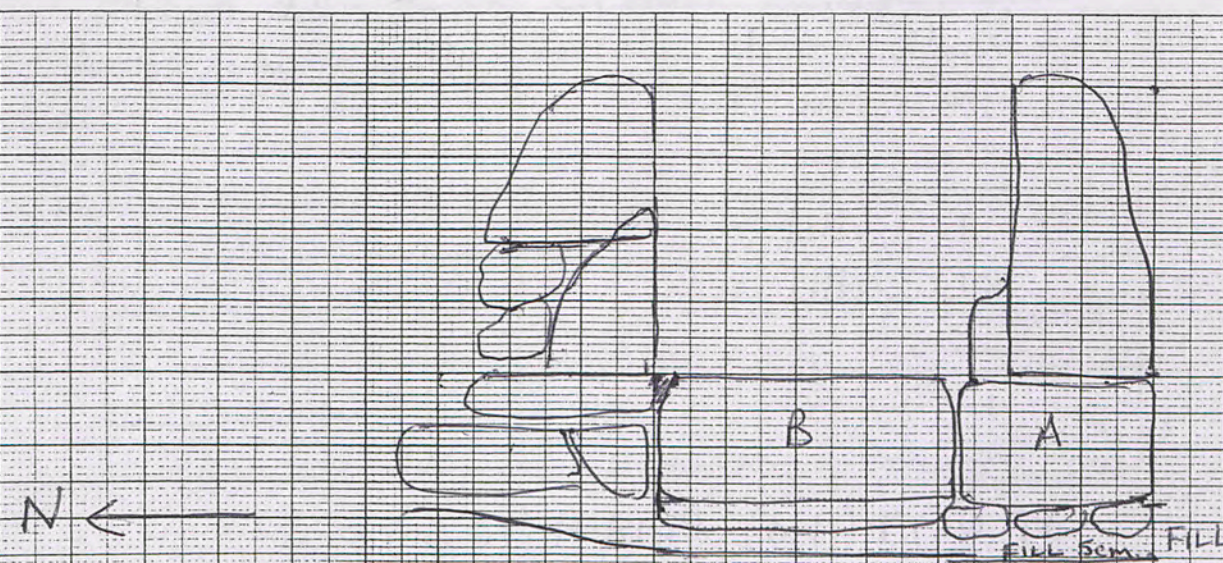
DRAWING OF DOOR & THRESHOLD 18A

NB Threshold projects west into Area 46 by  
10 at A  
18 at B south

| Context | Report |
|---|---|
| 11.1 | Beginning this 50 cm sandage below the wide door east to see the foundations of the doorway. The soil removed is dark brown and tough, as we are digging through the floor surface. Large stones project west from threshold by about 13 cm. Pottery & bone from here. |

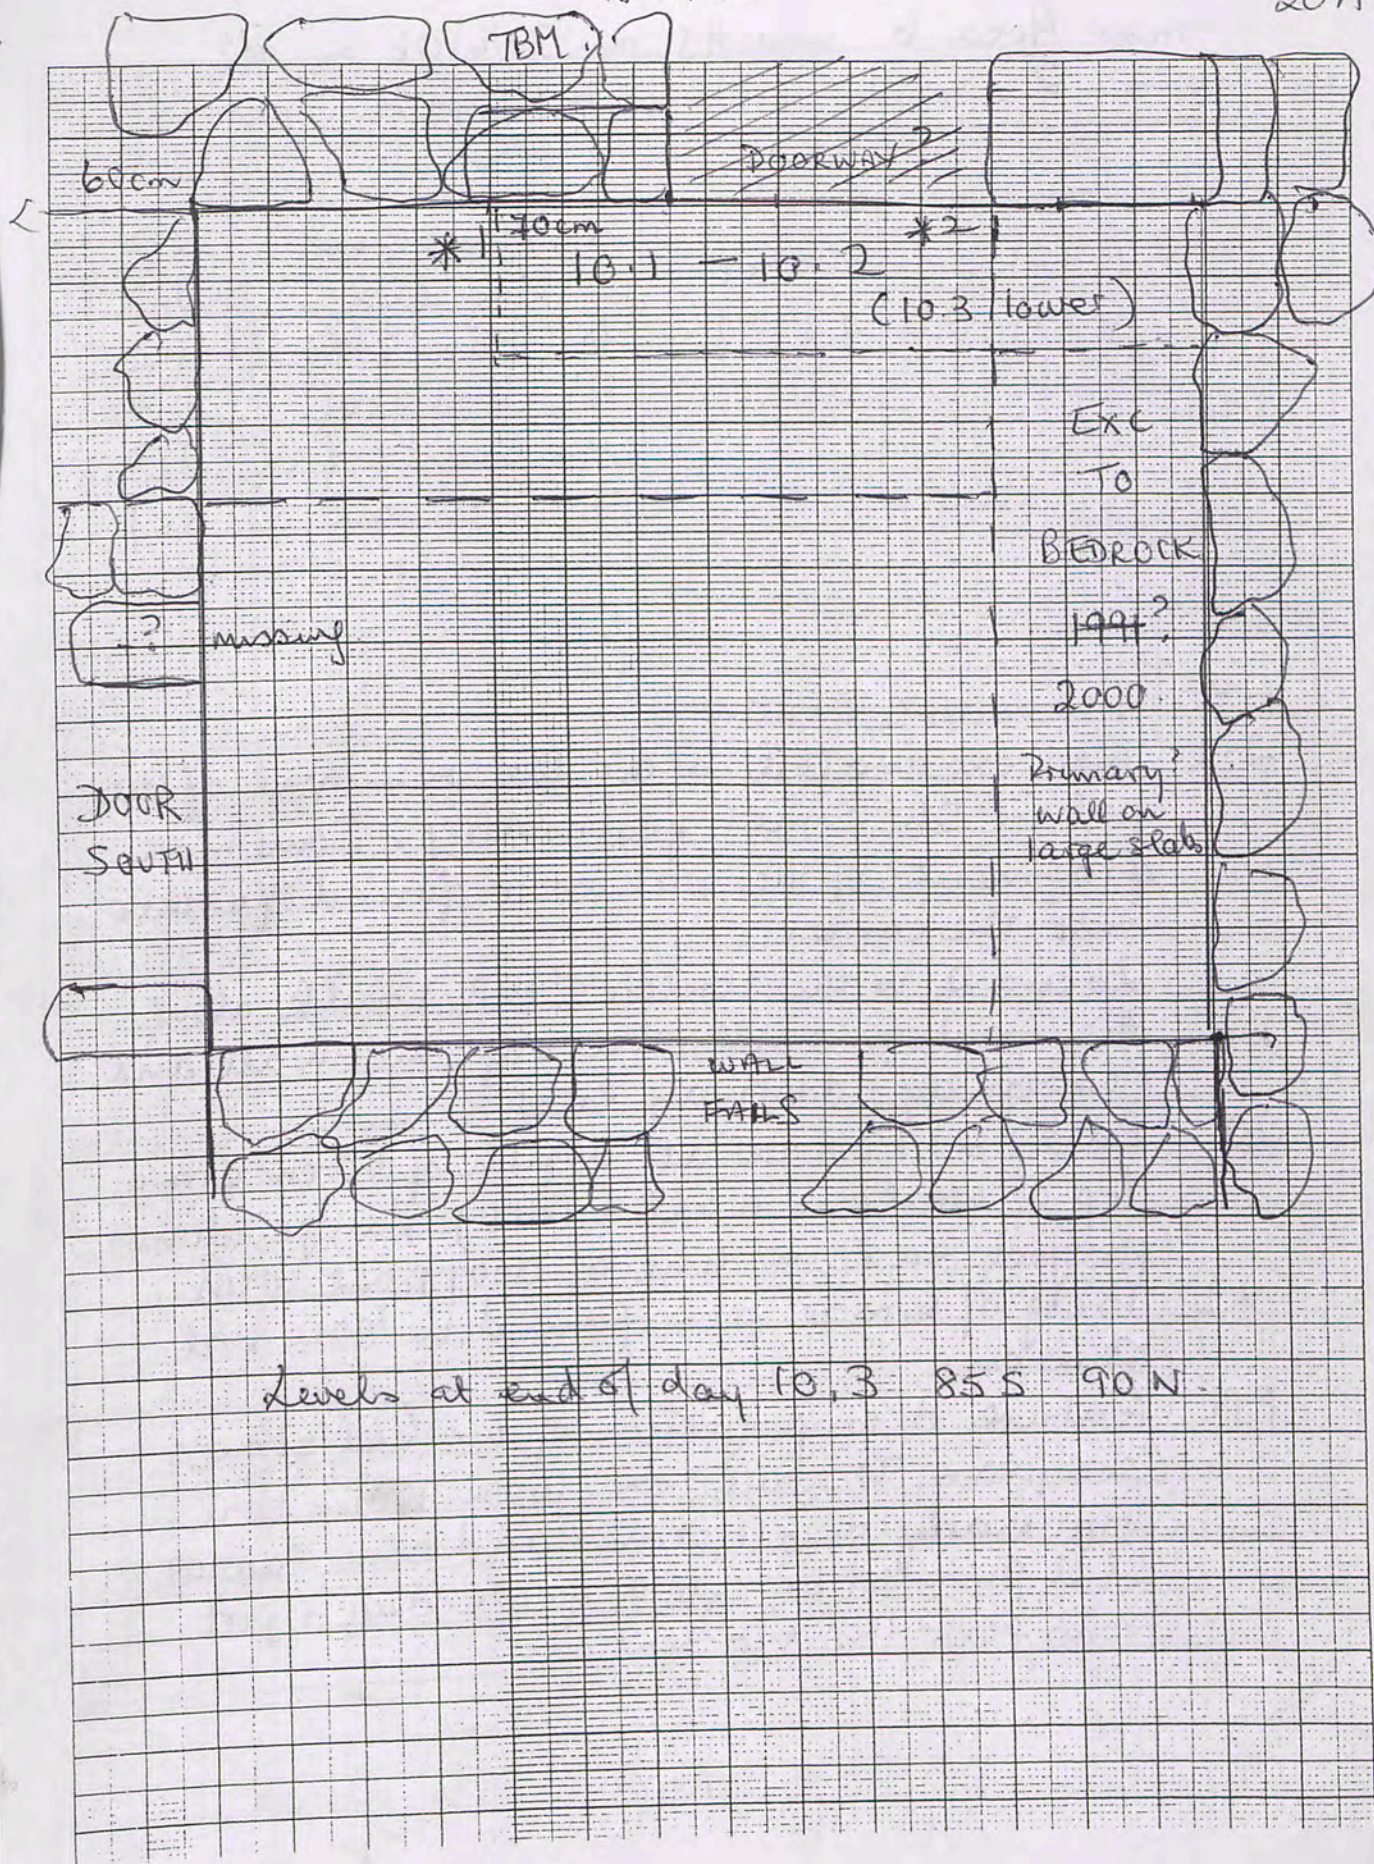
AREA 23      340 x 280

| Context | Report |
|---|---|
| 10.1 | This room was excavated to bedrock in the north but the SW corner was excavated (1990?) only to the level below tumble which is NOT a floor. We hope to reveal a blocked doorway into Area 27. Soil light brown, loose, with still some tumble and small stones. |

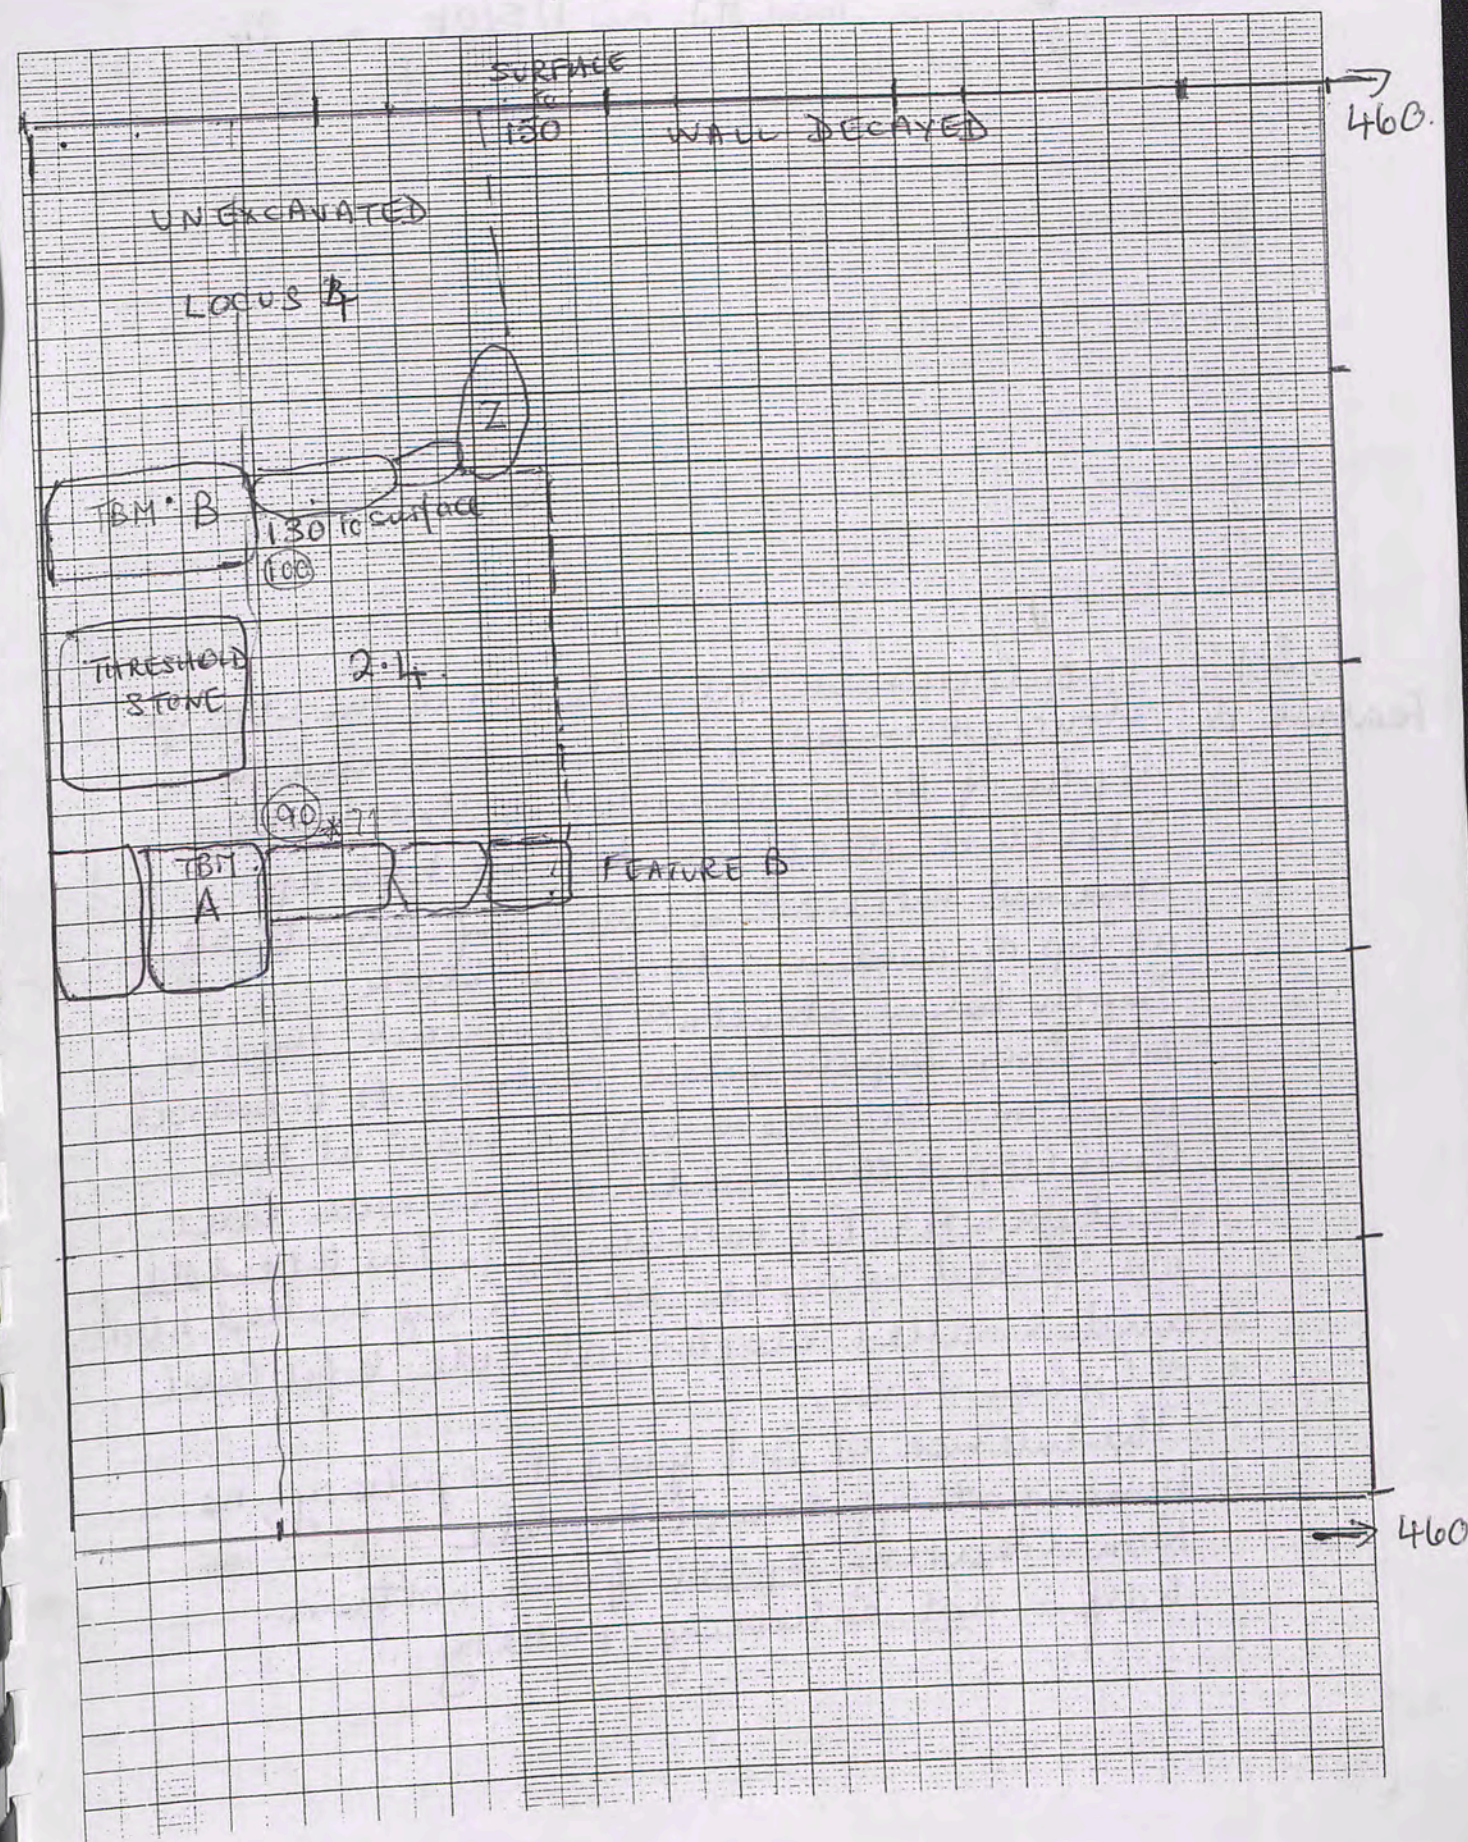
Area 6  
460 x 460

| Context | Report |
|---|---|
| 2.4 | <p>Spit lower than yesterday's in locus 2. Threshold stone revealed in centre of d'way - does not cover whole threshold but subcircular at 50 cm square.</p> <p>Feature B rests on fill of 20 cm depth which would correspond with higher floor level (not found elsewhere) and also with top of threshold so door could be used.</p> <p>Iron blobs at 90 cm below TBM A.</p> <p>Still loose brown soil but less pottery base.</p> <p>Some areas of tough soil at depth of 130 from TBM B. Proceeding with 2.4, leaving them in it which we must later investigate.</p> <p>The door threshold must have belonged to a floor higher than bedrock which we have not yet reached.</p> |

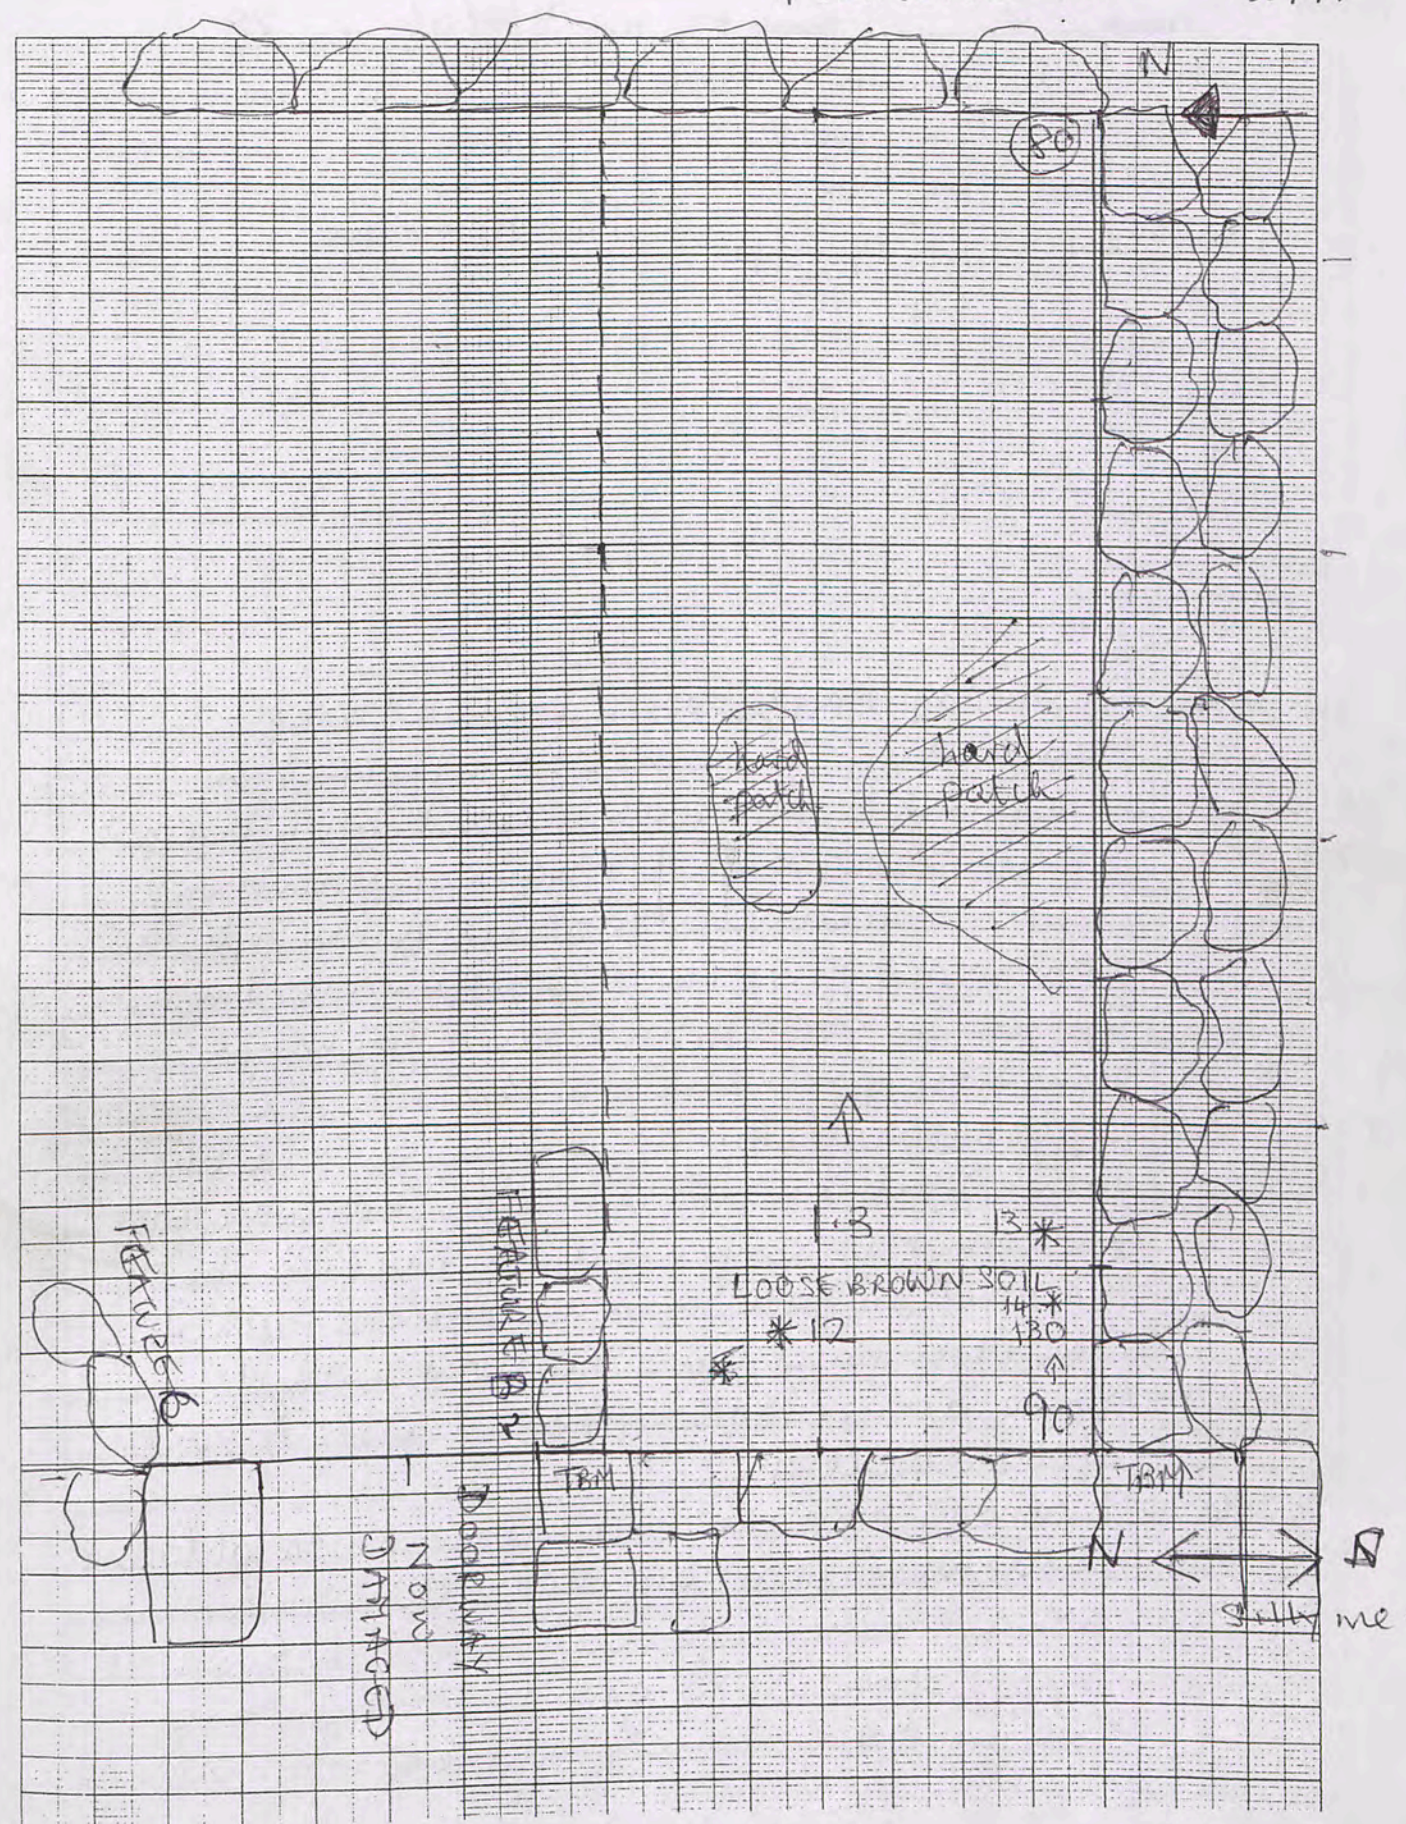
PERIMETER WALL 27A

130 SW corner  
120
