# Jebel Khalid

Field Record Book  
2006

Name..... HEATHER JACKSON BOOK 1 .. 2006 ..  
Trenches..... DQ ..... 61, 66, 44, 46, 6, 23, 47, 29, 30, 40, 15, 20,  
..... AREA S 7 [2], ..... 12/21, 48  
Dates..... 24/4/06 - 16/5/06 ..... 81/89.

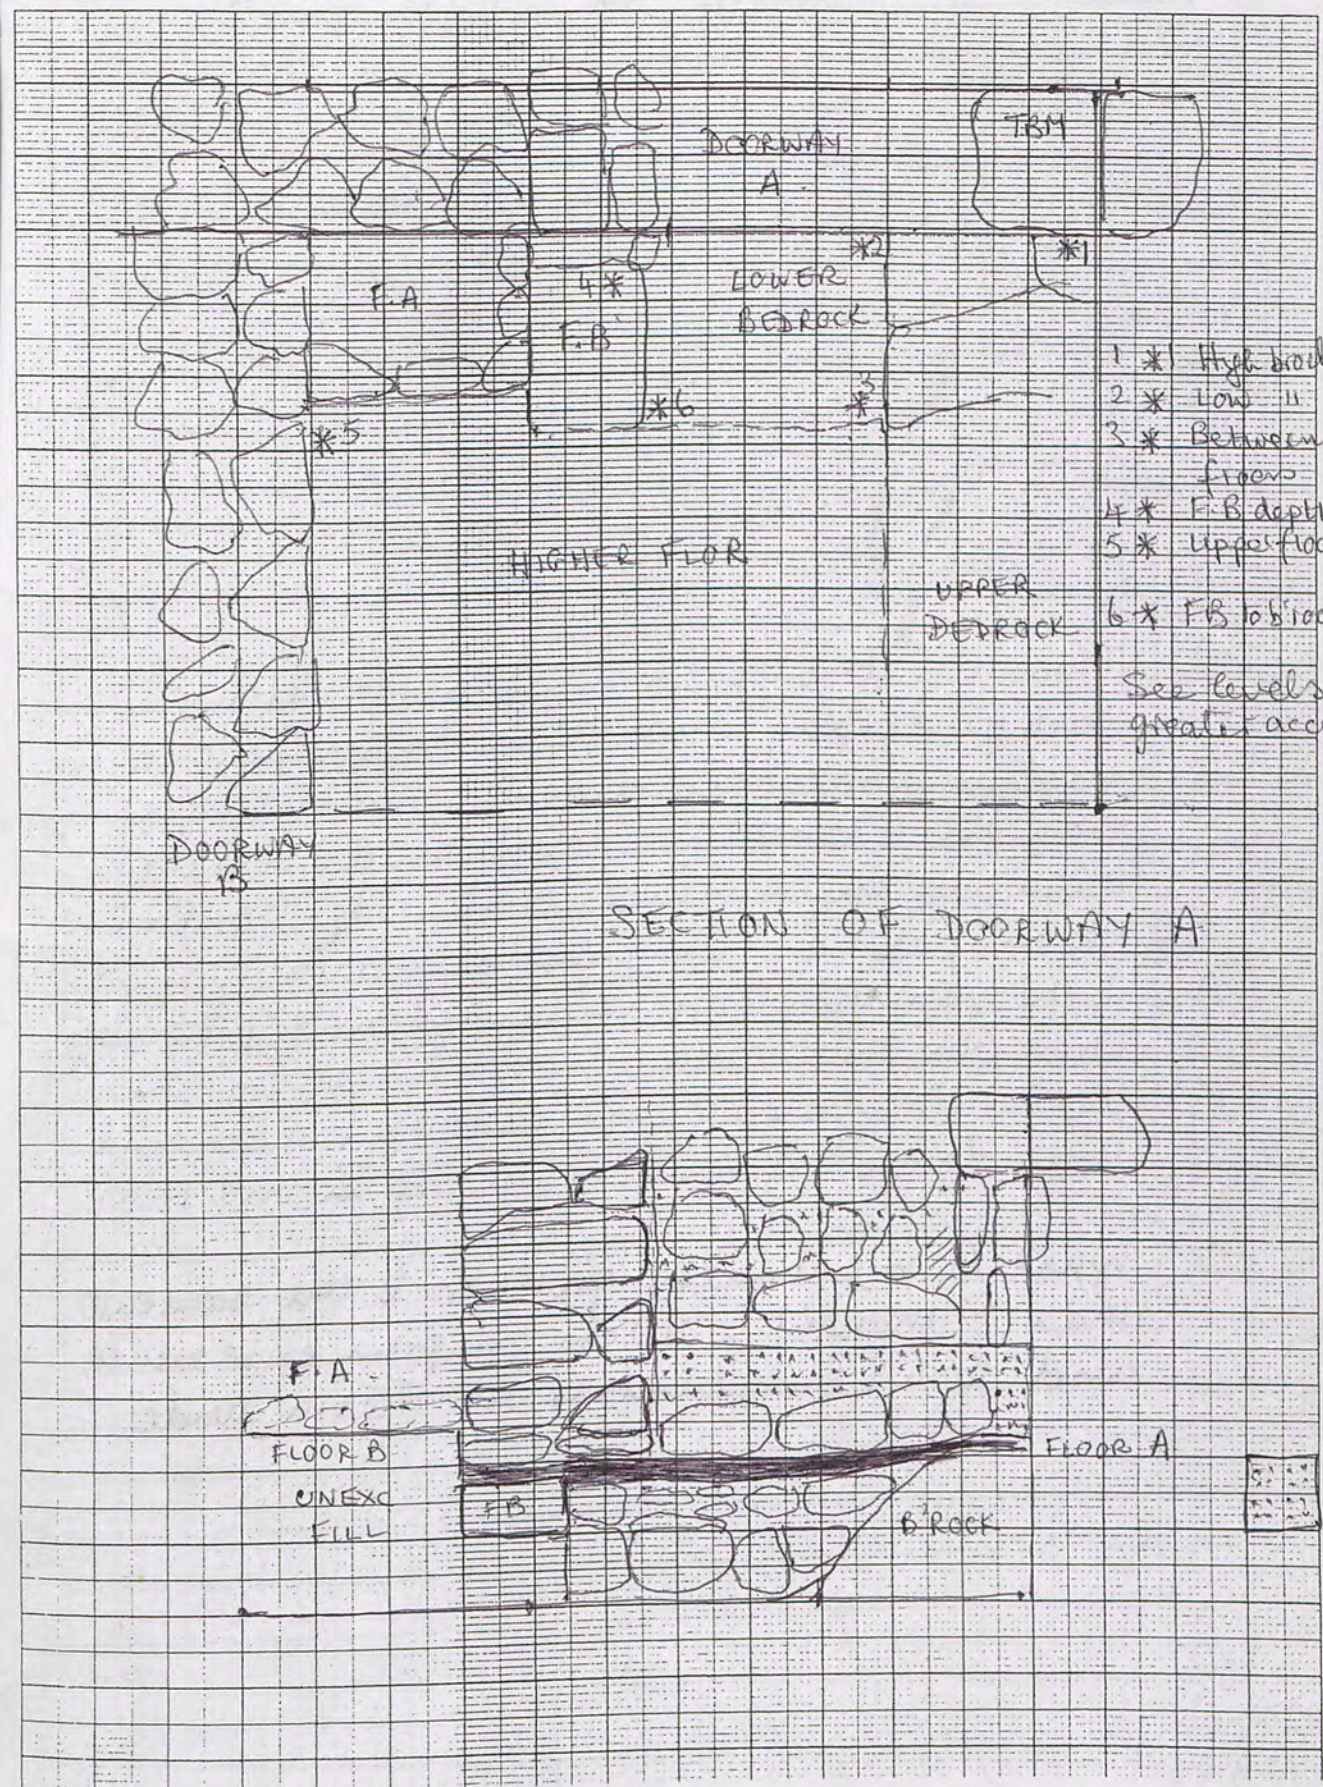
AREA 23  
SONDAGE.

- 1 \* High block 115
  - 2 \* Low " 150
  - 3 \* Between floors 35?
  - 4 \* F.B depth 90
  - 5 \* upper floor 63
  - 6 \* F.B block 45
- See levels for greater accuracy!

NOTE: Deliberately blocked above Floor B, but possibly still in use then (Phase B) with higher threshold. Fully blocked after that (B+)

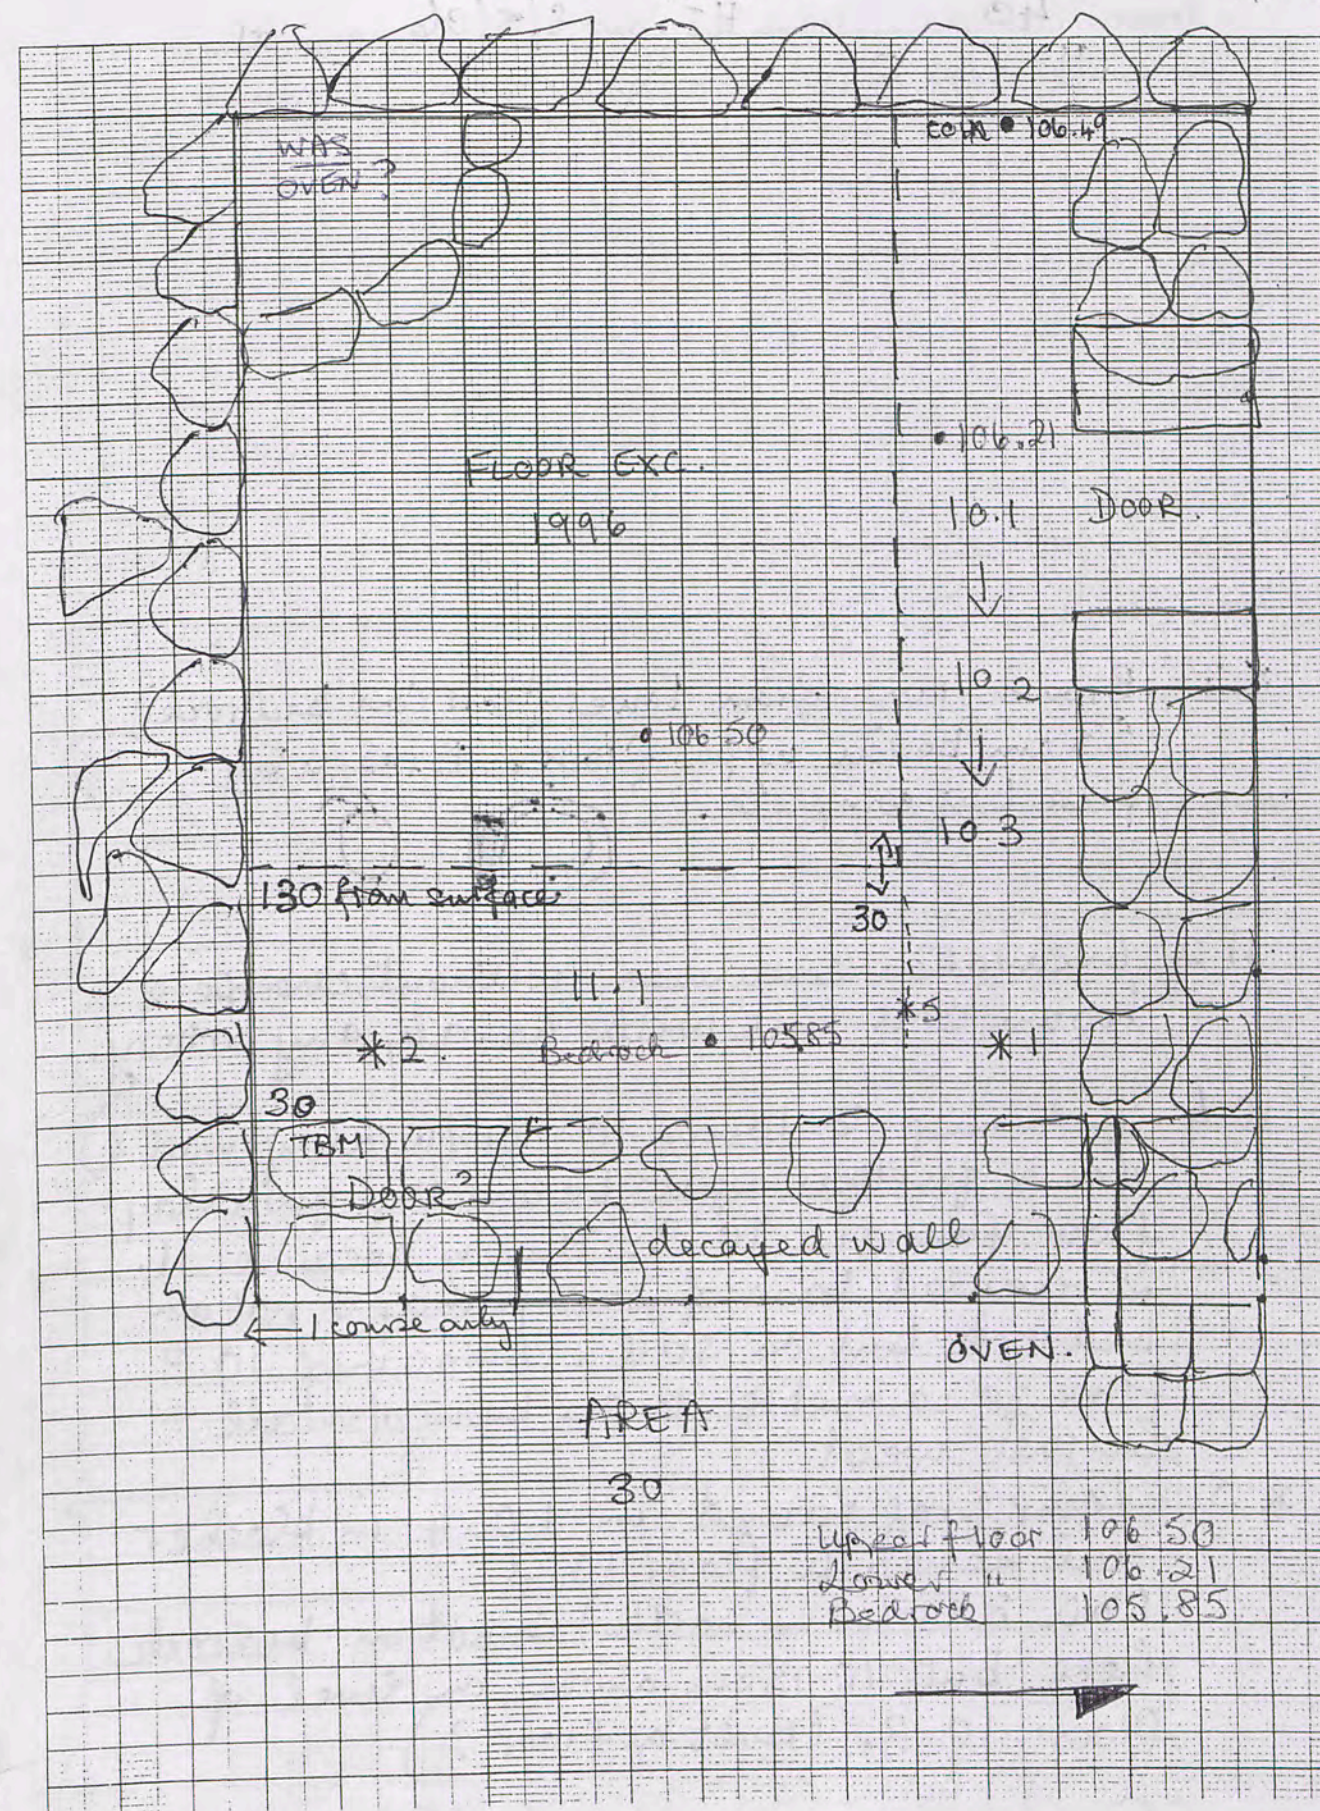
AREA 40

| Context | Report |
|---|---|
| Lowerfill | investigate the foundations of the wall and perhaps clarify the possible doorway east, altho' this area is very decayed. The spit is 30 cm BELOW upper floor exc. 1996 |
| *2 | Bronze object ( <sup>coin</sup> stud?) from fill (soil) to south. Loose rich brown soil, little pottery |

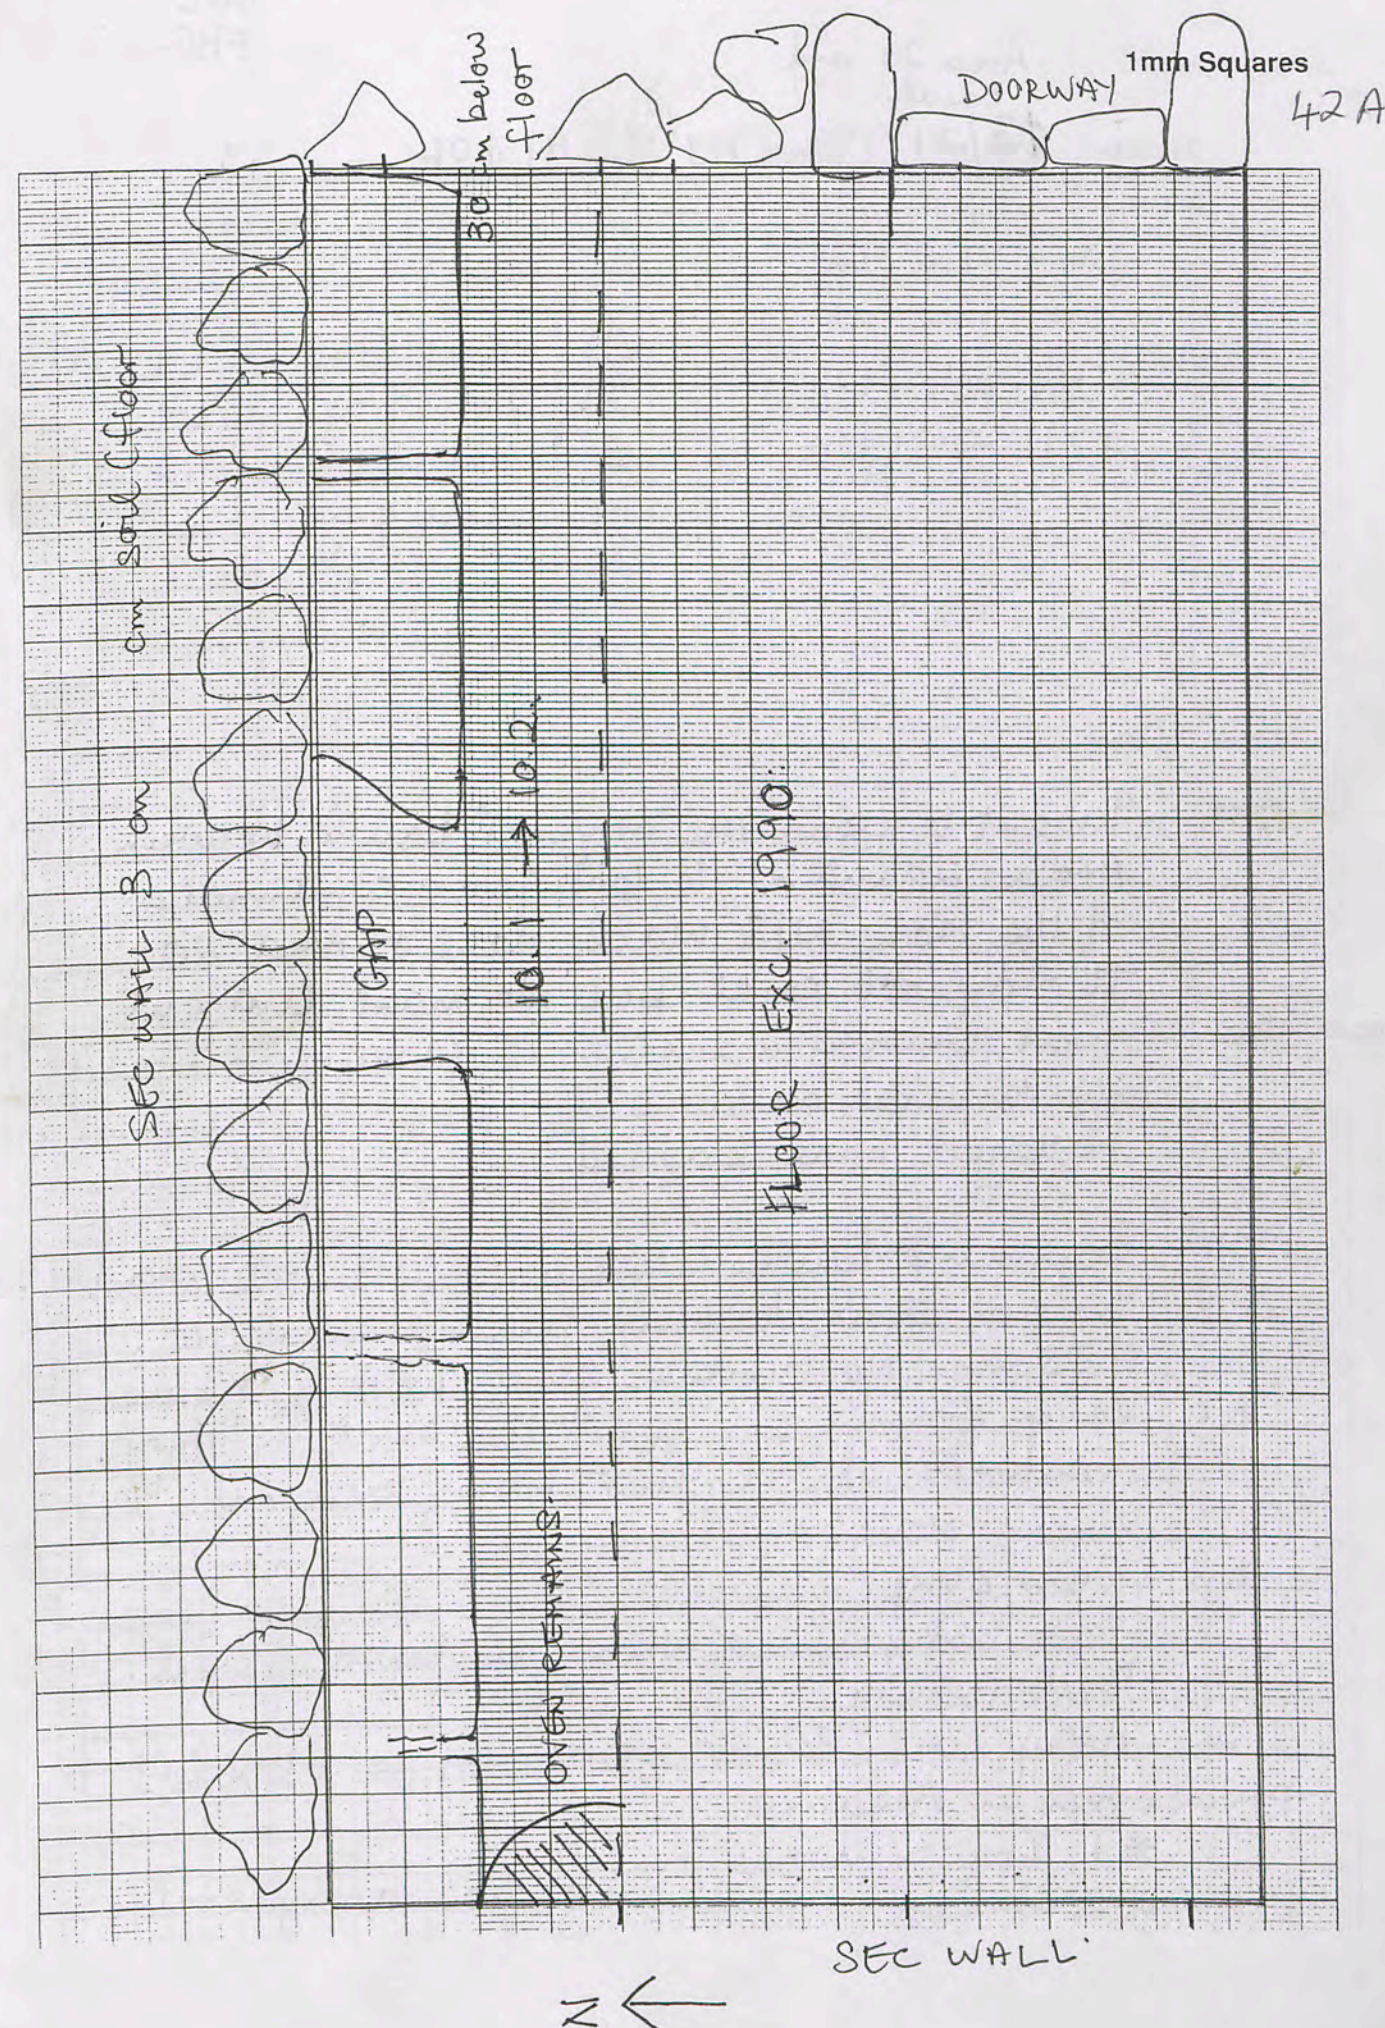
AREA 15

| Context | Report |
|---|---|
| 10.1 | Area 40 being cleaned; Meanwhile have transferred 3 workers to dig below the row of rock slabs in Area 15 to find bedrock - bedrock was never reached in this trench. Already cleared to a depth of 15cm. where base of slabs are visible. Some pottery, including an ung. toe in good condition. |

10.2 Below 10.1 - red, tough soil near bedrock. Still some pottery.
