# Jebel Khalid

2006  
Area S

Field Record Book

Name..... HEATHER JACKSON, BOOK 2, 2006.....  
Trenches..... AREA S: 7, 13, BIK 7/13.....  
DQ: 96, 99/98, 99, 13, 16, 86, 94, 3, 14, 84, 91.....  
Dates..... 17/5/06 - 2/6/06.....

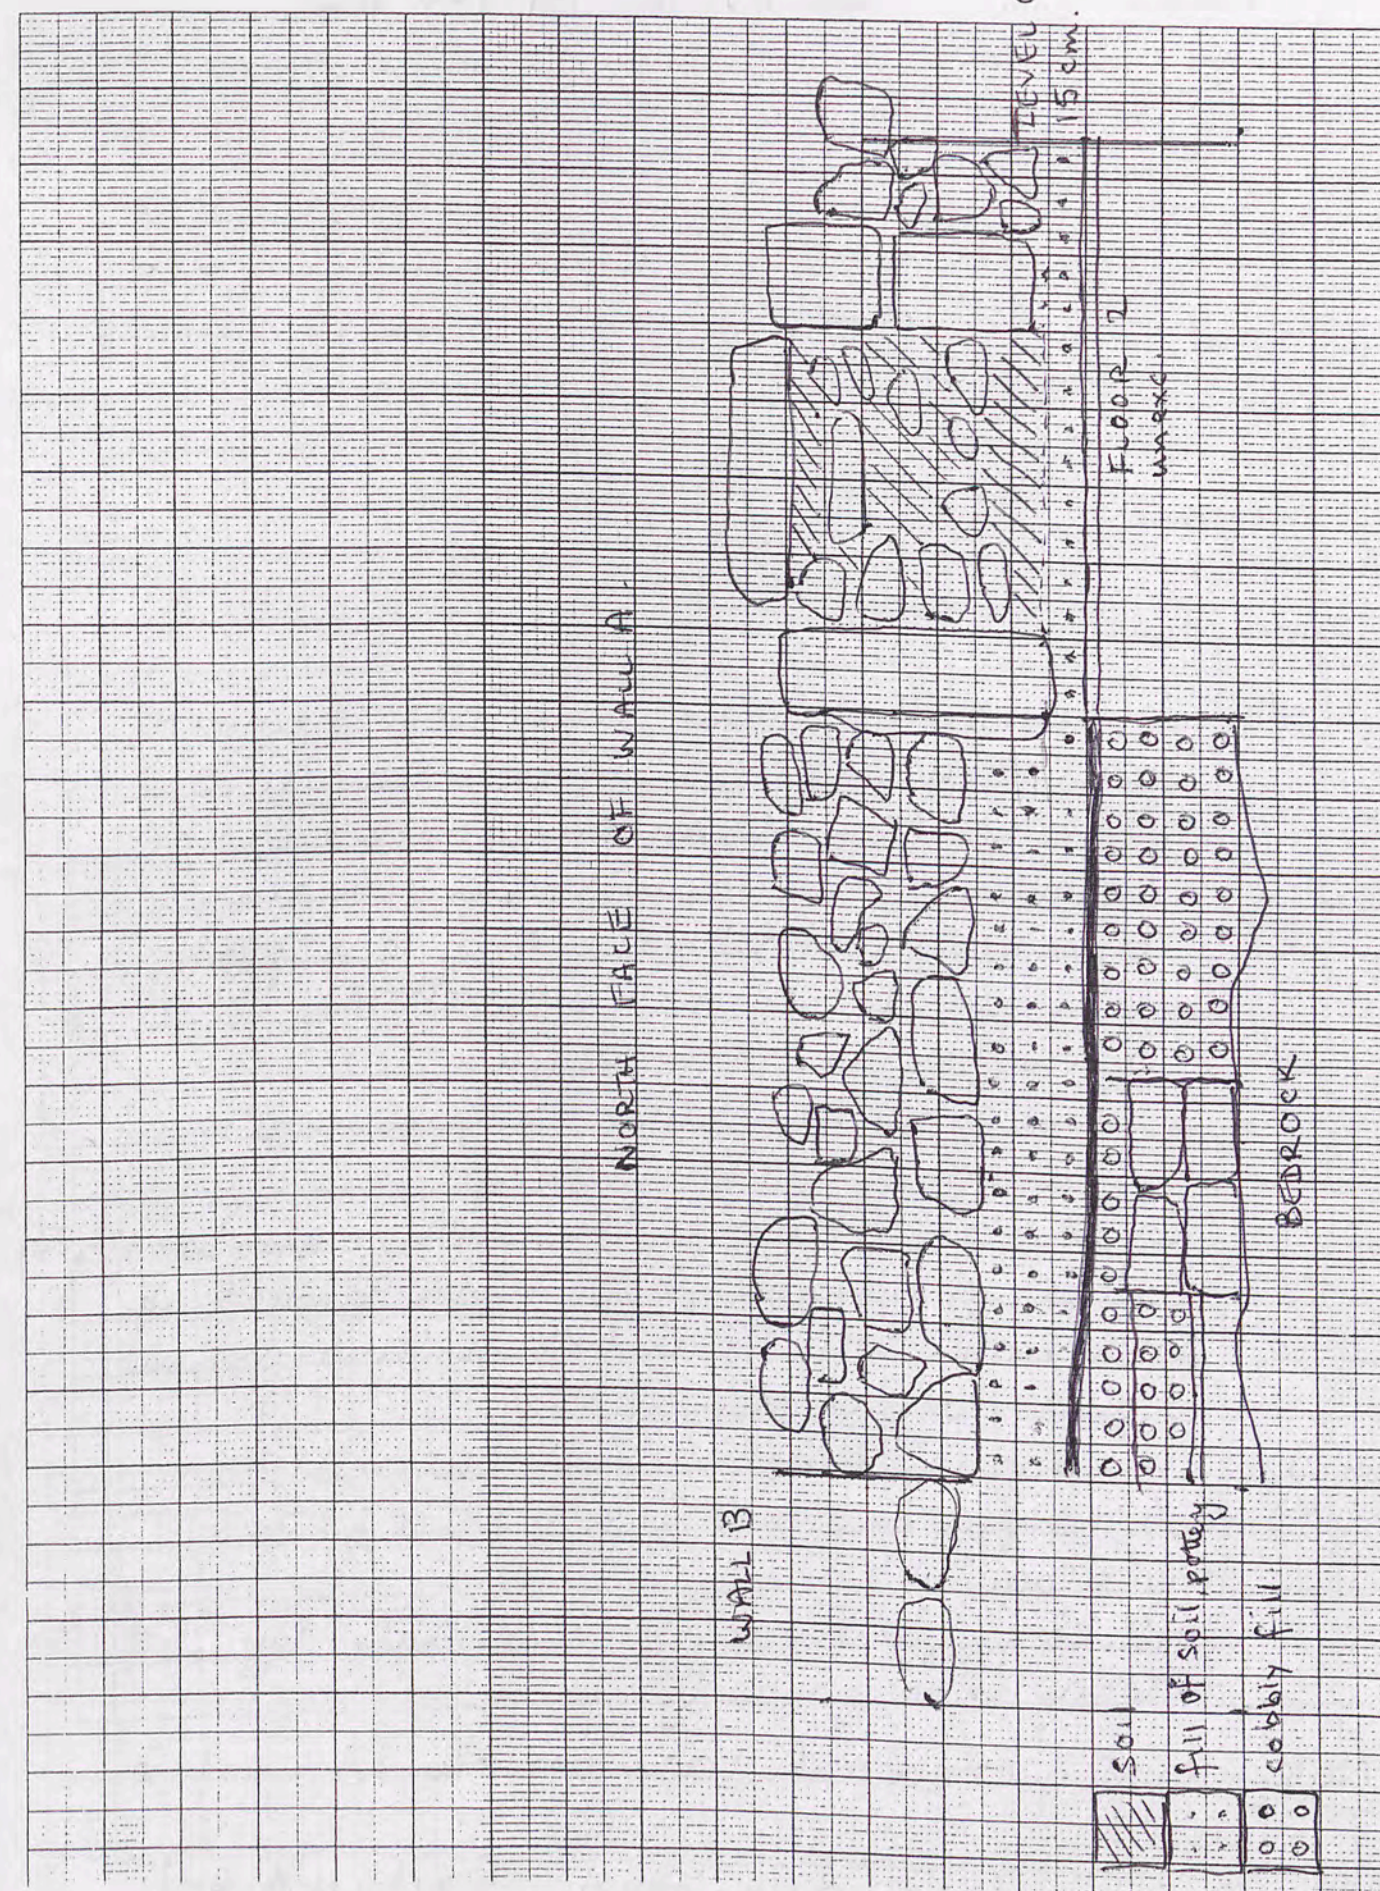
T7 1817

1:25.

drawn 28/5/06.

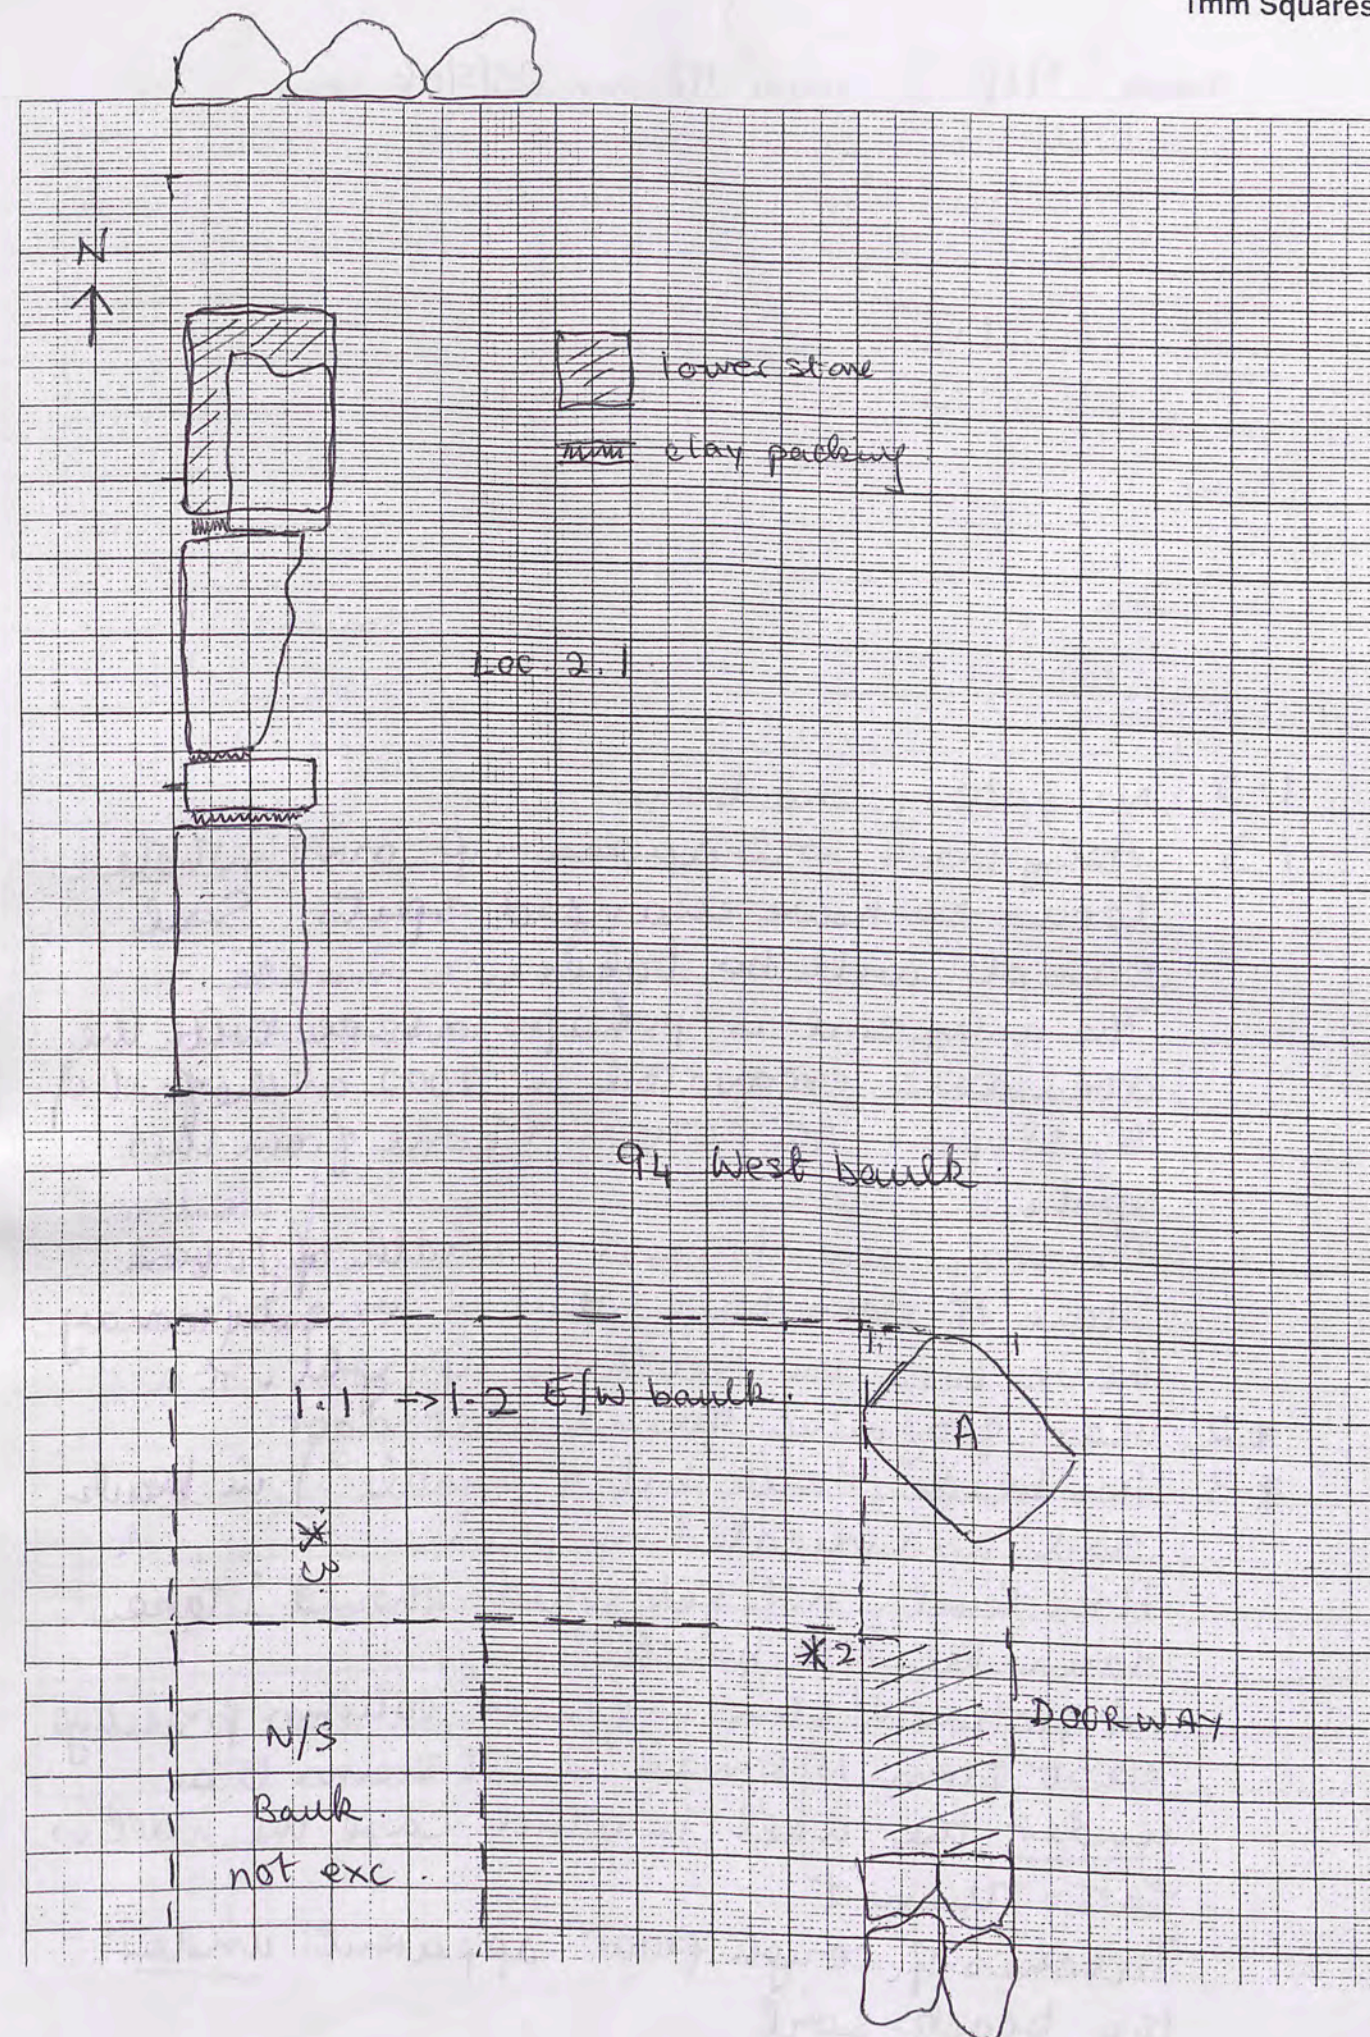
86/94 "stylebate"

| Context | Report |
|---|---|
| 1.2 | Tumble in loose brown soil. Some large worked stones |

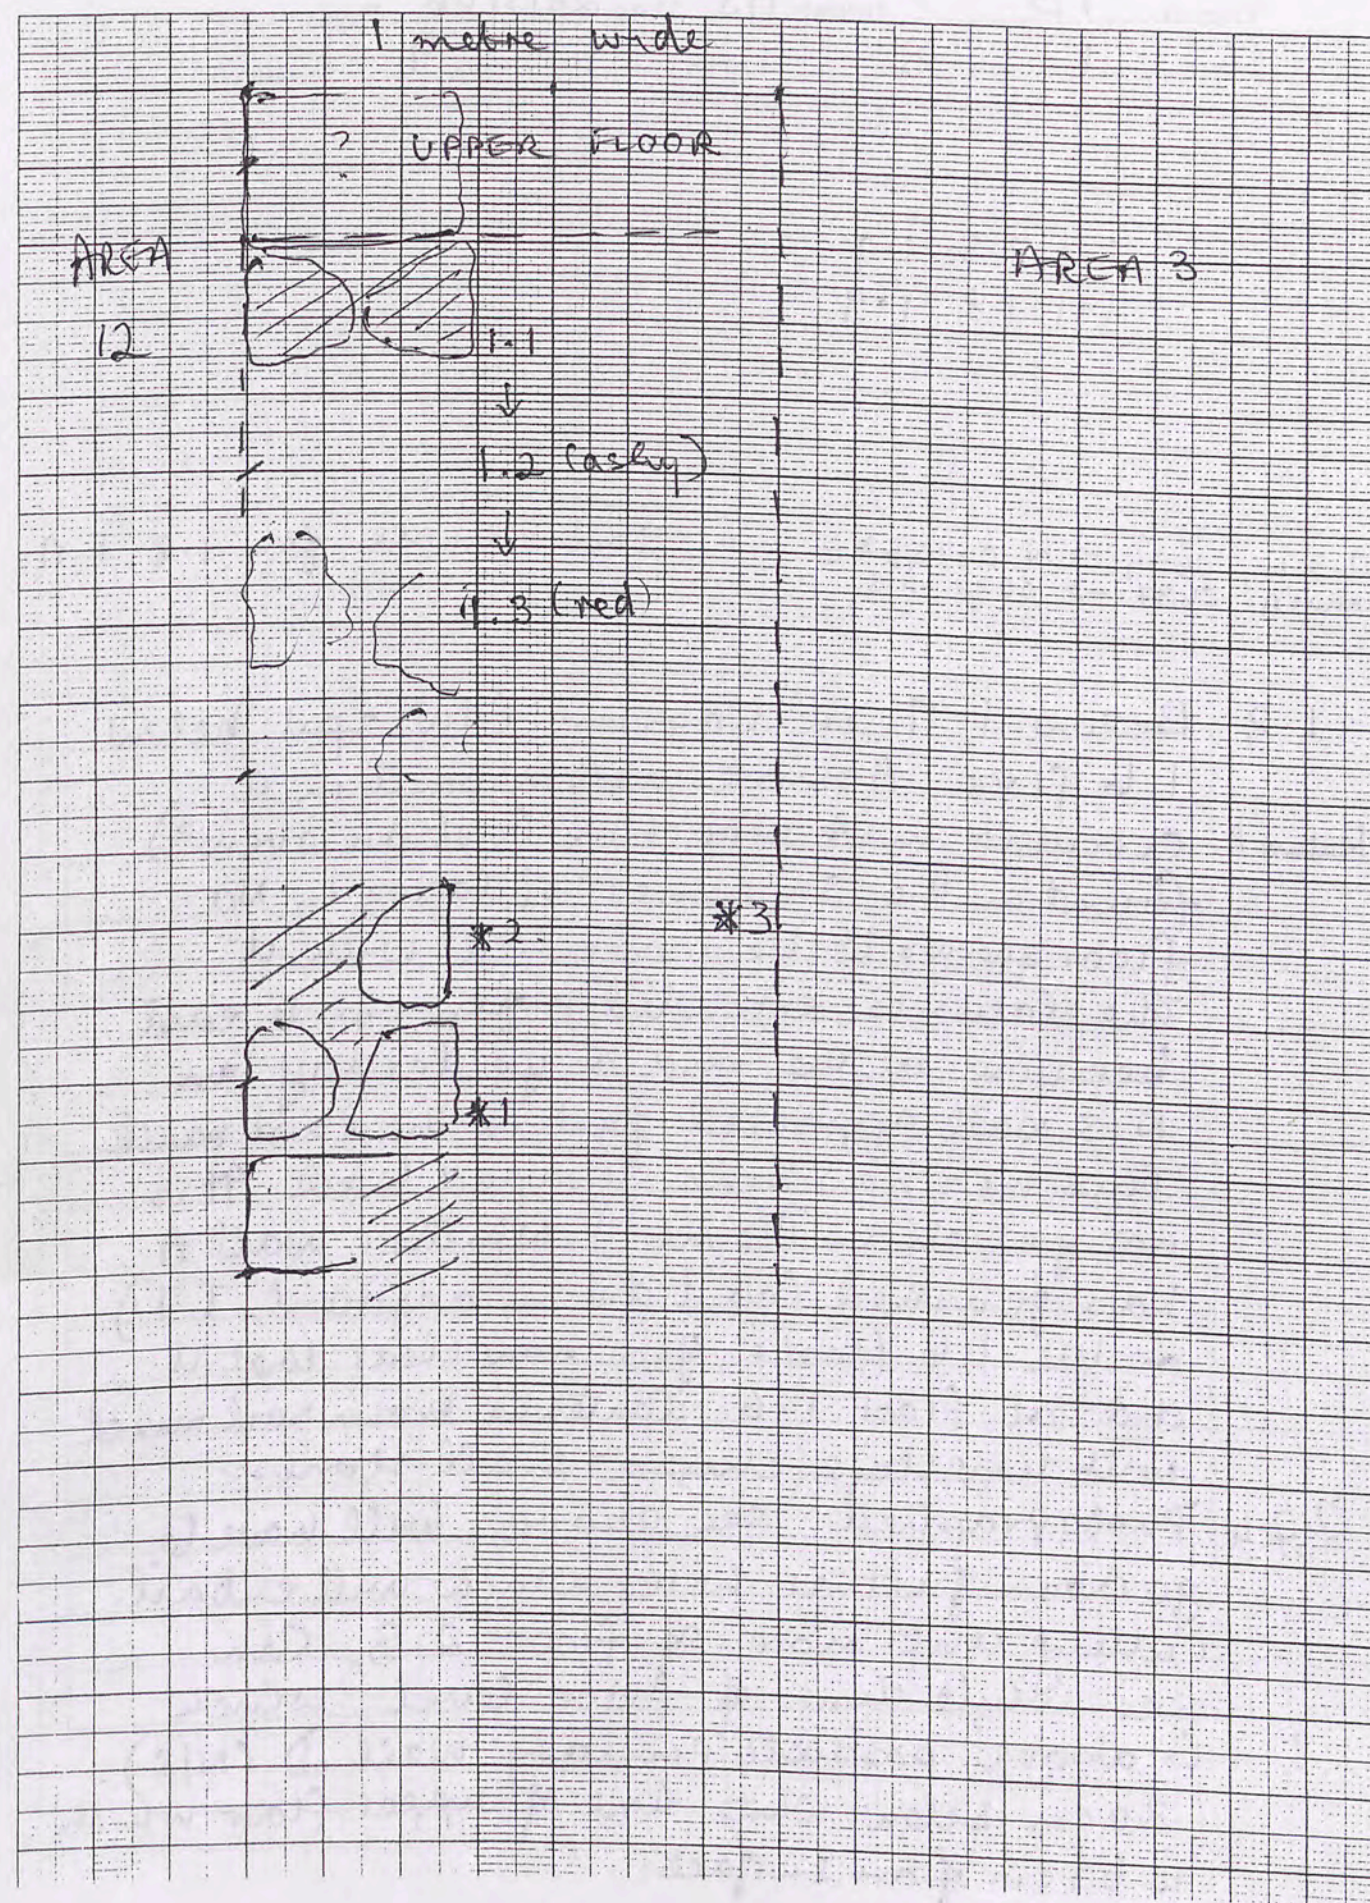
Area 3  
West Baulk.

| Context | Report |
|---|---|
| 1.2 | A more ashy layer below 1.1, yielding pottery and bone. This layer is equivalent to the upper floor found in Area 3 in 1996, but extends below? |
