# Jebel Khalid

## Field Record Book

Name Jamie Travis  
Trenches B38. B39(5) B38-39 Banks (Sth + Nth)  
B38-33 Bank.  
Dates 24/4/2006

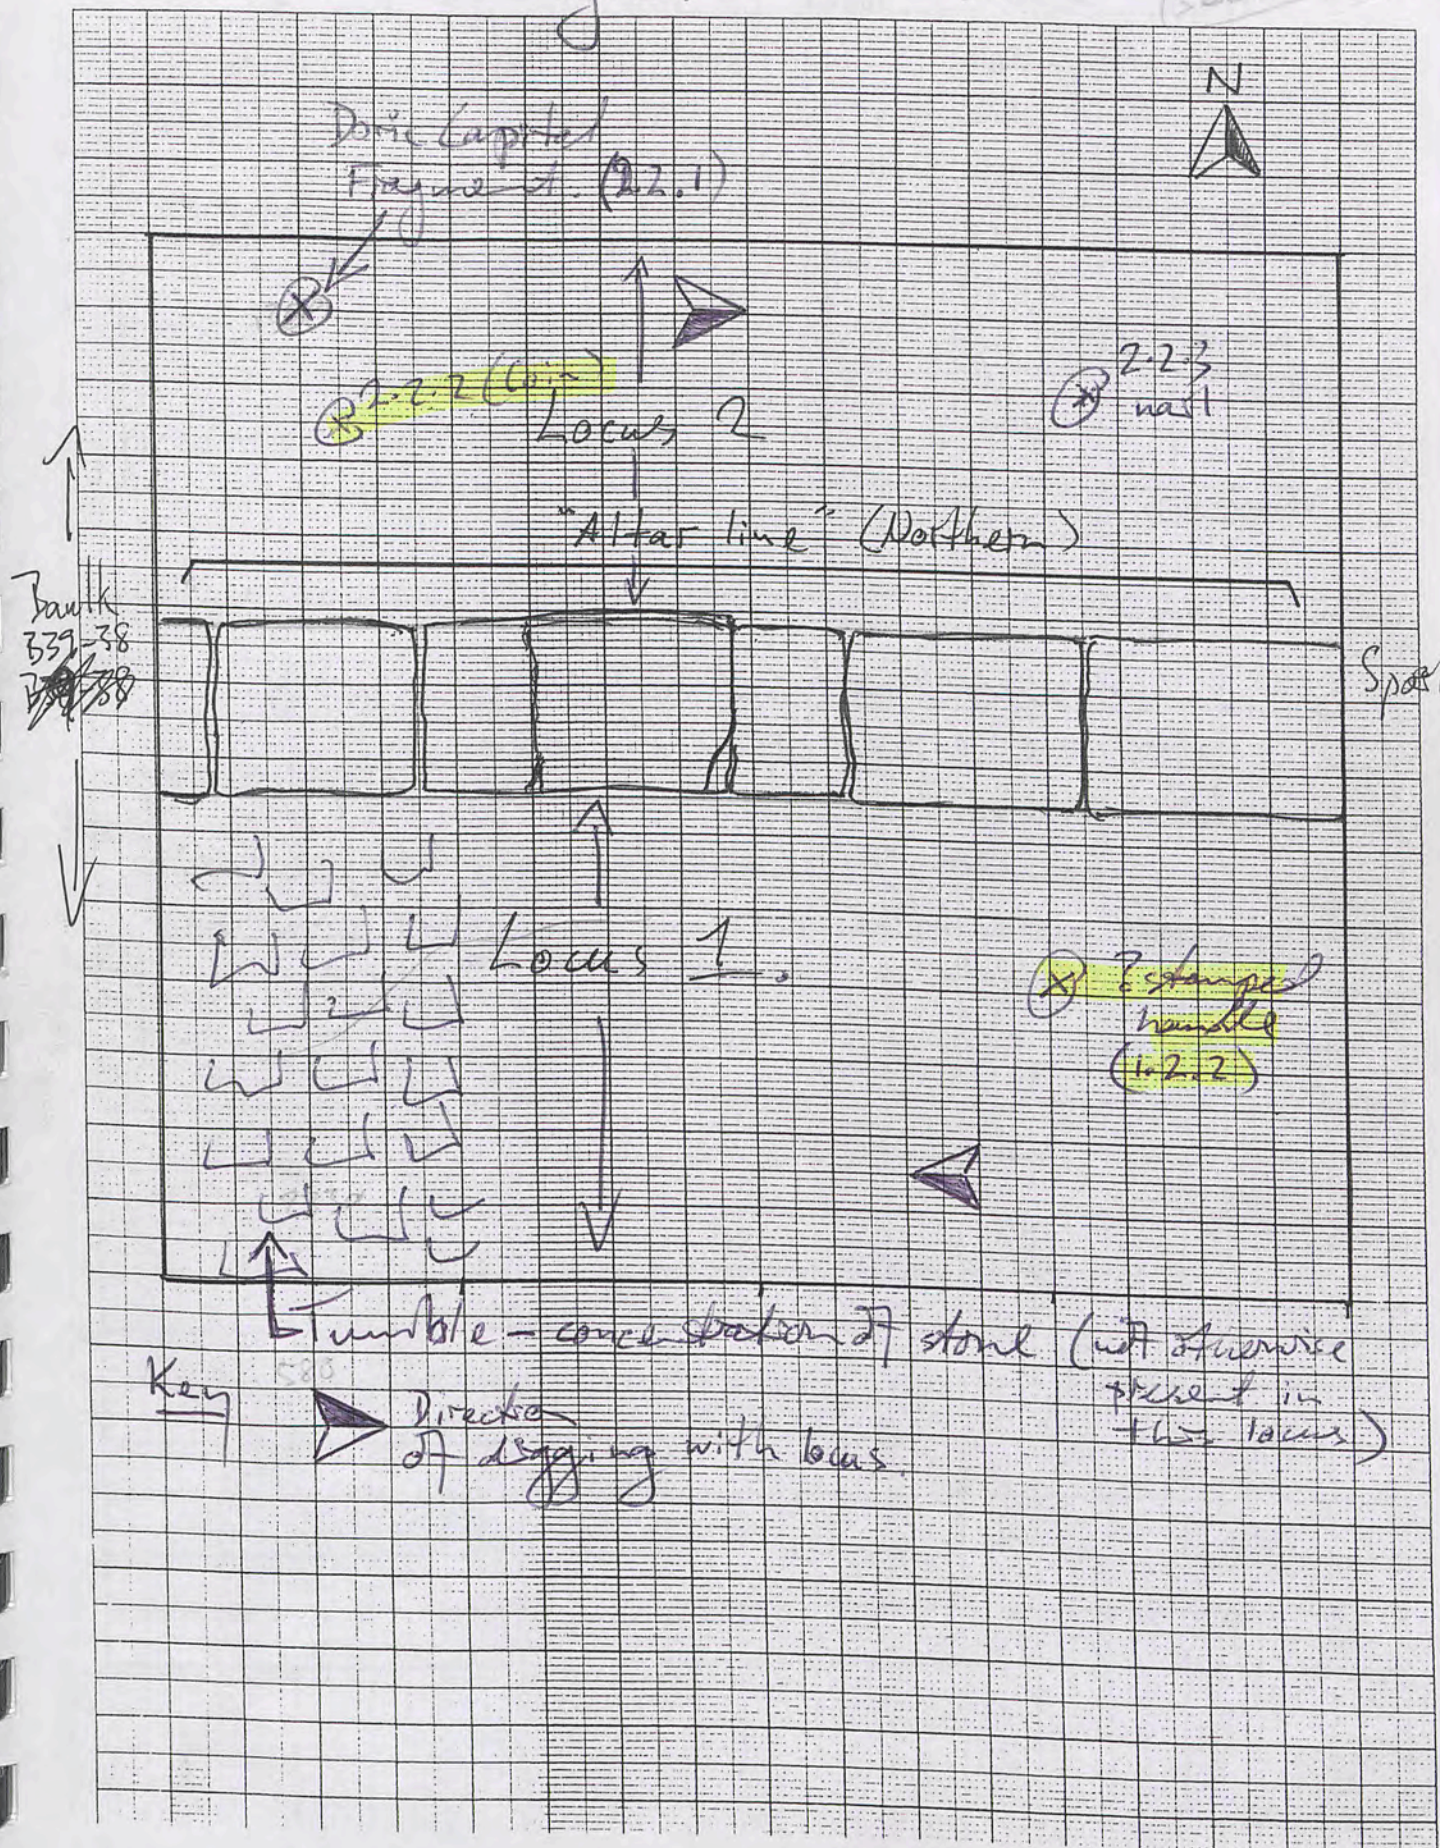
Scale. 1:25. Fig. 1. *اورنگ آباد*

| Context | Report |
|---|---|
| L1+2. | Trench dimensions 4.0m E-W; 3.5m N-S. |
| L1. | South of "altar line"; |
| L2. | N+L of "altar line"; |
| | (see fig 1 overleaf). |
| | Loc: 1+2 established either side of the East-West altar line (north side of main temple structure). |

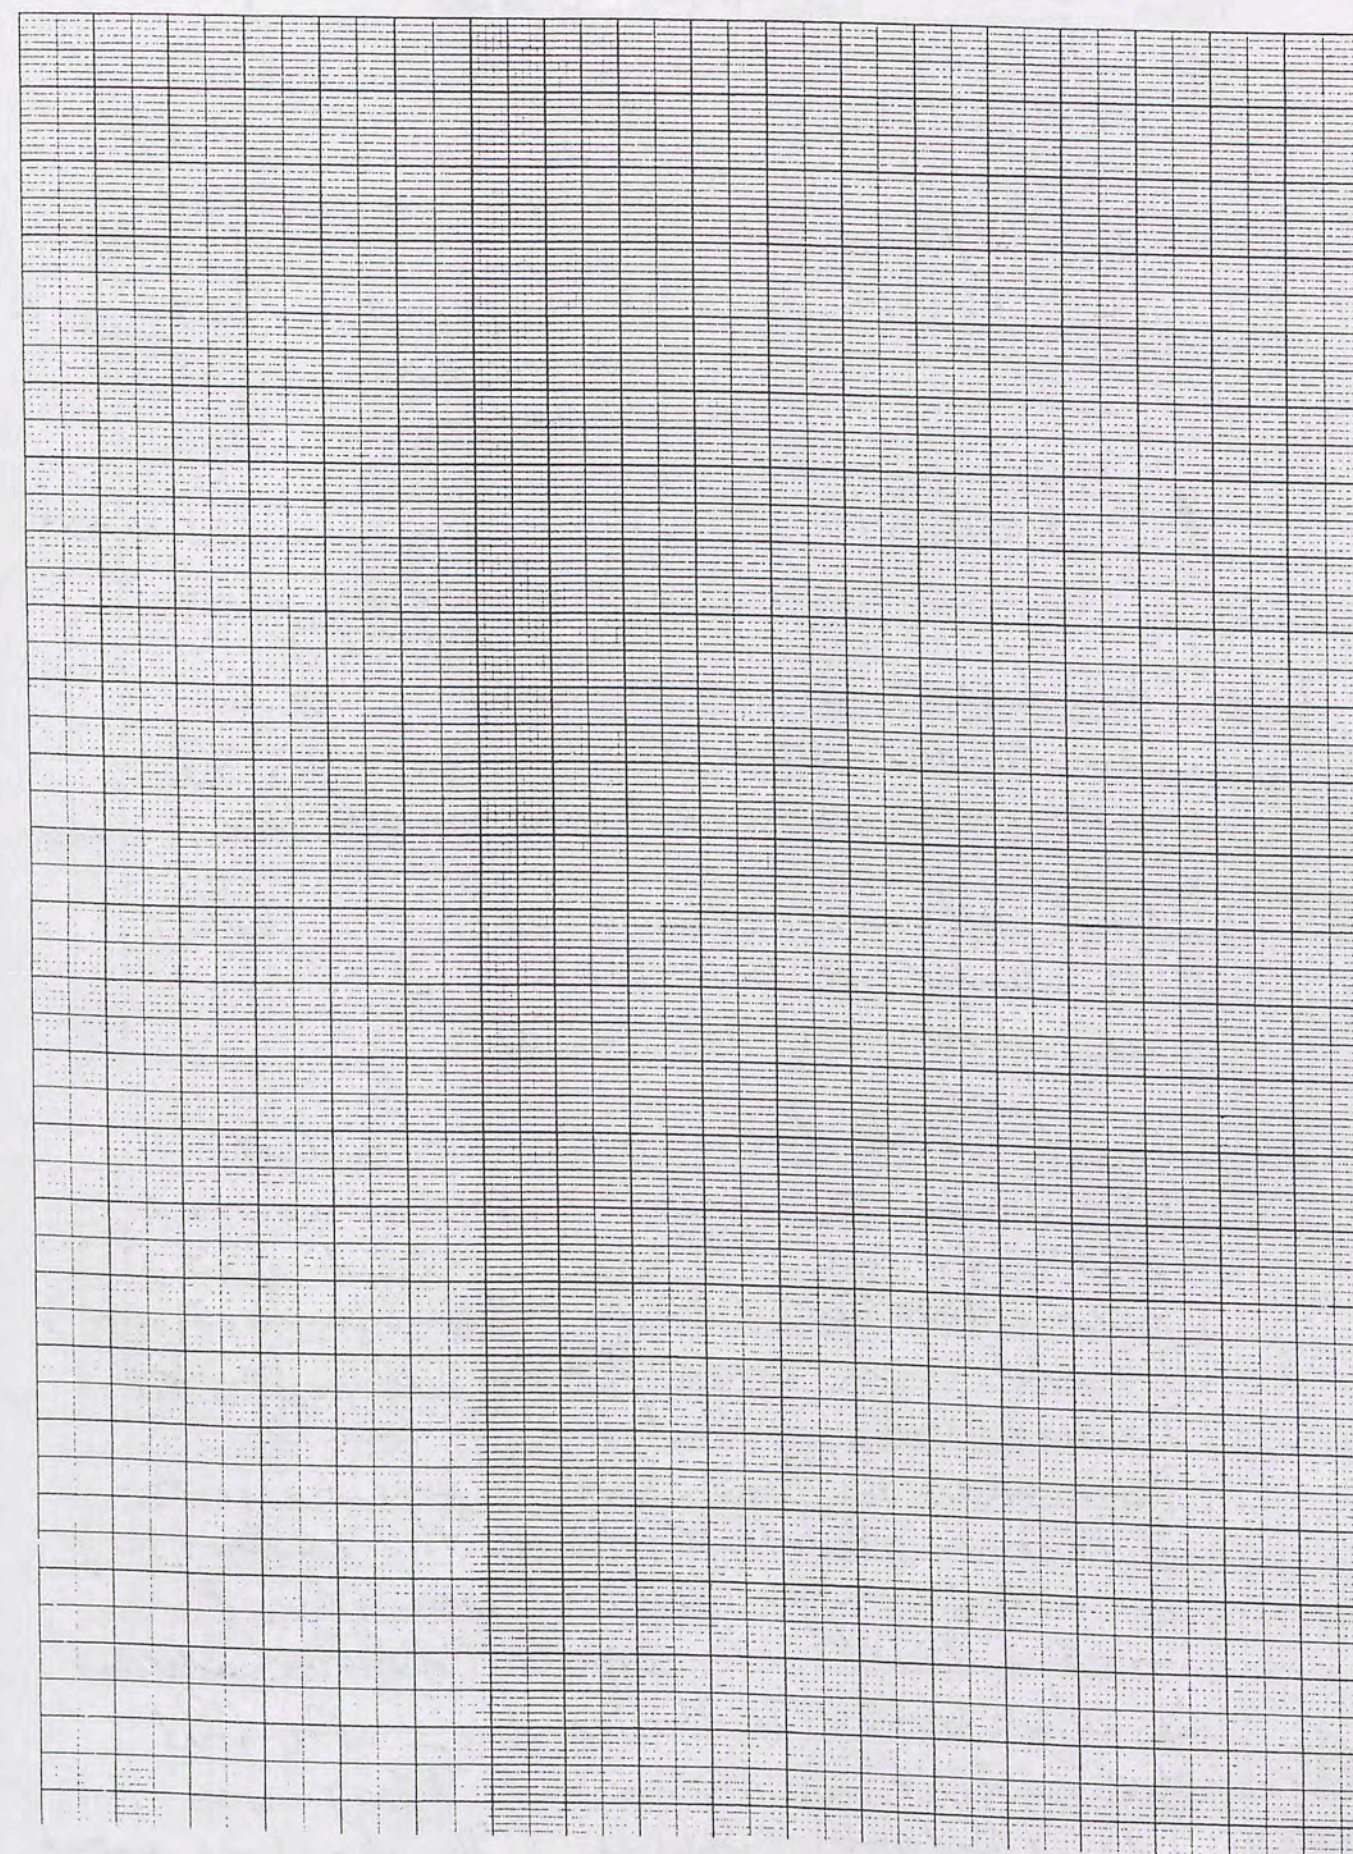
Trench B38 Initials J.T. Date 26/4/06 Page 1  
 Locus 1 Spit 1 Locus 2 Spit 2 Feature/s

| Context | Report |
|---|---|
| 2.3 | Ash deposit in northern corner — see fig 2.<br>Coin removed from this context (2.3.8)<br>— note: we are almost @ bedrock here. |
| 2.3/1.2 | Altar blocks are clearly on packing — clearly not intended for load bearing.<br>see photos Jt 0310 & 0311. |
| 2.3 | Objects prevalent thus far in this context.<br>ESA fragments suggest construction occurred post 150 BCE. "faded" evident just below this level. (at 900mm from top of altar) |
| 1.3 | 1.3 established approx 650 mm down from top of altar block in West end of Locus 1.<br>Distinguished by clay brown earth. Expect objects to become prevalent through this context.<br>— ESA fragments (Echinoid, etc) present.<br>— some small ash deposits disturbed adjacent to altar blocks to the south — note that this context in this corner (SW) was subject to 20th "robbing" (note also large amount of bone). |

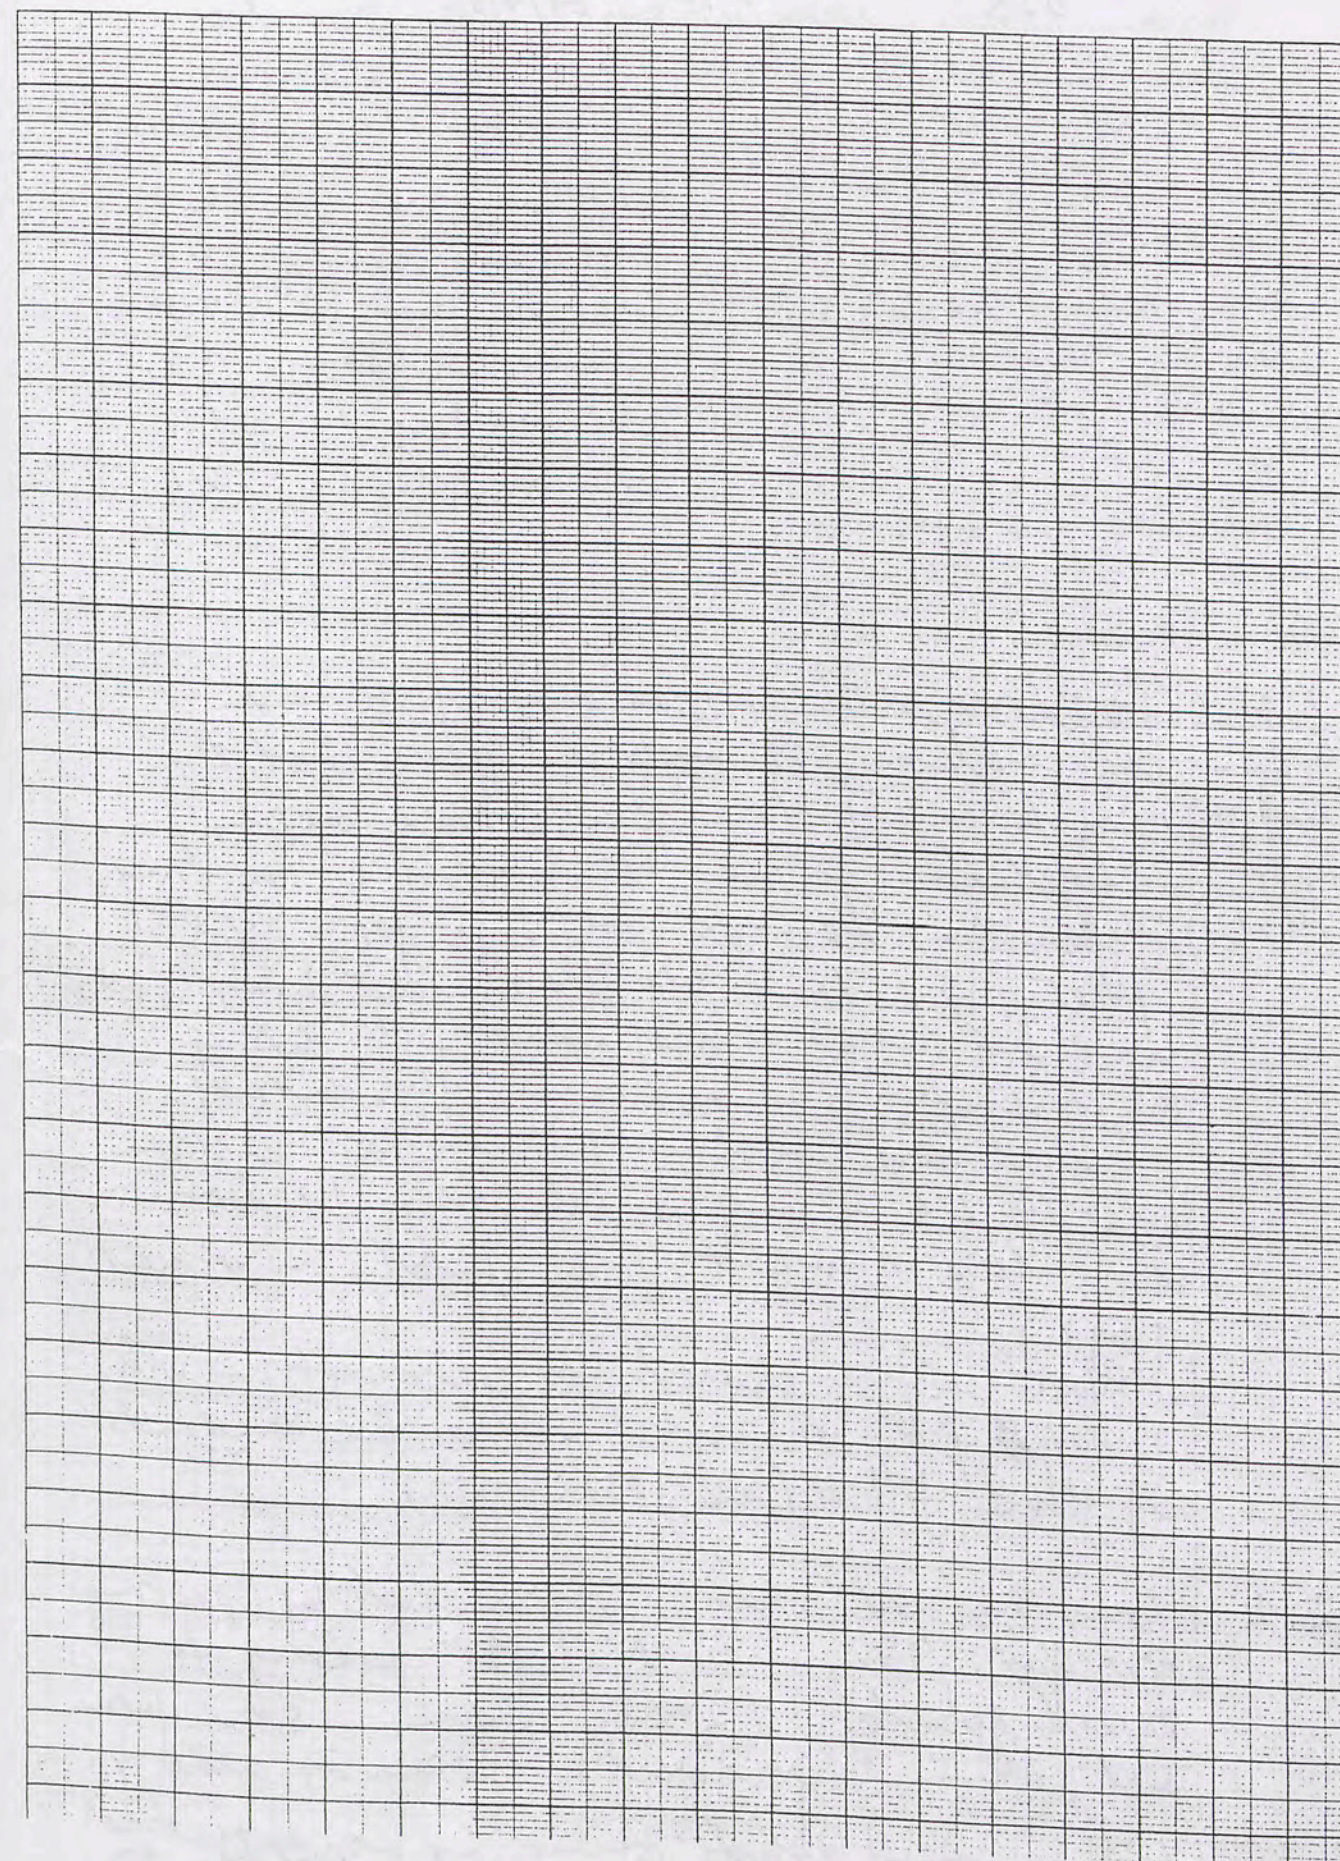
Trench B38 Initials J.T. Date 27/4/86 Page 1  
 Locus 2 Spit 4 Locus 1 Spit 1 Feature/s

| Context | Report |
|---|---|
| 2.4<br>(950mm down from top of altar line) | Proceeding with clearance of "floor" - on examination it appears that the irregularities of the jebel have been mitigated by use of "clay-like" packing (Hellenistic "No Gaps" or "large gaps crack filler"). Lamp frag (2.4.4), Iron "clamp" (2.4.5), Lamp frag (2.4.6) - may assist with dating the construction that occurred in this context.<br>Peculiar <del>stone</del> <sup>ceramic</sup> moulding lifted from eastern border of 2.4 - may be architraving for door or some interior ornament. (see sketch on adjacent page).<br>"Floor" surface cleaned for photography - will remove "floor" thereafter to examine contents of this fill. (see J0328 + 0329) |

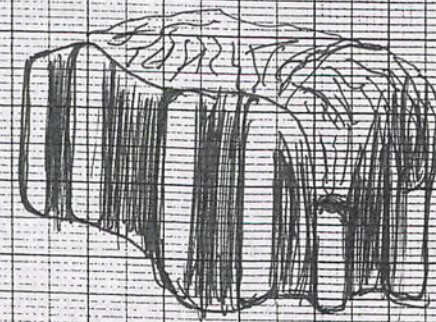
2.4.7 (from "floor" clearing)  
 Moulded  
~~stone~~  
 Pottery  
 ? architraving or  
 interior ornament  
 moulding / furniture?

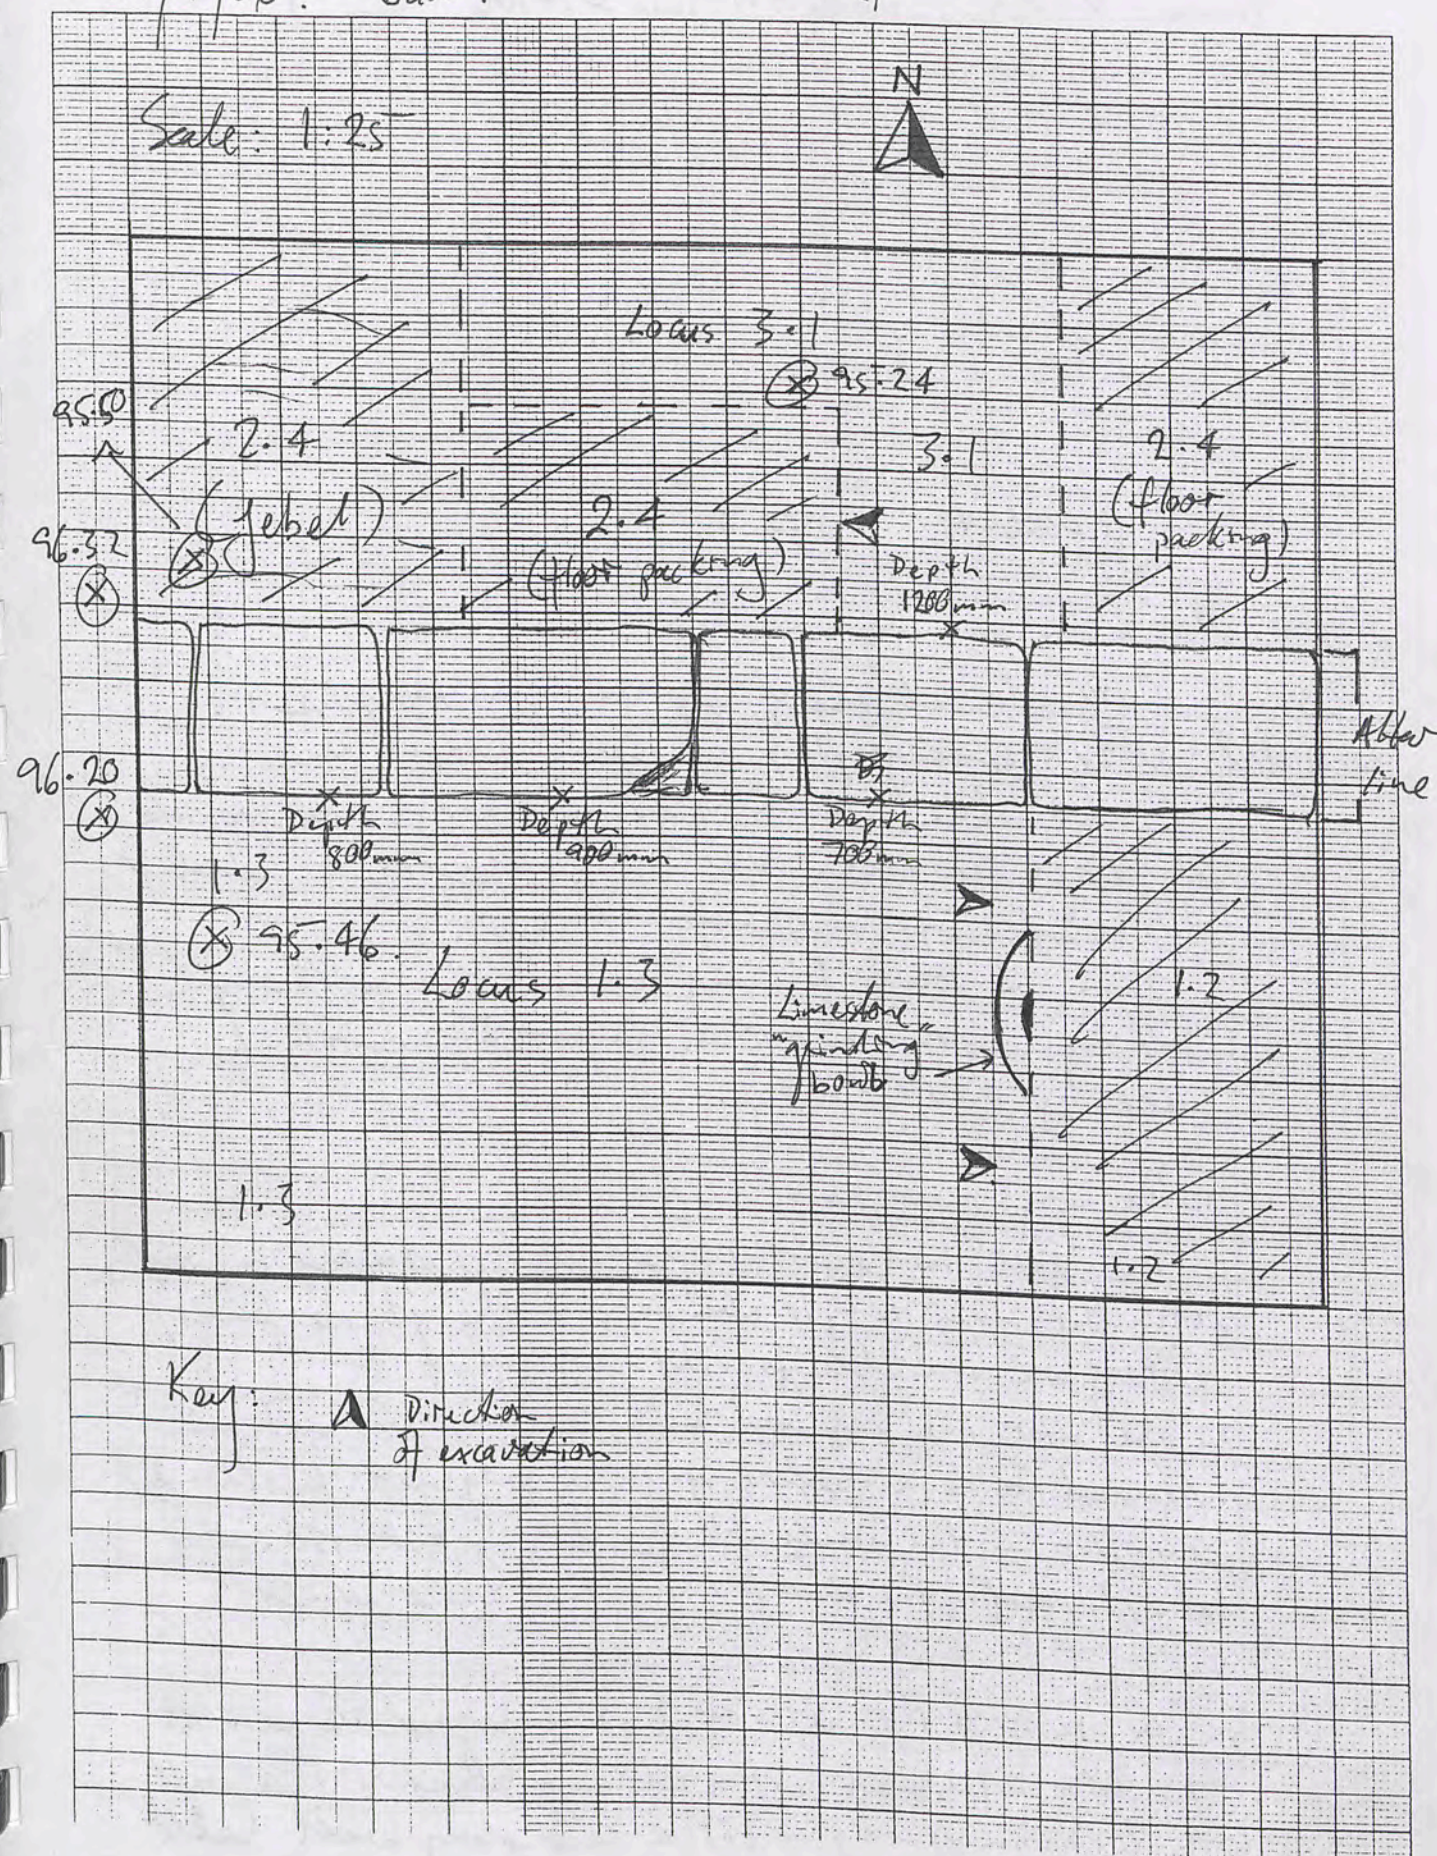
#2

End 29/4 -> hard "floor packing" present as in 2.4 - will sweep down for photography on 30/4/06. Thereafter will excavate a small section to bedrock.

Jebel (limestone) appears to be in situ in eastern section of 1.4 - though sitting on a small thin layer above the floor.

| Context | Report |
|---|---|
| 3.1 | Excavation of "floor packing" reveals levelled jebel. More or less barren of pottery - some coarse ware + some iron evident.<br>* See photos J+0343-44 for reference. * Packing approx 150-200 mm thick (variable over the irregularities of the bedrock).<br>(*) NB - ESA in pottery comes from surface of this spit i.e. pressed to floor + NOT within packing below. |
| 1.4 | 1.4 established - jebel evident in western border adjacent to temple platform to south. Associated pottery coming up including ESA (as 2.4).<br>Plan: work to bedrock as for Locus 2/Locus 3. |

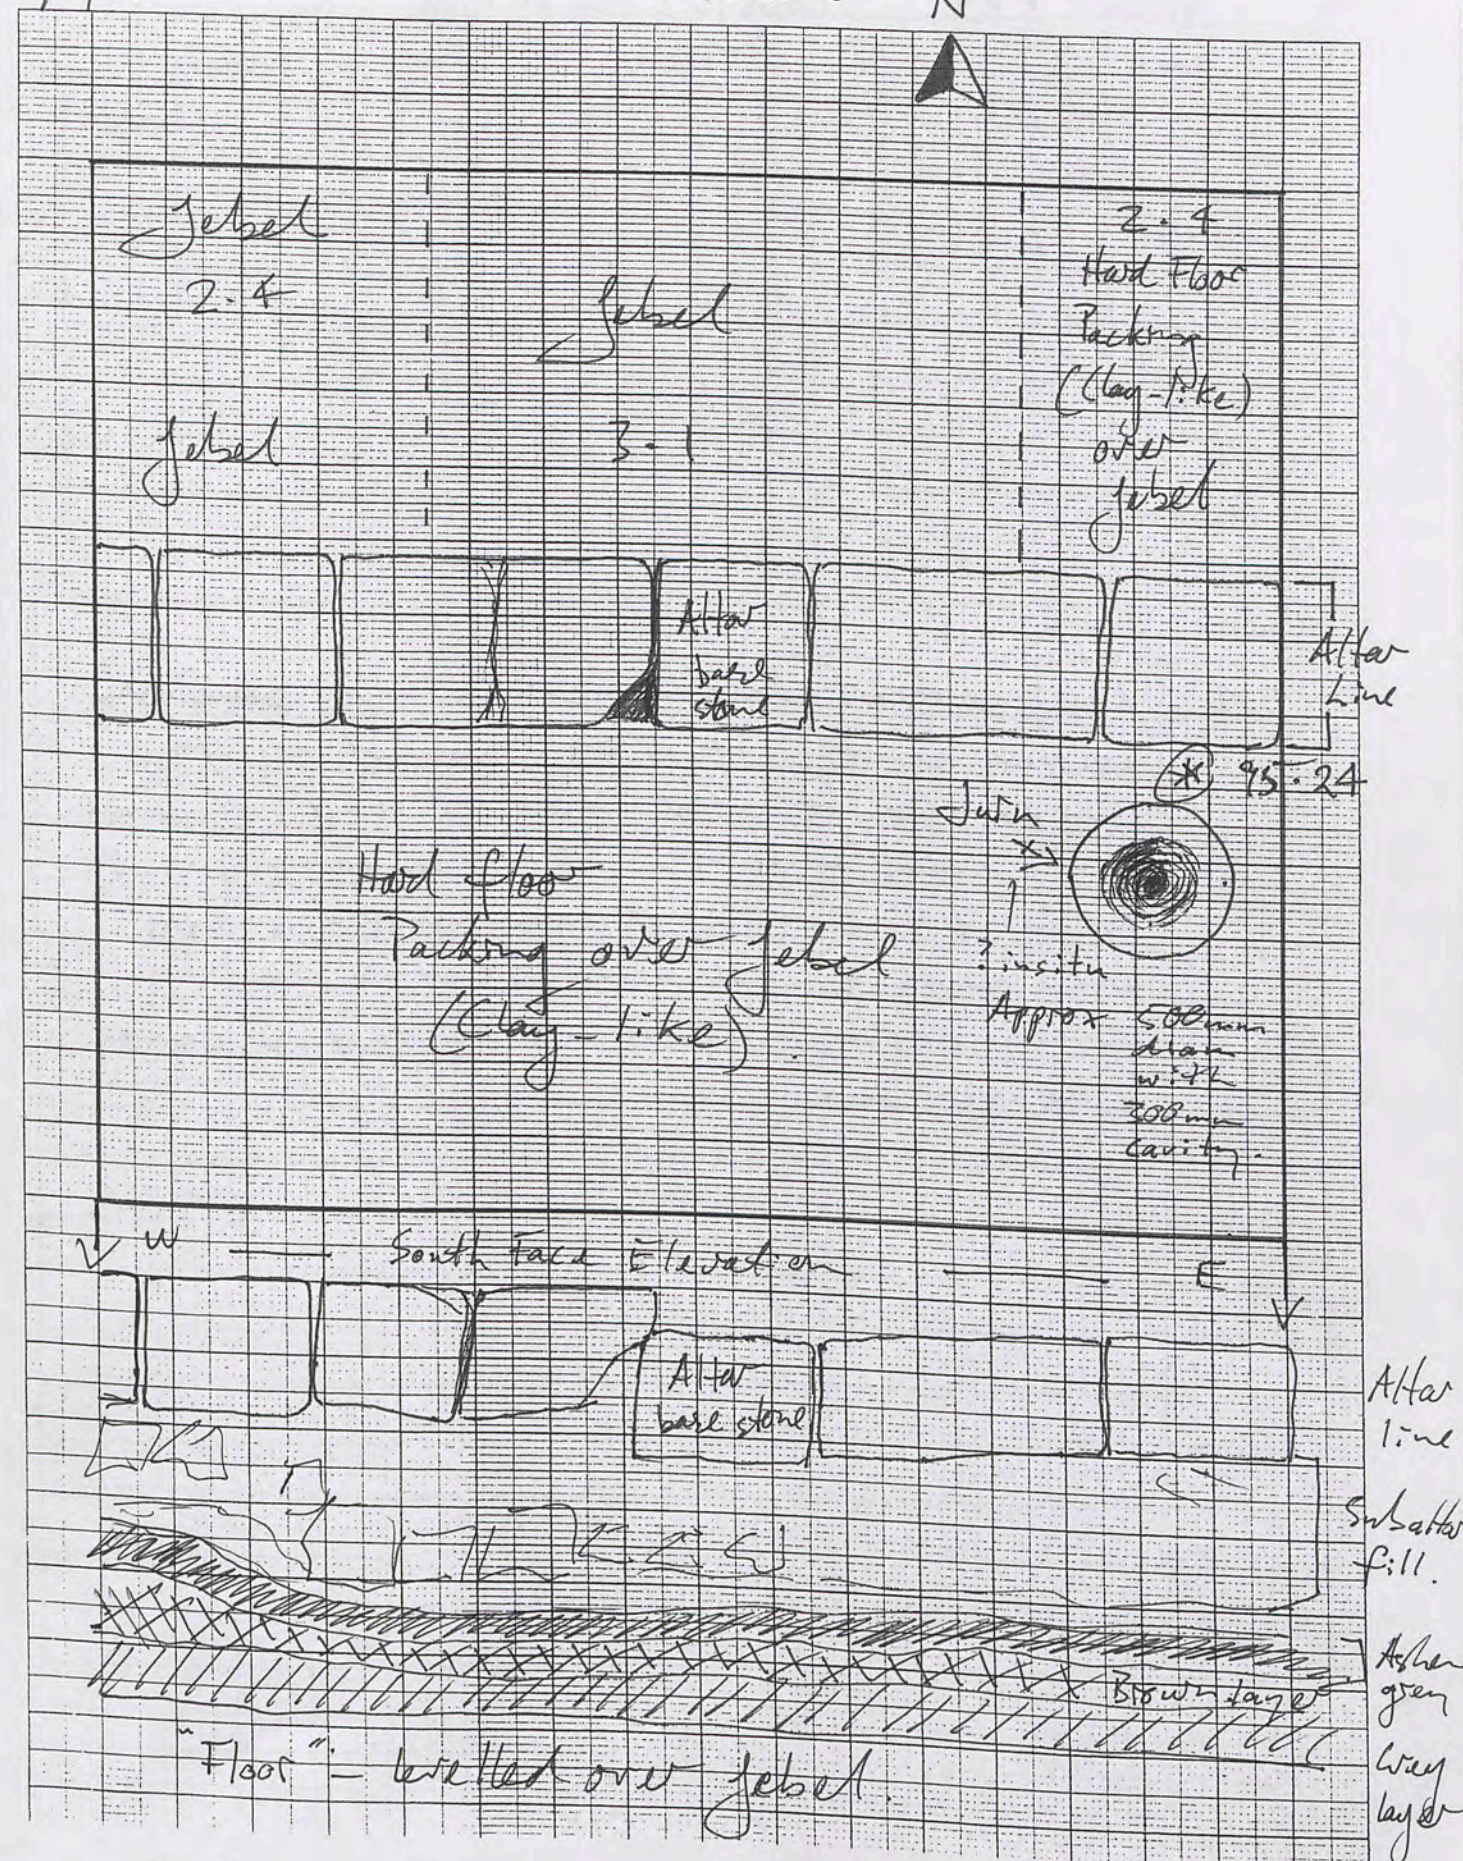
30/4/06 Scale 1:25 7:30 am

| Context | Report |
|---|---|
| B38 | Trench cleared up & photographed. Note stratigraphy beneath altar line & also, the hard packing used to provide a level surface over the bedrock (evident both sides of the altar line).<br>J.T. in locus 1 may be in situ although sitting upon a silica layer of earth. (see Jt 0377-78).<br><u>Preliminary conclusions</u><br>1. The "floor" laid over the Jebel was constructed concurrently with the main temple structure - though no finds/pottery are available to verify this.<br>2. The altar line was laid much later & was not intended to be a feature of the original building complex - the crude fill (containing ESA-150 BCE or later) beneath the altar line & either side would verify this hypothesis. |

3. The walls to the north of B38 & beyond its context may represent (i) a retaining structure (see wall with 2 column drums) & (ii) a secondary wall built long after the establishment of the temple & the time that the altar line was laid (verified by the sub wall packing consistent & that below the altar).  
some spec. conclusion.

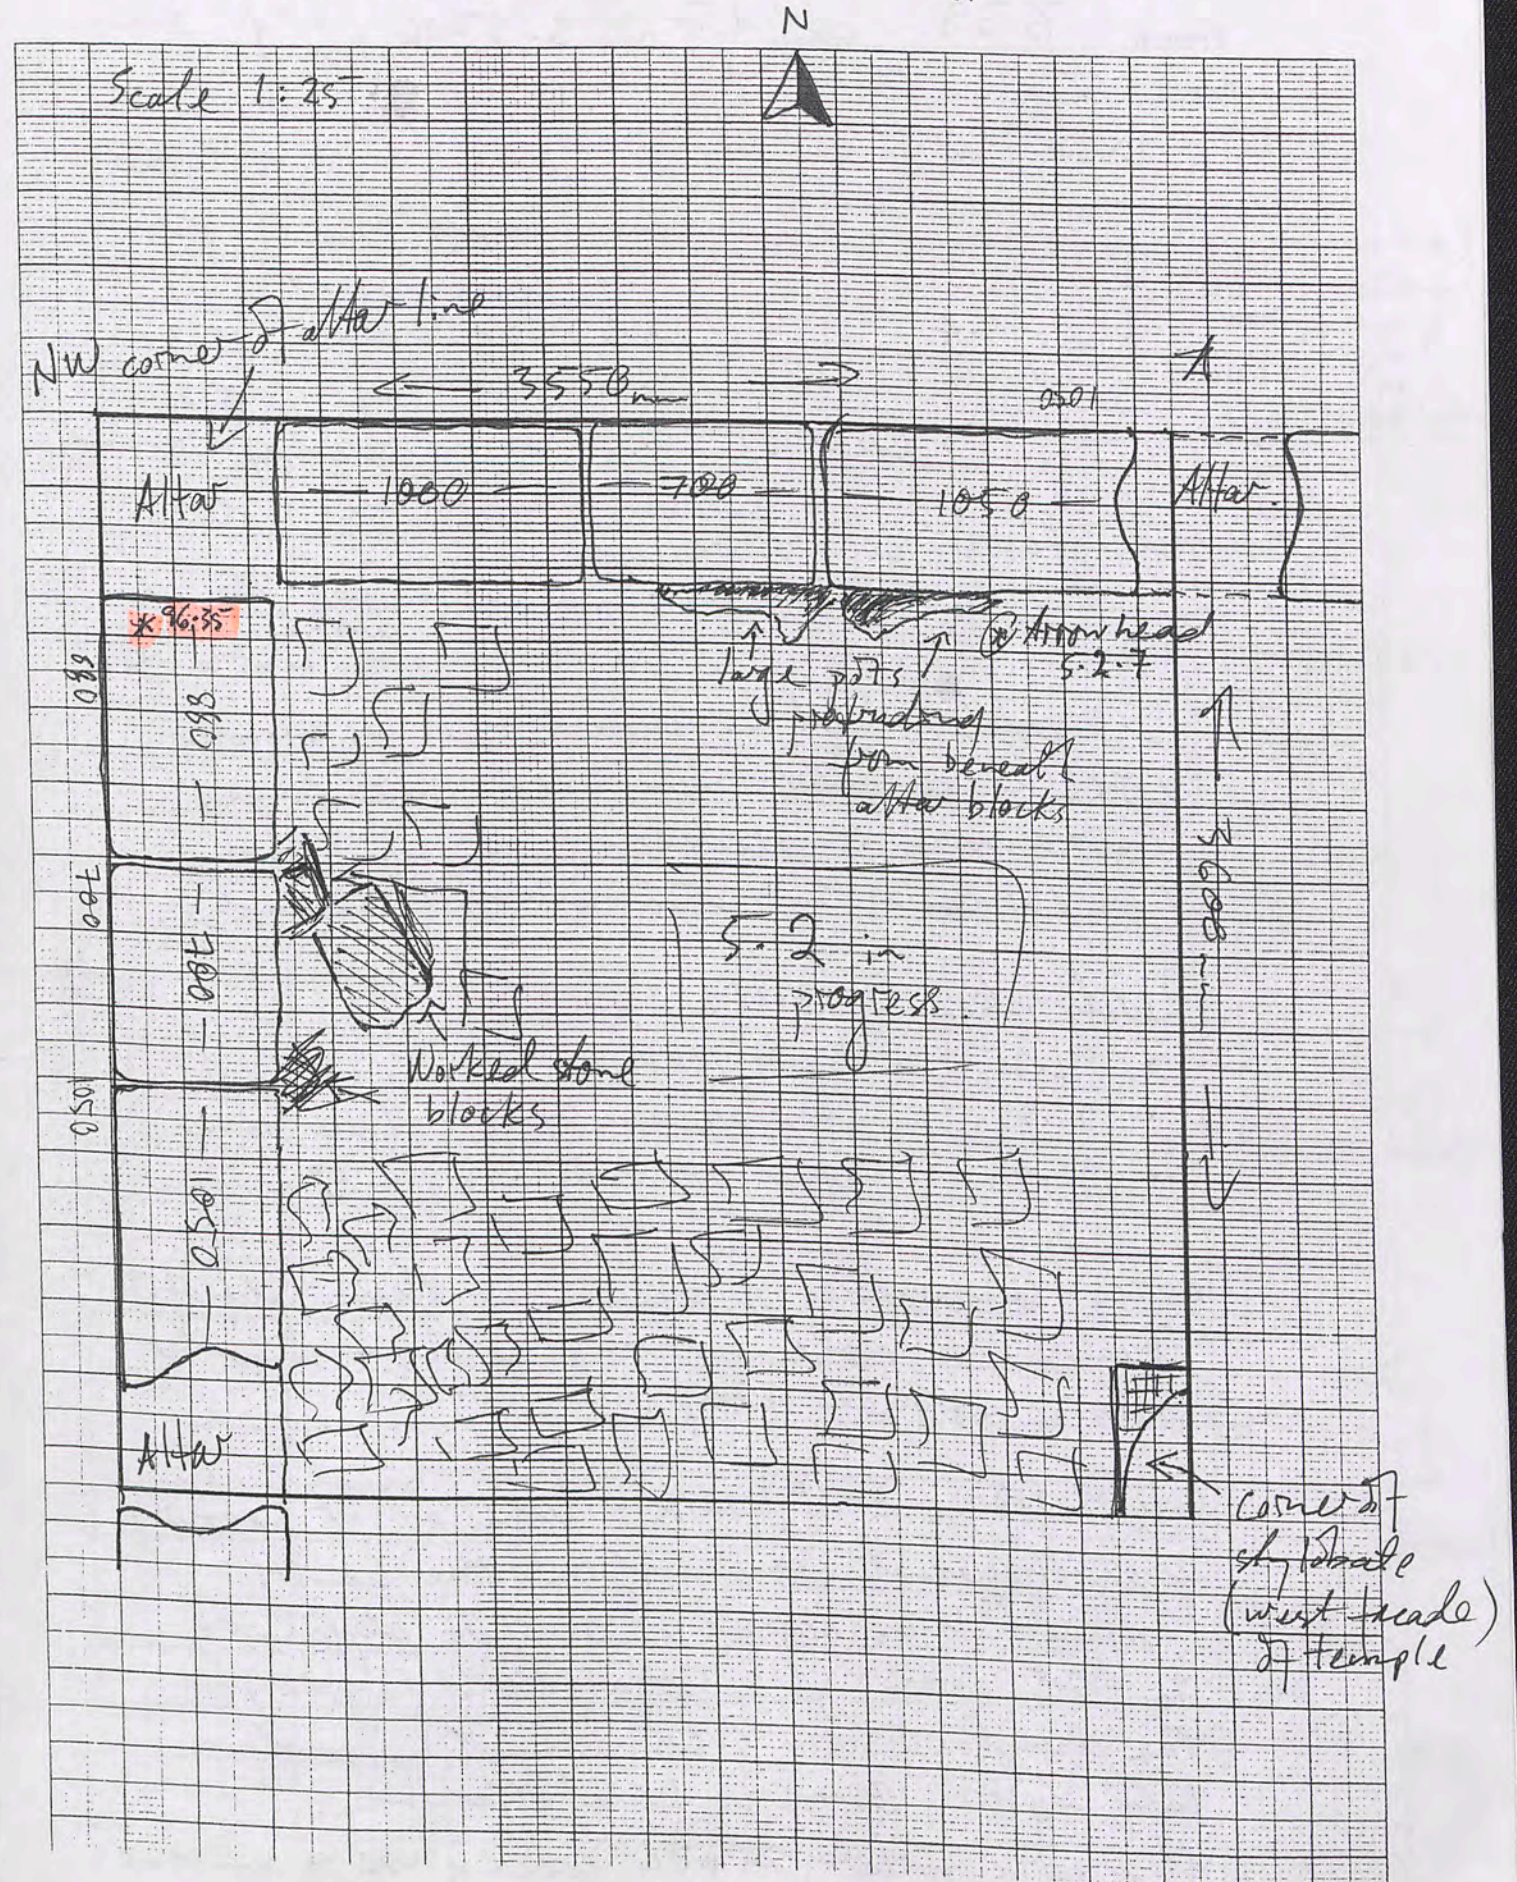
2-5-2006.

| Context | Report |
|---|---|
| 5.2 | <p>Tumbled stone appears to be sitting on a more forgiving brown earth. Easier going once layer of tumble removed.</p> <p>Large pot shards protruding from beneath the altar line (E-W) - no doubt thrown in as part of the sub altar packing.</p> <p>Should be able to reveal the detail of the corner of the temple facade beneath the NW column base - one wonders whether we'll see a definitive step on this side.</p> <p>All objects (5.2.4-6) found along southern border - then again, beautiful arrowhead lifted from NE corner near pot shards (in situ).</p> |

All measurements of ashlar blocks are approximate. 1mm Squares

| Context | Report |
|---|---|
| | Worked, ashlar block lifted from middle of western border of 5.2.<br>Measurements: 620 x 360 x 320 mm. |
| | Two more appearing to the north of this just below the altar line blocks - will leave in situ for now. |

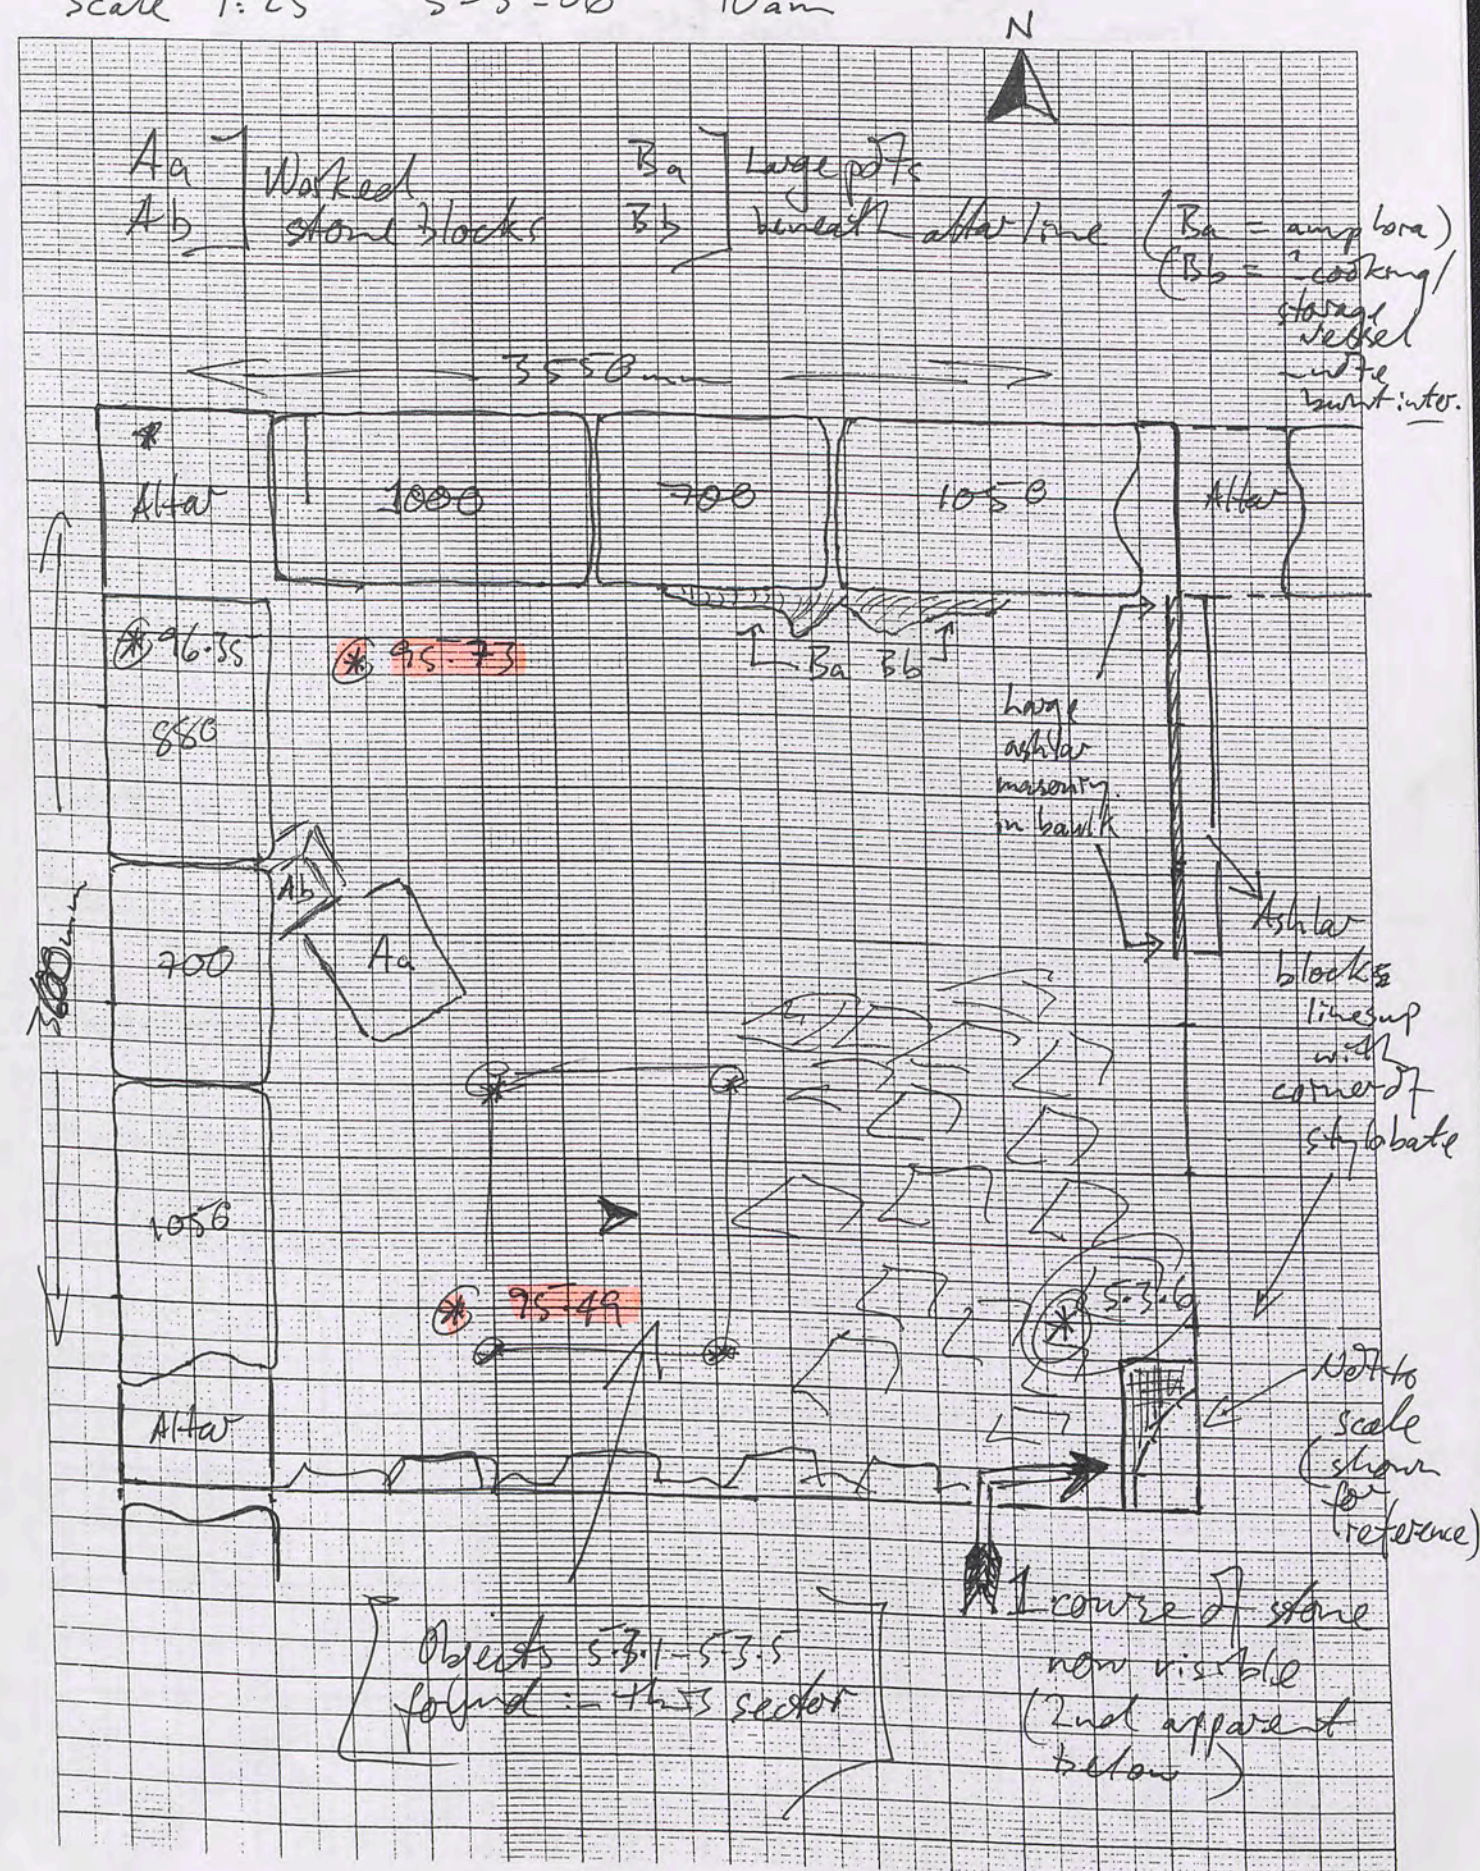
Scale 1:25 3-5-06 10am

| Context | Report |
|---|---|
| 5.3. | 5.3 established - characterized by brown earth & <del>more</del> tumbled limestone. Coarse ware is prevalent & some bone (as evident in B38 at this level).<br><br>Levels taken @ 7:45am<br>* 96.35 - top of altar line<br>* 95.73 - after clearance of 5.2 (NW corner)<br>* 95.49 - after clearance of 5.3 (in SW corner)<br><br>Note: comparatively rocky in southern half of trench - more forgiving earth & smaller rocks in northern half.<br><br>Note: NE corner - E. bank: large ashlar masonry faces the trench from within the bank (appears to be aligned to corner of stylobate in SE corner) - 1300mm long (approx) |

Four objects 5.3.1 - 5.3.5 found in southern half approx 1500mm in from altar line.

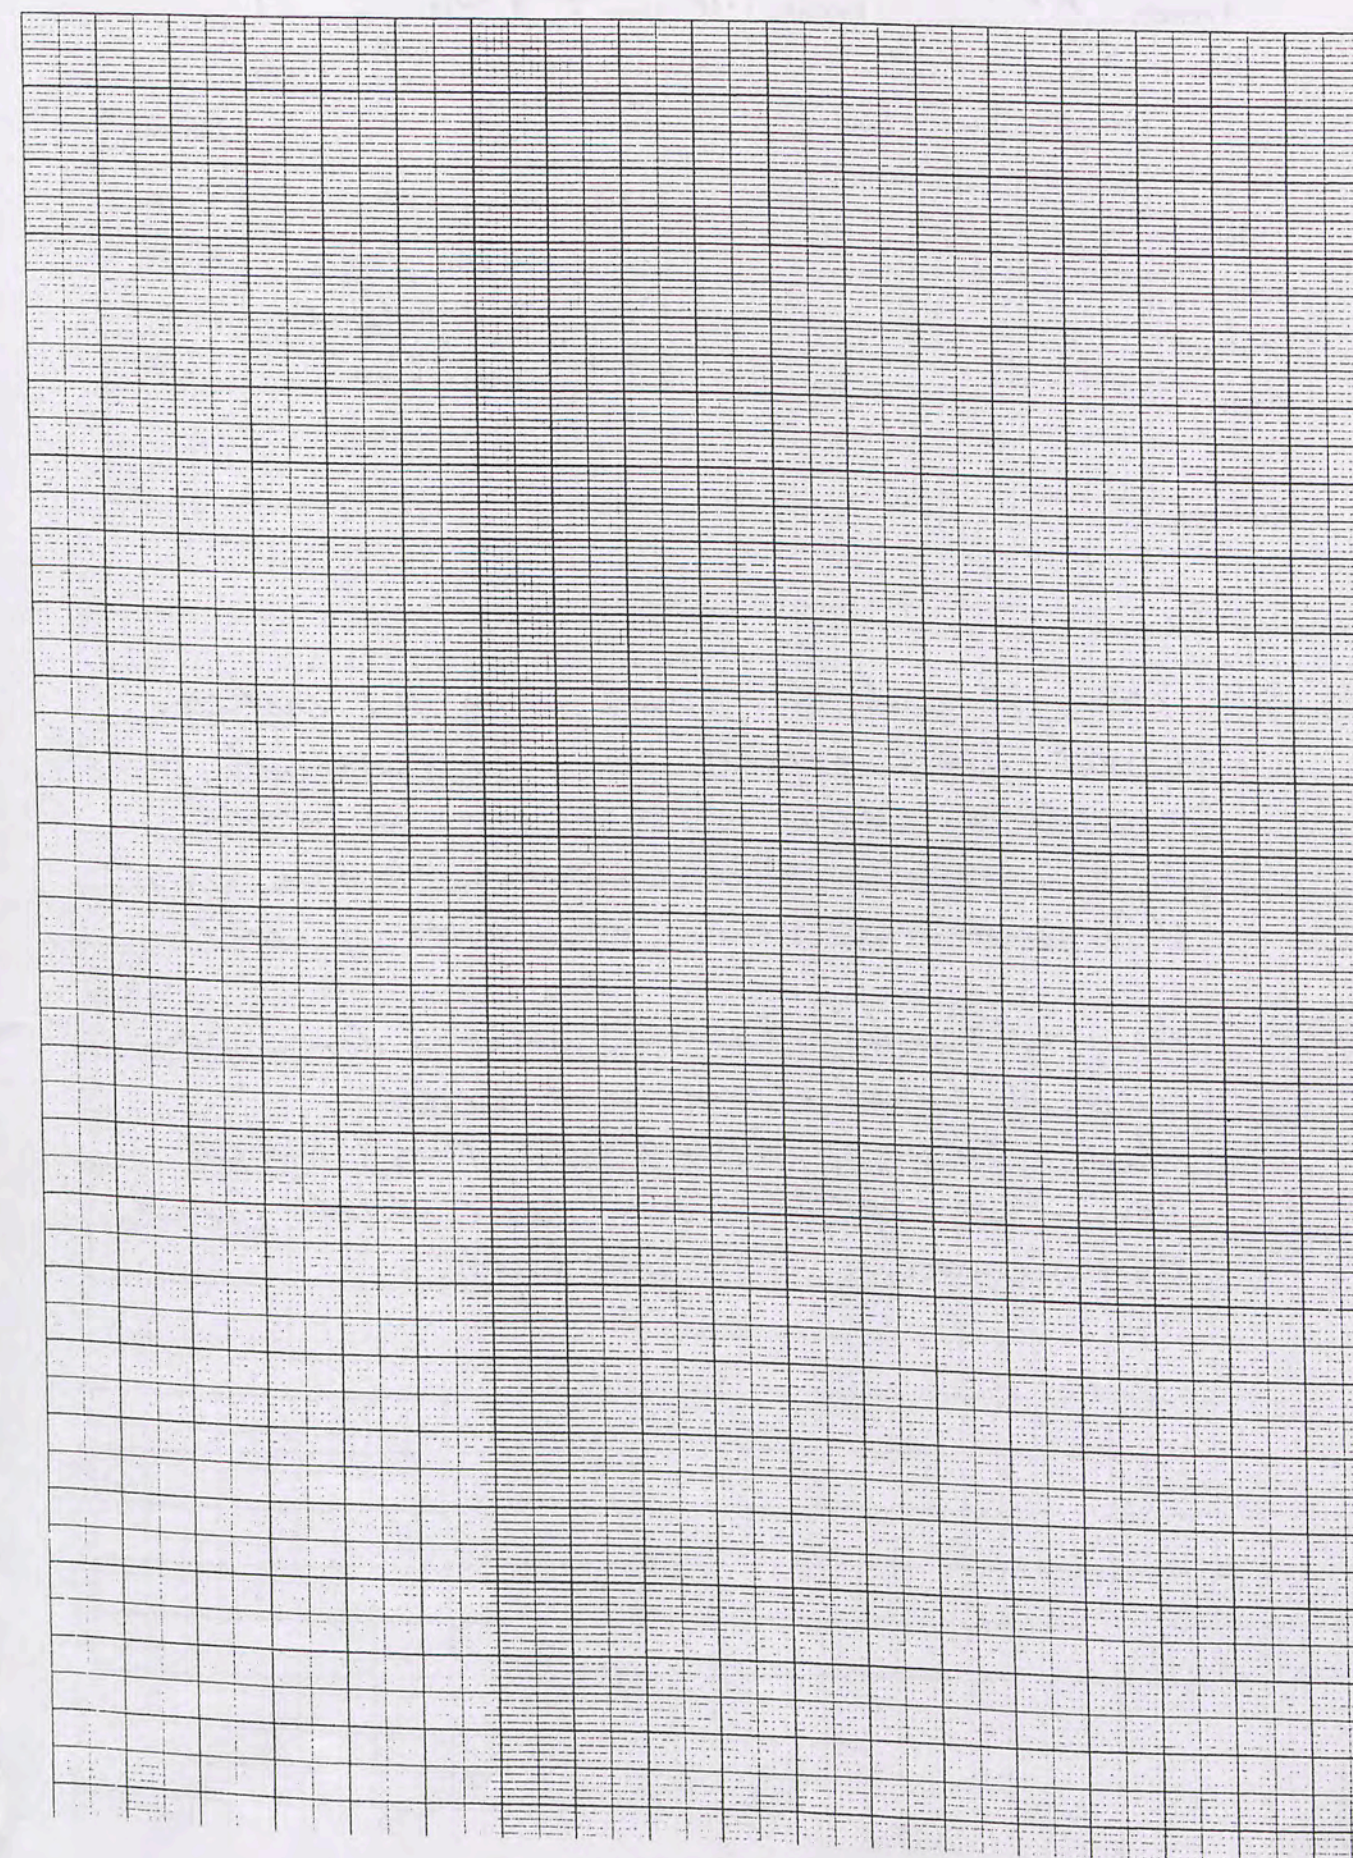
Trench.....B39.....Initials.....J.T......Date.....4-5-06.....Page.....1  
Locus.....5.....Spit.....3.....Locus.....5.....Spit.....4.....Feature/s.....

| Context | Report |
|---|---|
| 5.5 | Coin (pos. Greek Obol) found in fill surrounding large <sup>block</sup> piece of masonry in SW corner. |
| | Masonry displays moulding on one exposed side - clearly architraving - in addition, small piece of a column capital found beside the architraving block. |

| Context | Report |
|---|---|
| 5.5 | Heavy going in 5.5 due to dense packing. So far this material is rather barren next to nil pottery (with the exception of the coin found earlier). Will take levels once we reach jebel - may need to turn archiving block (5.5A) to check for moulding (however, this may fracture the stone). |
