# Jebel Khalid

## Field Record Book

Name Jamie Travis  
Trenches B38. B39(5) B38-39 Banks (Sth + Nth)  
B38-33 Bank.  
Dates 24/4/2006

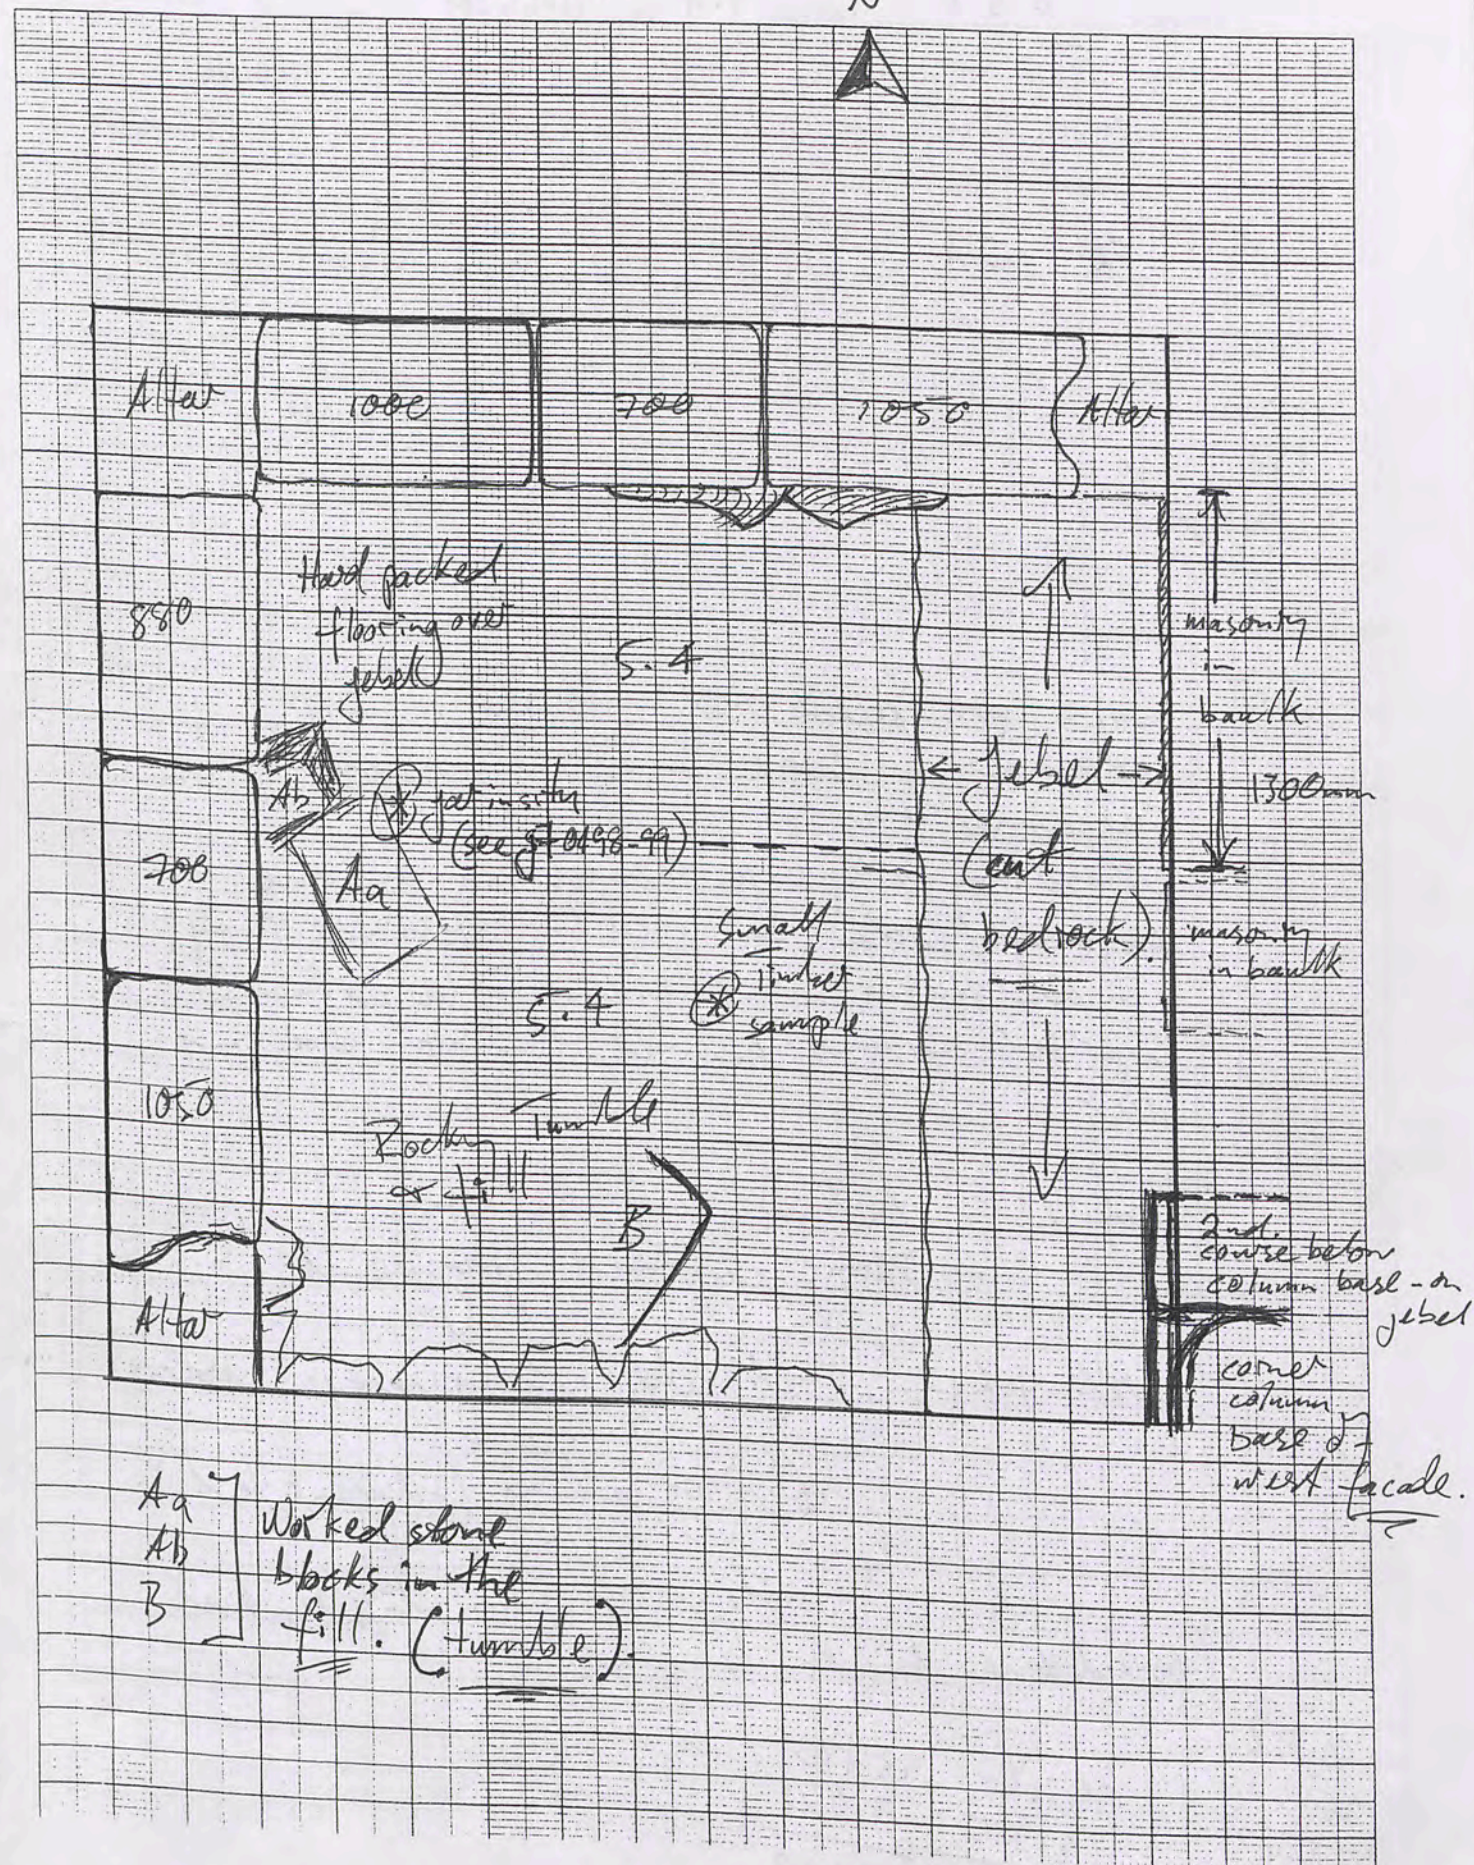
Scale 1:25

| Context | Report |
|---|---|
| 5.4 | <p>starting to see the firm "packing" over the jebel in the NW corner of the junction of the altar lines (as evident in B38).</p> <p>Jebel along east border has been cut to provide, what seems to be, a "step up" to the temple podium.</p> <p>Note: ashlar masonry evident in the fill along the southern border of the trench - its position suggests that there is some way to go before we hit bedrock (currently approx 20 cm down from bedrock "step" to the east).</p> <p>Jar removed from beneath features Aa + Ab - see photos + 0438-99.</p> <p>Timber sample lifted from mid-trench.</p> |
| 5.5 | <p>New spit established <del>to</del> within the southern quarter of the trench - defined by rocky tumble / fill. (1200 mm in from northern border i.e. E-W altar line).</p> |

S. 4 before establishment of S. 5.

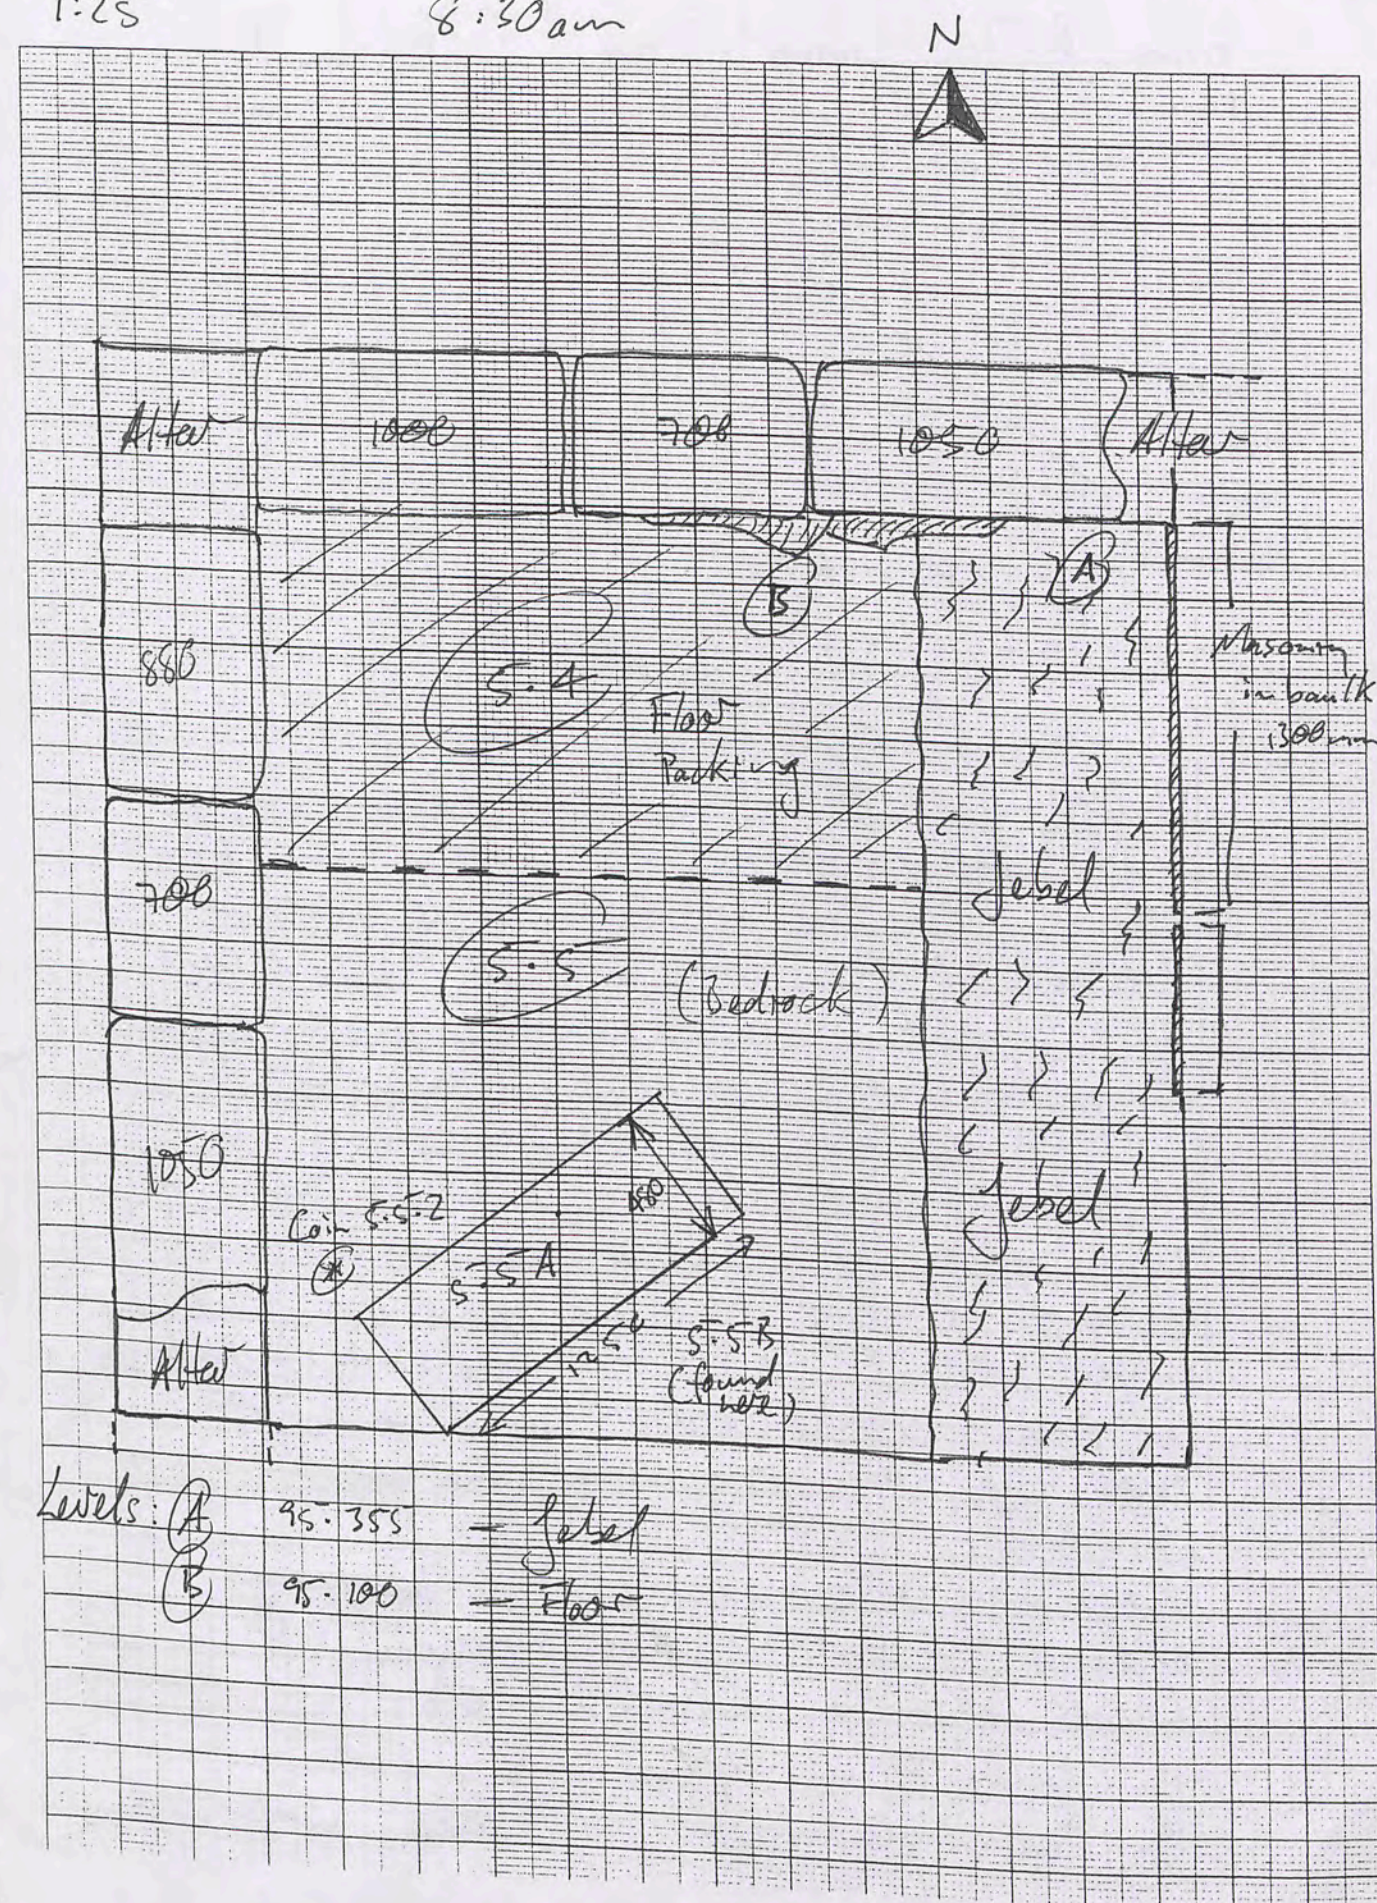
7-5-06

| Context | Report |
|---|---|
| 5.5 | Heavy going in 5.5 due to dense packing. So far this material is rather barren next to nil pottery (with the exception of the coin found earlier). Will take levels once we reach jebel - may need to turn archiving block (5.5A) to check for moulding (however, this may fracture the stone). |
| | 5.5.5 - "crystal"-like stone bagged for analysis. - found adjacent to jebel in SE corner. (probably nothing significant) |
| | By end of day, have yet to encounter bedrock though we may be near given the crushed limestone now evident in the "sub-floor" packing. |

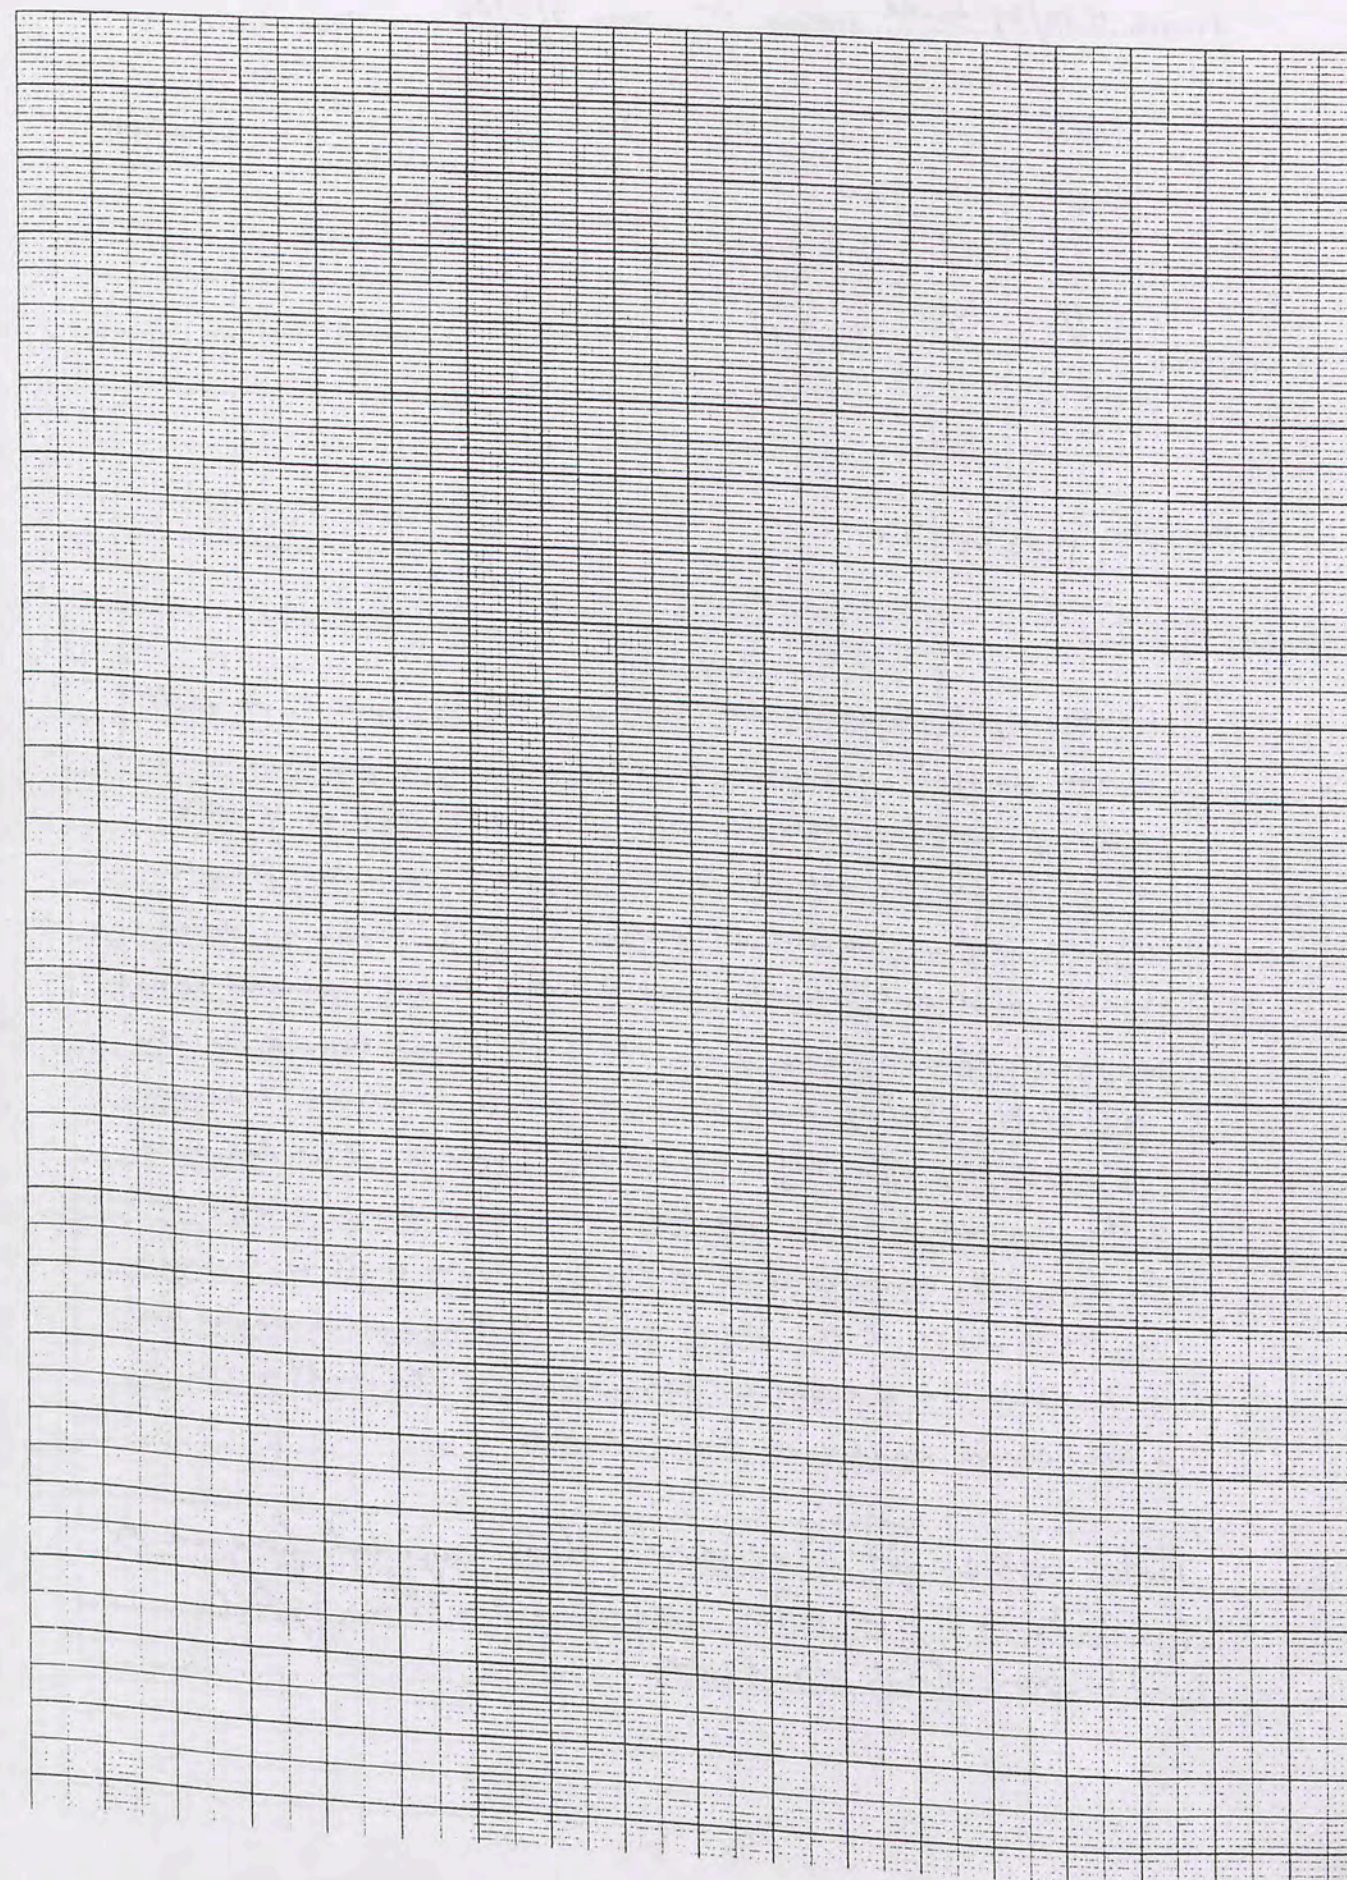
Trench... B38/39 baulk ... Initials... GWC ... Date... 9/5/06 ... Page... 2 ...  
 Locus... .. Spit... 2 ... Locus... .. Spit... .. Feature/s

| Context | Report |
|---|---|
| | Continuing to clear baulk from S to N, as spit 2. It will reveal largely masonry blocks. Already a few more pieces of worked basalt, but it doesn't look as if the masonry blocks are at all continuous from the temple stylobate (but could be fallen blocks). However some are clearly laid deliberately. Yet another basalt pounder (not bagged). After cleaning up we will clear baulk to the N, still B38/39 but to distinguish the area I'll call it B38/39N [baulk] spit 1 + then spit 2. Further piece of the degraded doric capital recovered from B38/B39(S).<br>By 11 a.m. The continuation of the masonry wall is emerging on the N side of the altar line - but again it might only be tumble. The deliberate formation of the wall to the S is now clear, seated on the bedrock. |
| | Photos take of "detached" doric capital fragments (J+0576-77) - note: fragment on the right not from this context! |

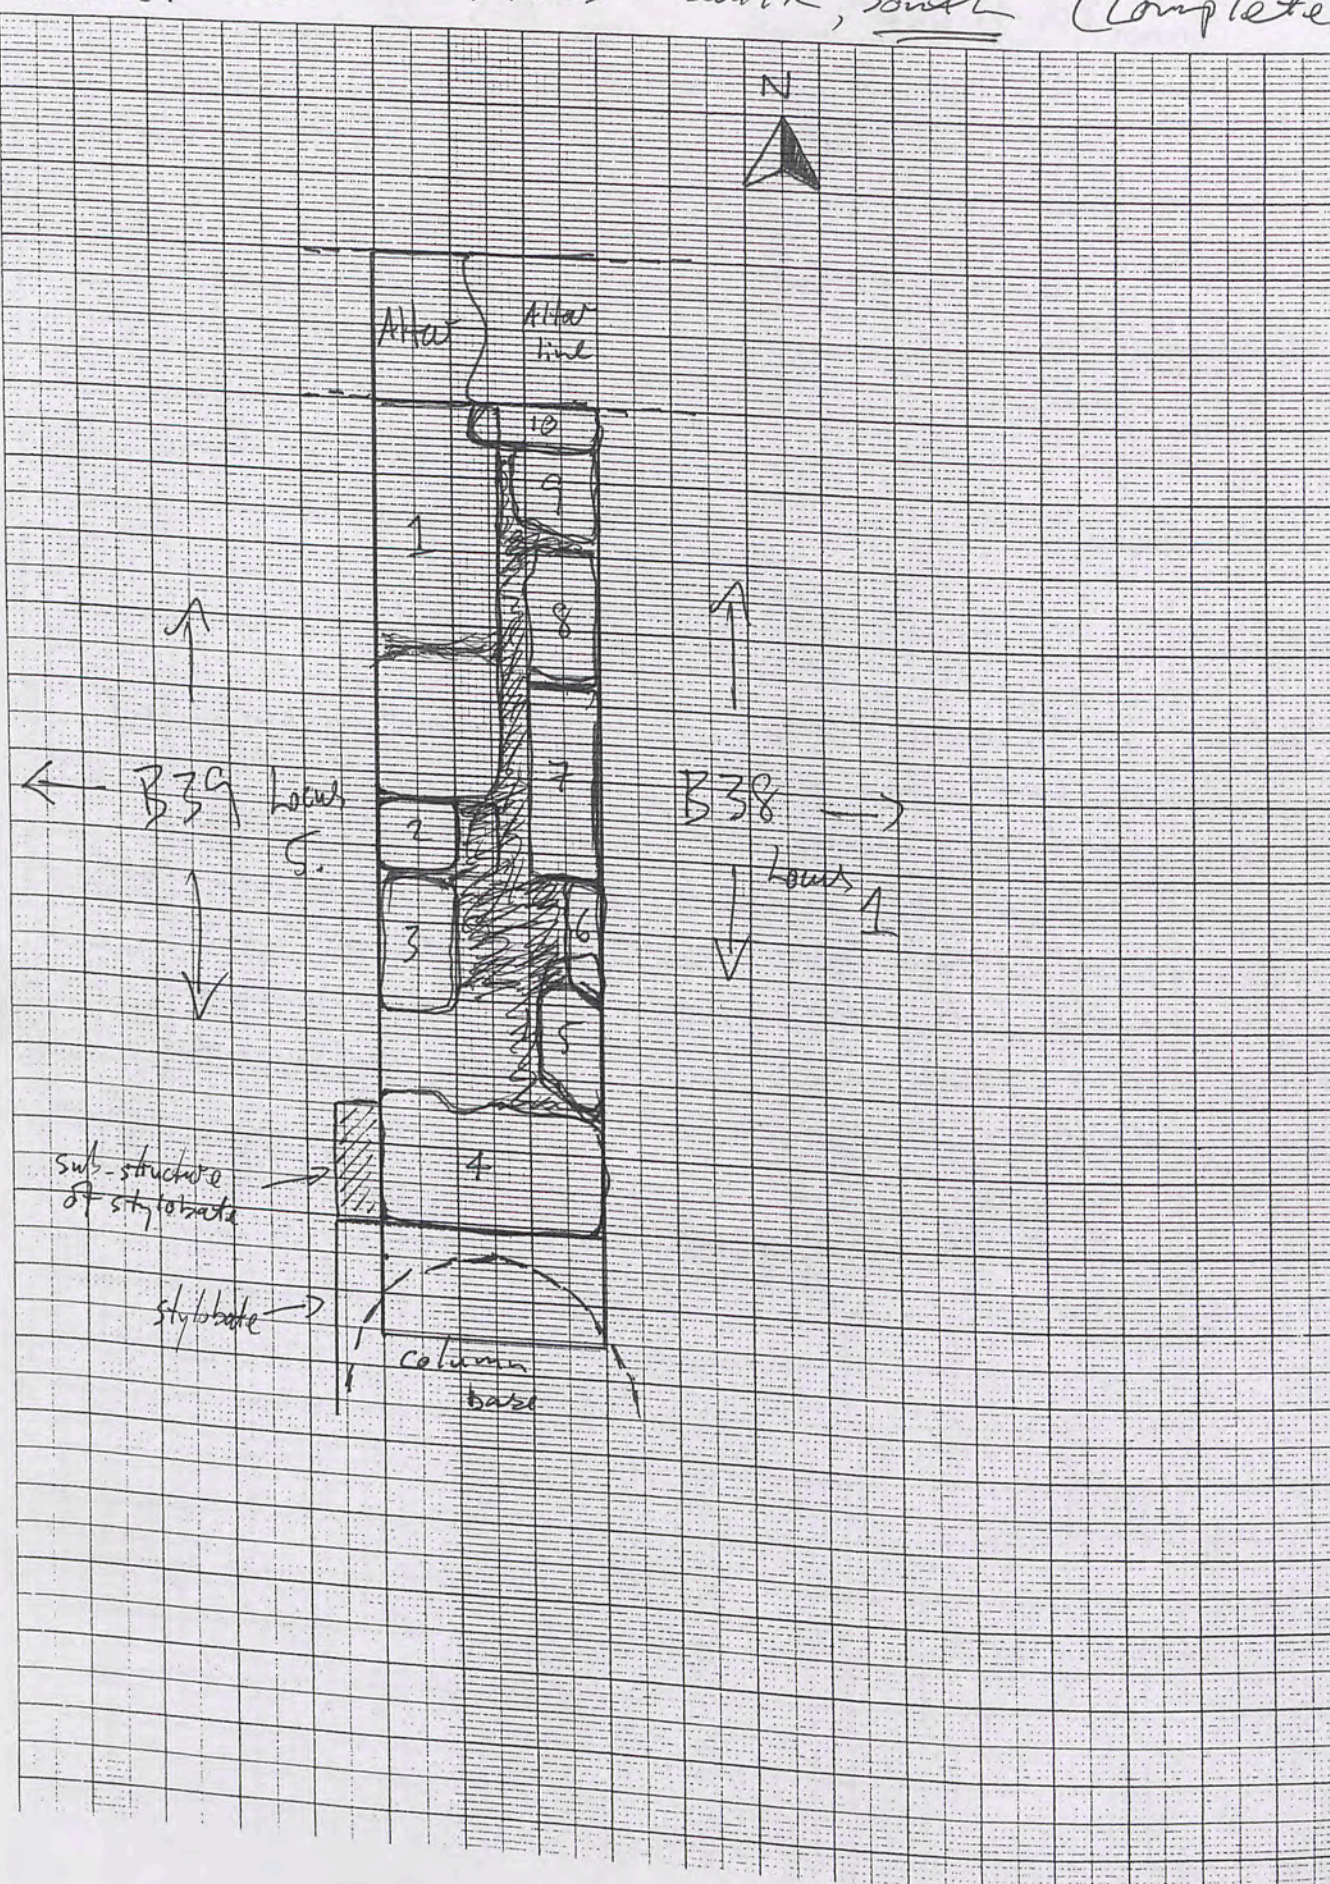
B 38-39 Bank, South (Complete)

Hand-drawn sketch of a site plan on graph paper. The plan shows a central rectangular area labeled "Worked Block" with a dashed line labeled "Alter Line" running through its center. To the left of the "Worked Block" is a vertical strip labeled "Alter". To the right of the "Worked Block" is a vertical strip labeled "Quarried Ridge of Gabbro (Both north/south faces quarried)". A dashed line labeled "Boundary of B38-39 (North)" runs horizontally across the middle of the "Worked Block". A north arrow points towards the top right. A note with an arrow points to a heart-shaped area on the right, stating "Heart shaped column base here."
