Jebel Khalid

200 B  
Area S

Field Record Book

Name.....	Jan Perry
Trenches.....	S 23, S 29
.....	
Dates.....	27.4.08

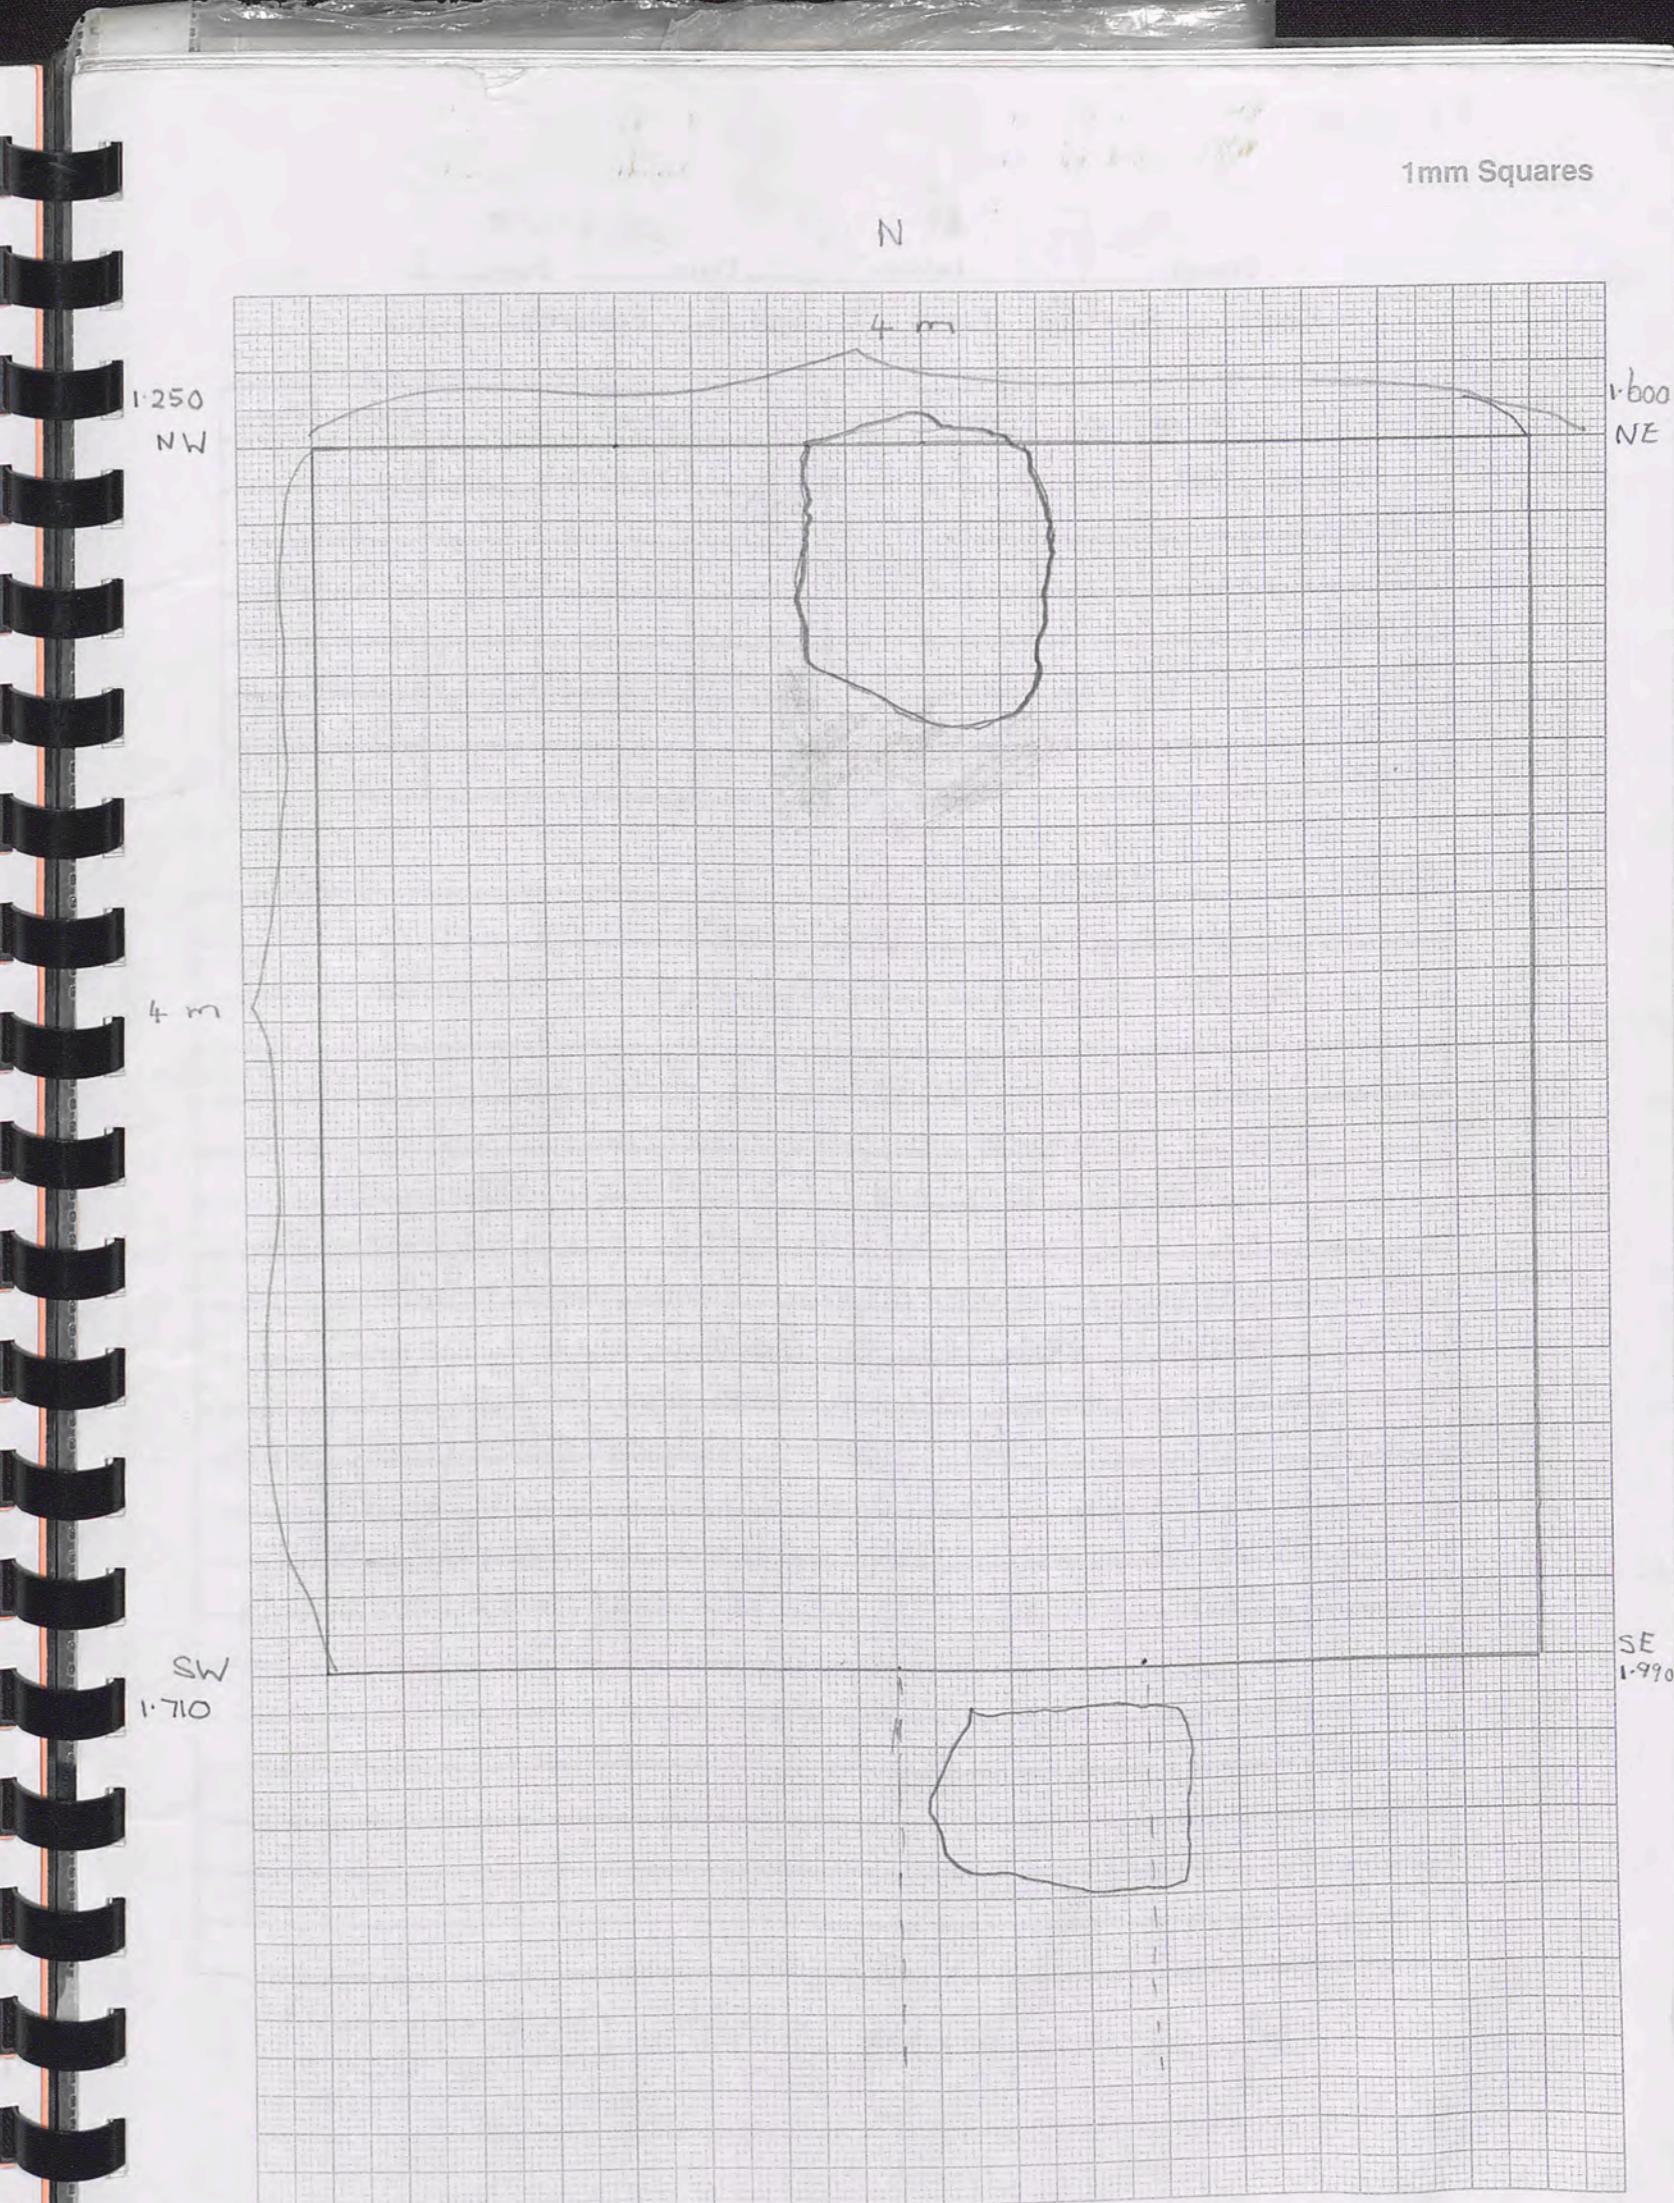
Context	Report
1.1	<p>2 photographs 'top shots'</p> <ul style="list-style-type: none"> <li>- image 1709 - 1710</li> <li>- small bag of bone</li> </ul>
1.2	<ul style="list-style-type: none"> <li>- some walls tentatively identified - locus 1- is a square in NE corner.</li> <li>- workers leveled NE corner towards NS wall on western edge a possible NE northern boundary wall (e)</li> <li>- looking less like a northern wall (e)</li> <li>- two large rocks emerged further (f+g)</li> <li>- still upper fill, getting deeper along N. edge, tumble, still spit!</li> <li>- <math>46.5 \times 20 =</math> door upright western NS wall</li> </ul>

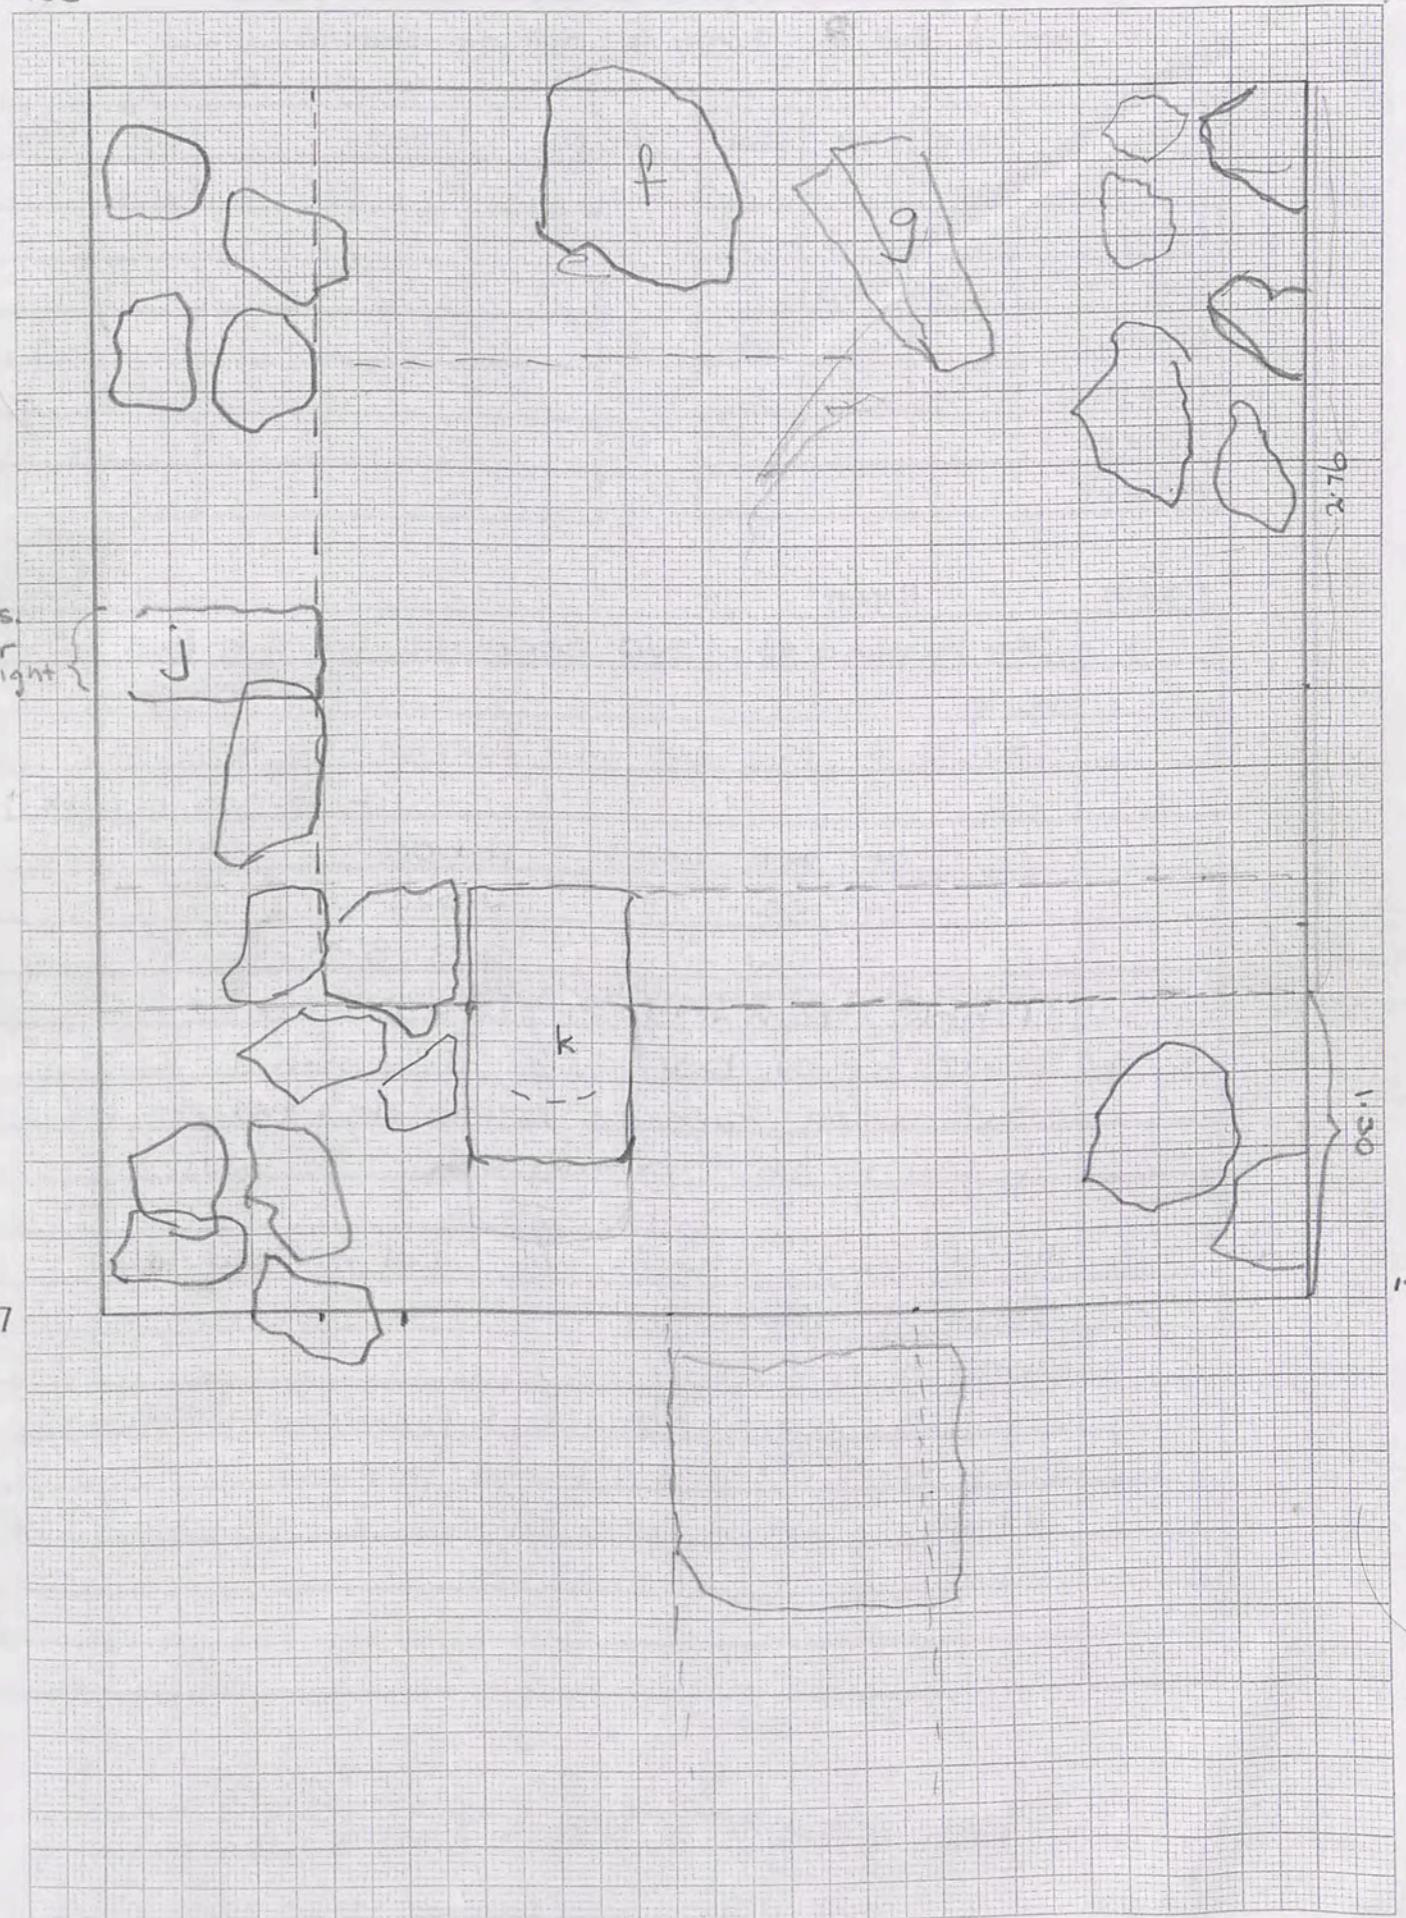
Back sight 1.730  
 rectangular rock = 60.55 cm

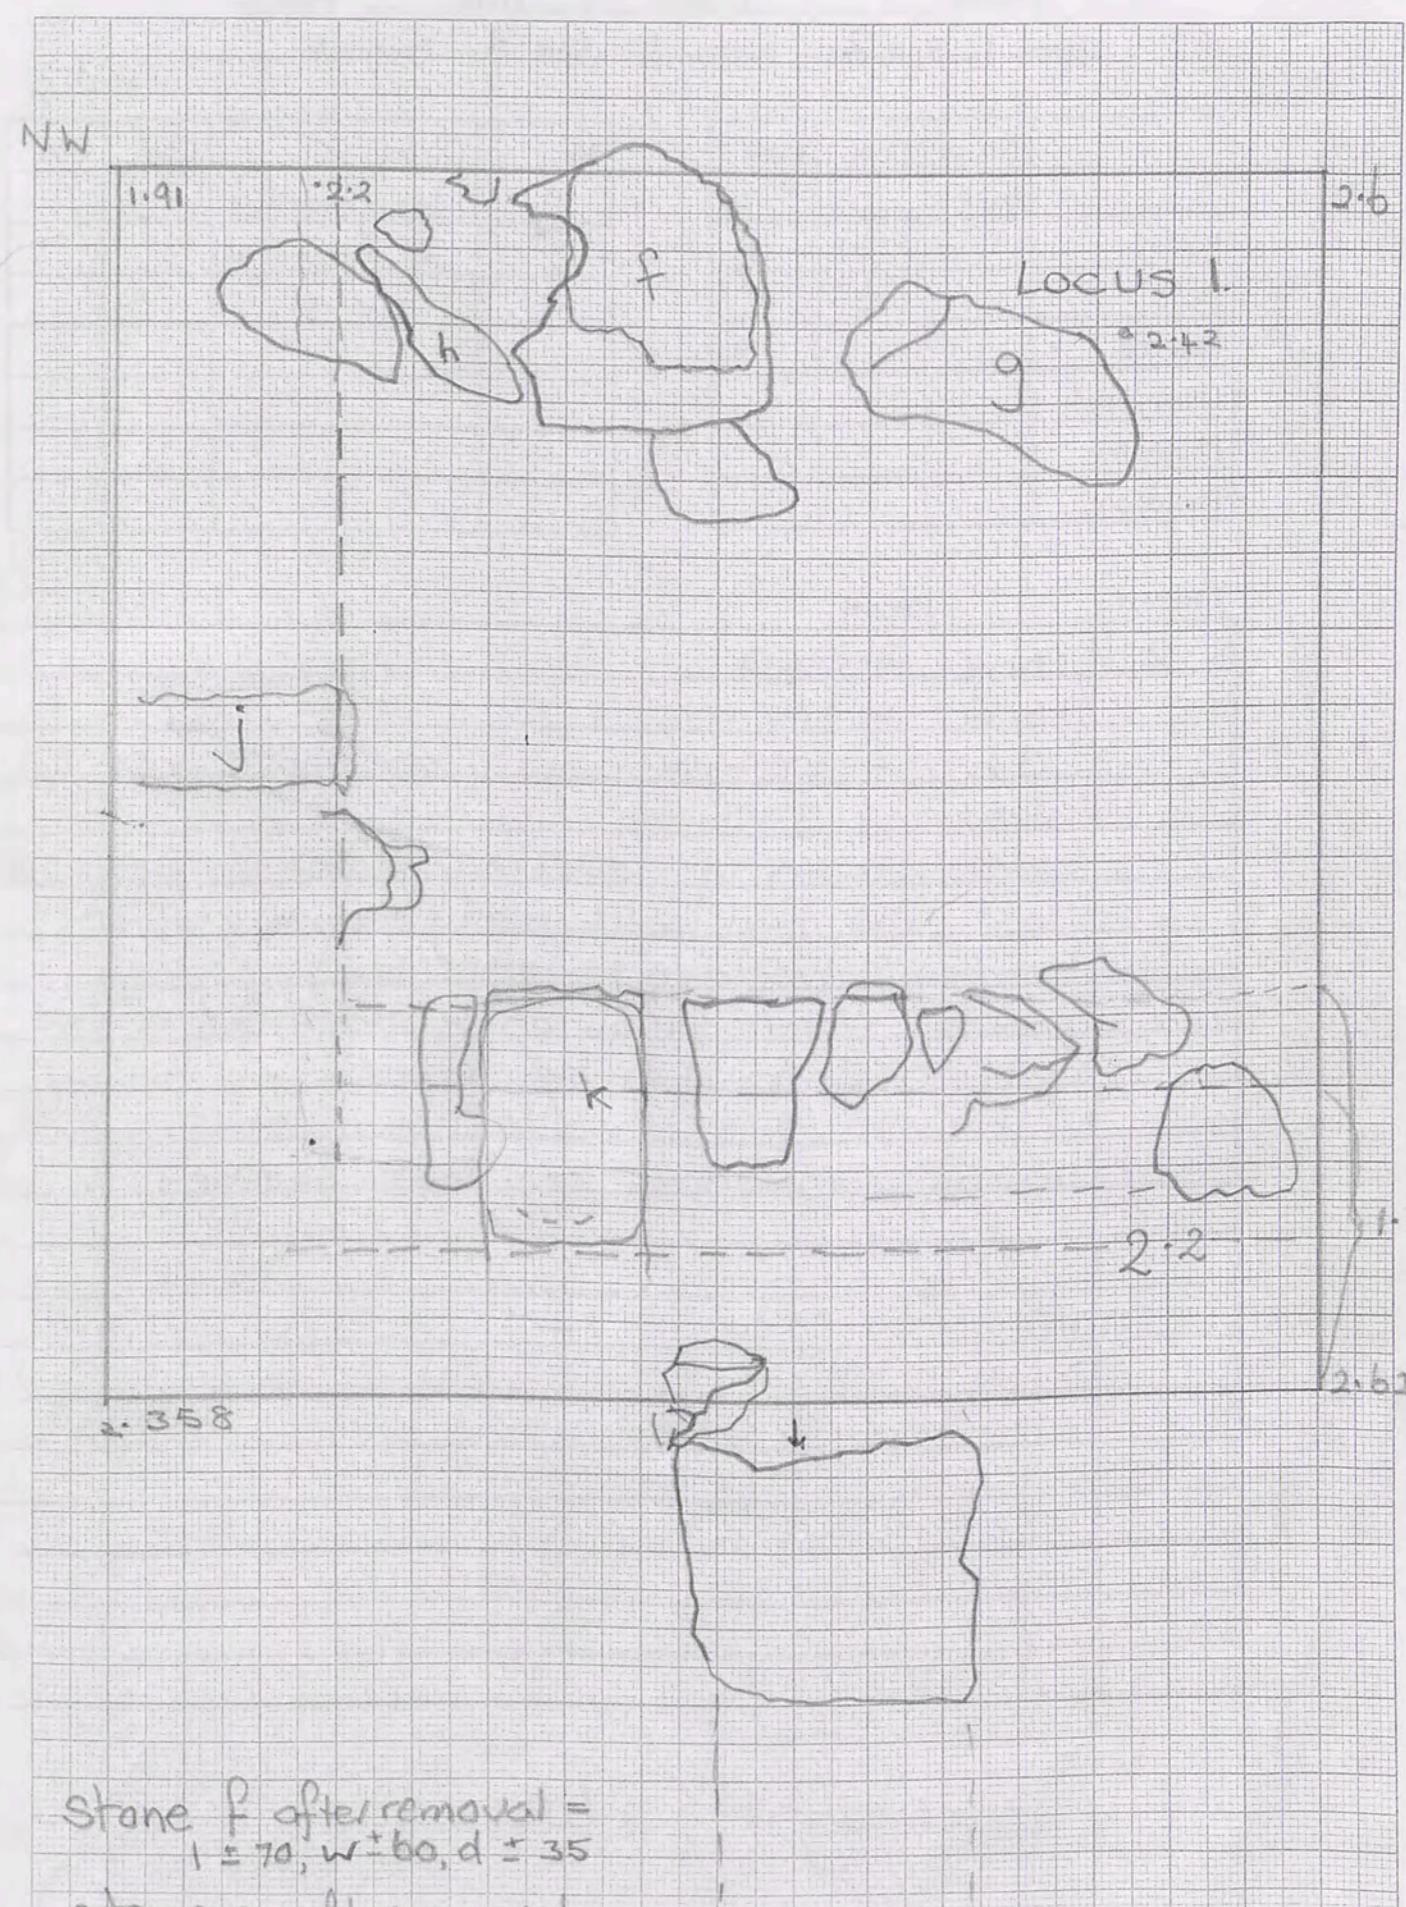
Context	Report
1.3	Still leveling at N end because of the two large rocks levels - two at NW corner - 1.910 top - 2.200 in wall - NE corner 2.600 corner - SE " 2.620 - SW 2.358 A hole (diam $\approx$ 19 cm) has emerged in large rock N border (f) - (the south face is being defined / of the W soil is loose brown with wall) small stones stones along eastern NS wall removed stone g removed stone f removed leveling continued - soft brown stoney earth. stone h (now much bigger) removed a lovely flattish open square $\approx$ walls along S + W

Stone f after removal =  
 $l \approx 70, w \approx 60, d \approx 35$

stone g after removal =

$l \approx 85, w \approx 40, d \approx 35$   
 possibly doorstones

stone g possibly shaped at NW end

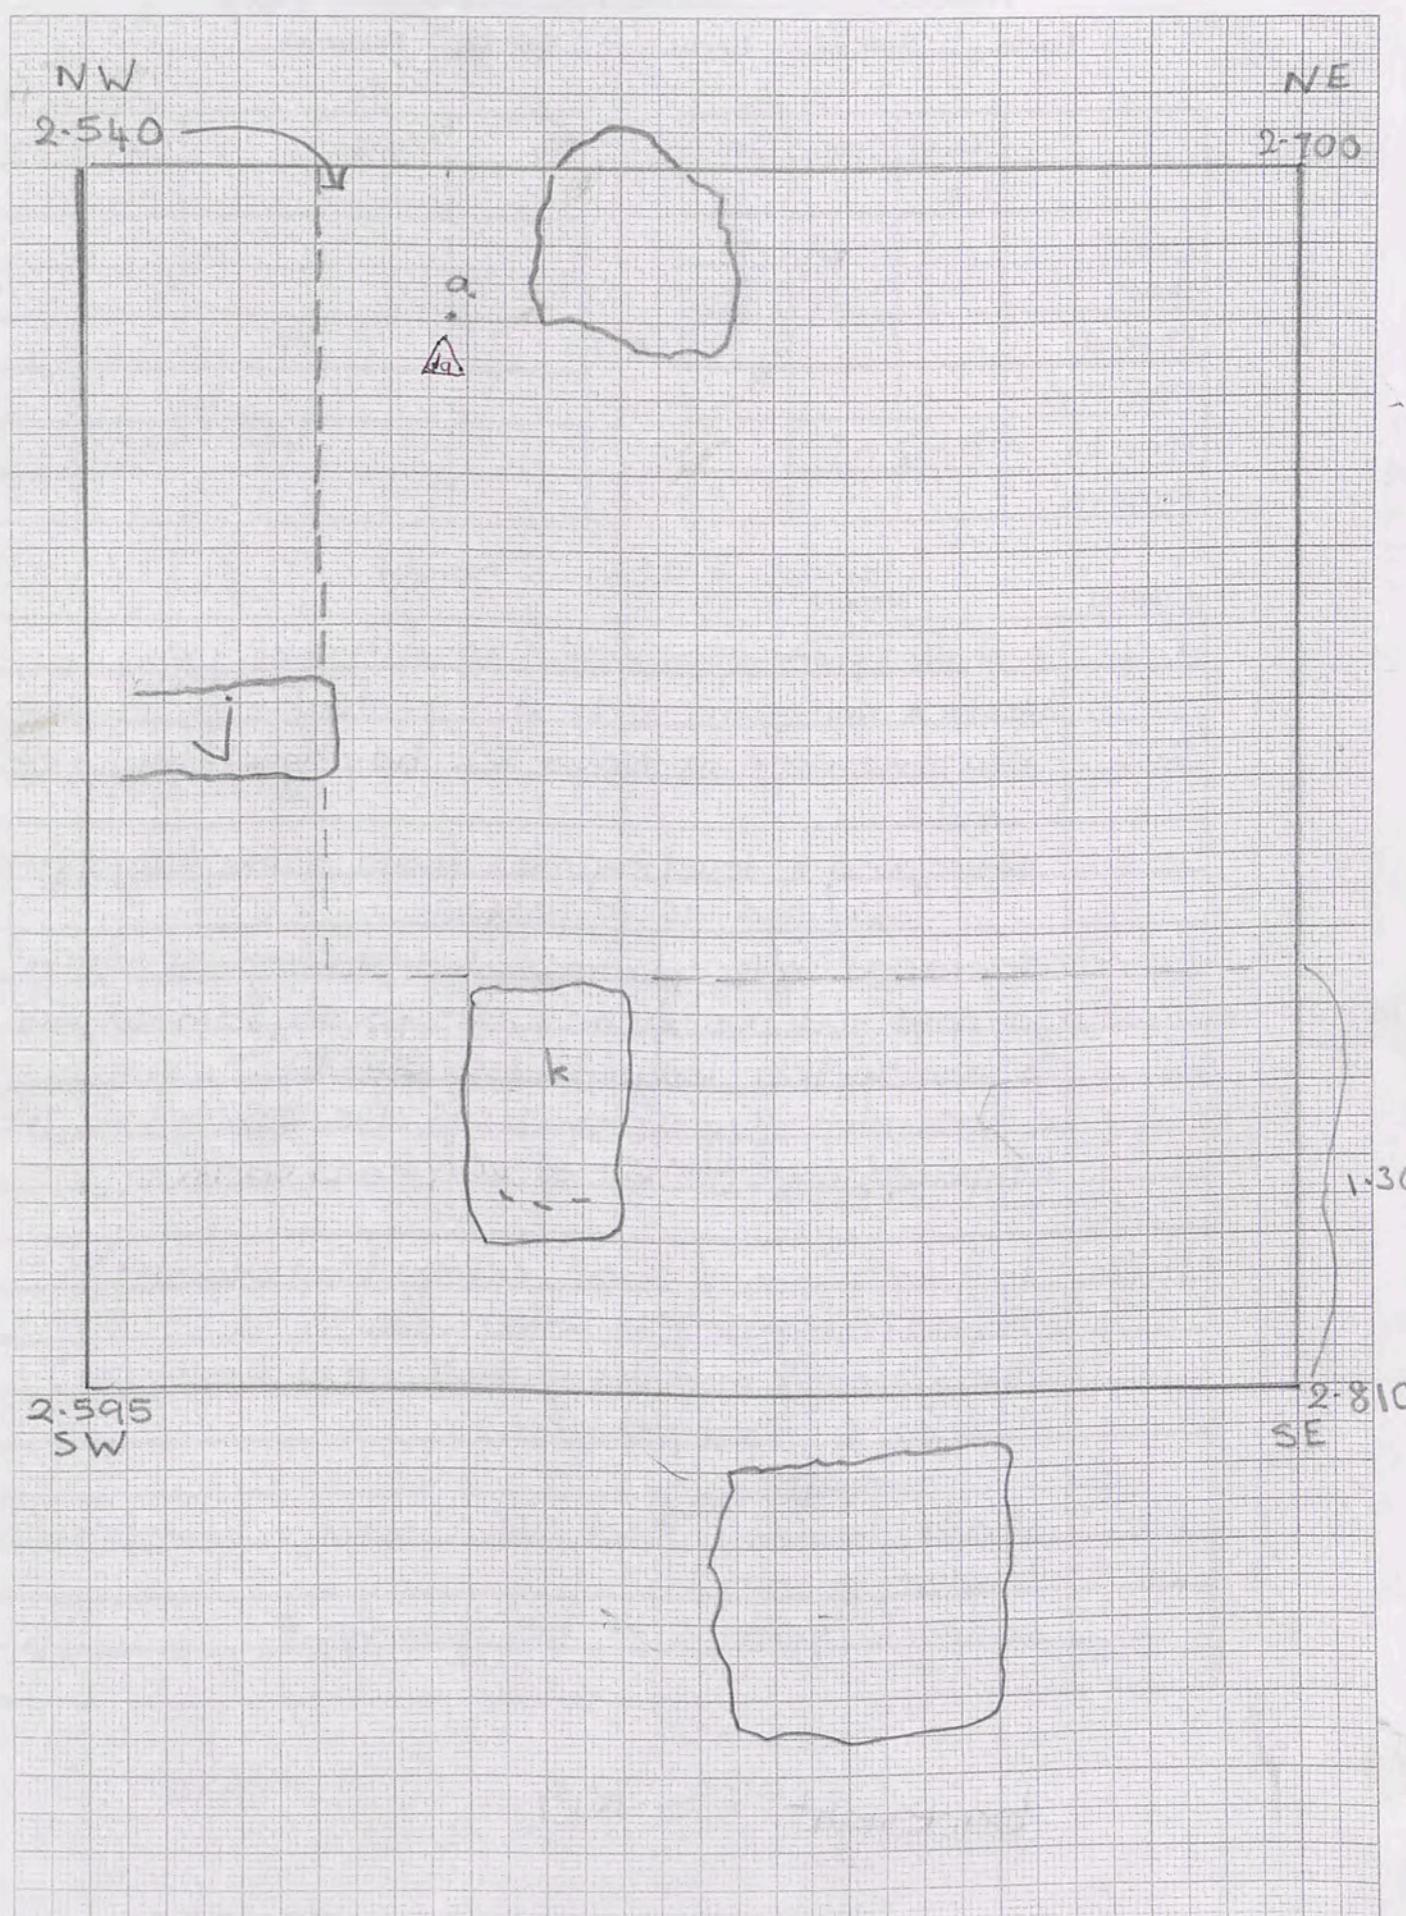
1.2 NW 2.540  
NE 2.700  
SE 2.67 - inner ear, outer ear 2.81  
SW 2.595  
continuation of leveling towards possible floor, the two walls being the only obvious features. Working towards W.

1.3 possible floor - tough on W side but a soft spot on E so digging deeper  
*(w.)*  
sieving commences as floor emerges

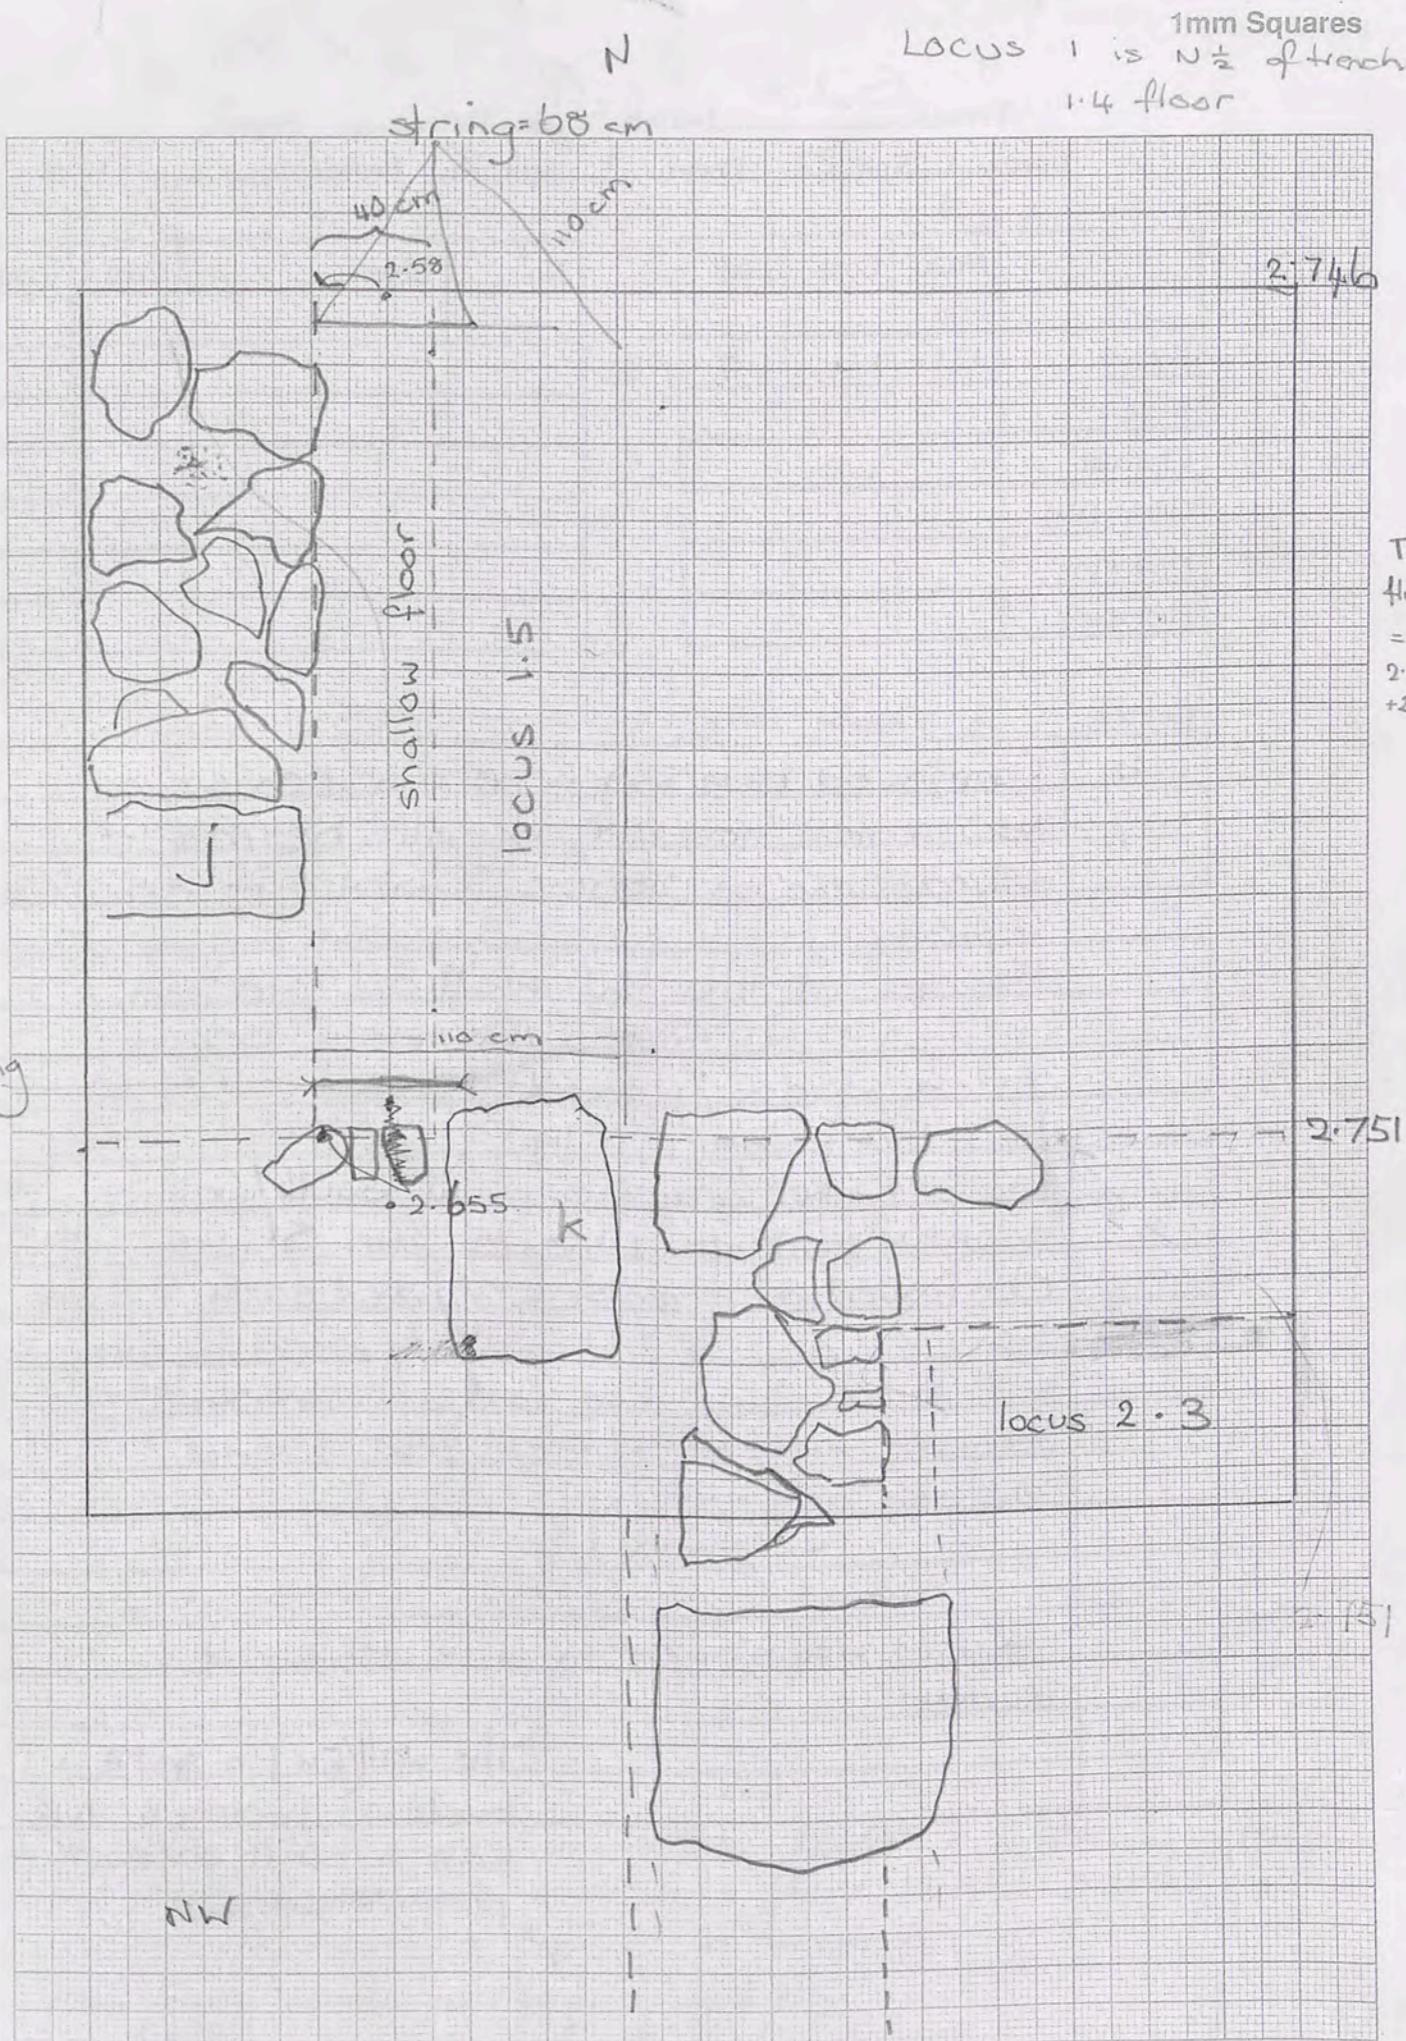
- Context Report
- ledge ± 8 cm in height
- 1.3 a shallow floor appeared ( $\pm 40$  cm in width) along the western wall from N to S. photography necessary
  - 2.3 further work in locus 2.2 tidying + removing rocks
  - 1.3 sweeping + leveling main floor - the ledge was clarified as a feature
  - 1.4 declared after photography. a string was hung from N wall to S wall @ 48 cm from W wall to enable the ledge to be dismantled as a feature & straight digging towards the West. The ledge appears to be of very hard earth -
  - 1.5 1.10 cm from W wall repeat (as above) to find bedrock or another floor
    - the floor is comprised of thick, hard, heavy clay-like earth, hard packed spit
  - 1.6 floor locus lifted, New spit - limestone layer - softish
    - bedrock appears to be imminent

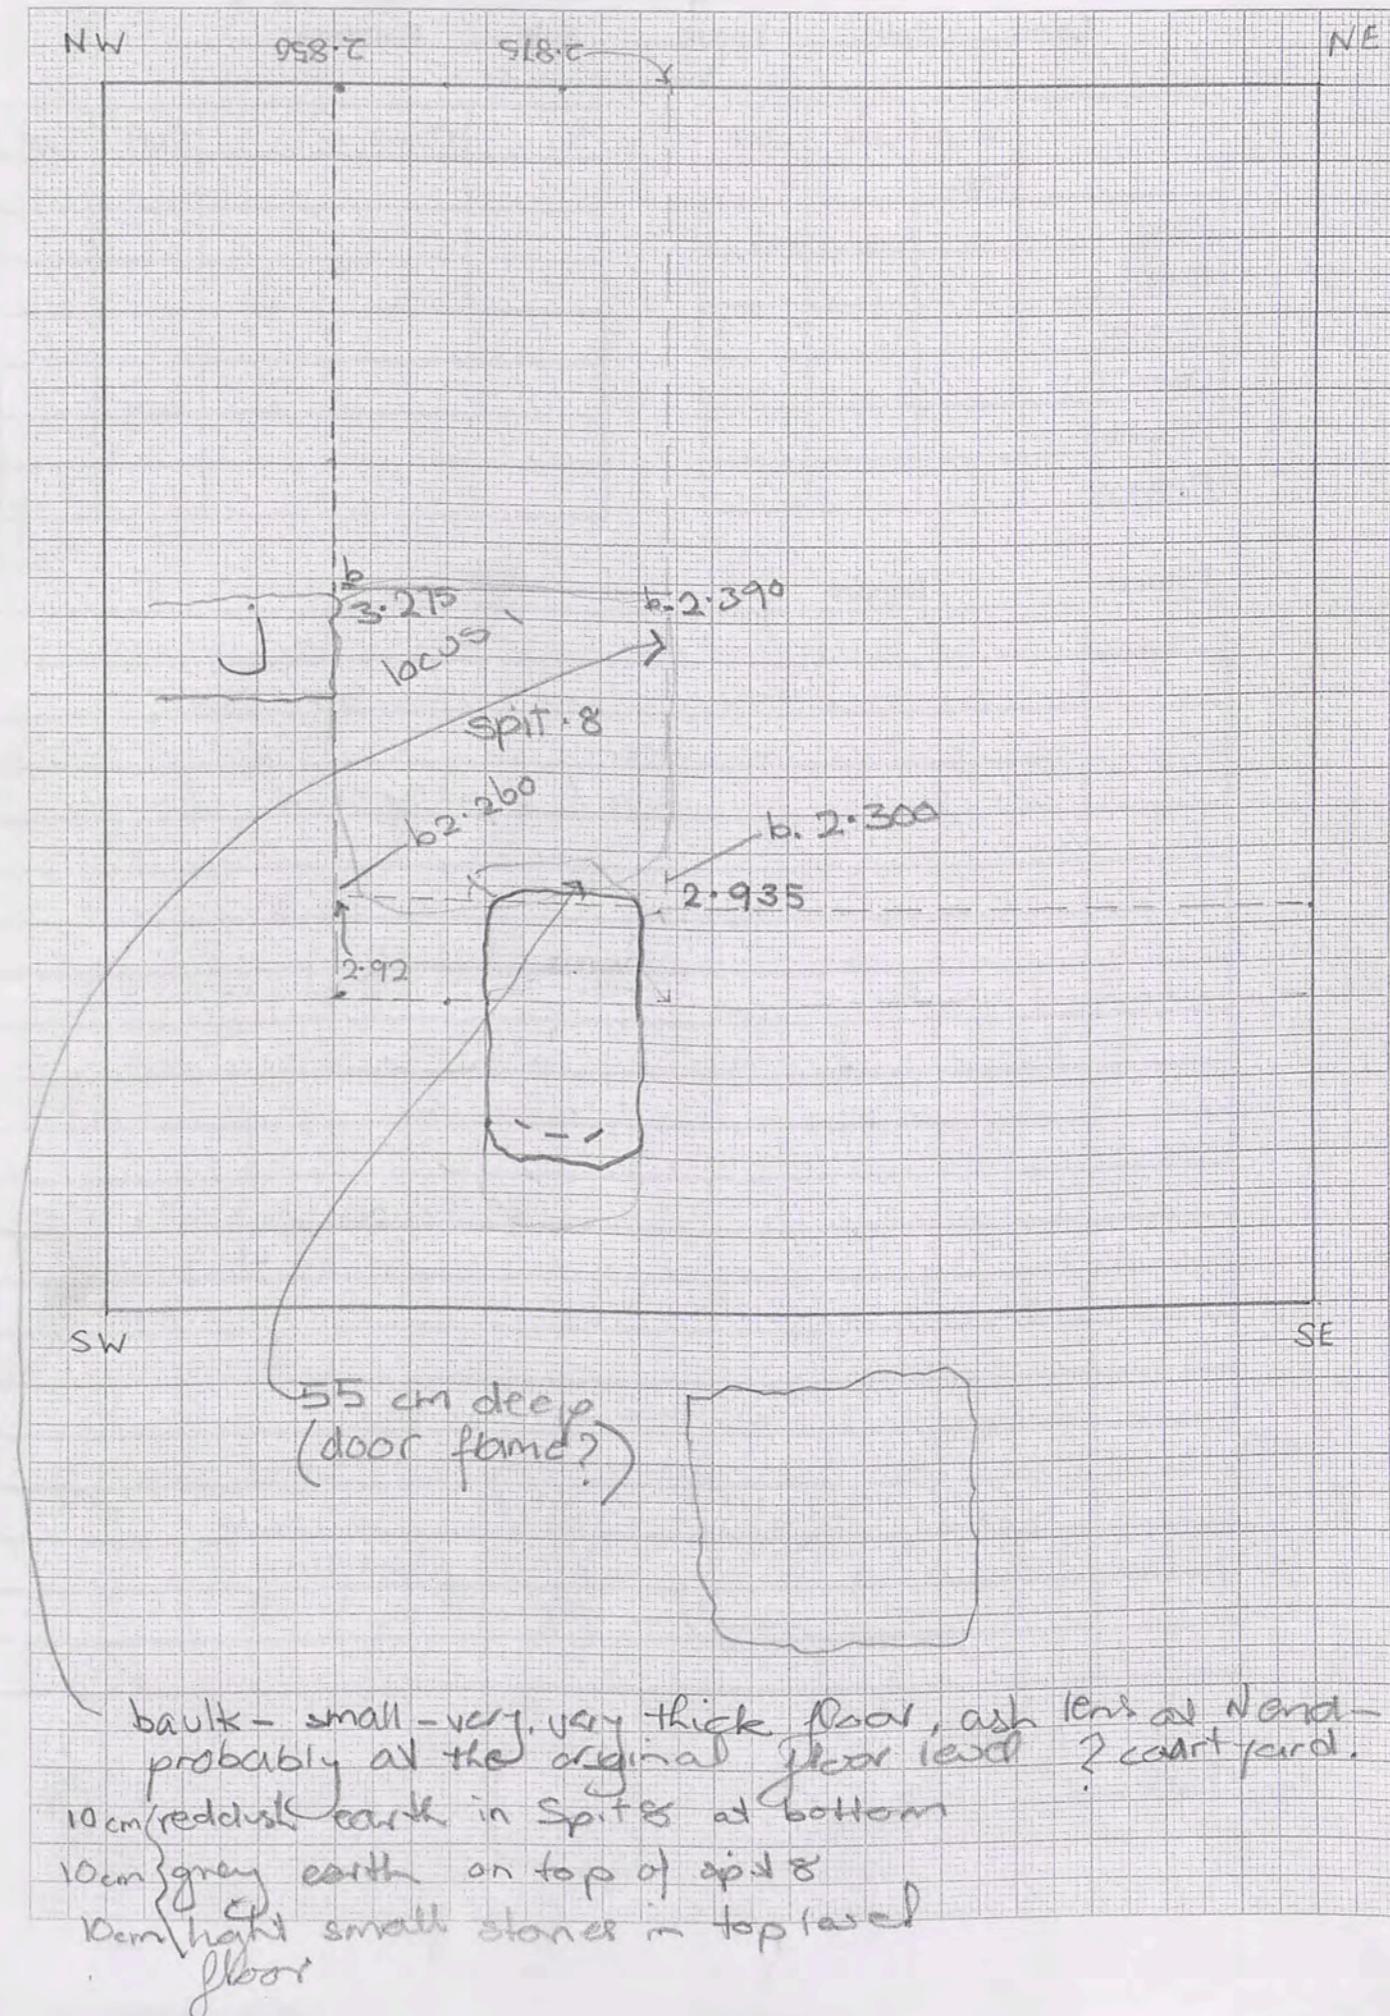
1.6 Continued lowering - red soil emerging  
 1.7 New context toward possible bedrock - sieved although stoney. Tumble in earth. A floor became apparent in the strata of the W wall at 1.10 m below surface. The wall began (rested upon) that level.  
 New backsight 1.790  
 See p7 for drawing of W baulk/wall  
 1.8 b. new spit to 1 metre from S wall // continuation of reddish v. hard earth ? floor  
 The lower part of E/W wall exposed by digging  
 spit 8 revealed two large rectangular stones (worked) placed end to end horizontally. (K)  
 If this is a doorway it is deliberately blocked  
 The wall(EW) in spits is built on bedrock. NW Wall is built on earth - pedestalled.

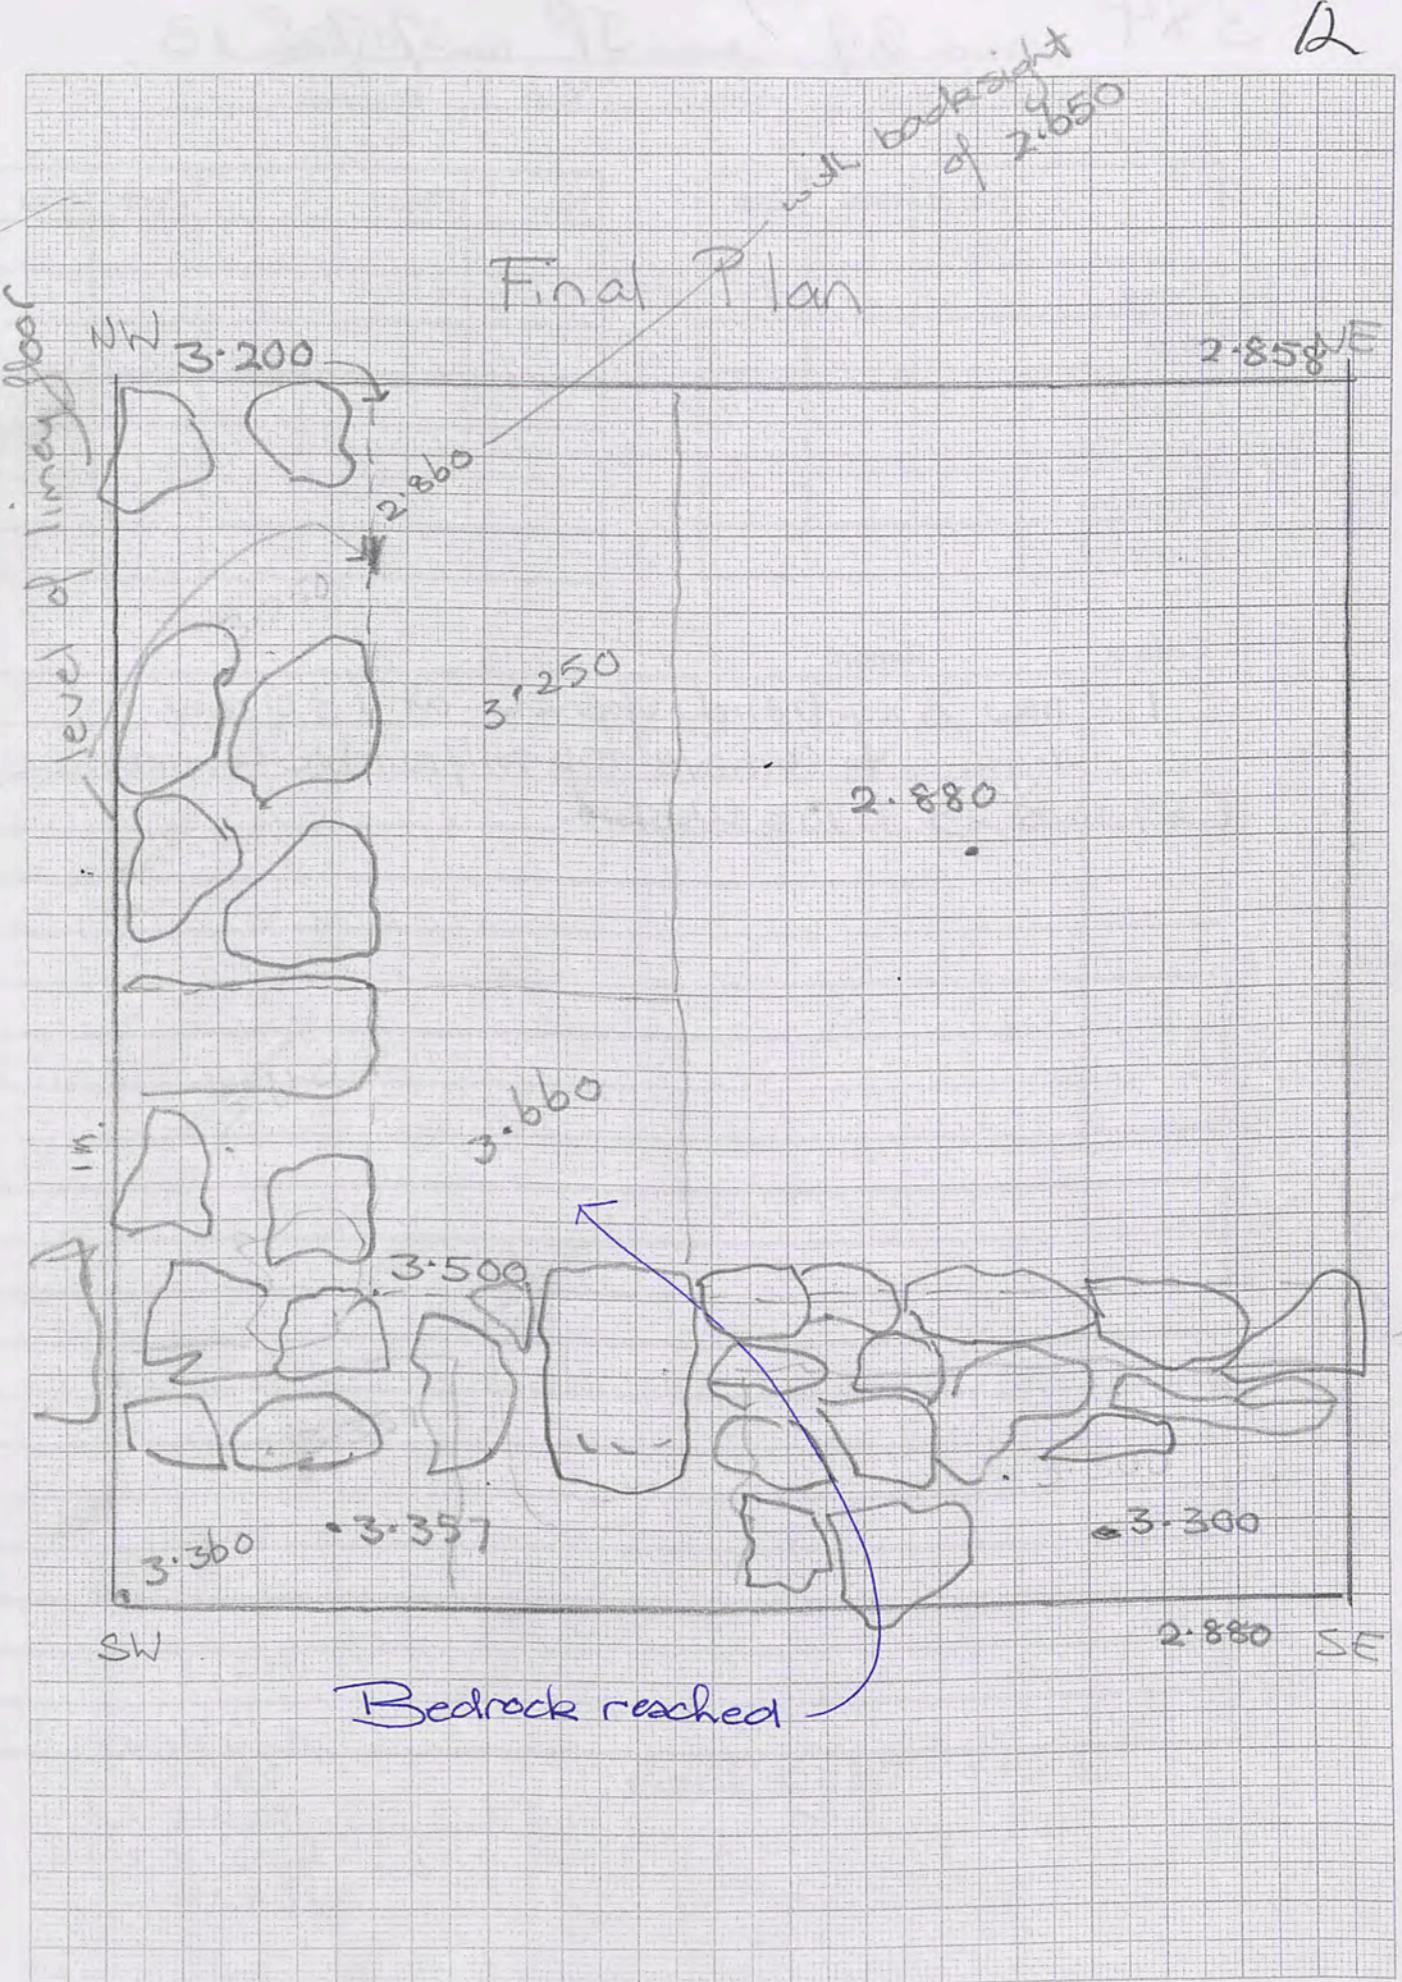
Final levels to be taken when final plan drawn up.

bedrock achieved  
 the level of the limay floor  
 was taken with the backsight - 2.650 -  
 the limay floor was at 2.860

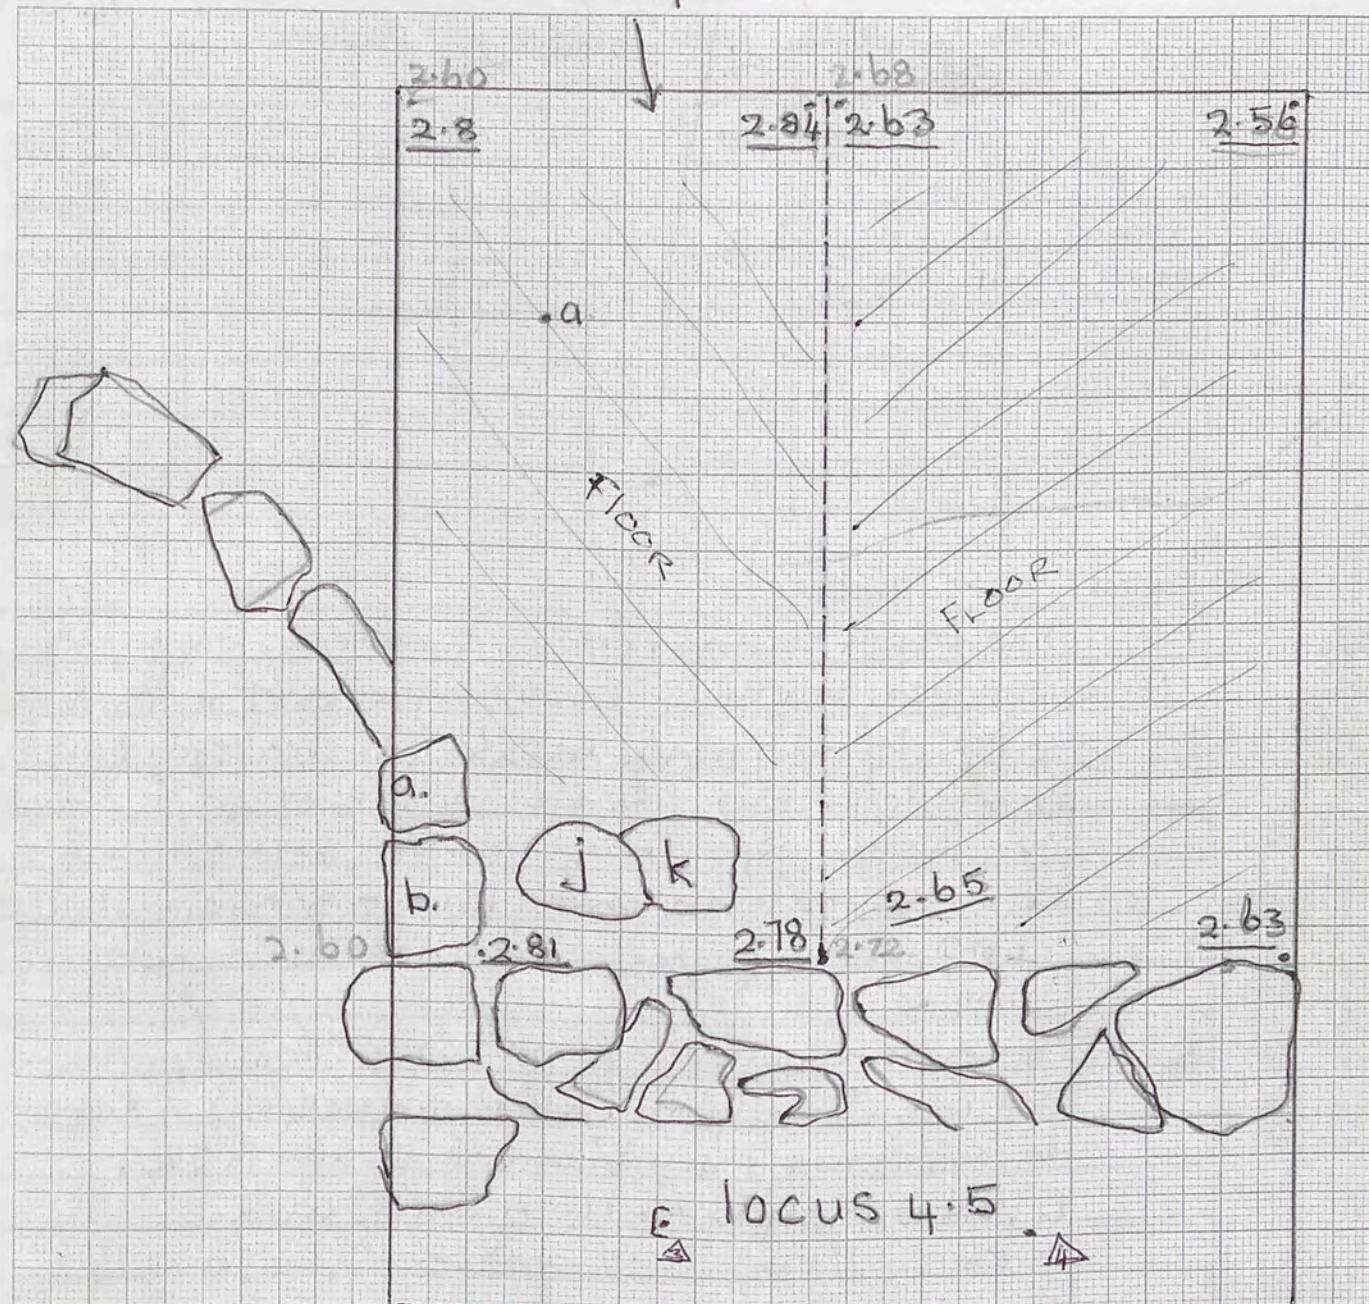
Stones a+b now 45cm from floor on which they  
stand. Wall appears to be roughly plastered  
with earth - same as floor.

locus 3.4

The northern wall  
of 4.5 is tumbling  
& likely to fall. A  
floor was not  
reached before  
excavation ceased.

Final levels locus 4.5  
NN 3.15  
SW 3.85  
SE 3.135  
NE 3.18
