Jebel Khalid

200 B  
Area S

Field Record Book

Name.....	Jan Perry
Trenches.....	S 23, S 29
.....	
Dates.....	27.4.08

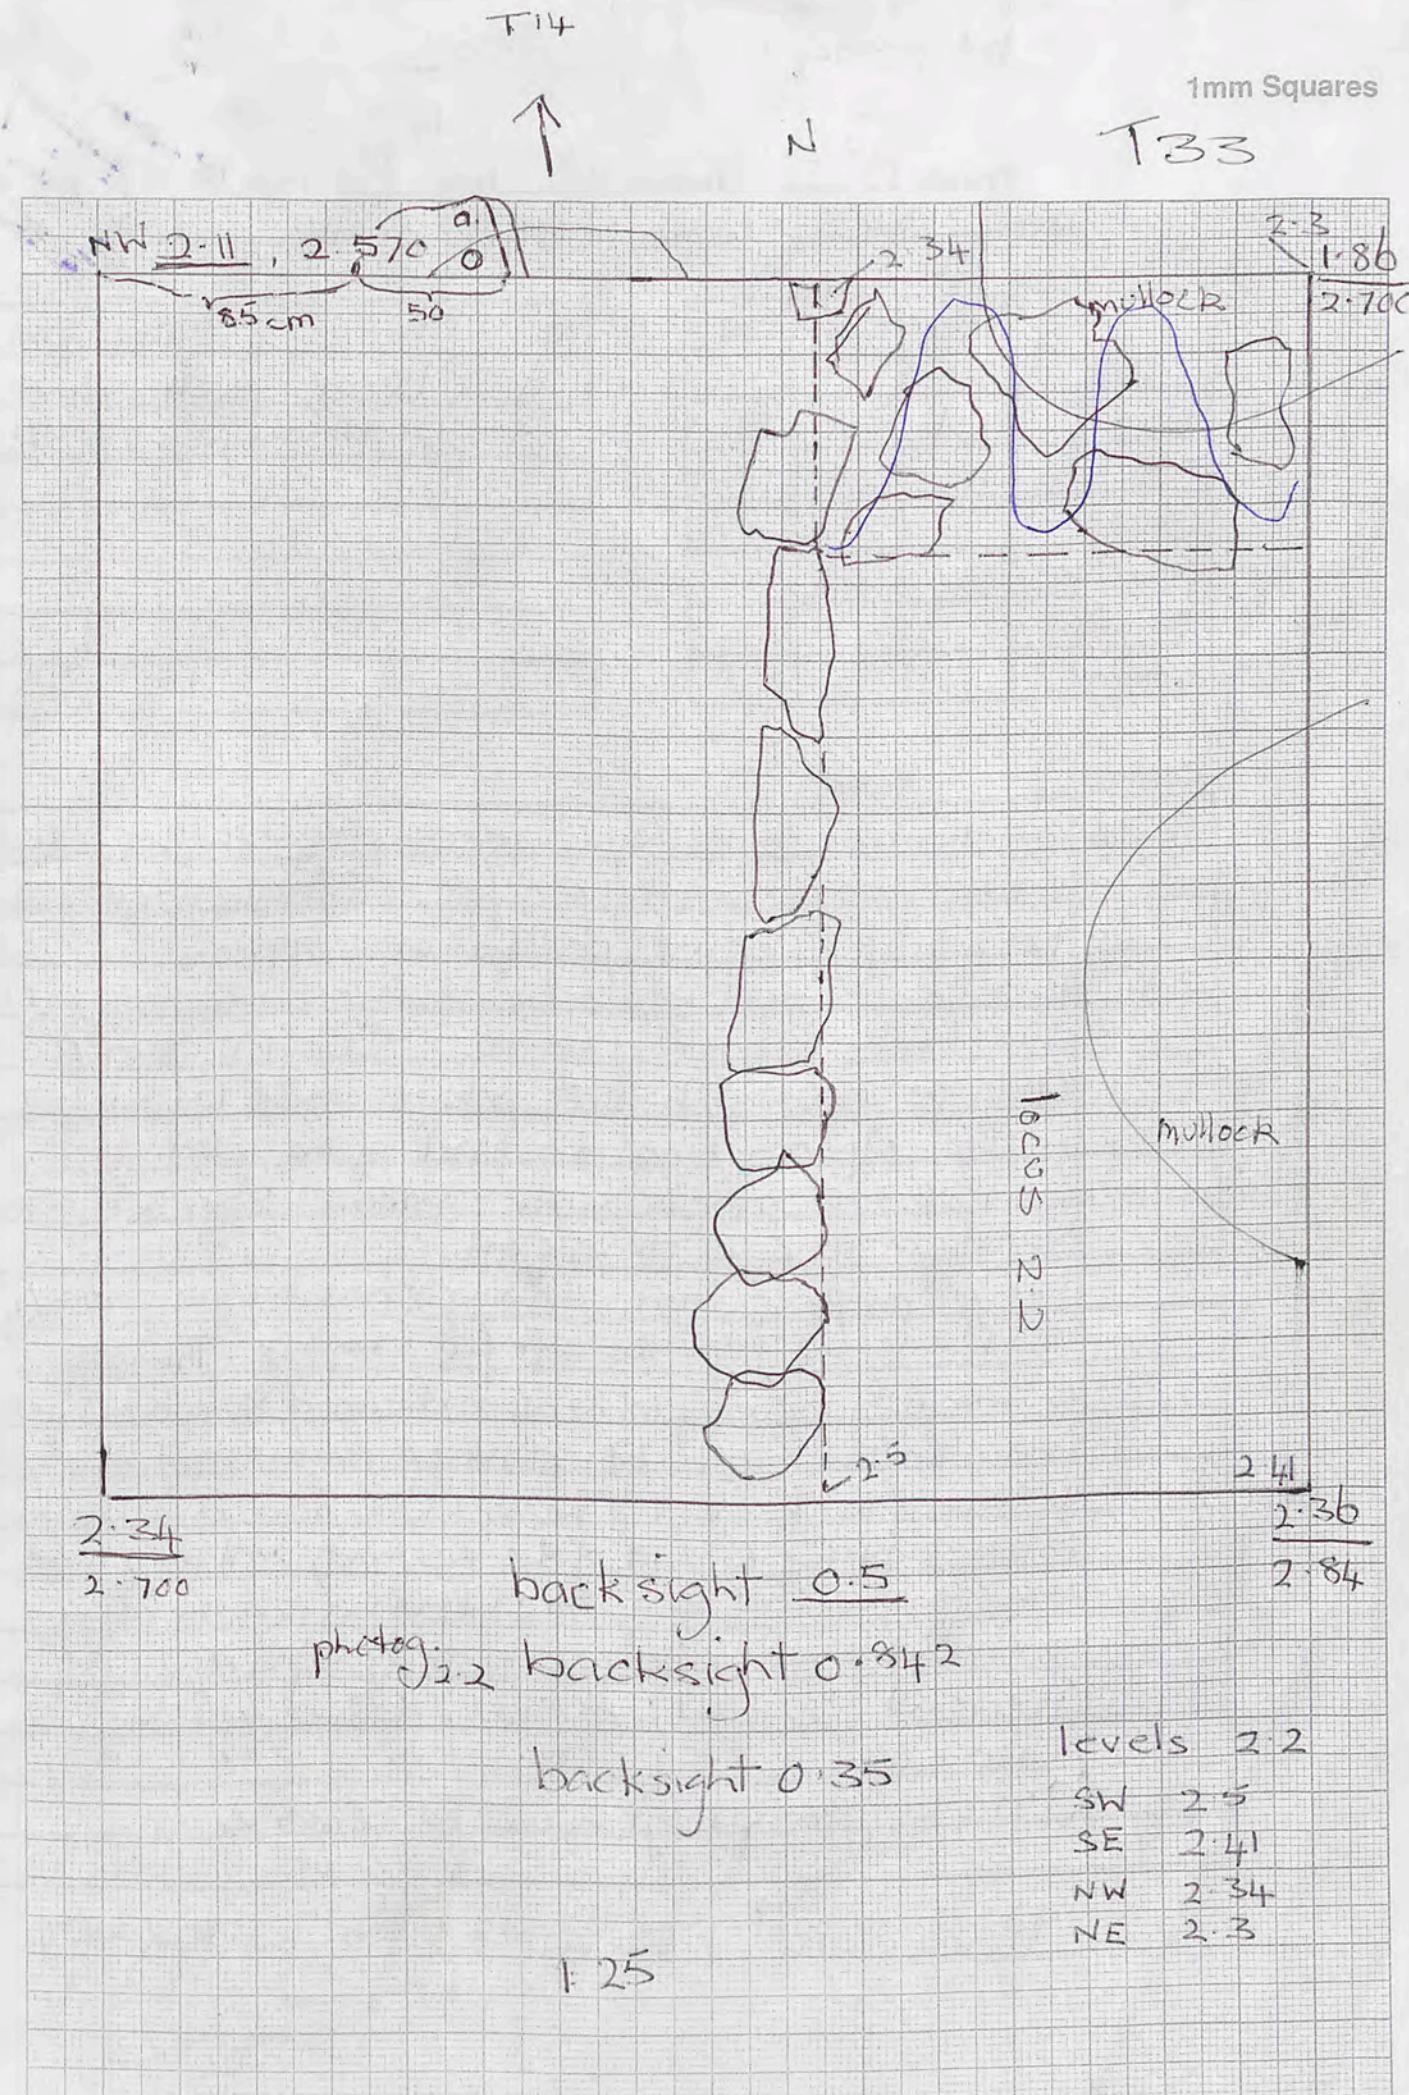
- 1.1) The trench contains parts of 2 mullock heaps - being removed. V. dusty. Continuing to level mullock heaps levels whilst defining trench boundaries. A courtyard may emerge to the East of the East facing building & steps down-monumental. Spoil heaps removed, surface is level, stones are emerging in centre of trench - tumble; also plant roots. Photograph - surface covered in stoney tumble  
21b9 K

1.2) Stones being removed from SE corner. There is possibly a wall N/S. Stone a. may <sup>be an</sup> indication of wall (n/s) as it appears to continuation of a substantial N/S wall in T14. A wall is emerging N/S 1.60 m from E baulk. Rocks NN removed - apparently not a wall. Levels taken New spoil - same starting levels

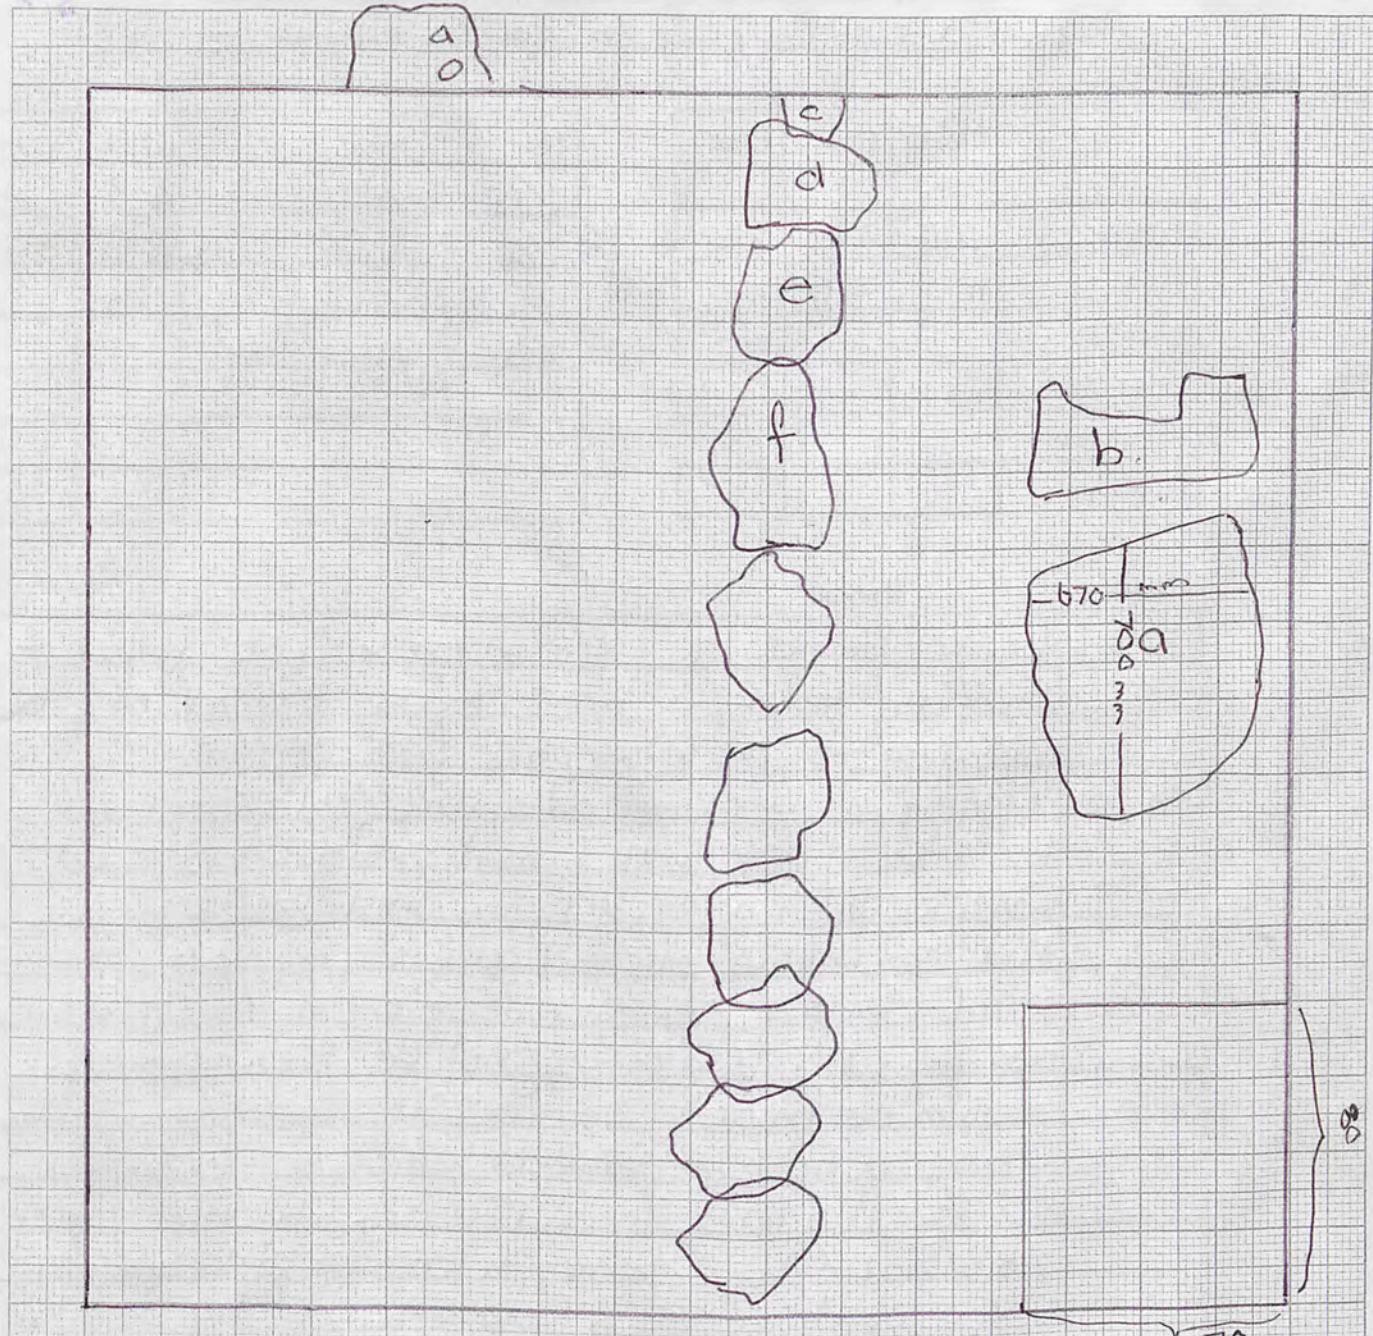
2.4	15.5.08 Eastern spit! heap along E bank removed by ± 40 cm along length of bank. Surface find A. A large square-ish rock, perhaps worked, has emerged in 2.4. Approaching the level of the floor in 2.4 from 'ab' - no floor in sight - snake's eggs x 5. Rain. Squarish rock a. dimensions See graph for location & drawing of basalt wine press (b) that emerged from the soft fill & tumble. This surface is extremely uneven & not at all conducive of taking levels yet, today. The large rock <sup>(a)</sup> 60 x 70 will be removed. It raises the issue of the location of the structure from which it came. Stones at the N end of the NS (mid) wall may need to be removed as they stand upon a softish 'ashy' glob that came away very easily & partly undercut the wall considerably & third (or fourth) phase wall. A 70 x 80 floor was left in situ at SE corner

14.5.08 backsight 0.350 (2.3) levels 2.3  
SW 2.5  
SE 2.41  
NW 2.34  
NE 2.3

15.5.08 backsight 1.45 (2.4)

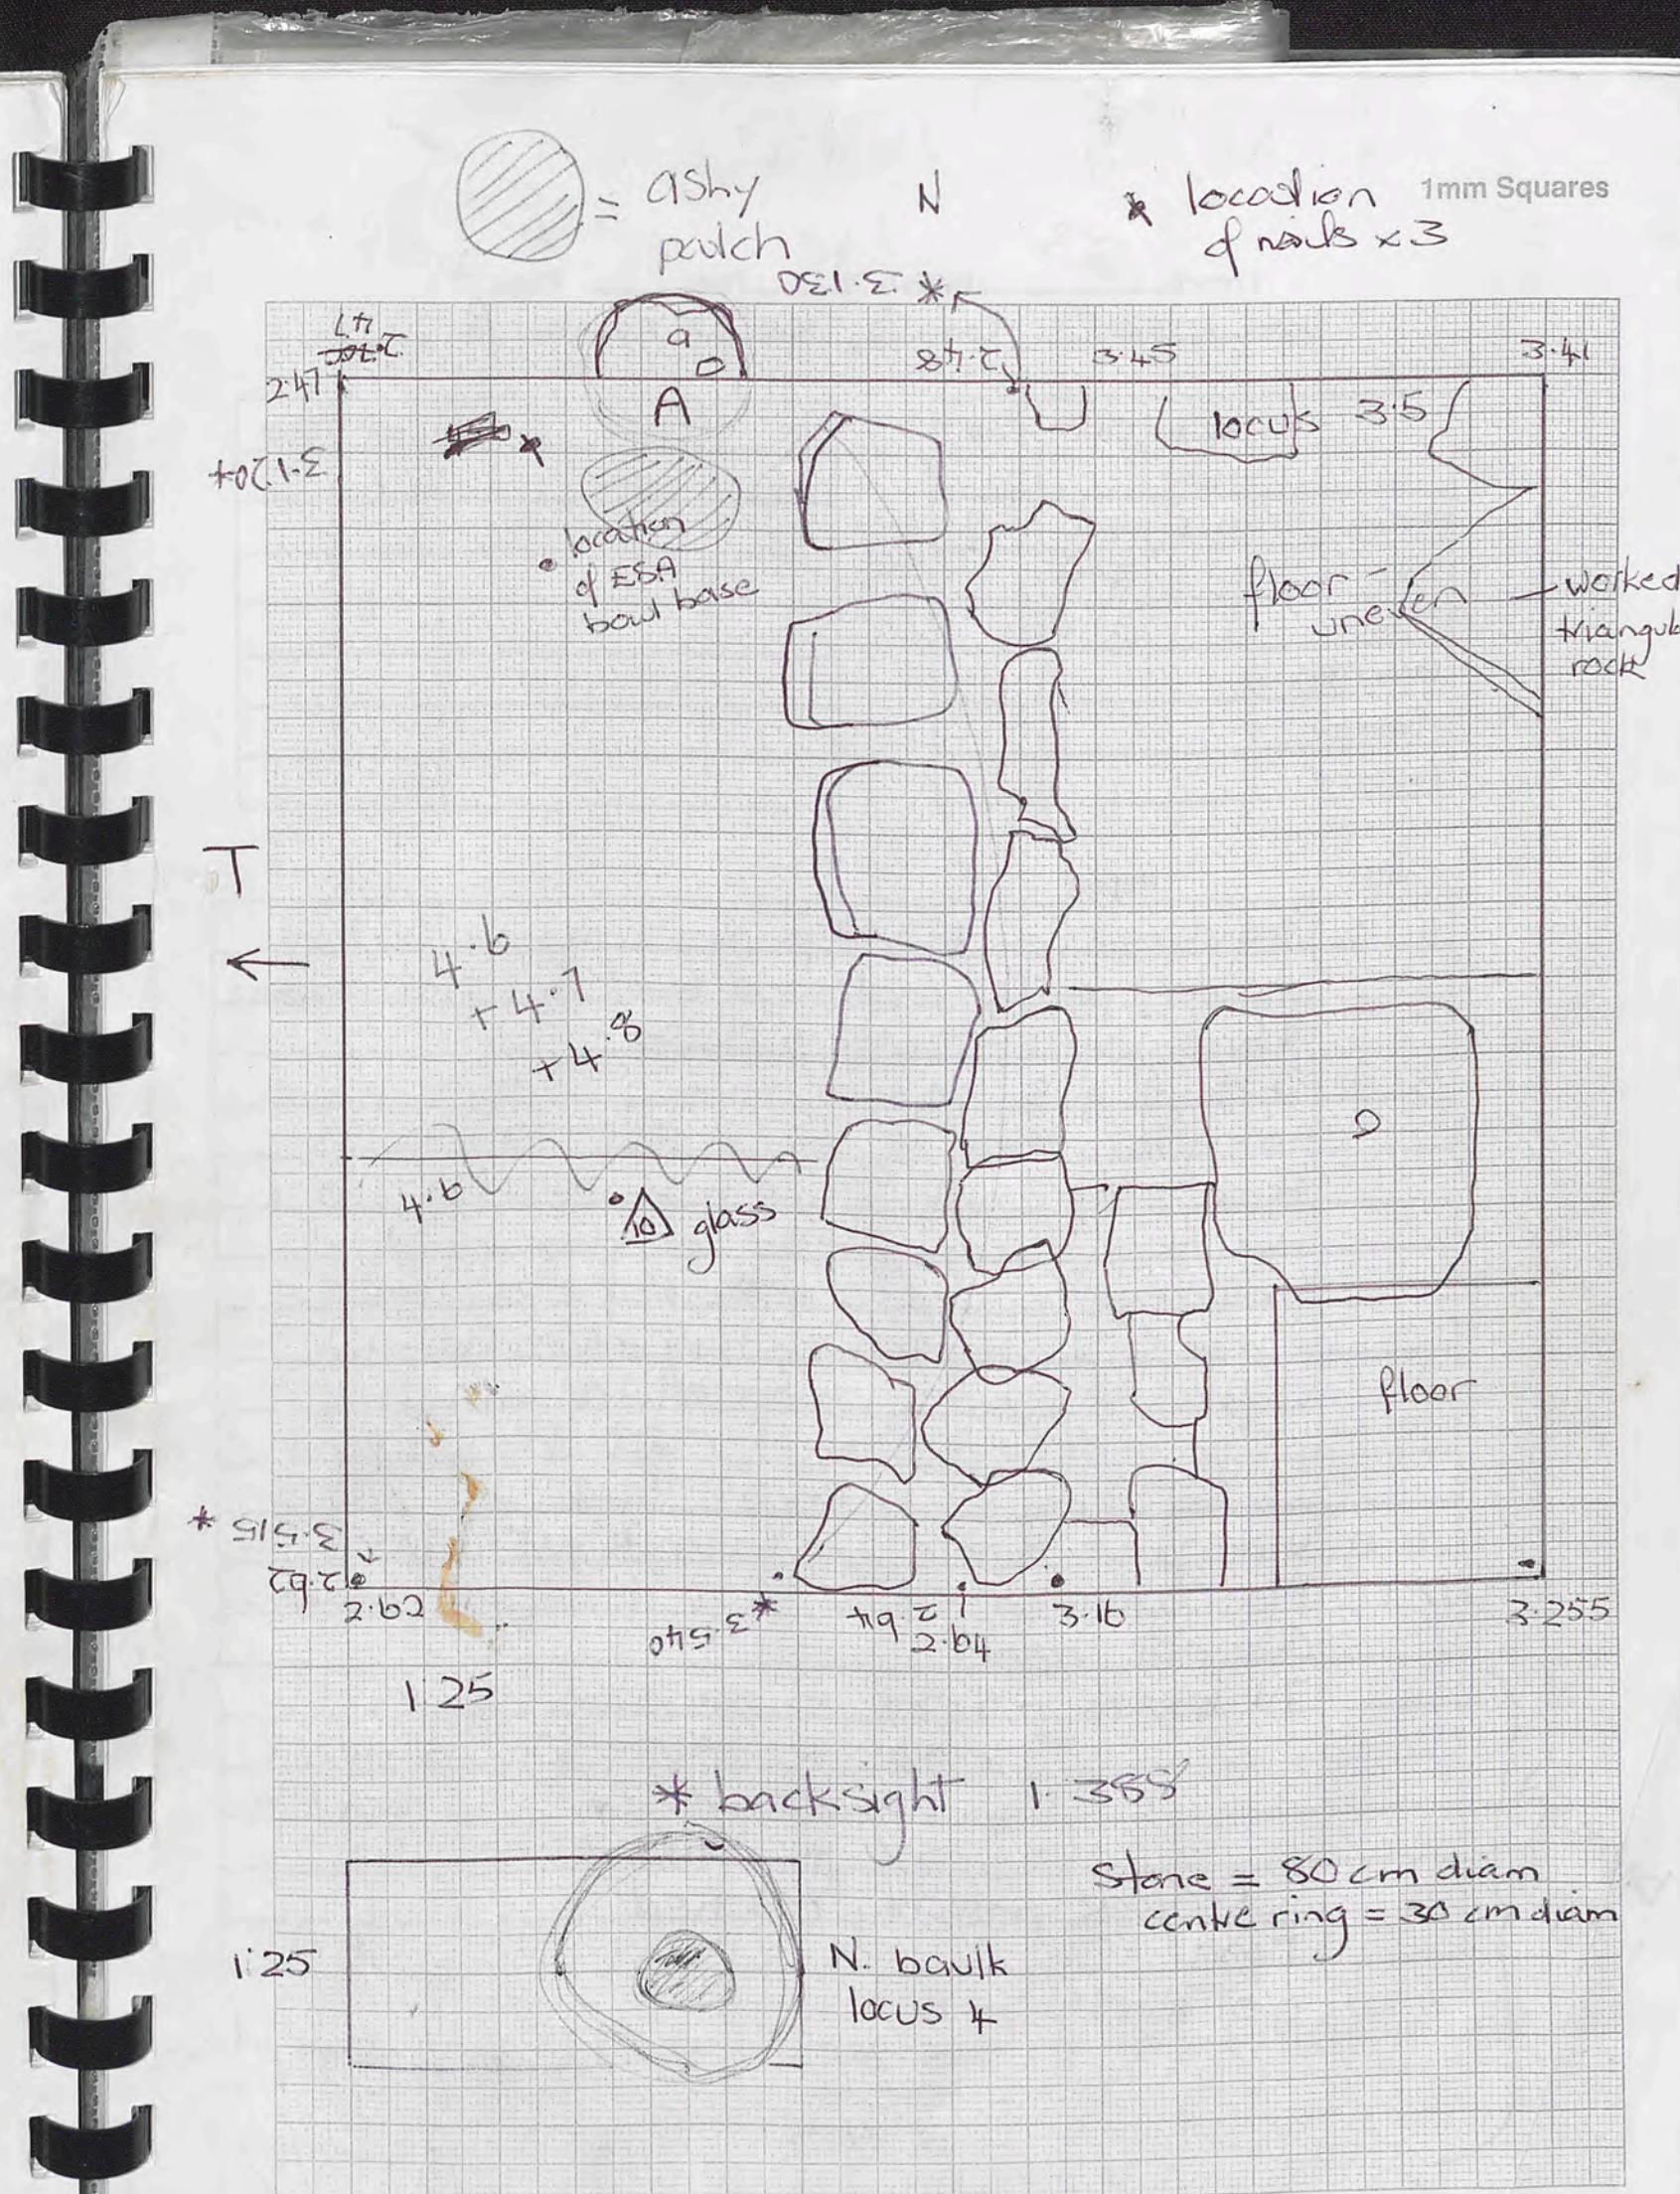
4.6	Digging commenced at surface (-1) - stones fill W. side of NS Wall in mid trench is being clarified.
4.7	Continuation of leveling in W ½ of trench. Mid (NS) wall has emerged as a poorly-built 2mtry of testaceous wall of 2 courses built on a floor that was not found - dug thru (3.5) the floor cannot be seen in the balk. The wall is bowed. A piece of Eastern sedulata was found - indicates this level is less than 150 BC. A piece of green glaze rim (a.) Stone a. emerged as circular with a pounding circle in the centre. Ashy patch 30 cm in front of stone.

4.8	Continuation of leveling context 4. 3 nails found. Stoney tumble + soft fill. Dish near circular stone = nails in this area. As floor appears to be absent, I measured the levels in T-W at 2 points: i below steps - bottom level of steps ii floor level of large, placed, stones rectangular

NS wall appears to be of one course only - the uppermost. i 3.970 It is laid on tumble + fill - ii 3.840 very unstable, can't be swept. iii 4.220

Stone = 80 cm diam  
centre ring = 30 cm diam
