Area S Photographic record 1989-1995 - from field notes

**JEBEL KHALID**  
DOMESTIC QUARTER • GROUND PLAN 1996

JEBEL KHALID  
STOA

GROUND PLAN 1993

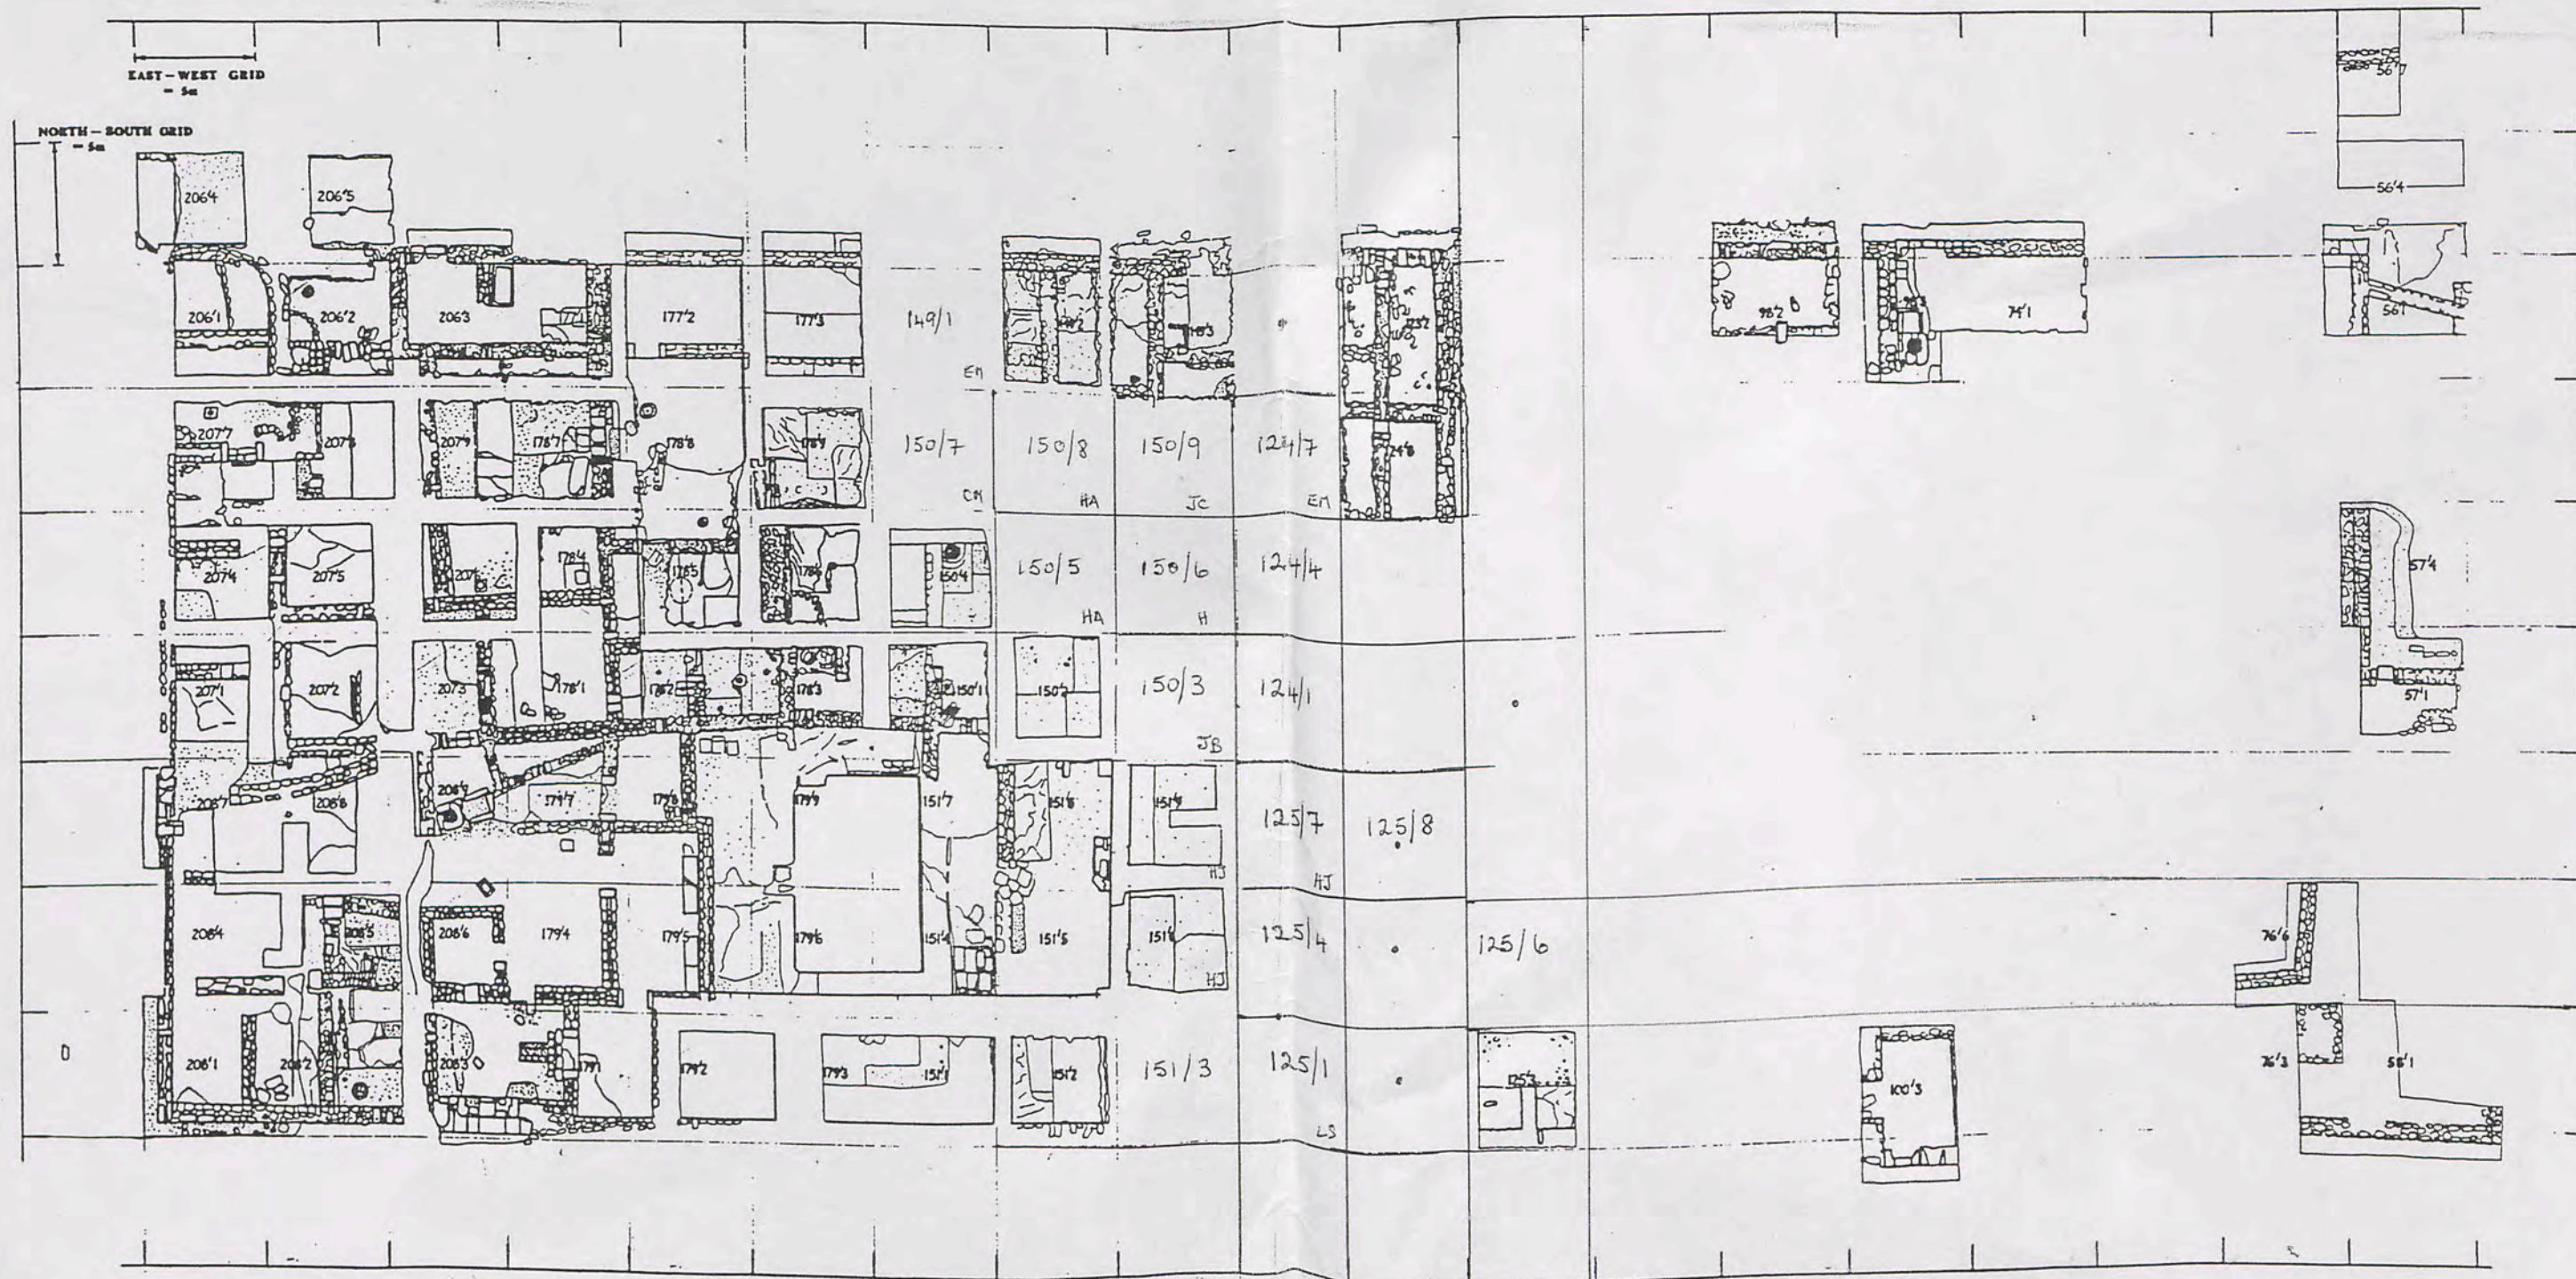
+ NEW TRENCHES 2000

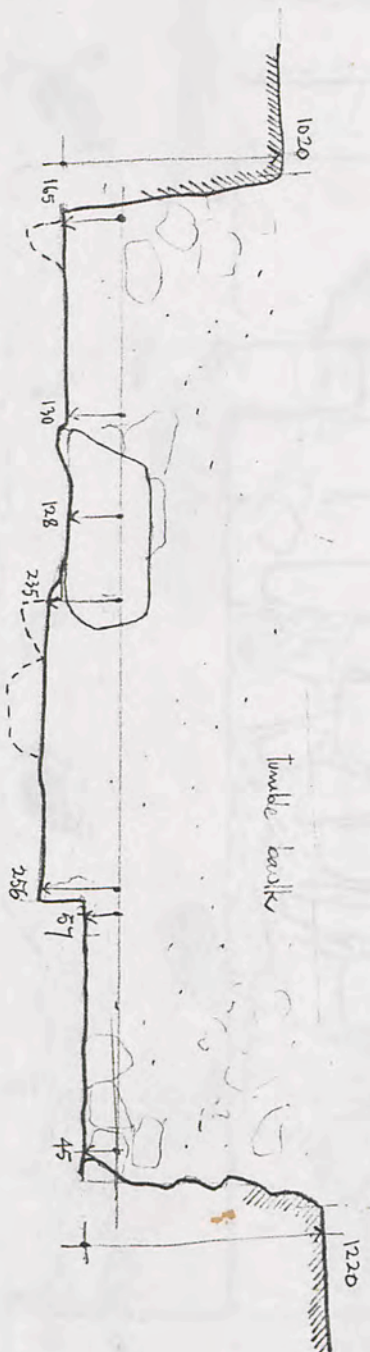
SECTION A-A.

STOA      T332/2      Oct 4 1995

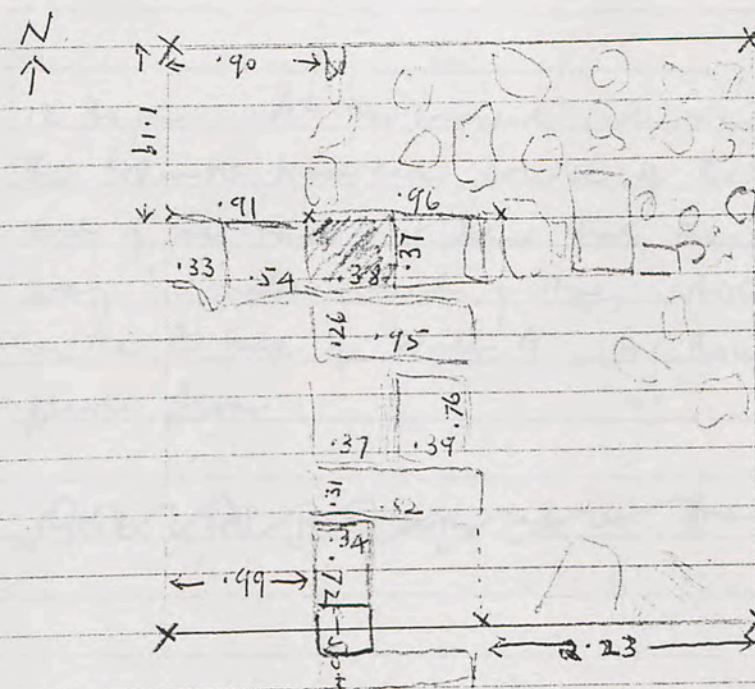
364/9

4m x 4m

9 m.  $\phi$  of tangle Roll 6, 17-25

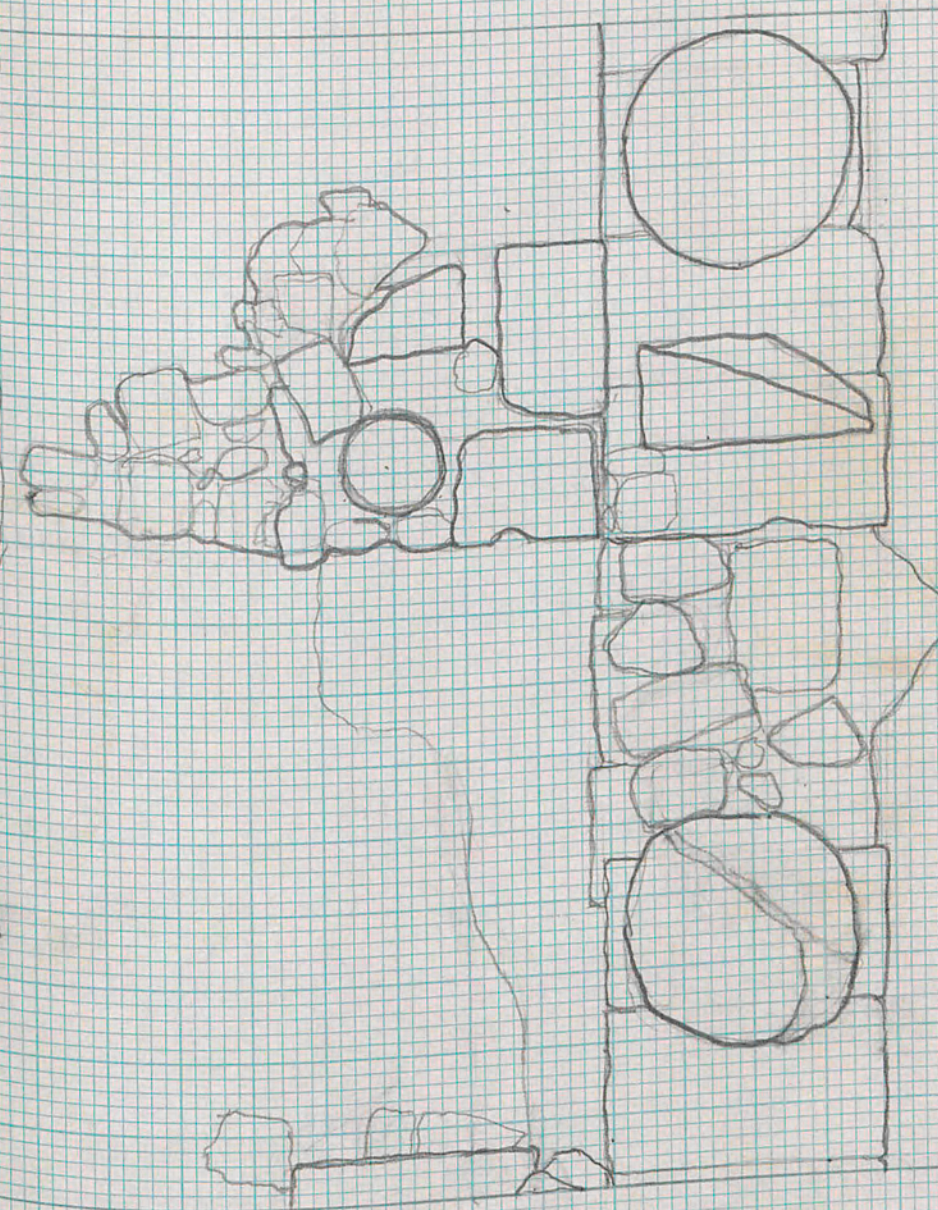
NOTE THAT THIS DRAWING HAS MISSED  
1 METRE FROM ITS EAST END - NO  
FEATURES IN THIS AREA

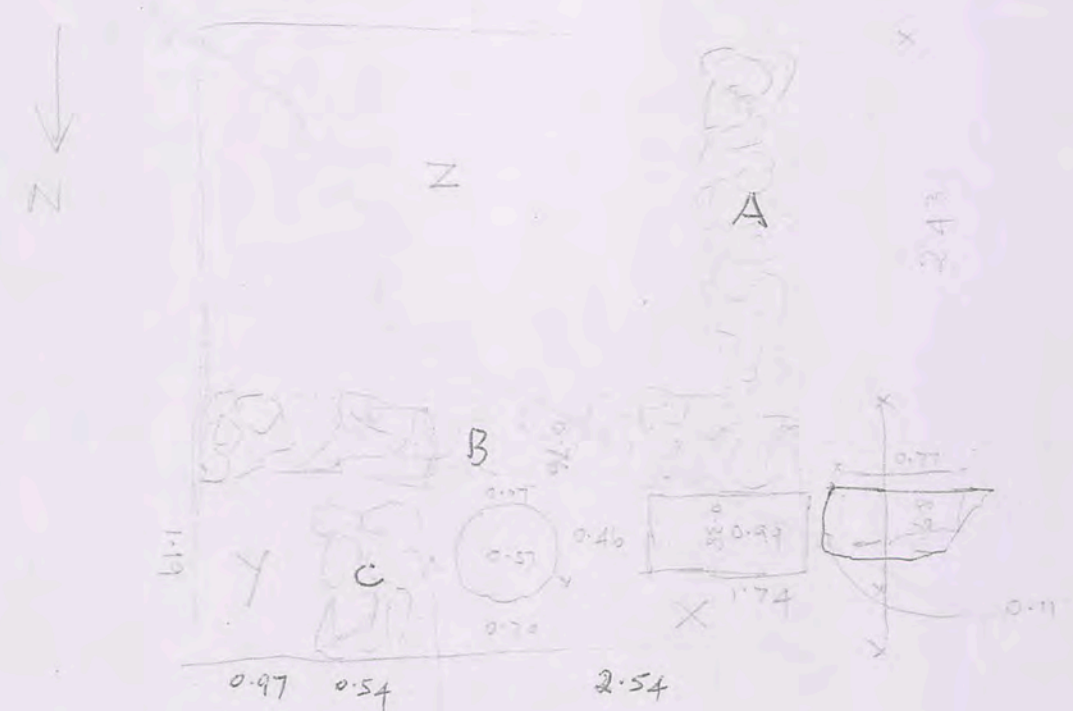
The tanour rests in the corner of the room and is very close to the soil surface. In wall C there is only one full course of stones above the tanour. It is 0.43 m down from the soil surface.

gray soil in tanour + round it

0.12 wall 20  
tanour 70 0.07-0.08 m wide

Work in the NW corner of the trench (= Area X of sketch of 23.5.90) has revealed a tanour close to wall C. There are several burnt bones from inside the tanour which are kept separate. There is also a small flag of bronze from just to W of tanour.

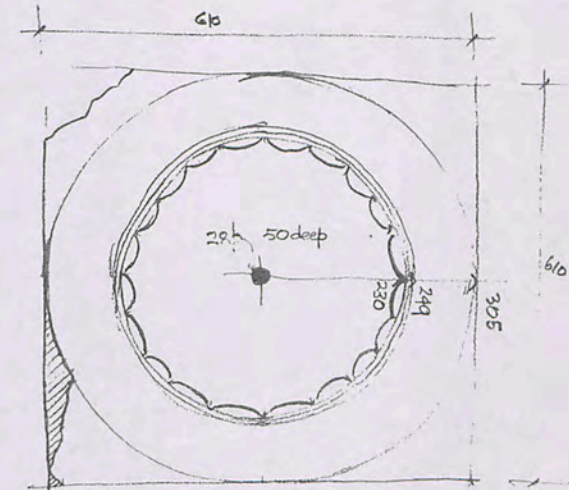
JR STOA Sept. 93.  
COLUMN CAPITAL: T 364/7

T 364/7 - (sta 2.1) ? Sept. '93. diam approx 610. % height = 214

- has one corner abacus broken - was in good condition.
- has 3 necking rings, each a much more rounded profile.
- has 120 flutes

- ① (very similar) - Capital T9-3 Abu Ibrahim's Stone. 3 identical necking rings and flutes abacus 740 sq. (smaller) height = 243.
- ② Fragment. capital T16. but smaller. 3 necking rings flutes. height = 230
- ③ Fragment - T27 - 3 necking rings + flutes - height 390, and width 380

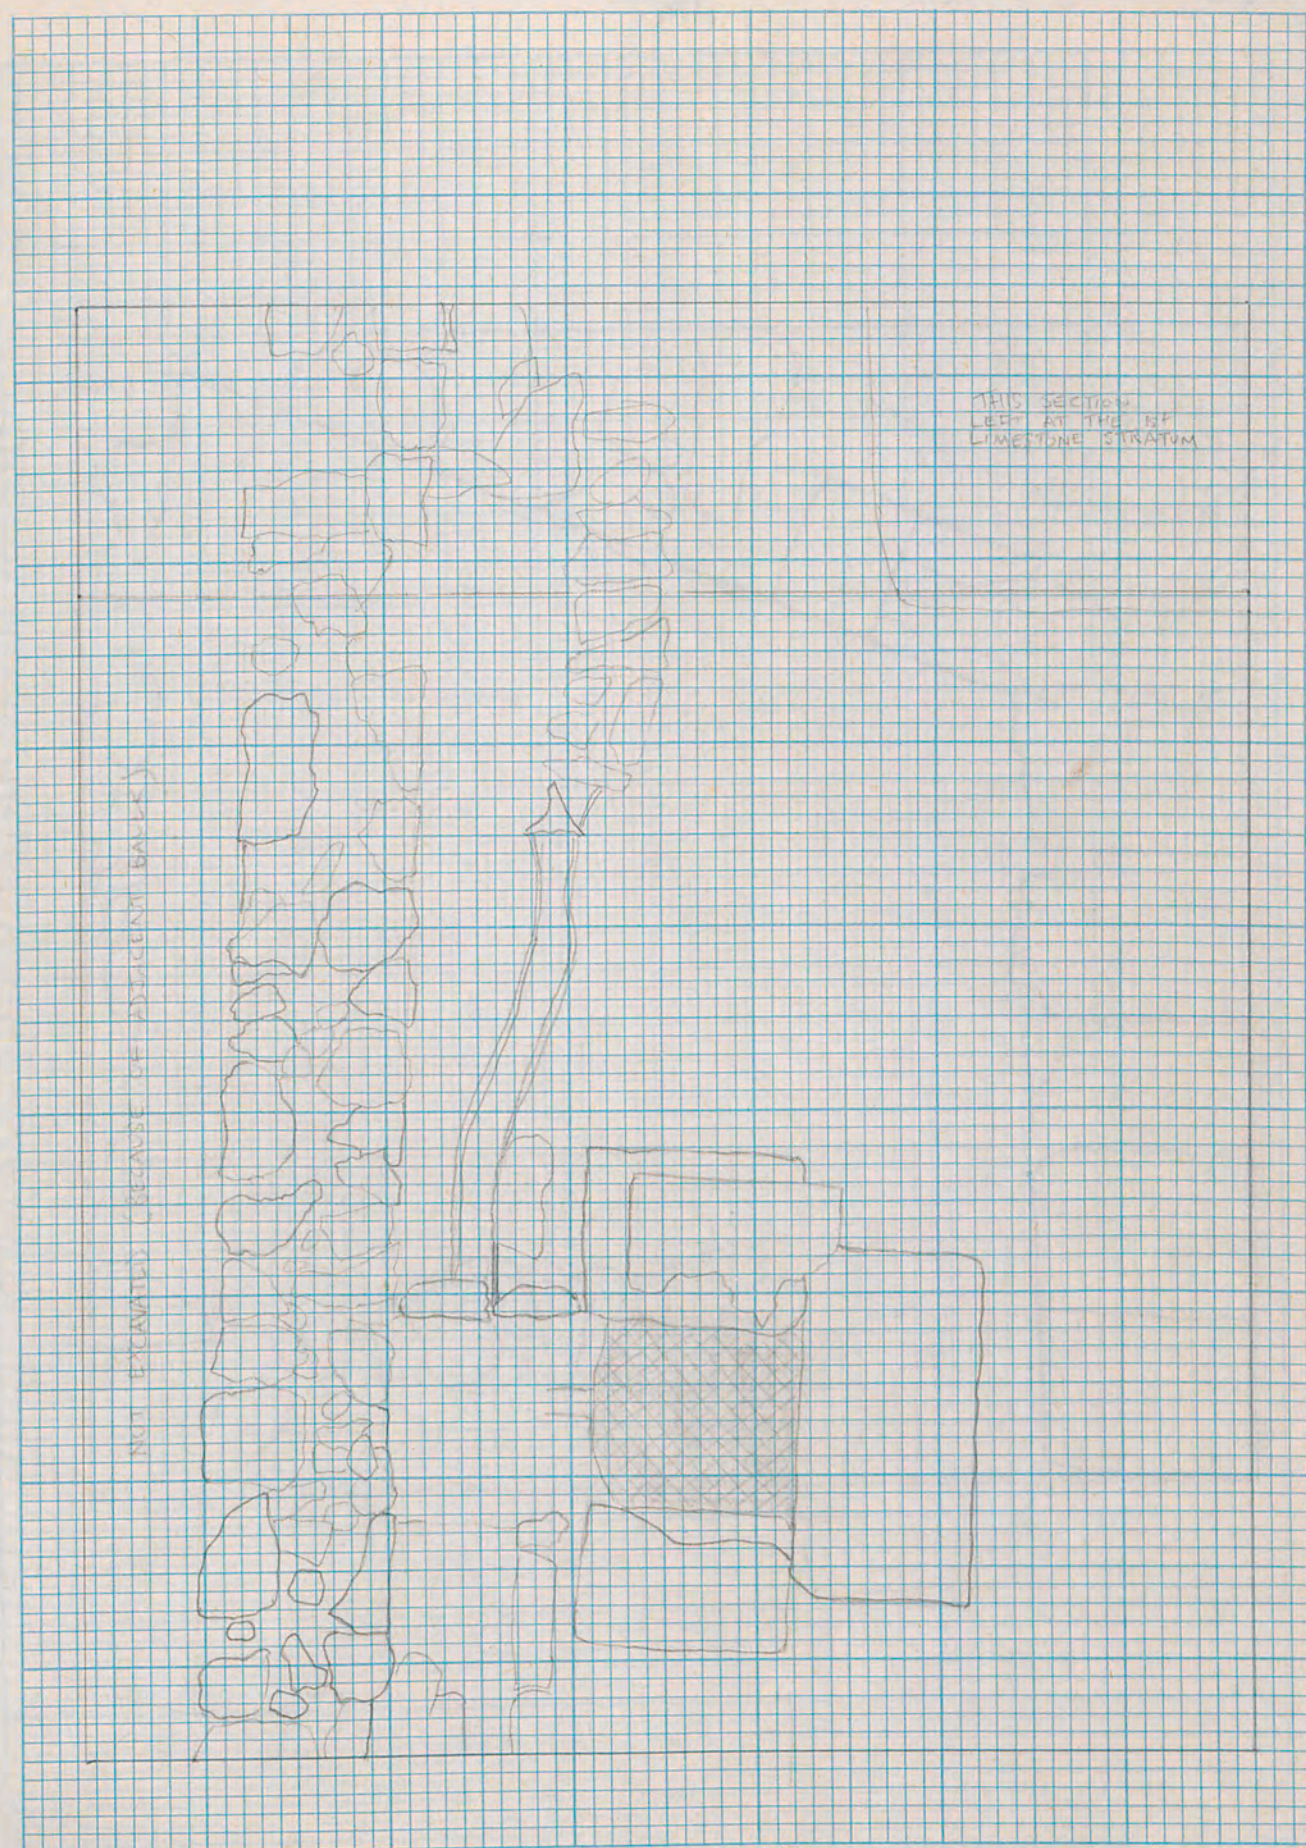
THIS SECTION LEFT AT THE TOP OF LIMESTONE STRATUM

NOT EXCAVATED (BECAUSE OF ADJACENT BANK)

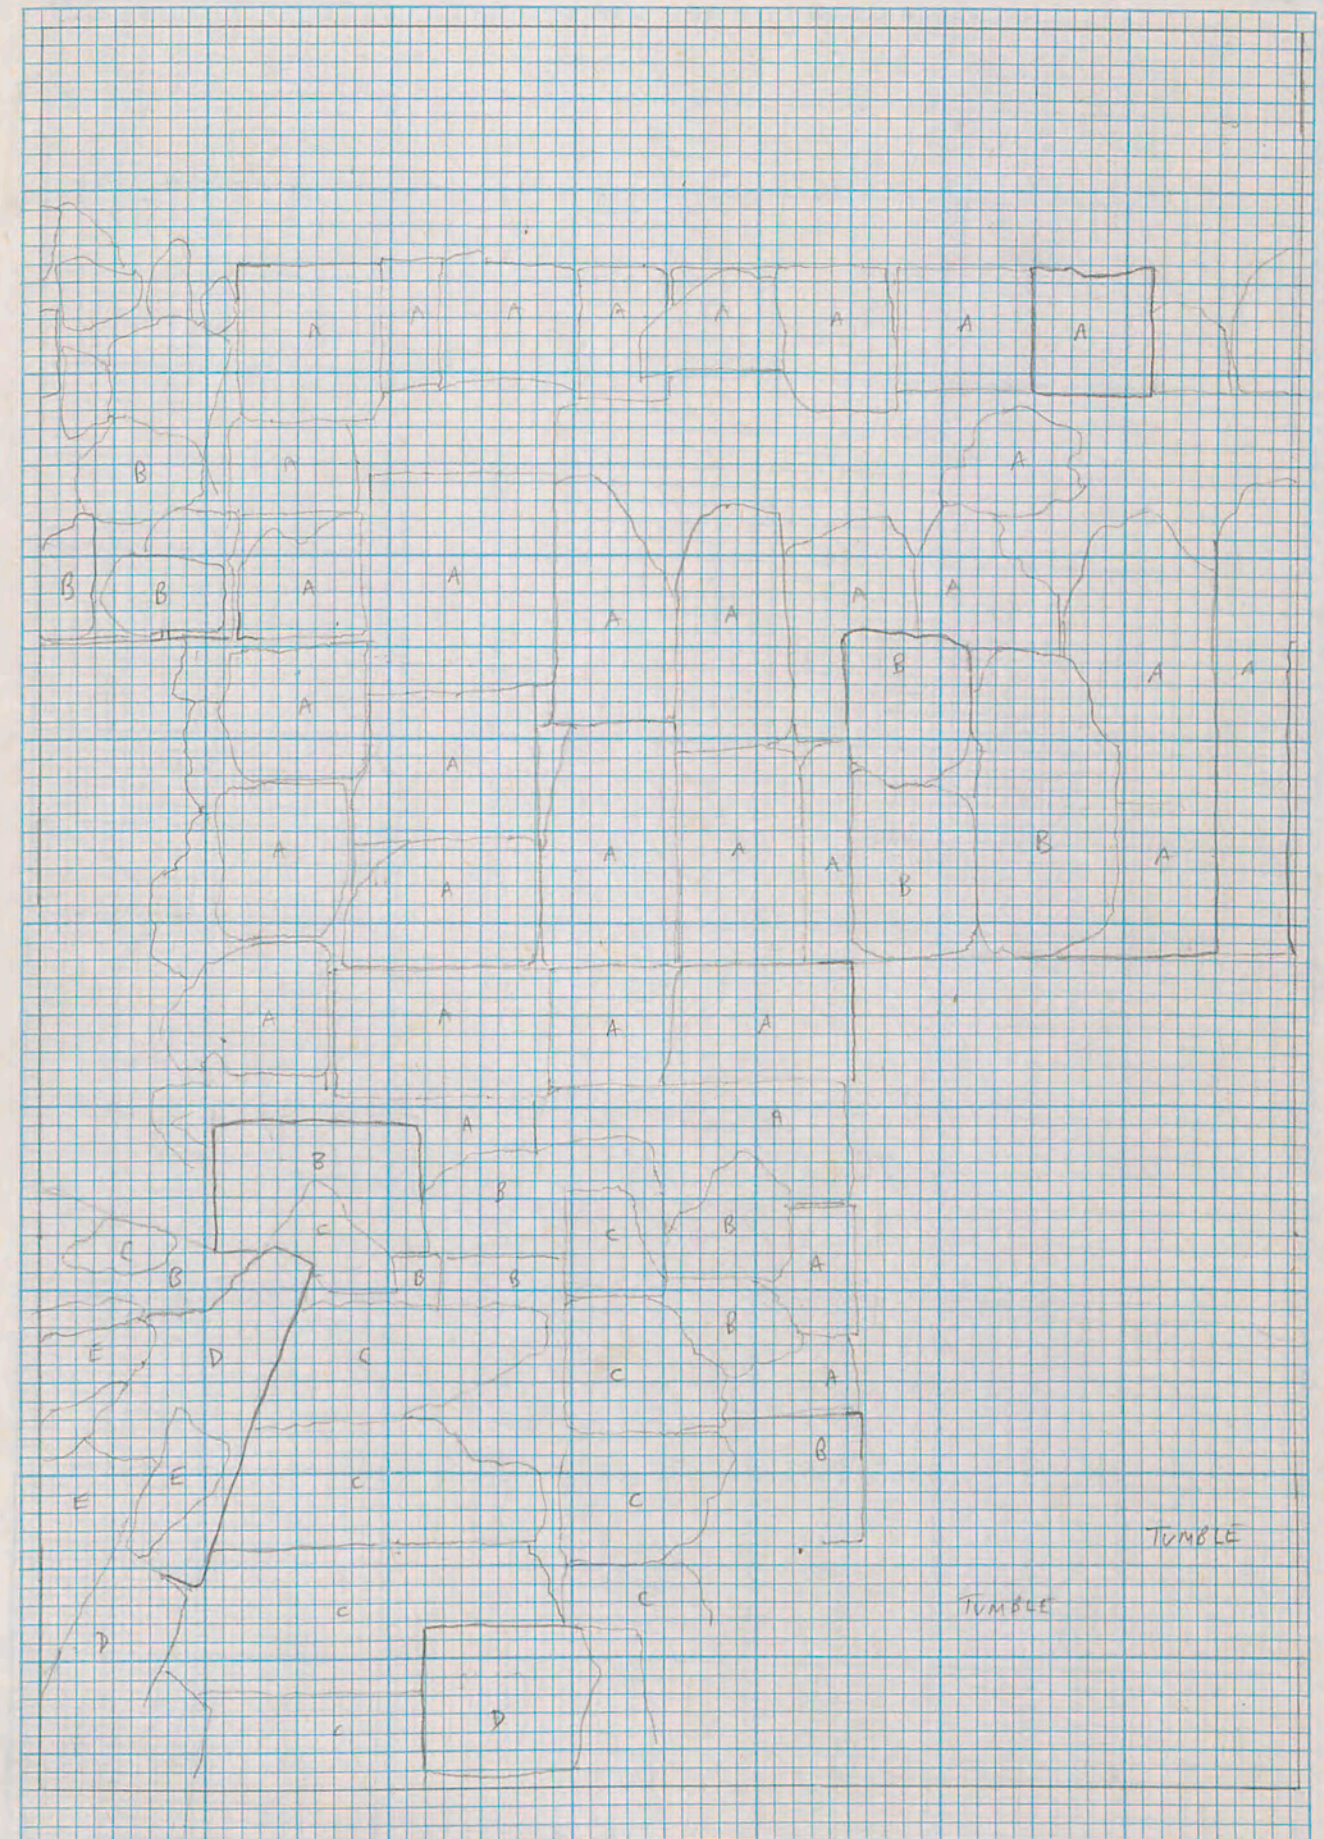
A = lowest E = highest contour.

1:300
