Jebel Khalid

Field Record Book

Name..... G.W. Clarke
Trenches..... Area B 7, B 15, B 16, B 18
.....
Dates..... April 23, 2001 —

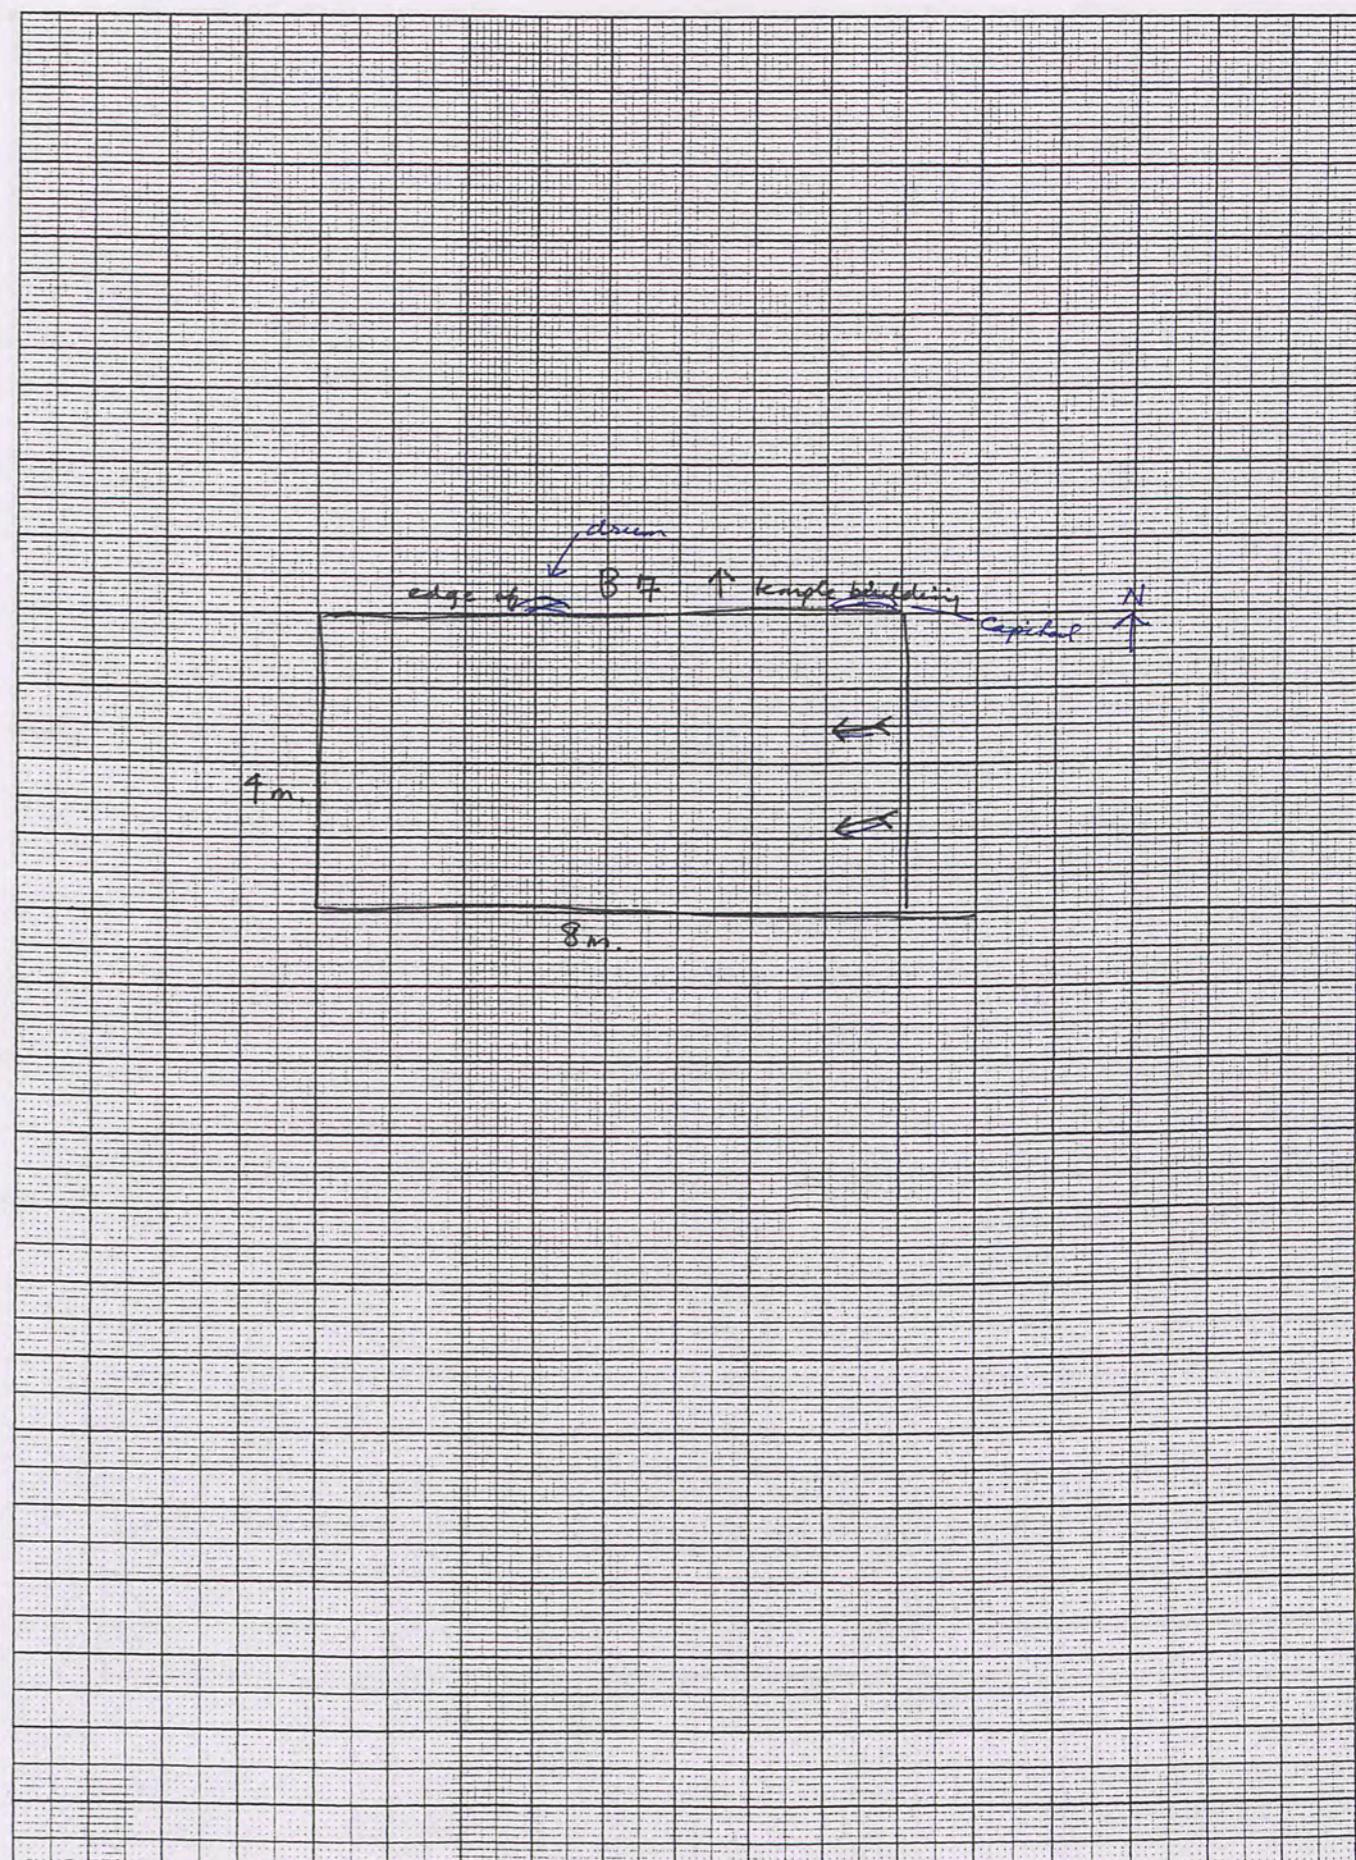
Clearing top soil thrown up from robbing activities and loose stones. Won't be much to show for the day. Usual chaos + not enough rakes/hands to go around. But below the initial wind-blown dust are stones from tumble. We should just take out from the whole 8x4m trench the first spit level. Below are visible in the N. bank a column capital and column drums. The soil is light + dusty. At 24/4/01 we clear the remaining level 1.1 at the western end + then will do a second spit throughout the trench from the east. On this second spit there is a lot of loose tumble + the soil is darker + more solid. But the stones are rubble with little left in the way of worked surfaces. A small amount of non-descript pottery is also coming up, likely to be alluvial from further to the West. A third spit has produced at eastern end 1.3.3, a metal pin frag - as well as a lot of tumbles + 1.3.4 a glass frag.

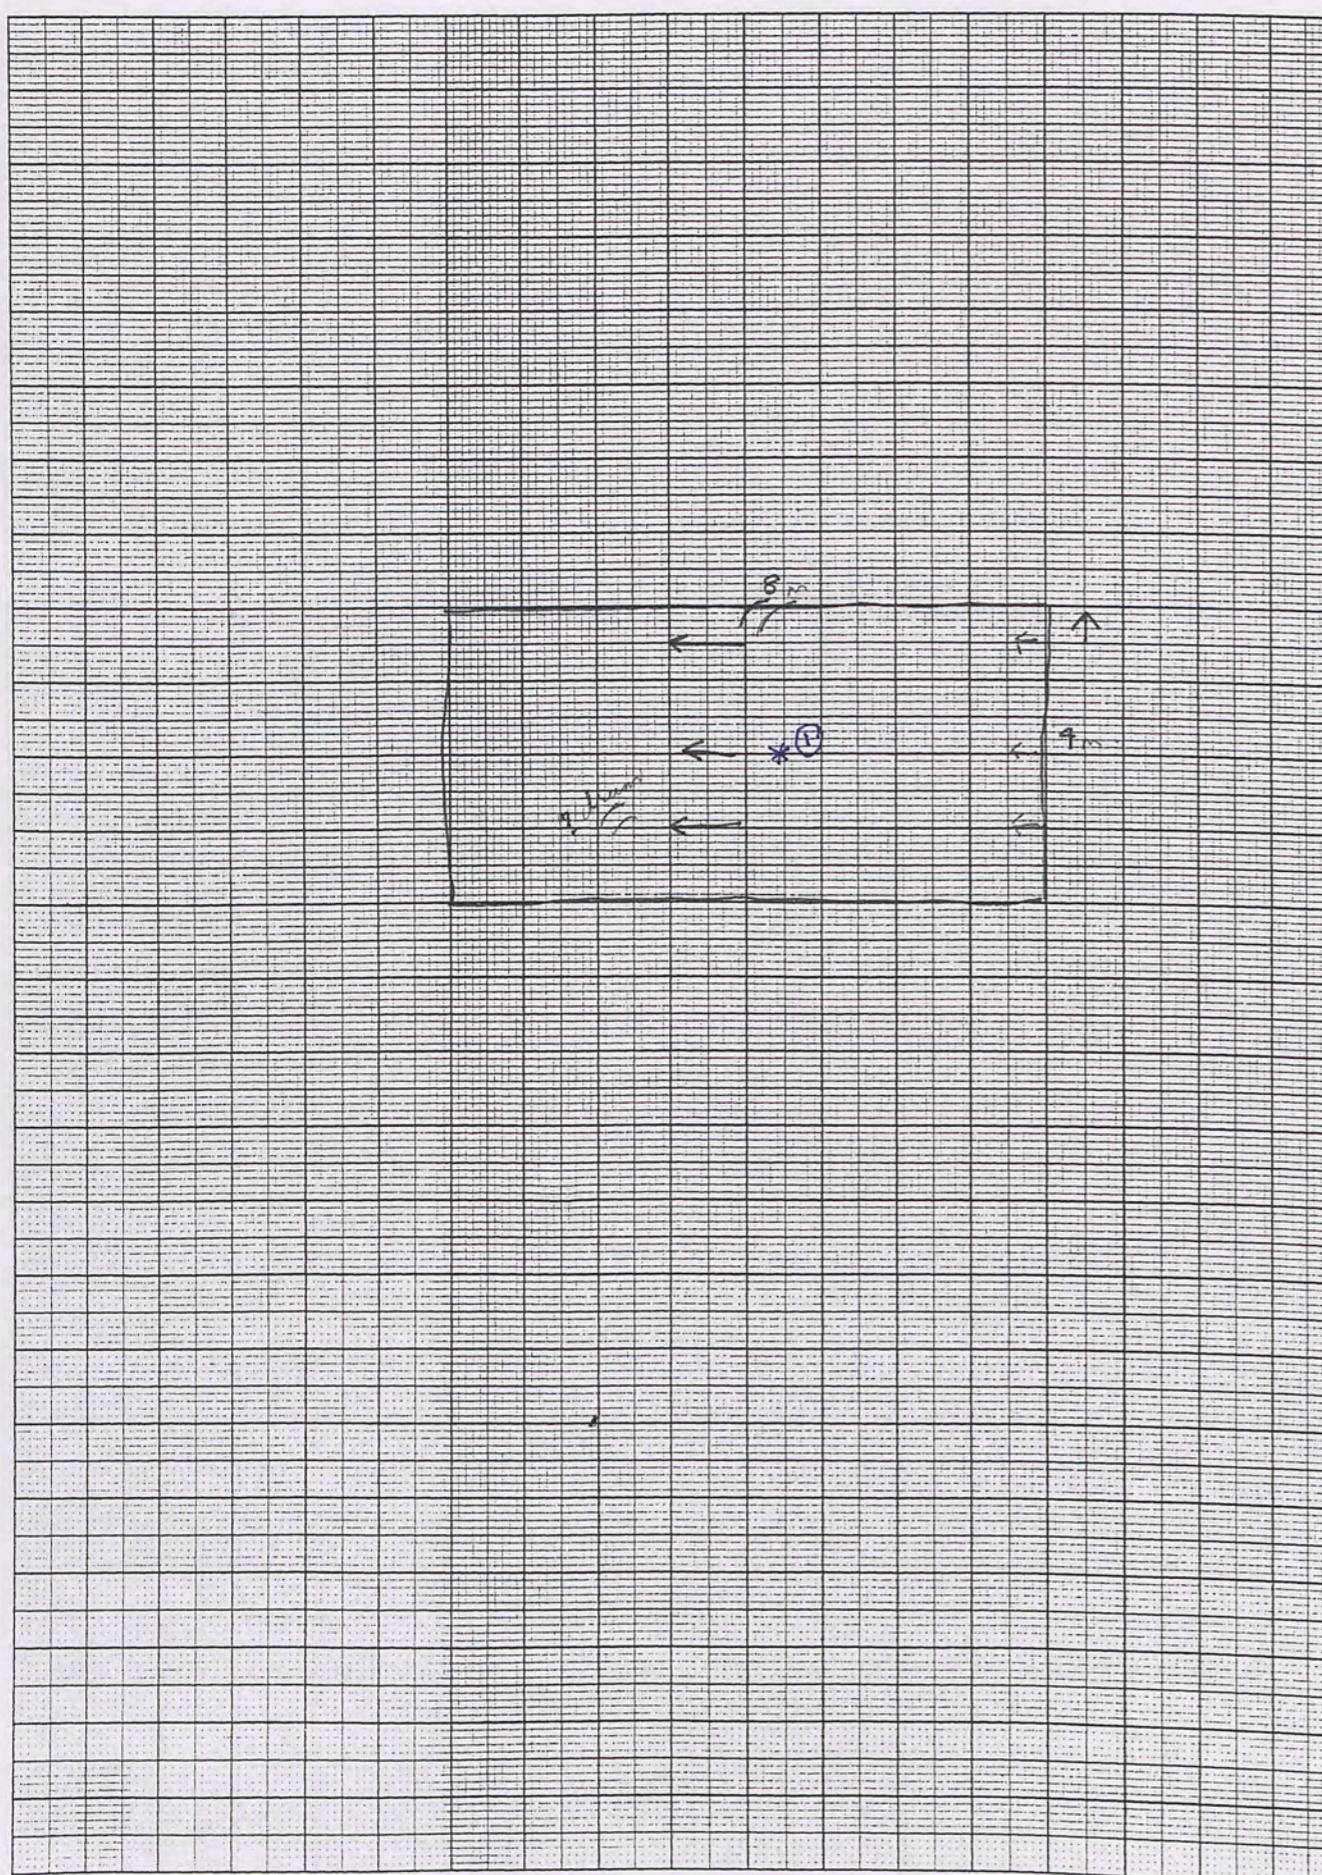
Trench... B7..... Initials... GWC..... Date... 25/4/01 Page... 01
Focus..... Spit... 3..... Locus..... Spit... 4.... Feature/s.....

As we get down to architectural pieces I'll call this new spit run locus 2, spit 1, starting from the eastern end. We should get more in the way of tumb - - hopefully ideas for the missing architectural details. Locus 2 starts at c. 650 from topsoil level. Small metal strip is object 1, at eastern end, Object ② is a glass rim in mid-trench, piece of marble (?slight) object ③, plus another marble piece (? part of finger).

We go through once more from east to west, encountering some very ash deposit at the eastern end with associated bone + broken pottery. We are now c. 60cm from topsoil. A nail + metal frags have come up at this level in mid trench towards eastern end. A column drum emerging in the east bank also. Glass frag. is object (2) by 5 bank, mid-trench. A triglyph block, much battered, has come up in mid trench. On 29/4/01 we finish off Spit 2 at the western end + then start up again from the east with Spit 3 at depth of 830 from topsoil (at SE corner). We still have quite a depth of soil to go, especially at the western end from which a great deal of tumbled stones, some with worked sides, have come up. 2.3 is producing more in the way of worked material & the next spit through should see features emerging of the worked stone. A piece of column capital with triple recking ring has come up, along with a late coin (Byz.? Arab?) on the north bank 2.3.(4). A large collection of ? human bones beneath the triglyph + melepe block.

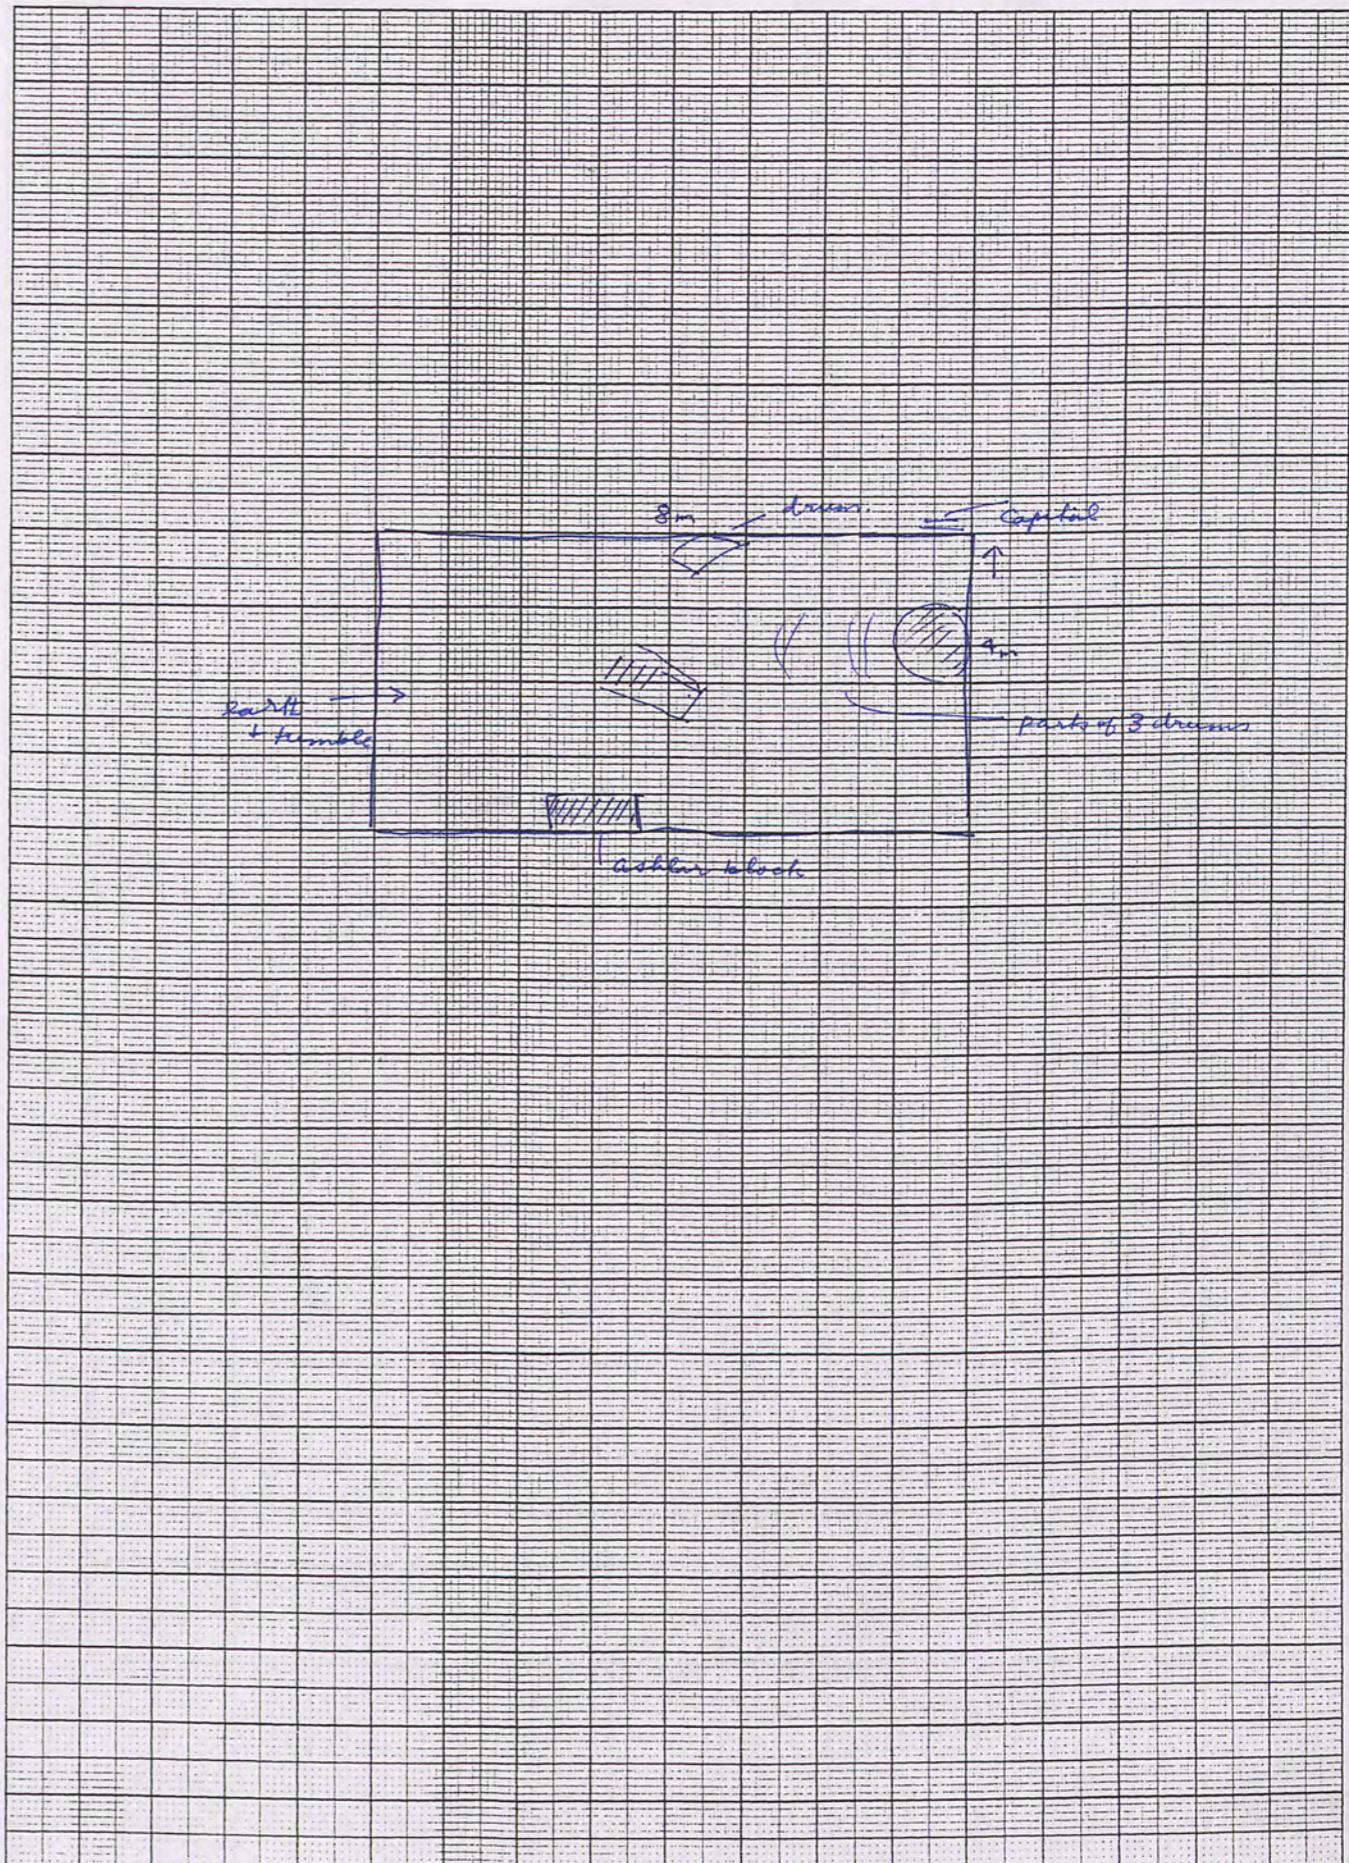
We clear 2.3 at the western end before starting locus 3, which should reveal more of the architectural pieces. A tiny glass bead is object ①, a metal ? rail, object ②, from W. end of spit 3. The dirt is soft + sandy-like but not much in the way of crushed limestone. We may not get much further information. There are a number of worked stones among the tumble but without definition except for a frag. of a capital showing triple necking rings and a triglyph frag. with a fragment of metope. Anxious that no significant marble pieces may have been discarded in error.... In the W. end little but earth + tumble but a great deal of pottery.

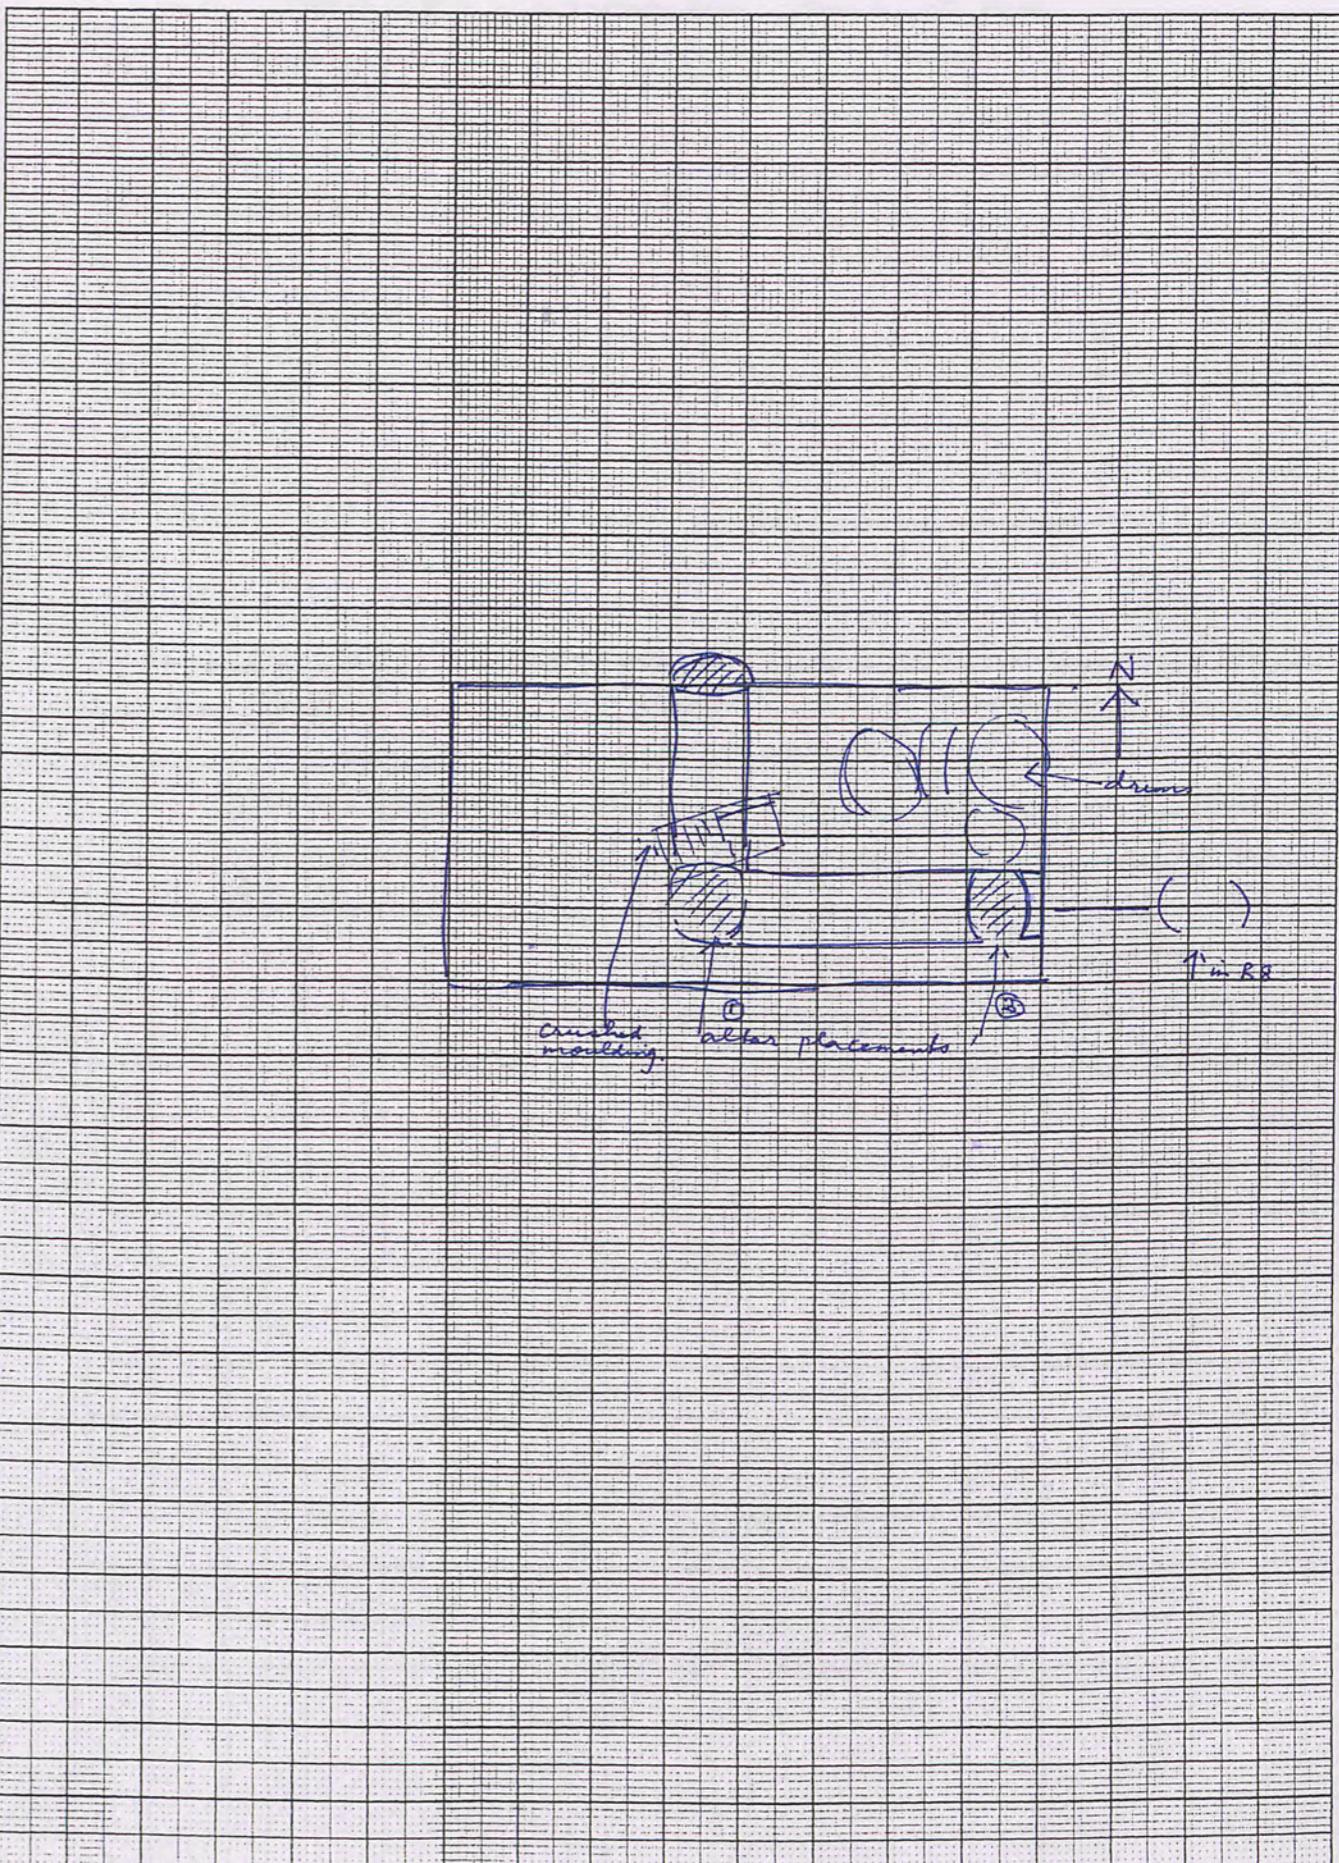
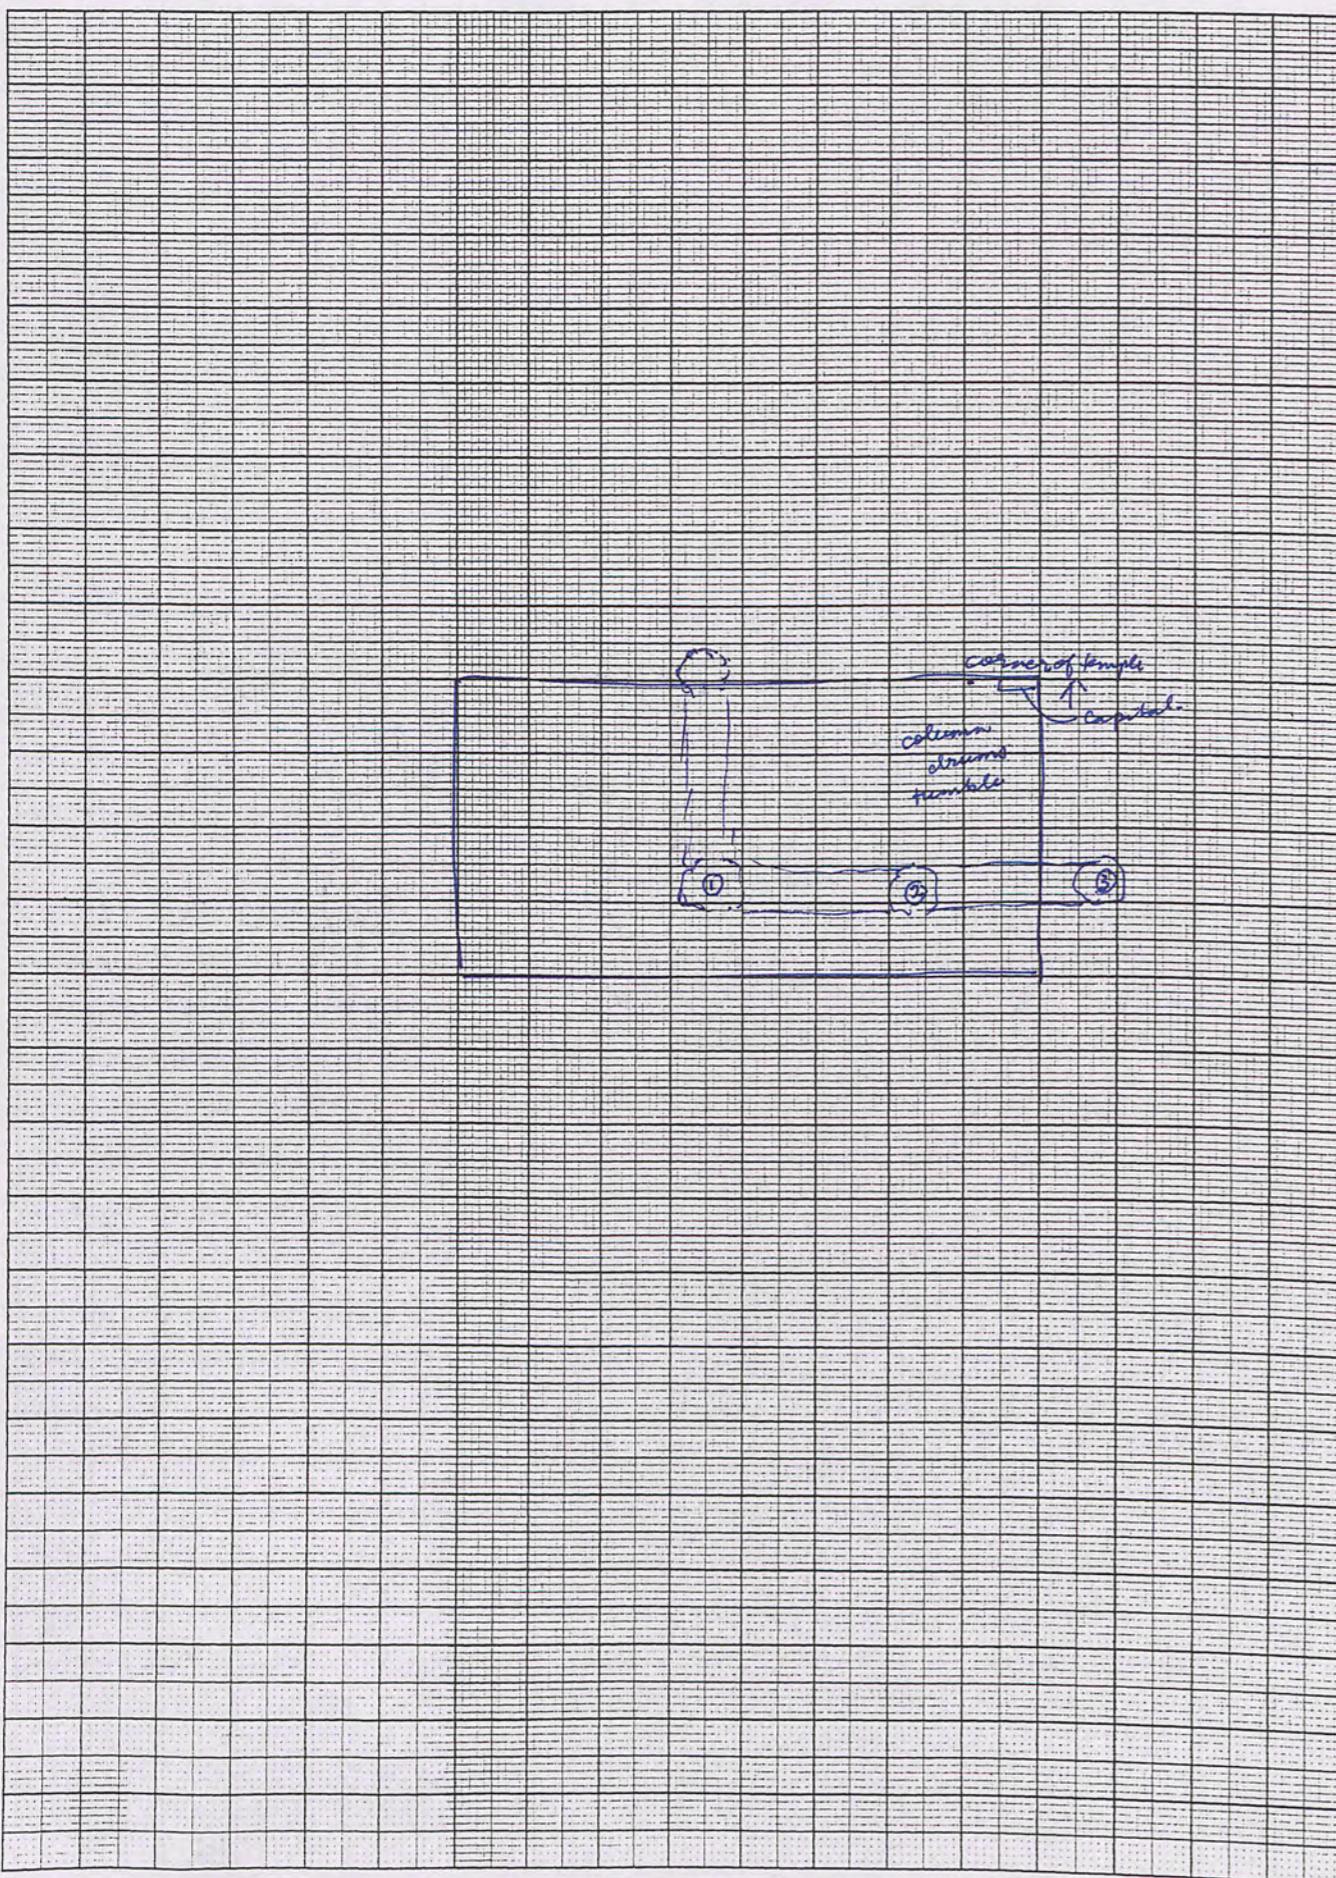
Context	Report
	After overnight rain, clearing to floor level through the mud. A sixth altar emplacement came up at the end of yesterday. Not clear yet that the "stylobate" continues southwards into the hulk. A worked stone adjacent to the metope/triglyph has unfortunately crumbled; likely to be cornice moulding from appearance. The presumed "perimeter" wall appears to continue westwards from B8 trench to the east, at the east of this a small heap of metal slug has appeared - probably to be associated with the ashy layer & burnt pottery found earlier in the same location. Unclear how the "perimeter" wall + the altar will adjoin. Weather continues cold & windy. Another altar place appears also on the S side! A frag. frag by altar ③.
01. 139

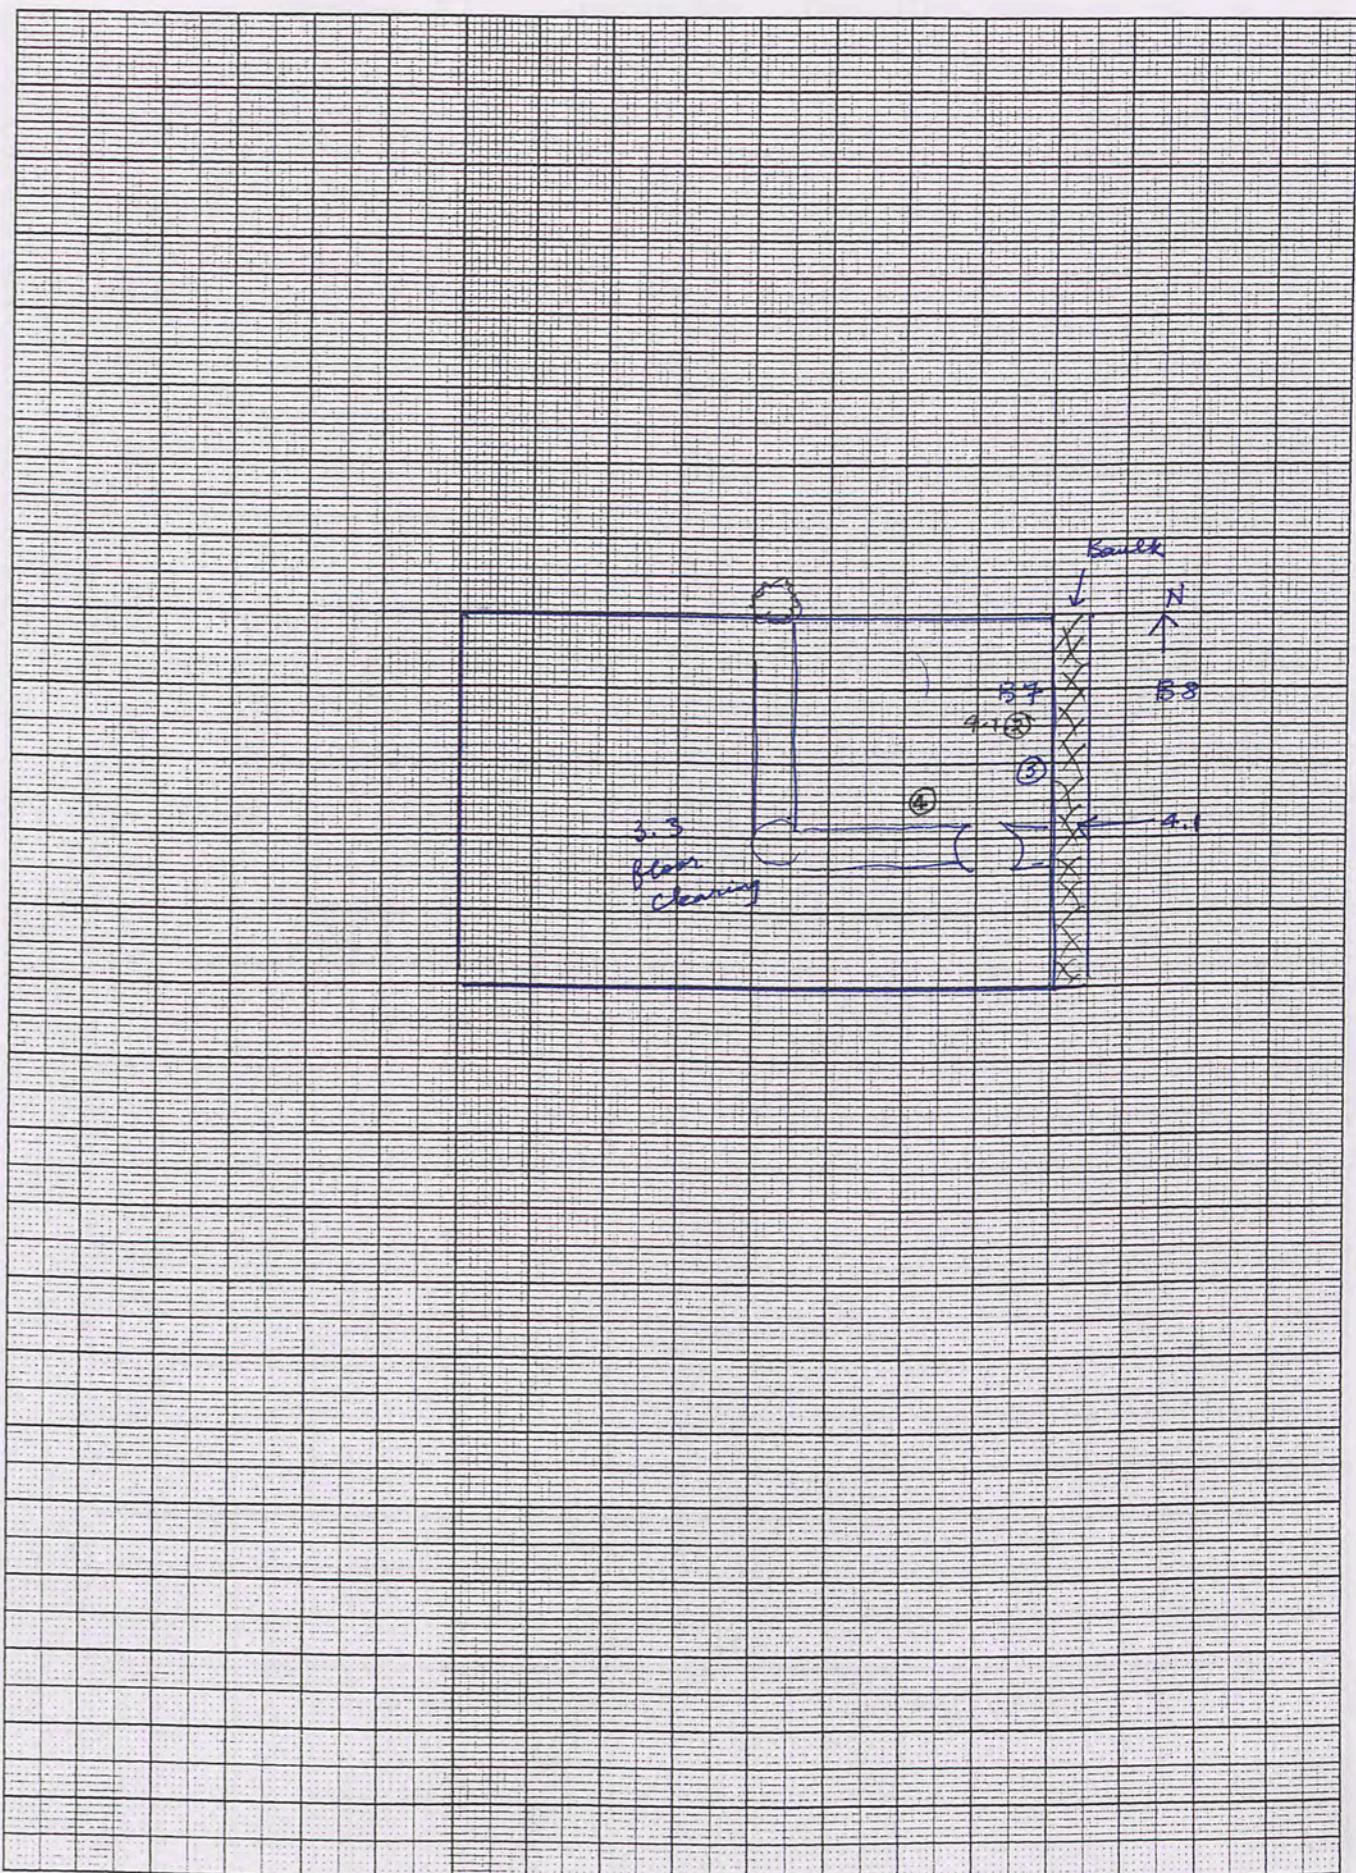
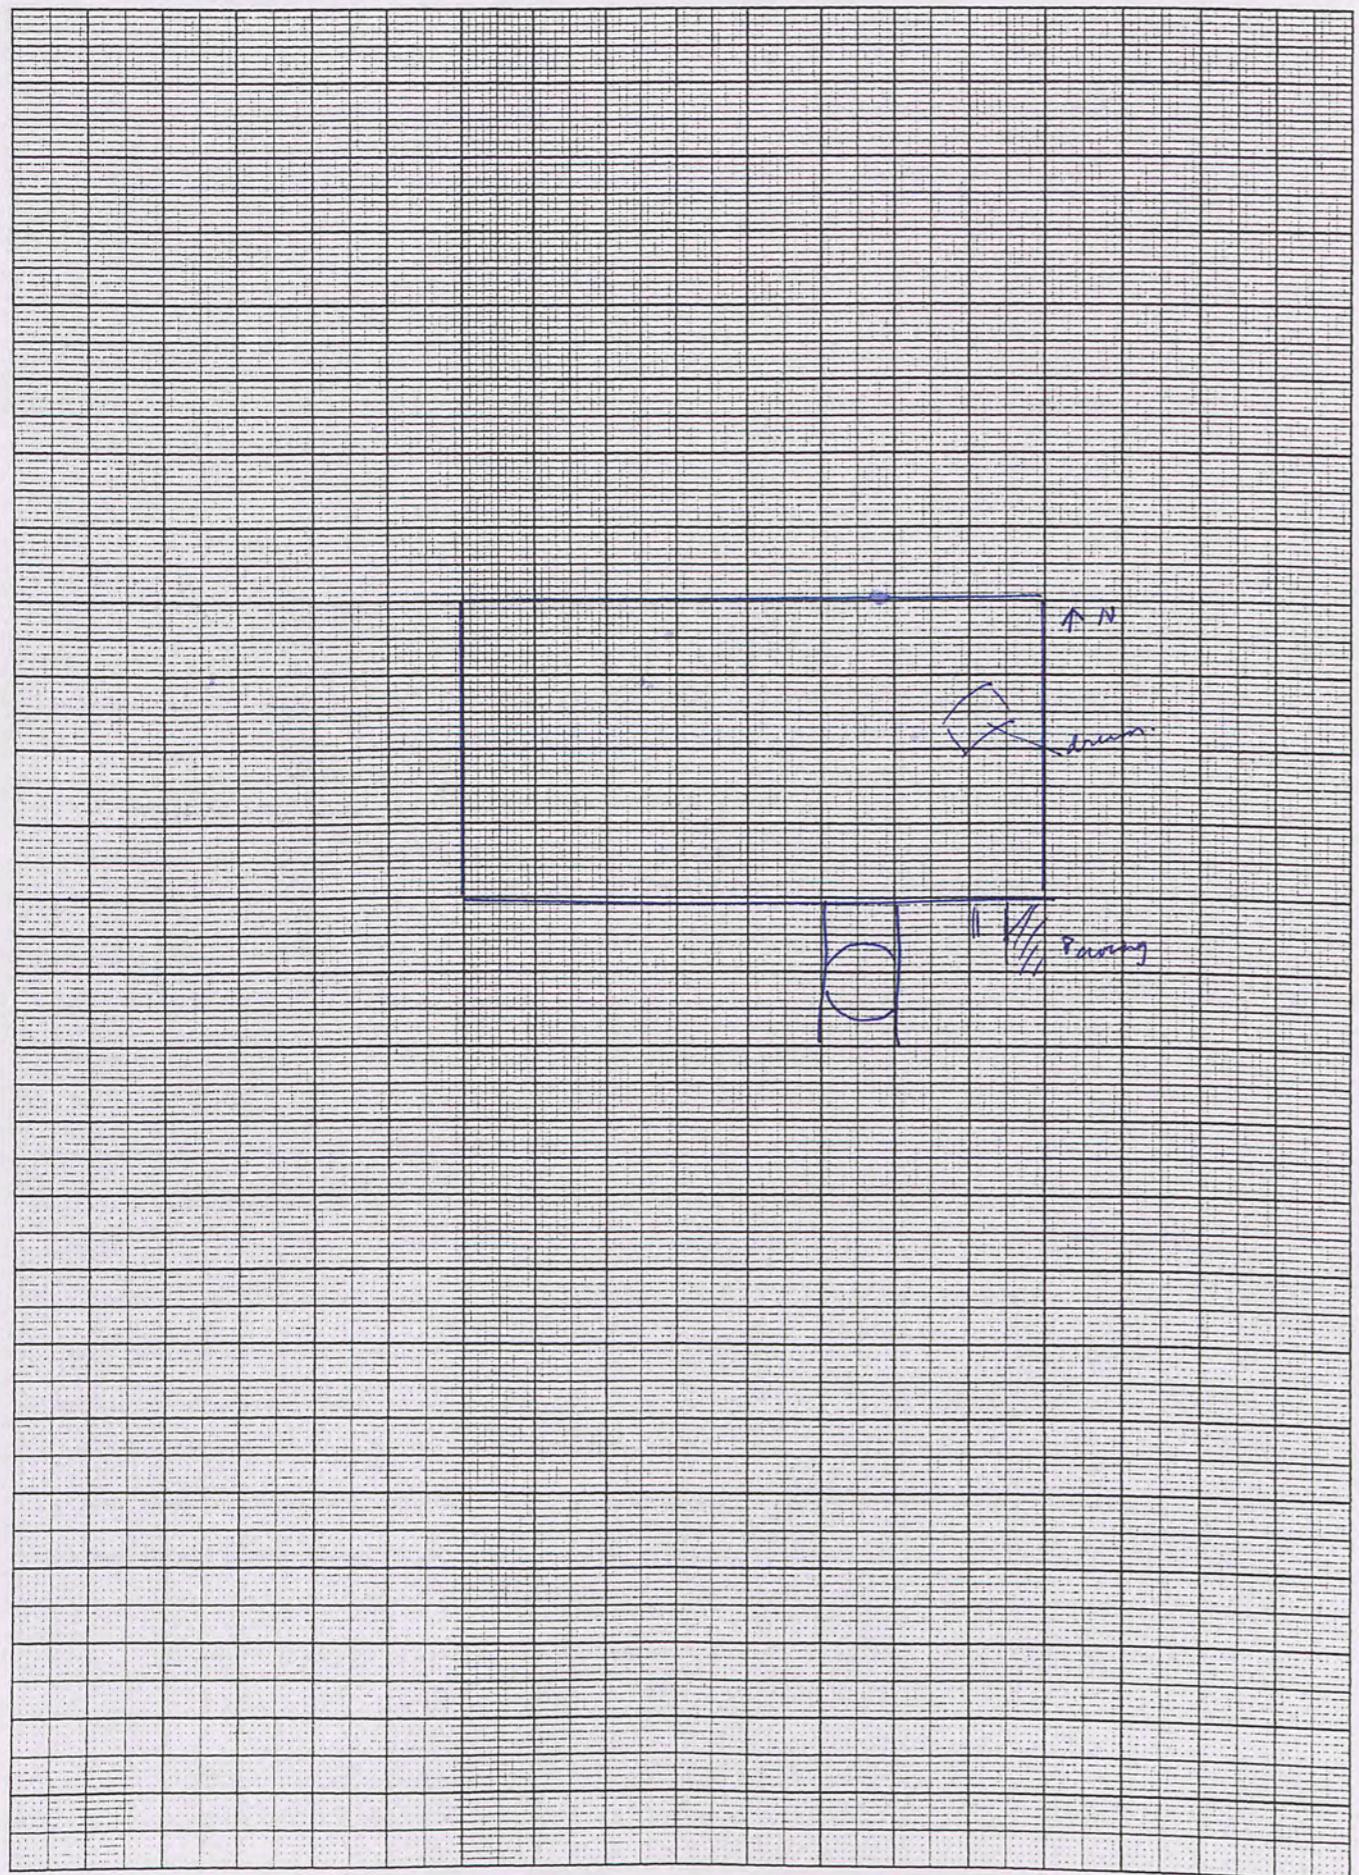
Context	Report
	<p>Clearing still at floor level, and eventually the baulk (locus 4.1) between B7 & B8. It will take the morning to clear + clean given the muddy conditions at floor level. Glass under a fallen column drum is 4.2 with a fine rim: large bowl or cup? A fine cornice piece next to fluted altar, in excellent condition. Otherwise some 12 column pieces in the NE quadrant. On 6/5/01 we'll continue in 4.1 clearing the baulk. A broken capital + parts of 3 column drums are revealed in the baulk. It is slow + difficult. A great deal of roof tile underneath the capital as well as discoloured soil presumably from decayed roof-beams +/or fire. Lot of burnt + smashed pottery. A piece with simple moulded end may have come from portal treatment. To be cleaned + photographed on 7/5/01.</p> <p>We clearly have the SW corner of the temple forecourt, with corner elements + column drums from the building's collapse. A precinct wall is likely to be another 2 meters or so beyond. Max depth of trench 1m 700 + floor 950 high, 470 across, Column drums 810. Altars 2m 575 apart from nearest point. Trenches B8+11 have produced 3 more altar places! ∴ 10 so far.</p>
