Jebel Khalid

Field Record Book

Name..... G.W. Clarke
Trenches..... Area B 7, B 15, B 16, B 18
.....
Dates..... April 23, 2001 —

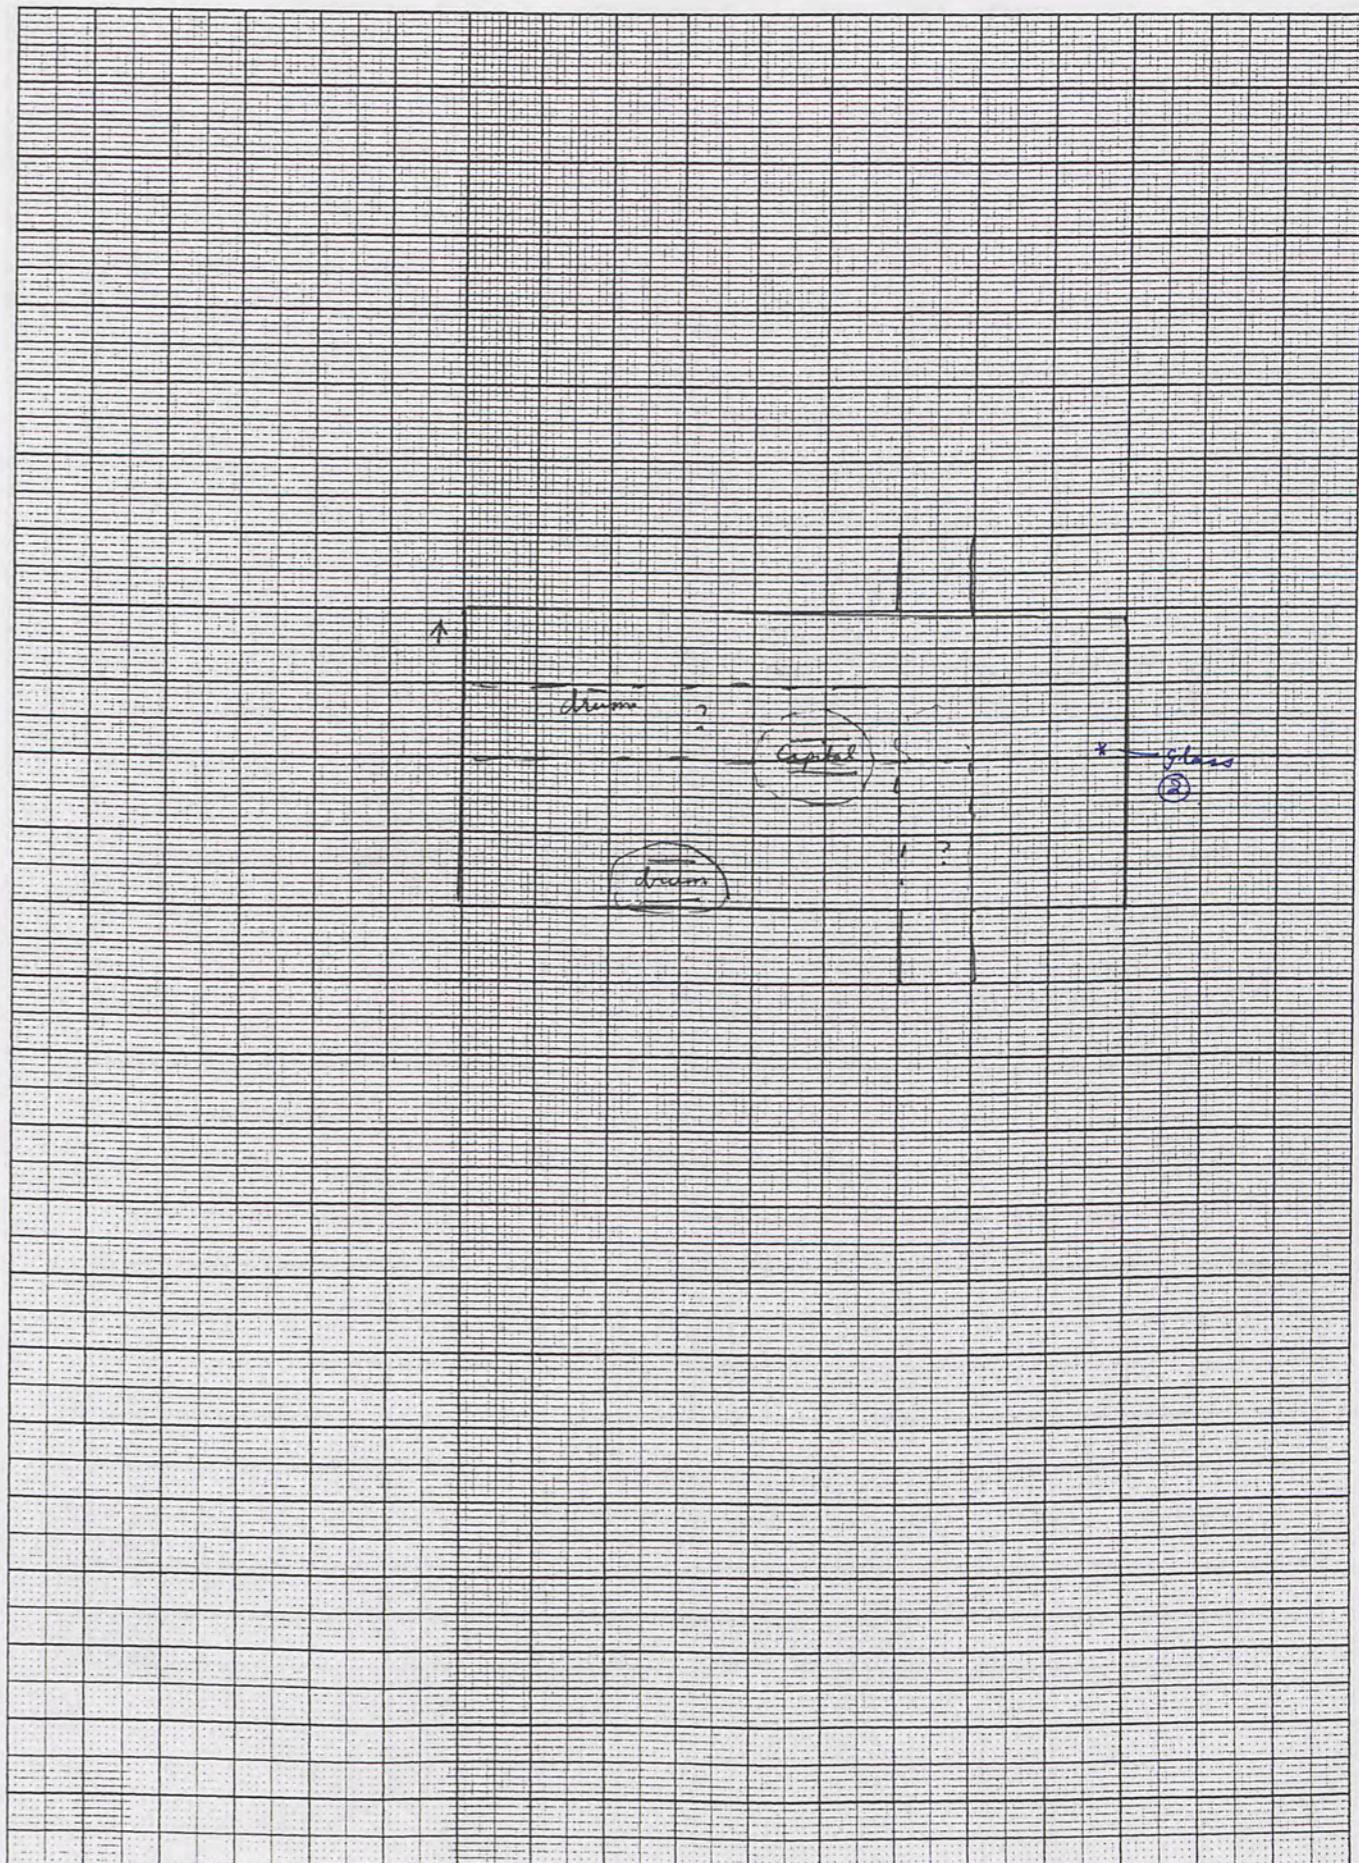
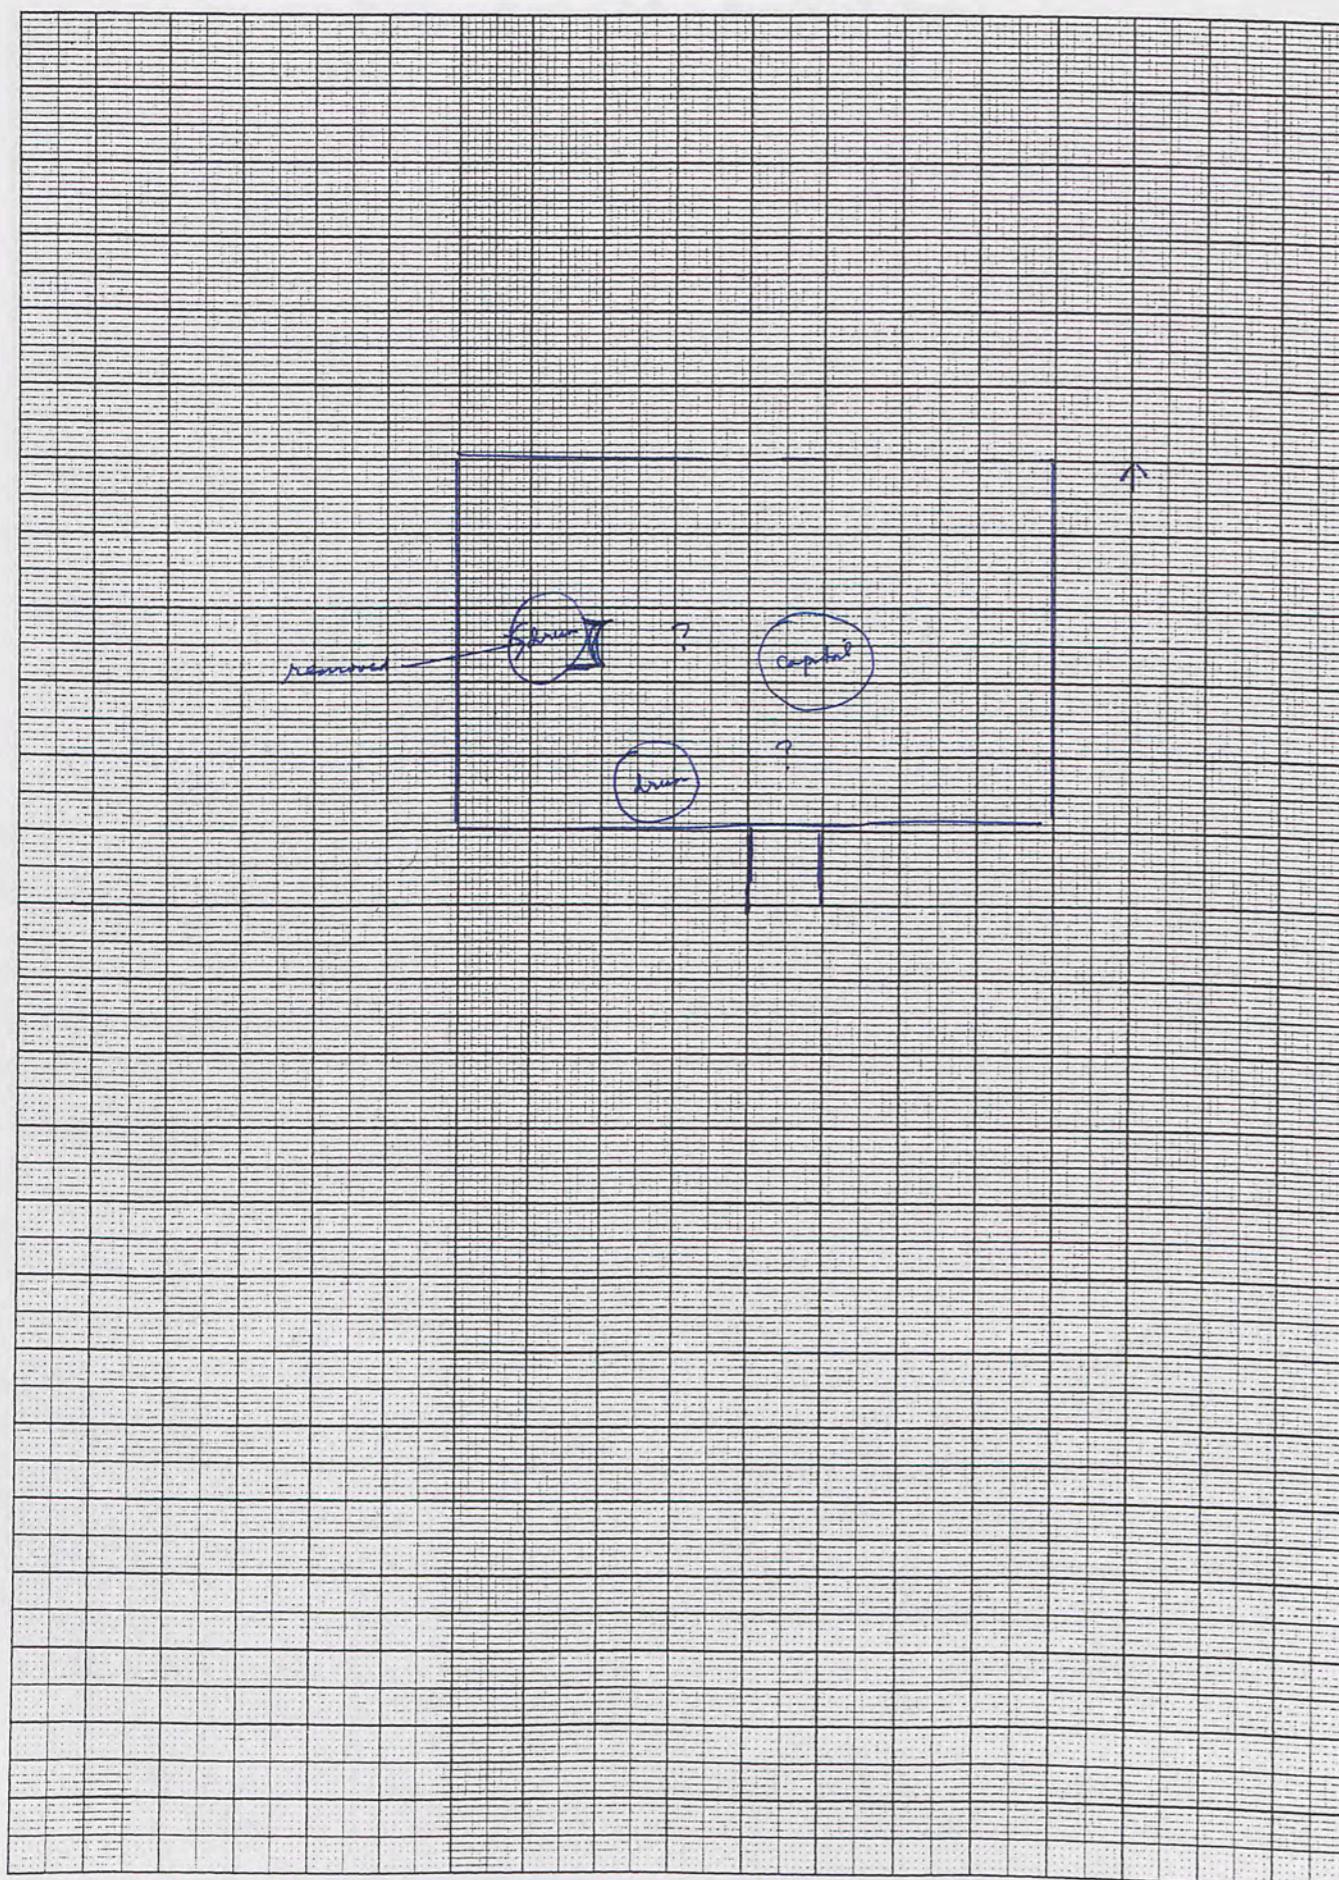
Despite cold + rain, persisting with digging after abandoning at 9:30am yesterday. We are now reaching the level of architectural pieces with three column drums so far appearing. Hoping for another altar. But a column capital has emerged in mid trench, upside down; not a column drum at all! Pretty well over the presumed altar placing. And a statue-head (limestone) found in B12! On 10/5/01 we continue Spit 1 and then start Spit 2, getting down further among the cracked + tumbled stones, great number of small abraded stones. So far no other features.

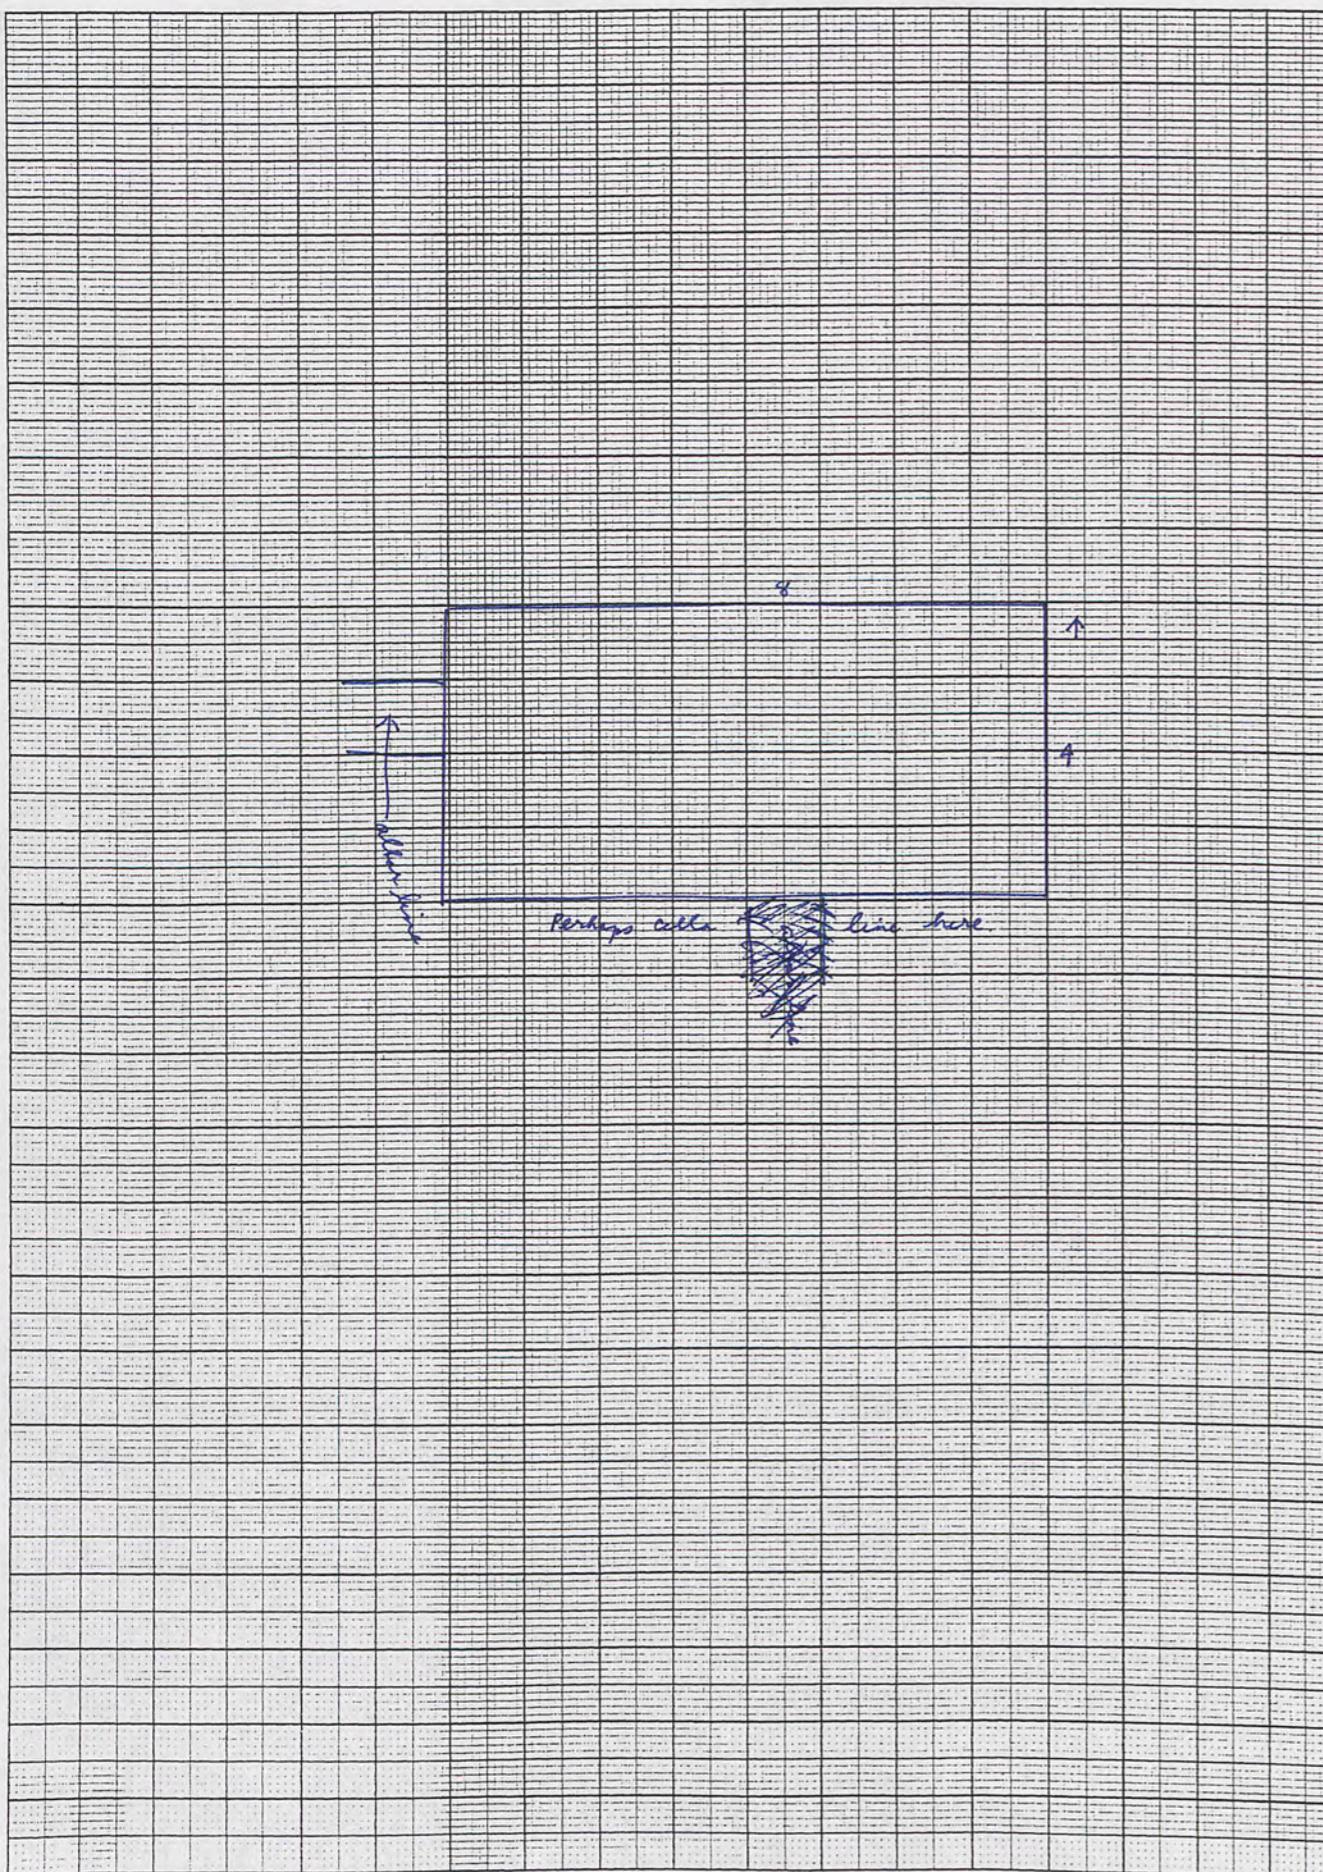
Trench..... B1b Initials..... gwc Date..... 21/5/01 Page....
Locus!..... Spit... 3 ... Locus!..... Spit... 4 ... Feature/s.....

Context	Report
1/4.	Garnum found just outside of altar line. Cleaned & washed & photographed. Left in place for conservator to remove. (500 mm deep - 1300 mm from Nth bank, 2500 mm from West bank). Altar line now apparent in Western half of trench. One more spit should clear the floor consistent & that is B15.
	Note: Metal clamp found inside altar line.
	Object 4 (coin) appearing to be late, found fairly high up above floor level. A piece of base altar fluting with tower flutes also came up, of the right circumference.

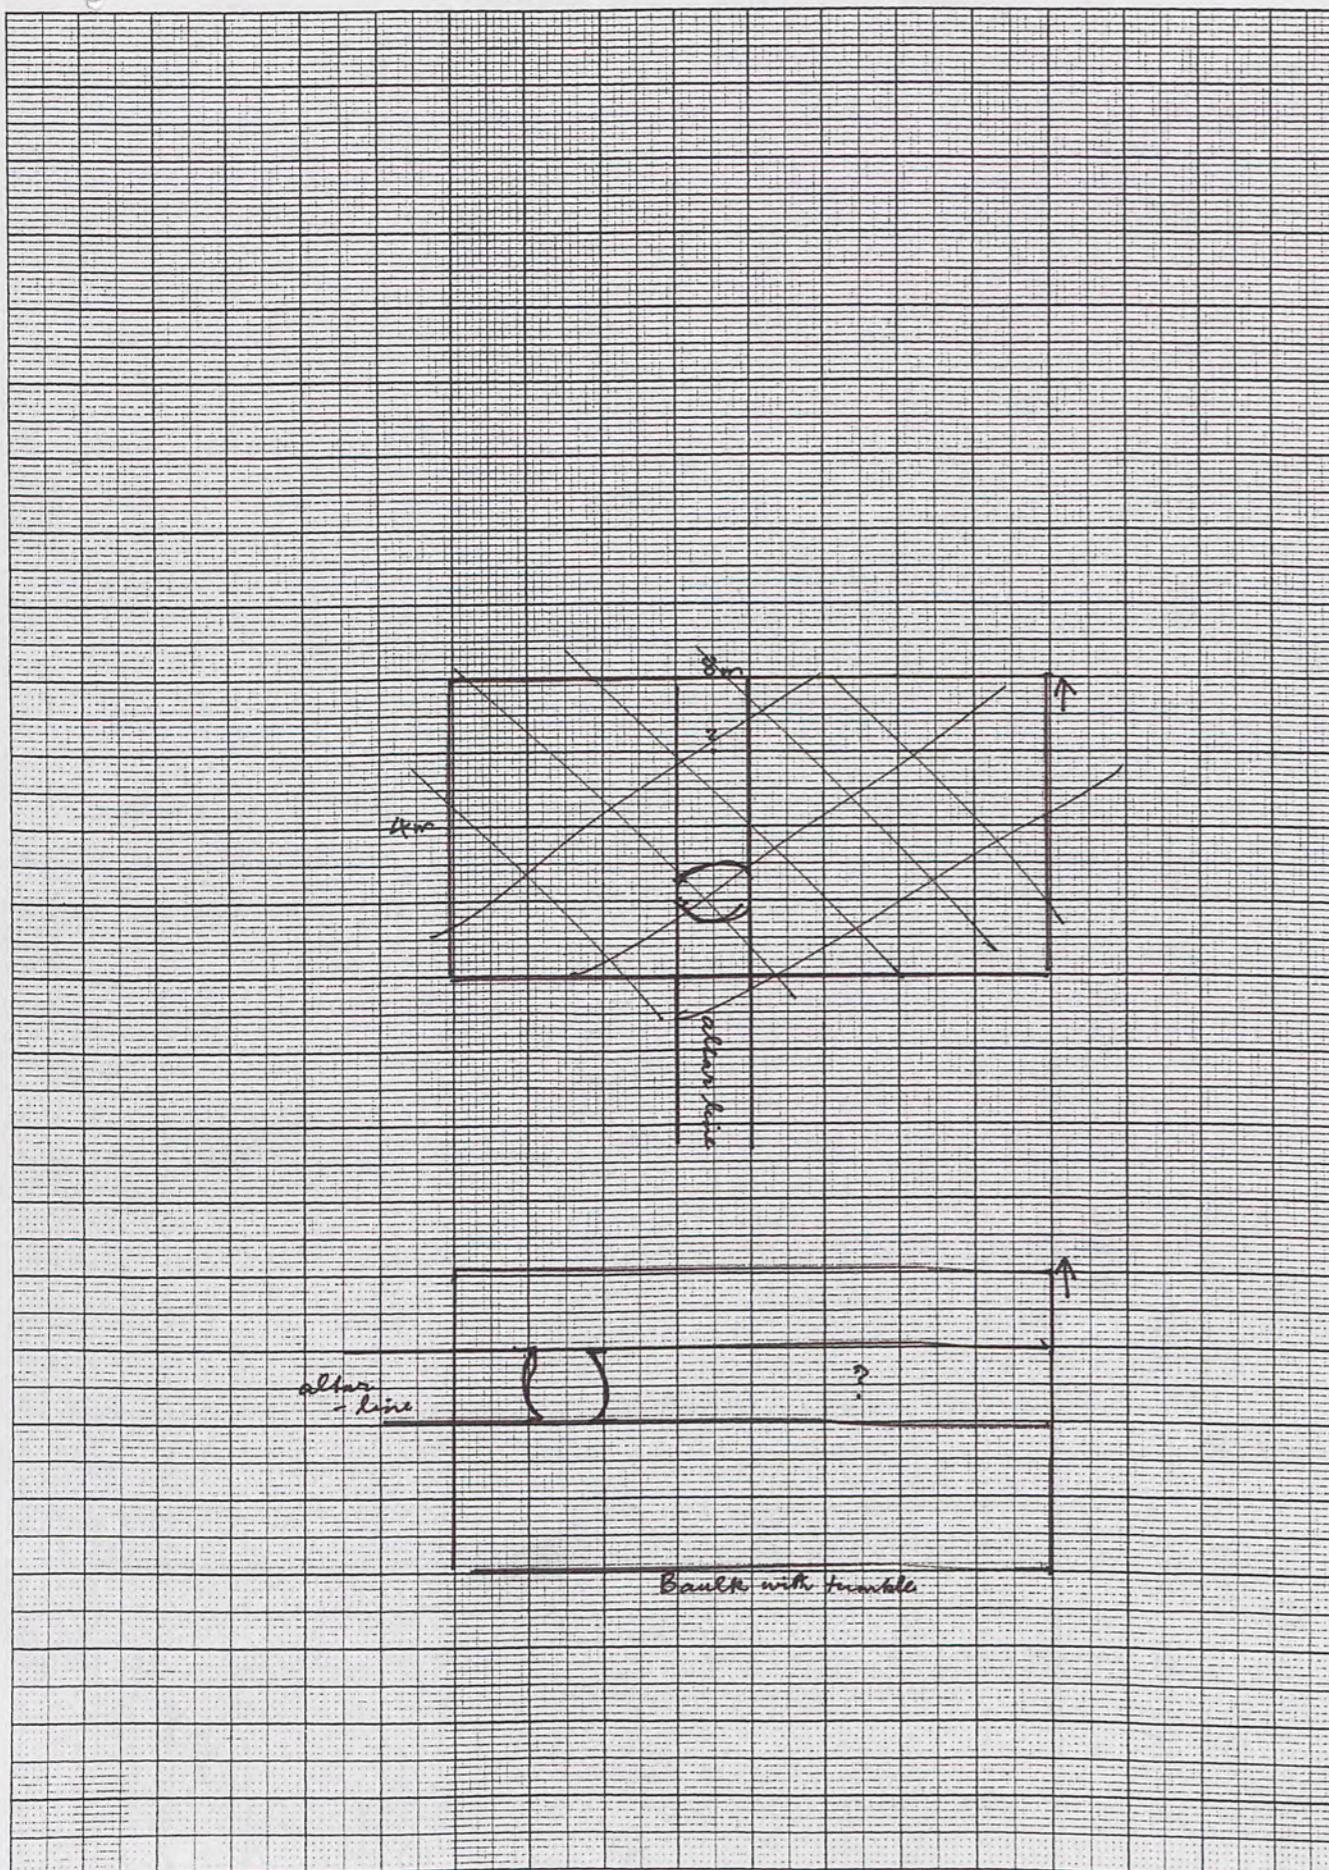
Trench..... B16..... Initials..... GWC..... Date..... 23/5/01 Page....
Locus..... Spit..... Locus..... Spit..... Feature/s.....

Cleaning of fill - Soil is dark brown with subtle 2 a fair quantity of pottery is present. Large grass object piece 15" found at middle trench about 150 cm down

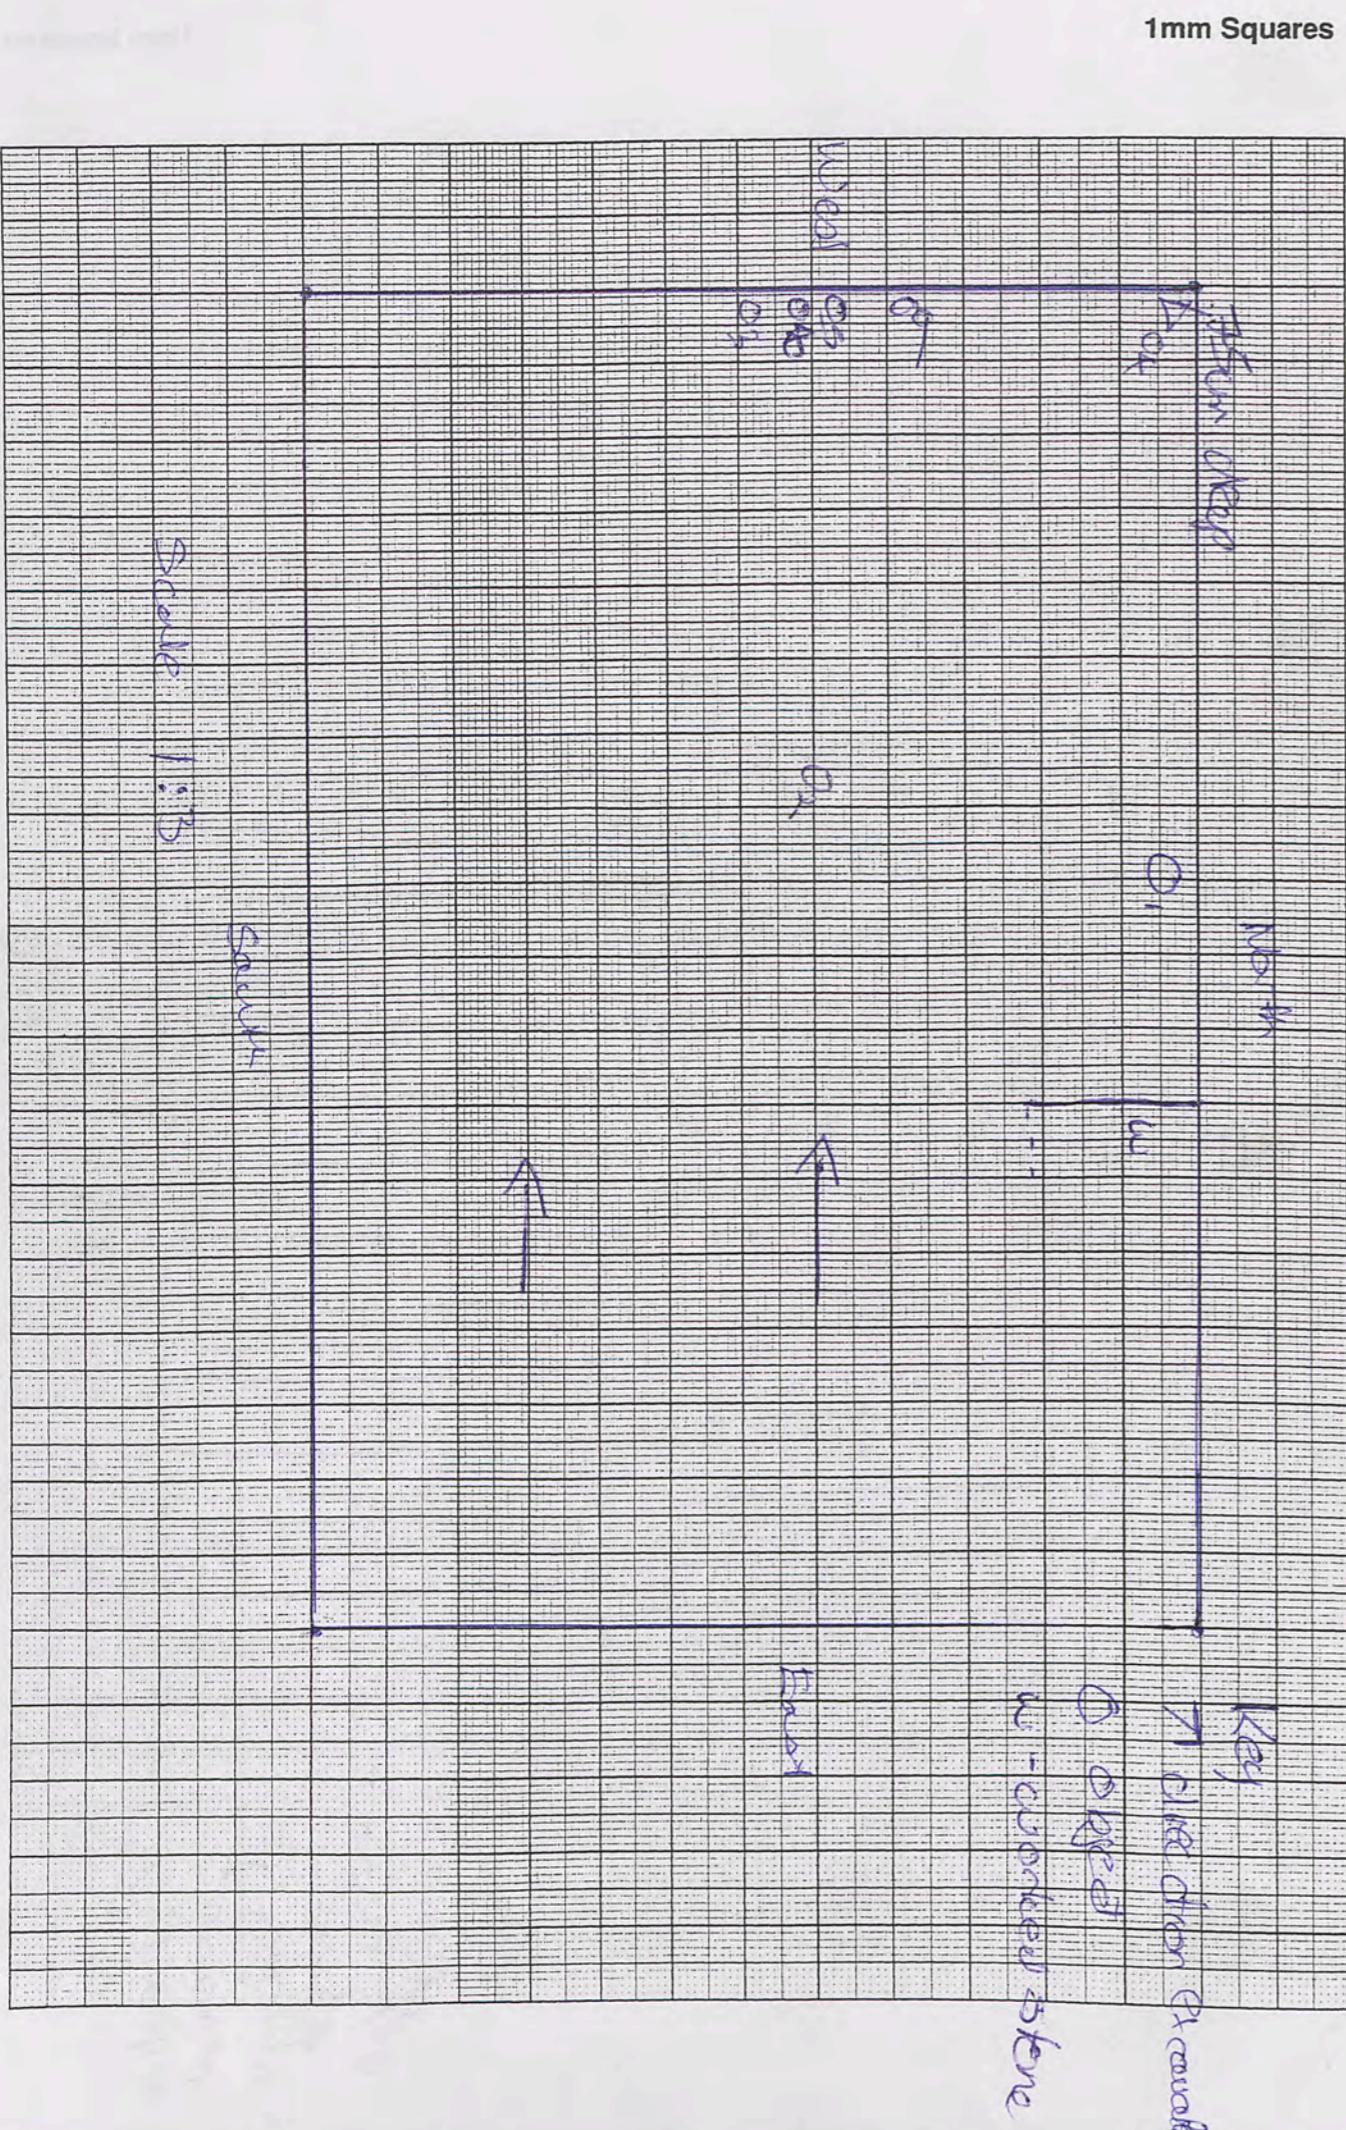
Trench... BB Initials... AF Date... 22.5.1 Page...
Locus..... Spit... Locus..... Spit..... Feature/s.....

Context	Report	10. nail 11	8 glass	9 glass
		Continued clearing layer 1.1 which is a thick spit, consisting of rubble with no stratigraphy & no archaeological significance. Soil is sandy & has big unwanted rocks. Significant amounts of pottery are present, & a small amount of bone. Various artefacts have been found throughout this layer. Concrete block found in rubble	1..1	1..1

Commenced Spit 1.2. Large May fragments of glass found particularly to west of Trench. One coin also recorded to west often in some sort of surface has been recovered. Surface appears to be of crushed limestone about 10cm thick. To the north (center) of trench large worked stones & medium stone appear to be purposefully placed. Soil is dark brown in centre south of trench Possible architectural piece ① so dig - This piece is possibly a column base as it has a circular hole in middle

Context	Report
	Convinced. Apat 1.3. Earth is reddish brown in South west corner. In south west cant a shaped in section stone has been carved to a three tiered shape (see below) is tight likely to be part of a foundation stones, large worked stone visible to north east of trench with worked block in situ on top.

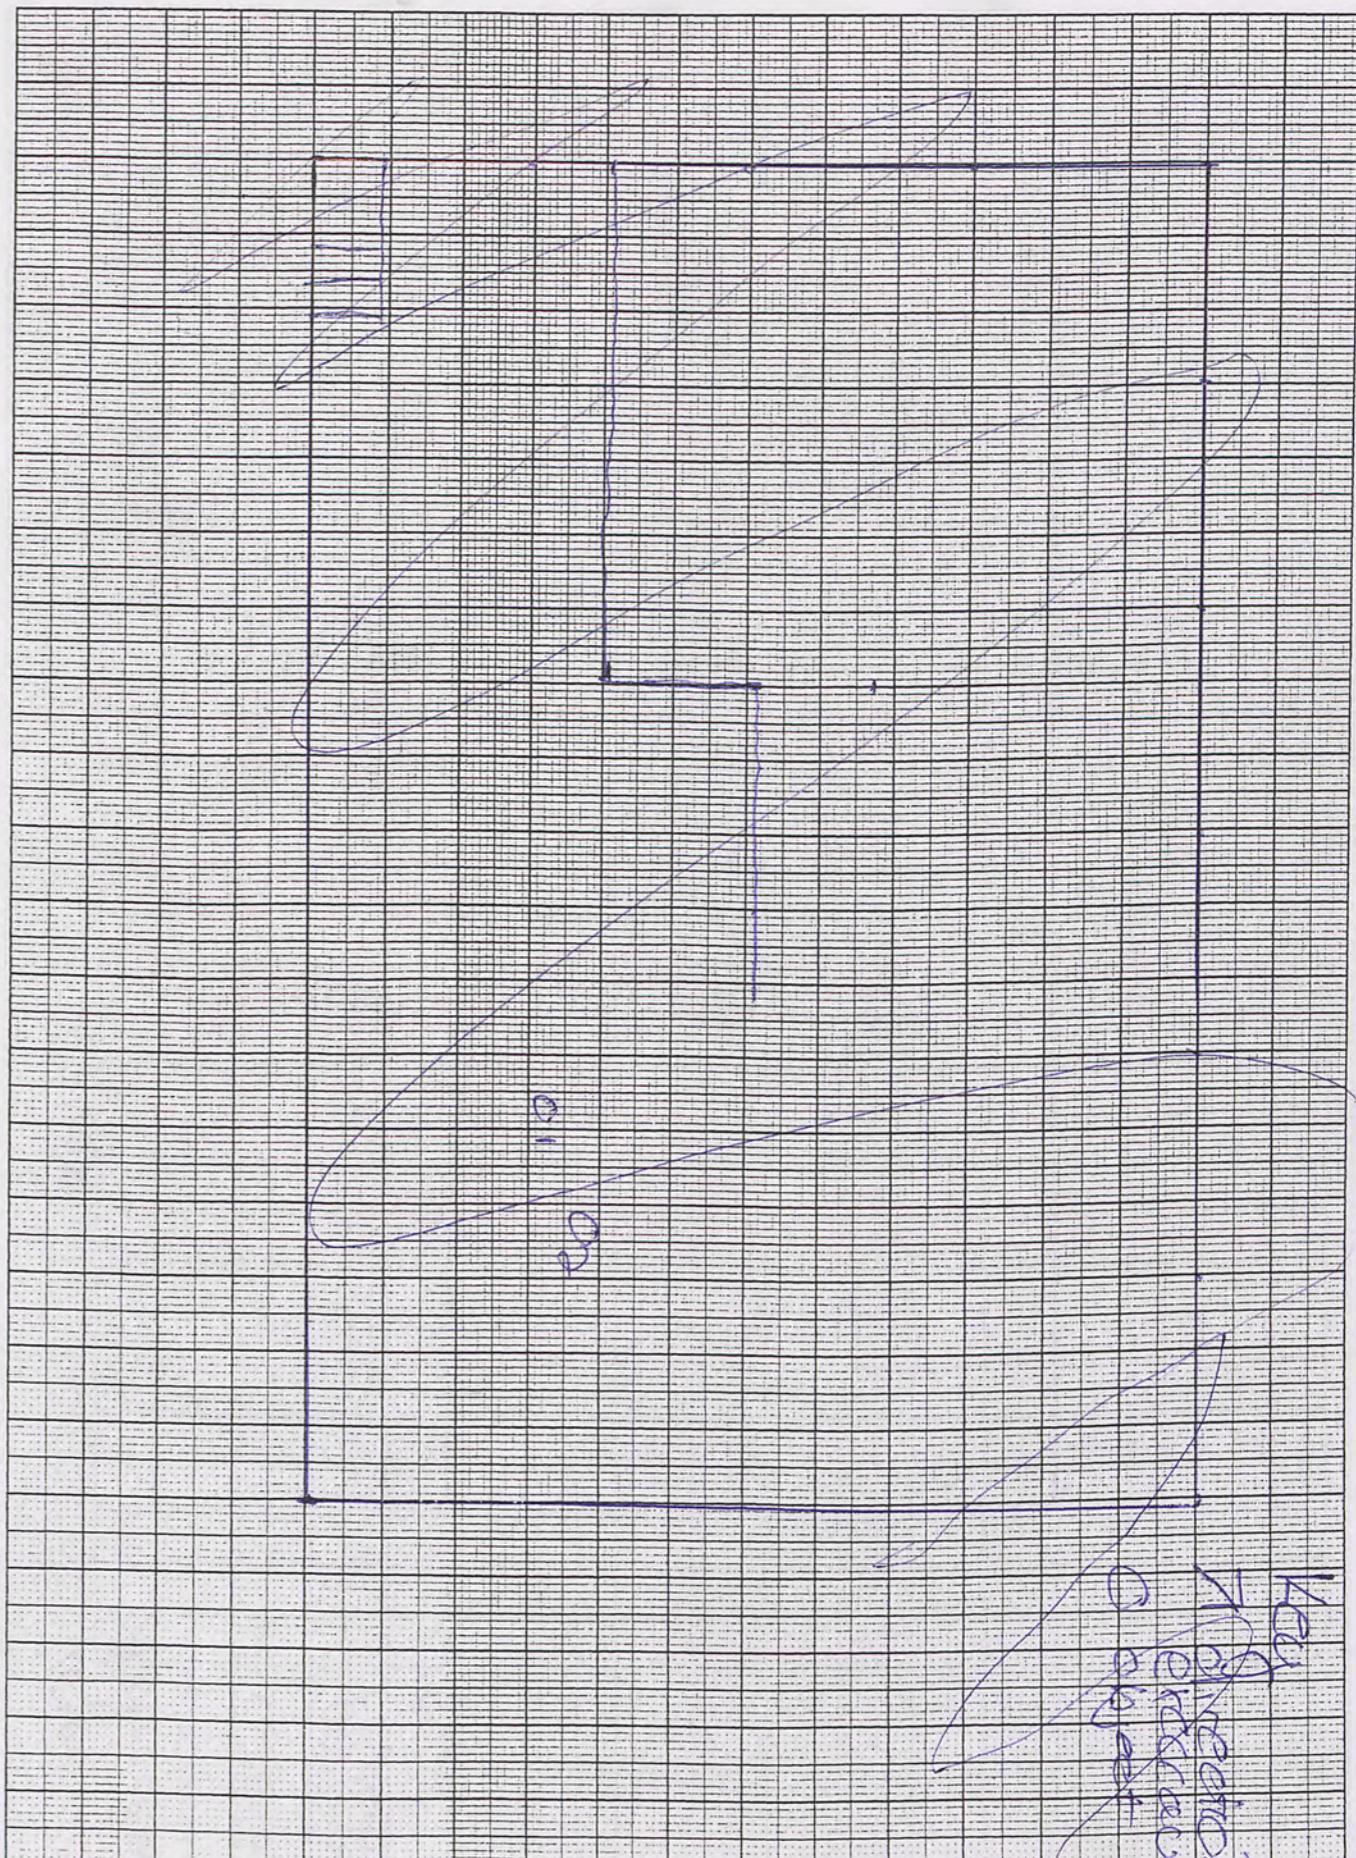
Context	Report
1.3 + 30.5.01	+ Confirmed with Spit 1.3. Soil is consolidated clay and Admelt layer. Established presence of faience-like stone in South west corner of trench. North west section of trench is more has not been excavated, but layer at previous Spit 1.02 as it is not confirmed if this layer is a floor level or top of loosely packed stones or rubble. the light layer which has been recognised as floor in B12 continues throughout stratigraphy to B17 parallel to the north east trench 2 largest stones (the larger with a possible pottery drum placed on top) appear to be related to the structure. It runs east/west.

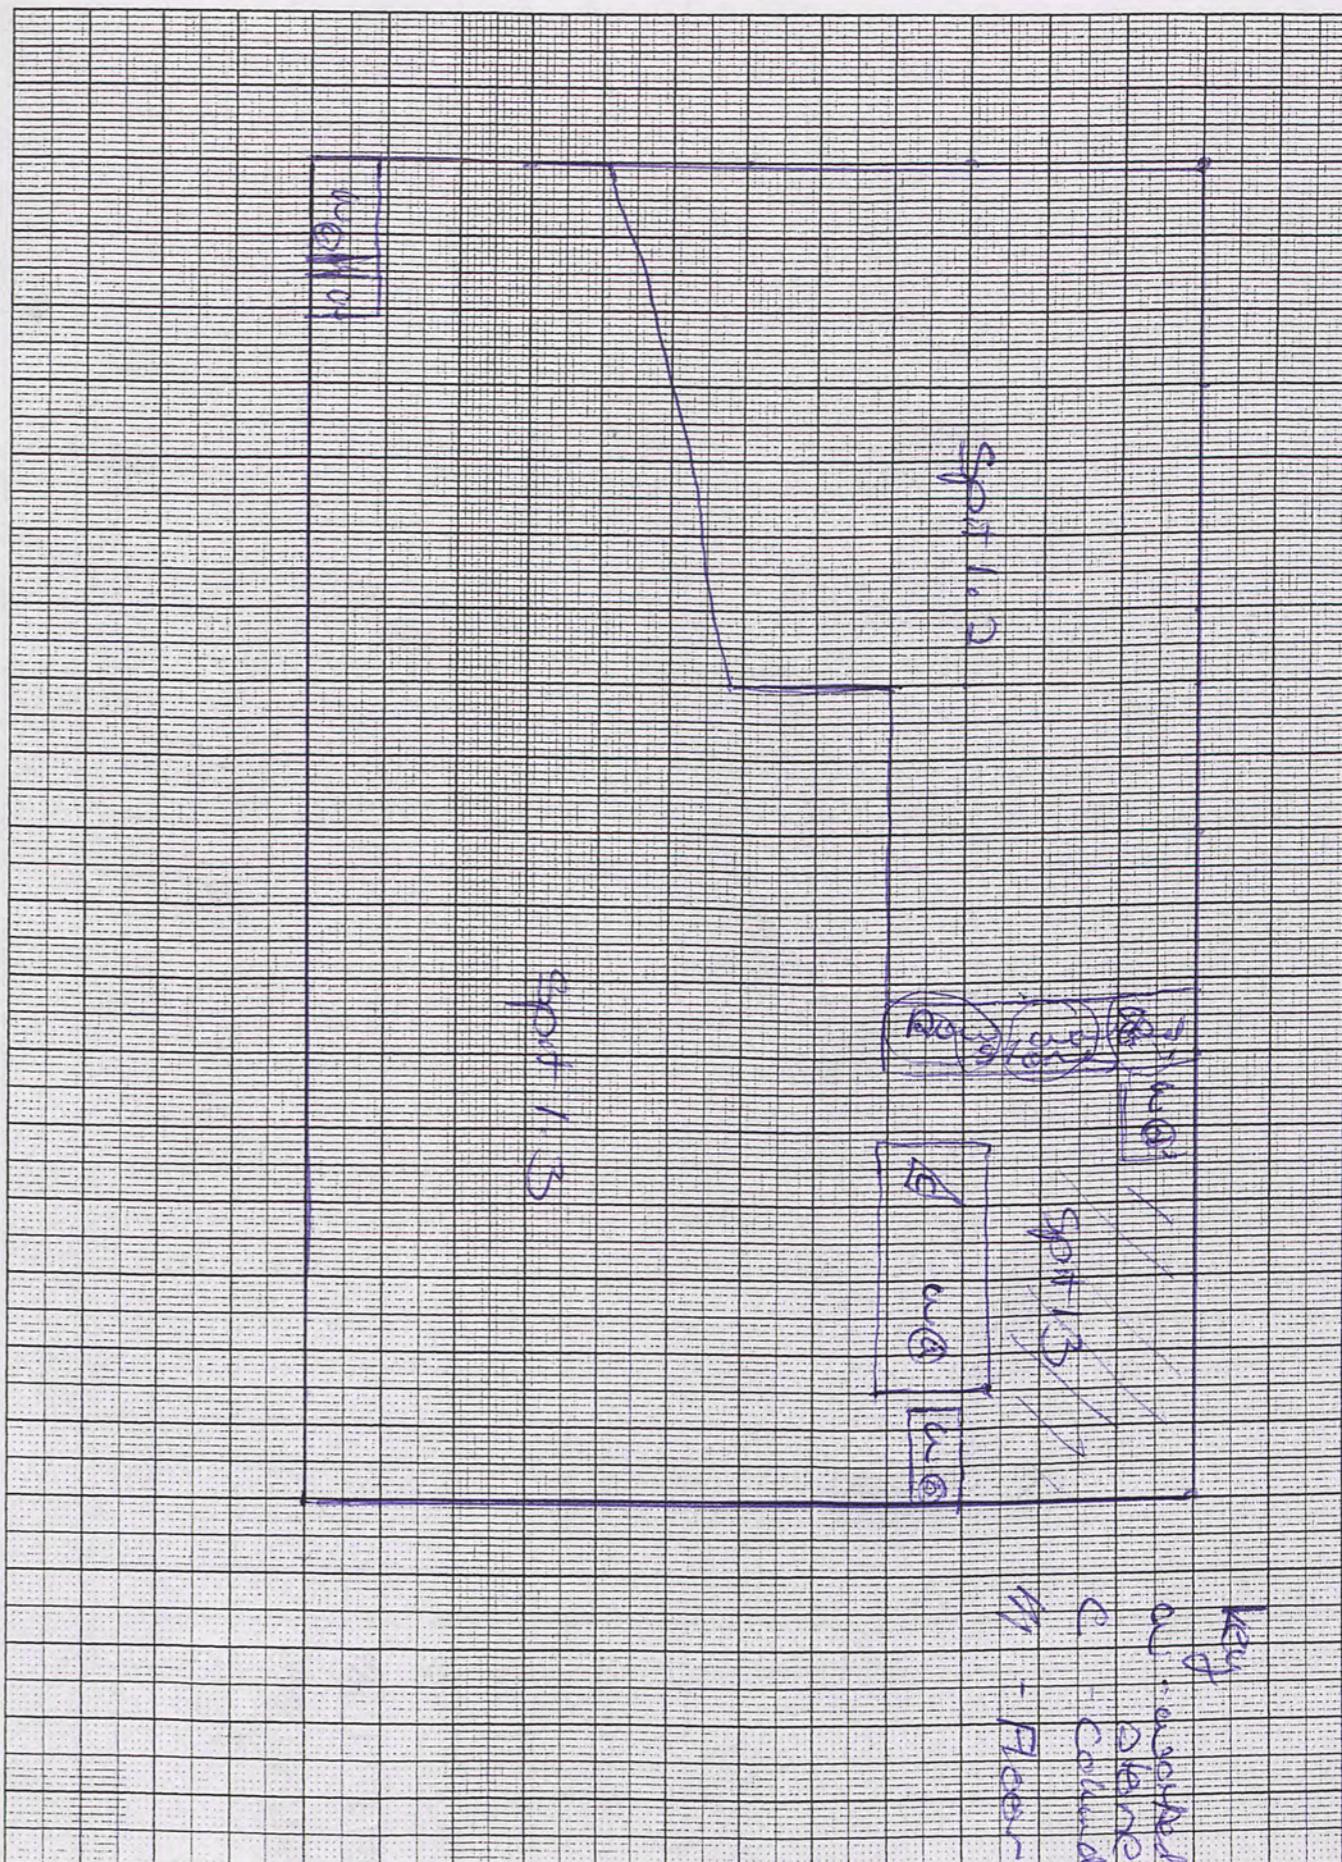
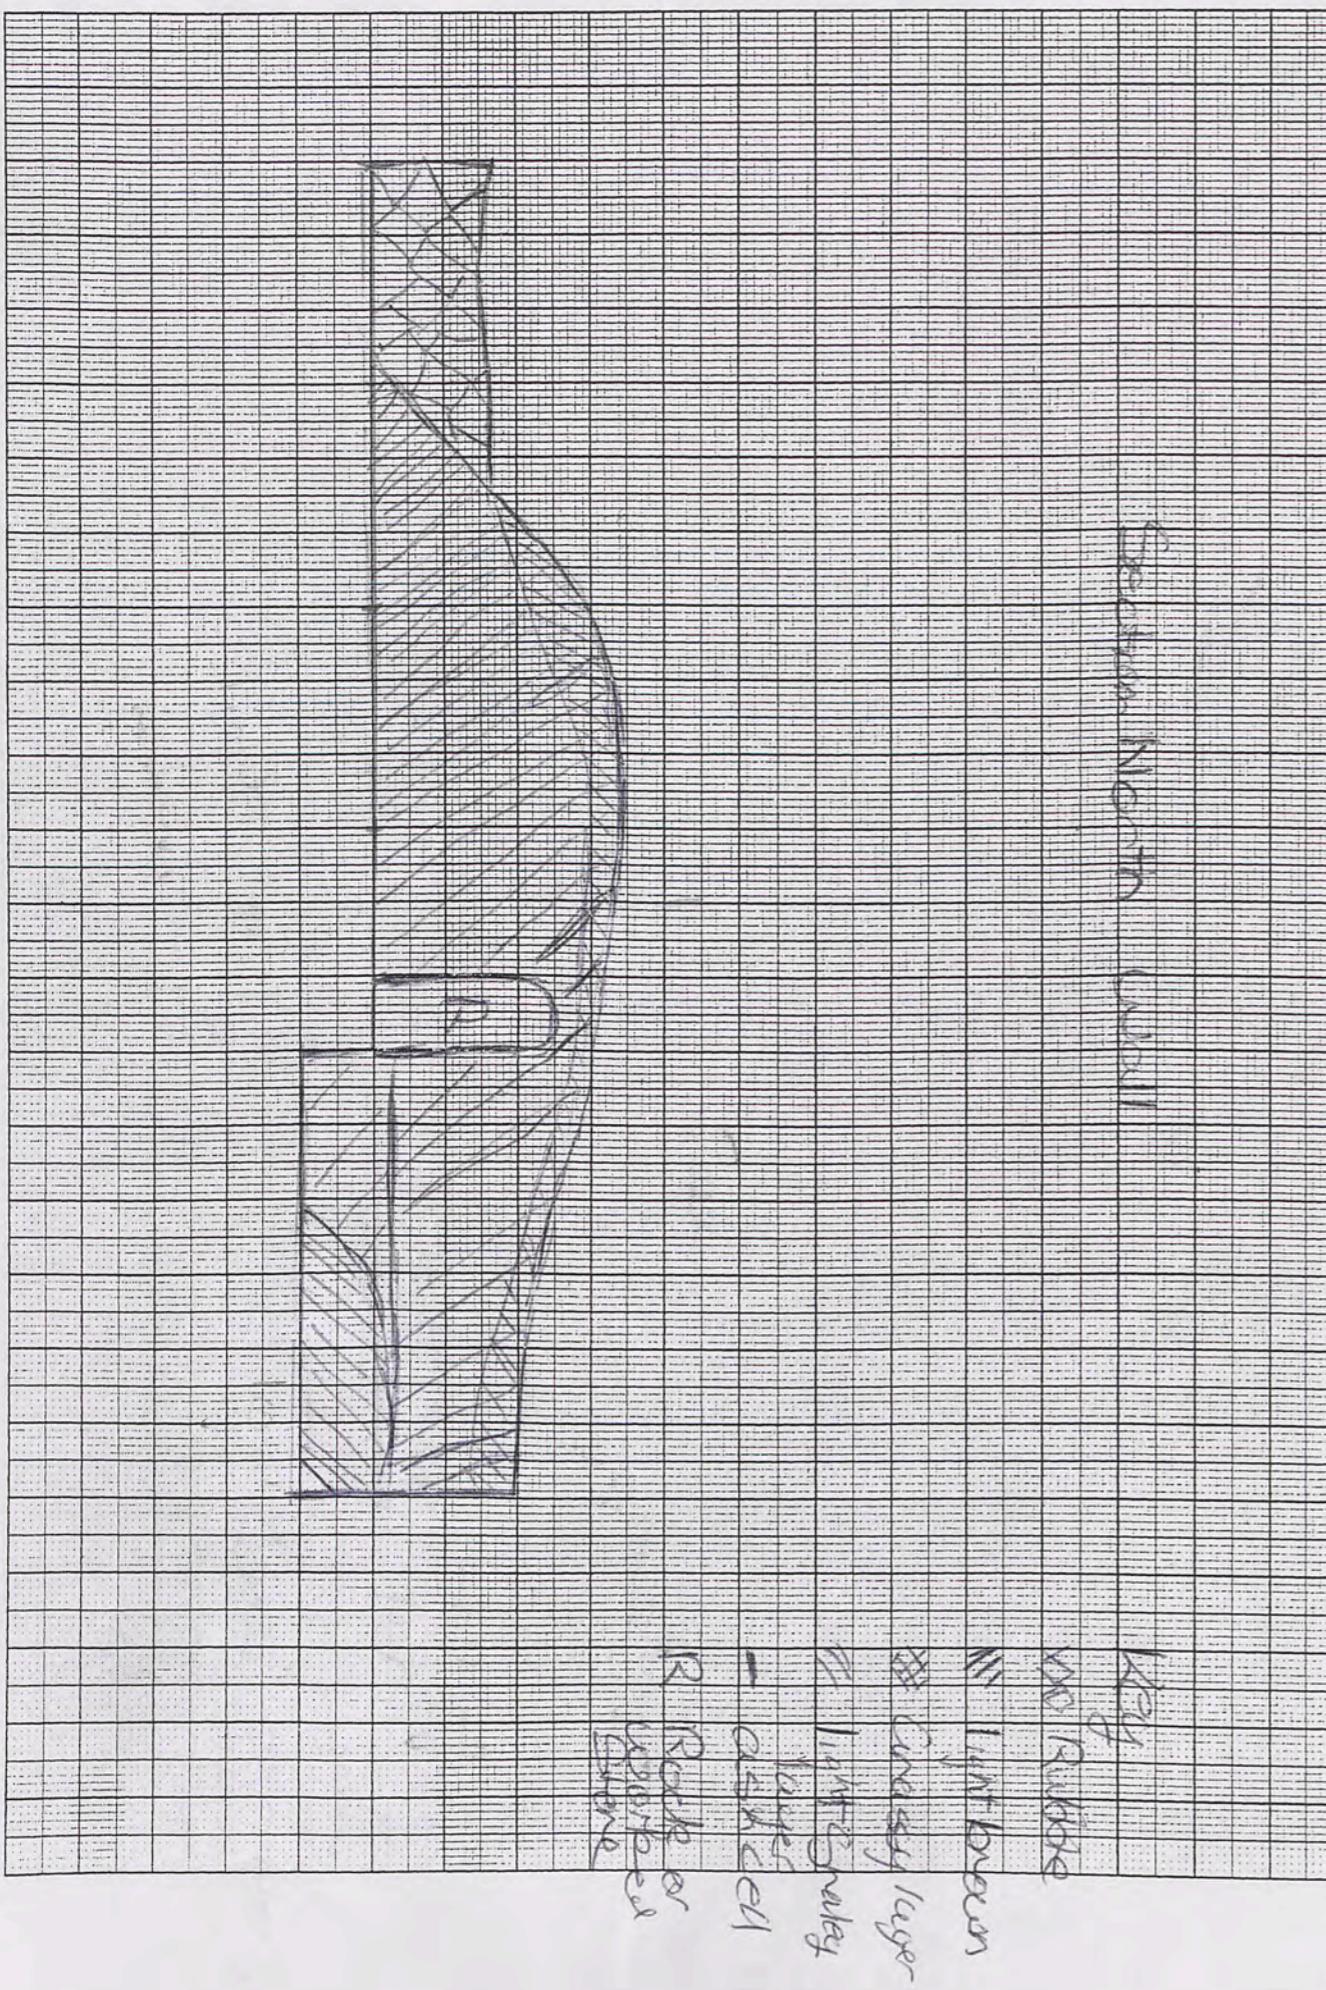
Context	Report
	<p>Trench was cleaned in order to get final photos for ^{the} end of a season. Further work needs to be done next season to establish the about spit 1.2 is. It appears (at the moment) to be rubble/soil with some small with floor surface in the west section, whilst in the eastern Section it appears to be rubble with little or no floor surfaces. In the north eastern corner of trench there is a small section of floor about 30cm, above the floor there is a 2cm coll of ash present/visible in the trench wall. Next season the purpose of worked stones a & b should also be determined. Spit 1.3 in section may often need to be at a floor or sub floor level due to the presence of fine embedded small stones.</p>
