Jebel Khalid

Field Record Book

Name..... G.W. Clarke
Trenches..... Area B 7, B 15, B 16, B 18
.....
Dates..... April 23, 2001 —

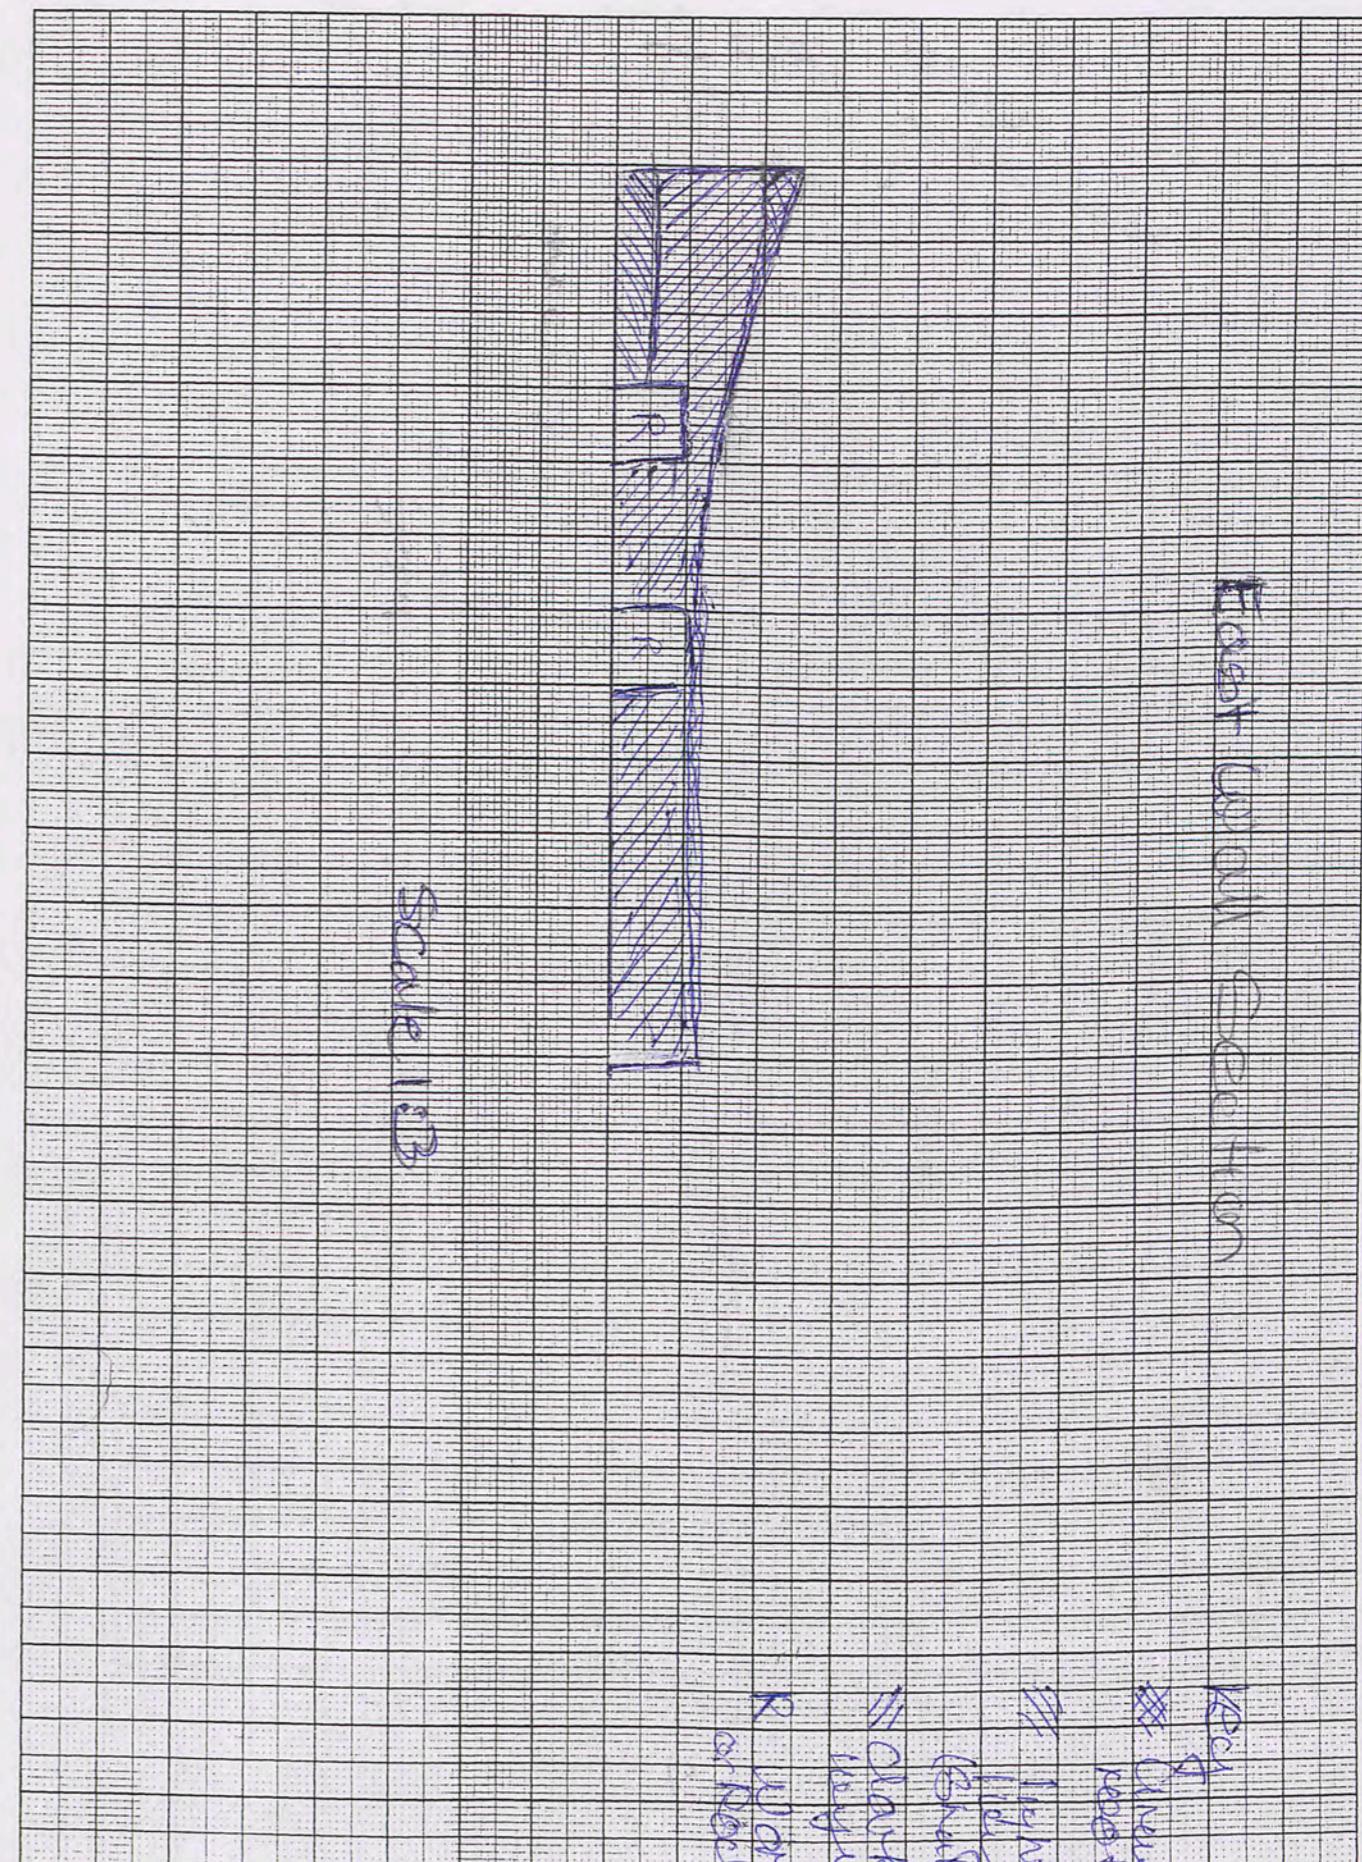
Dugout removed of reeds on post wall along diagonal (scrubbed)
 Stone rows revealed parallel to worked stone in a cut (see diagram)
