# Jebel Khalid

## Field Record Book

| Trenches..... | Area B B9, B12.<br>plus Summary for B9, 10, 12 + B complex! |
| Dates..... | 23/4/2001 to 31/5/2001 |

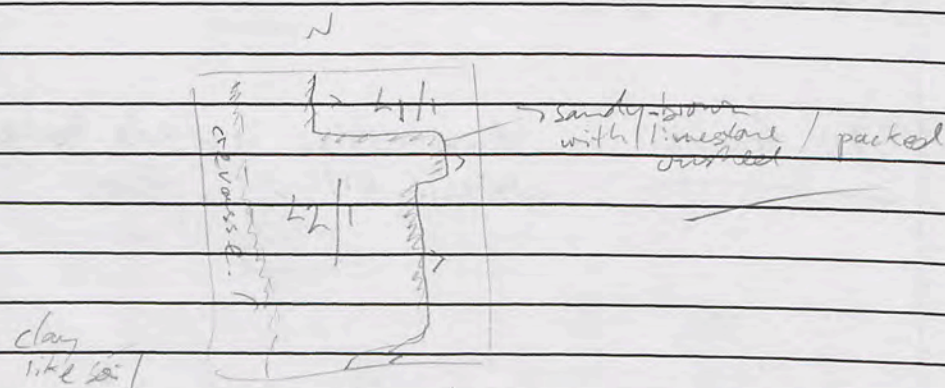
Fig 2: Bq - Section - Northern Bank. Scale: 1:2500  
24/4/2007

See section drawing of northern end/bulk of bench. (Fig 2)

Marble fragment lifted from centre of bench. ? statuary / ? handle fragment.

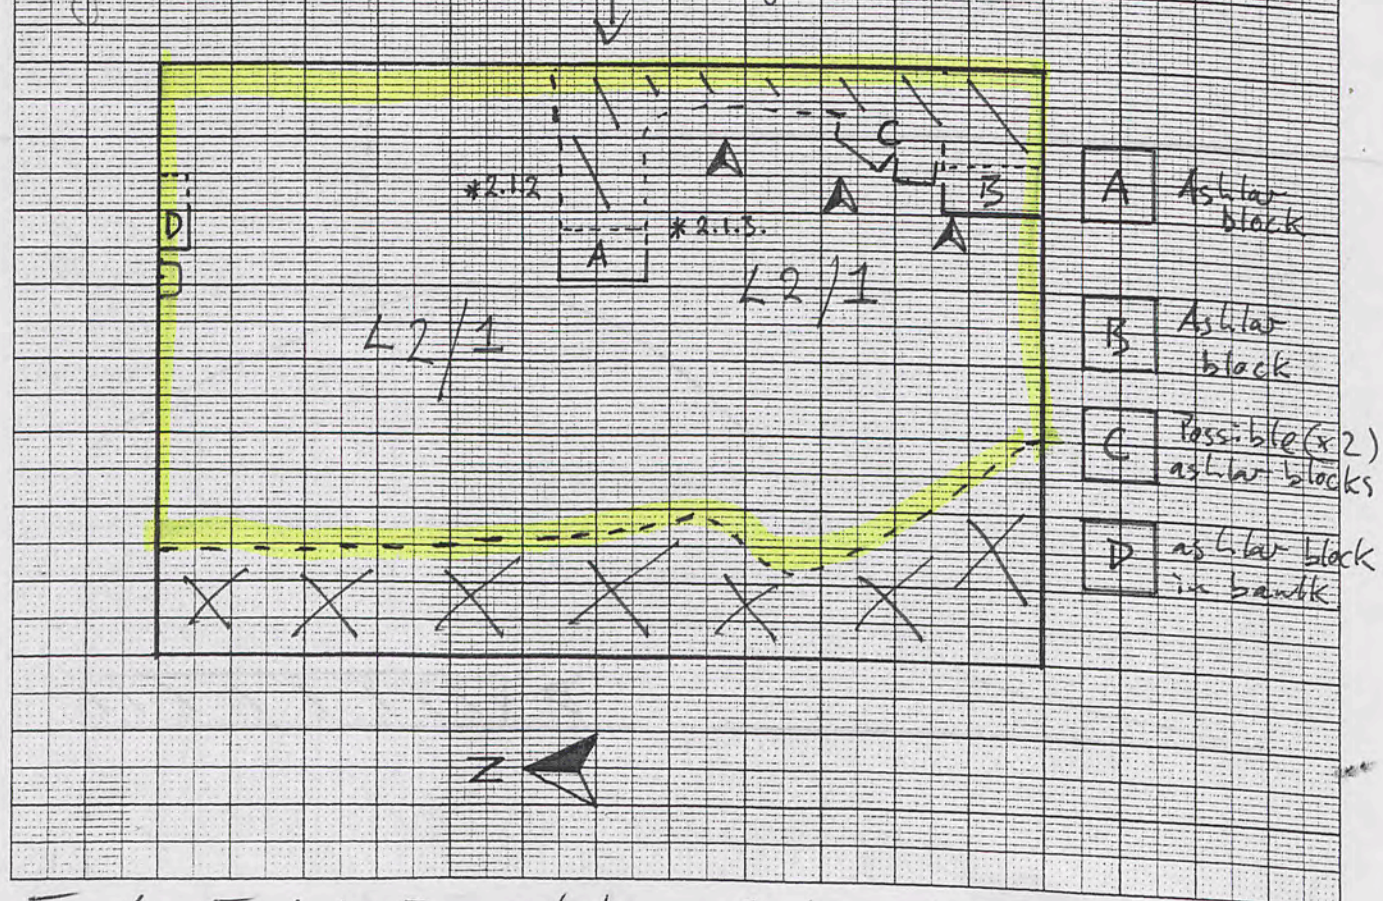
Fig 4: End Day 3 25/4/01 1:500mm

| Context | Report |
|---|---|
| | Other blocks [B] [C] + [D] now emerging ? pavers; ? blocks to support pavers. Latter may be correct given position in relation to stratigraphy, i.e. submerged in brown soil layer to crushed limestone crust. |

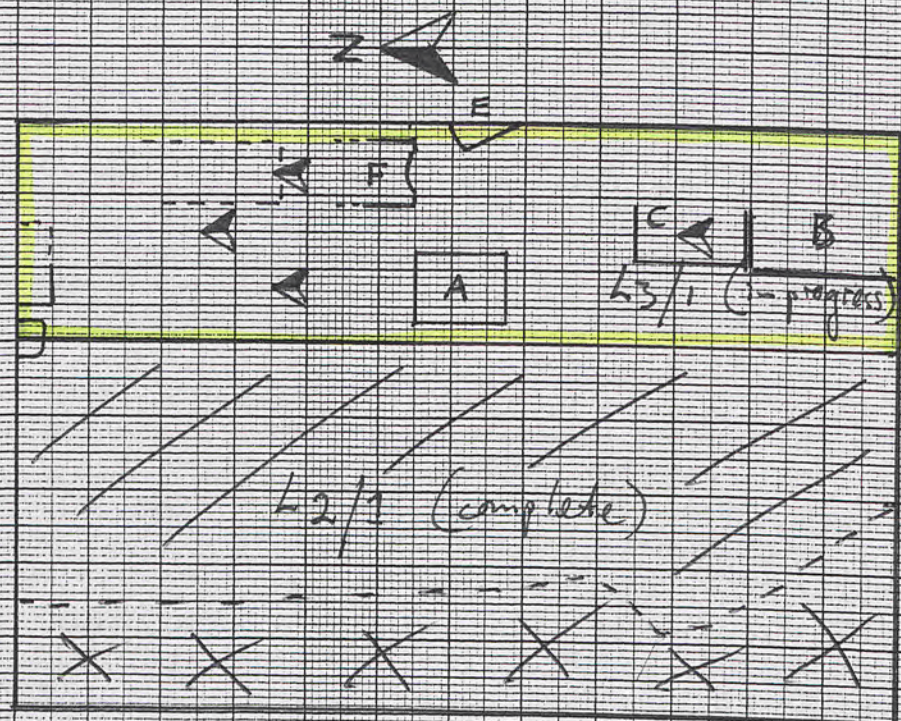
Fig. 5 End Day 4. B9 26/4/01 Scale: 1:500mm (not precise)

X debris

L2/1 complete

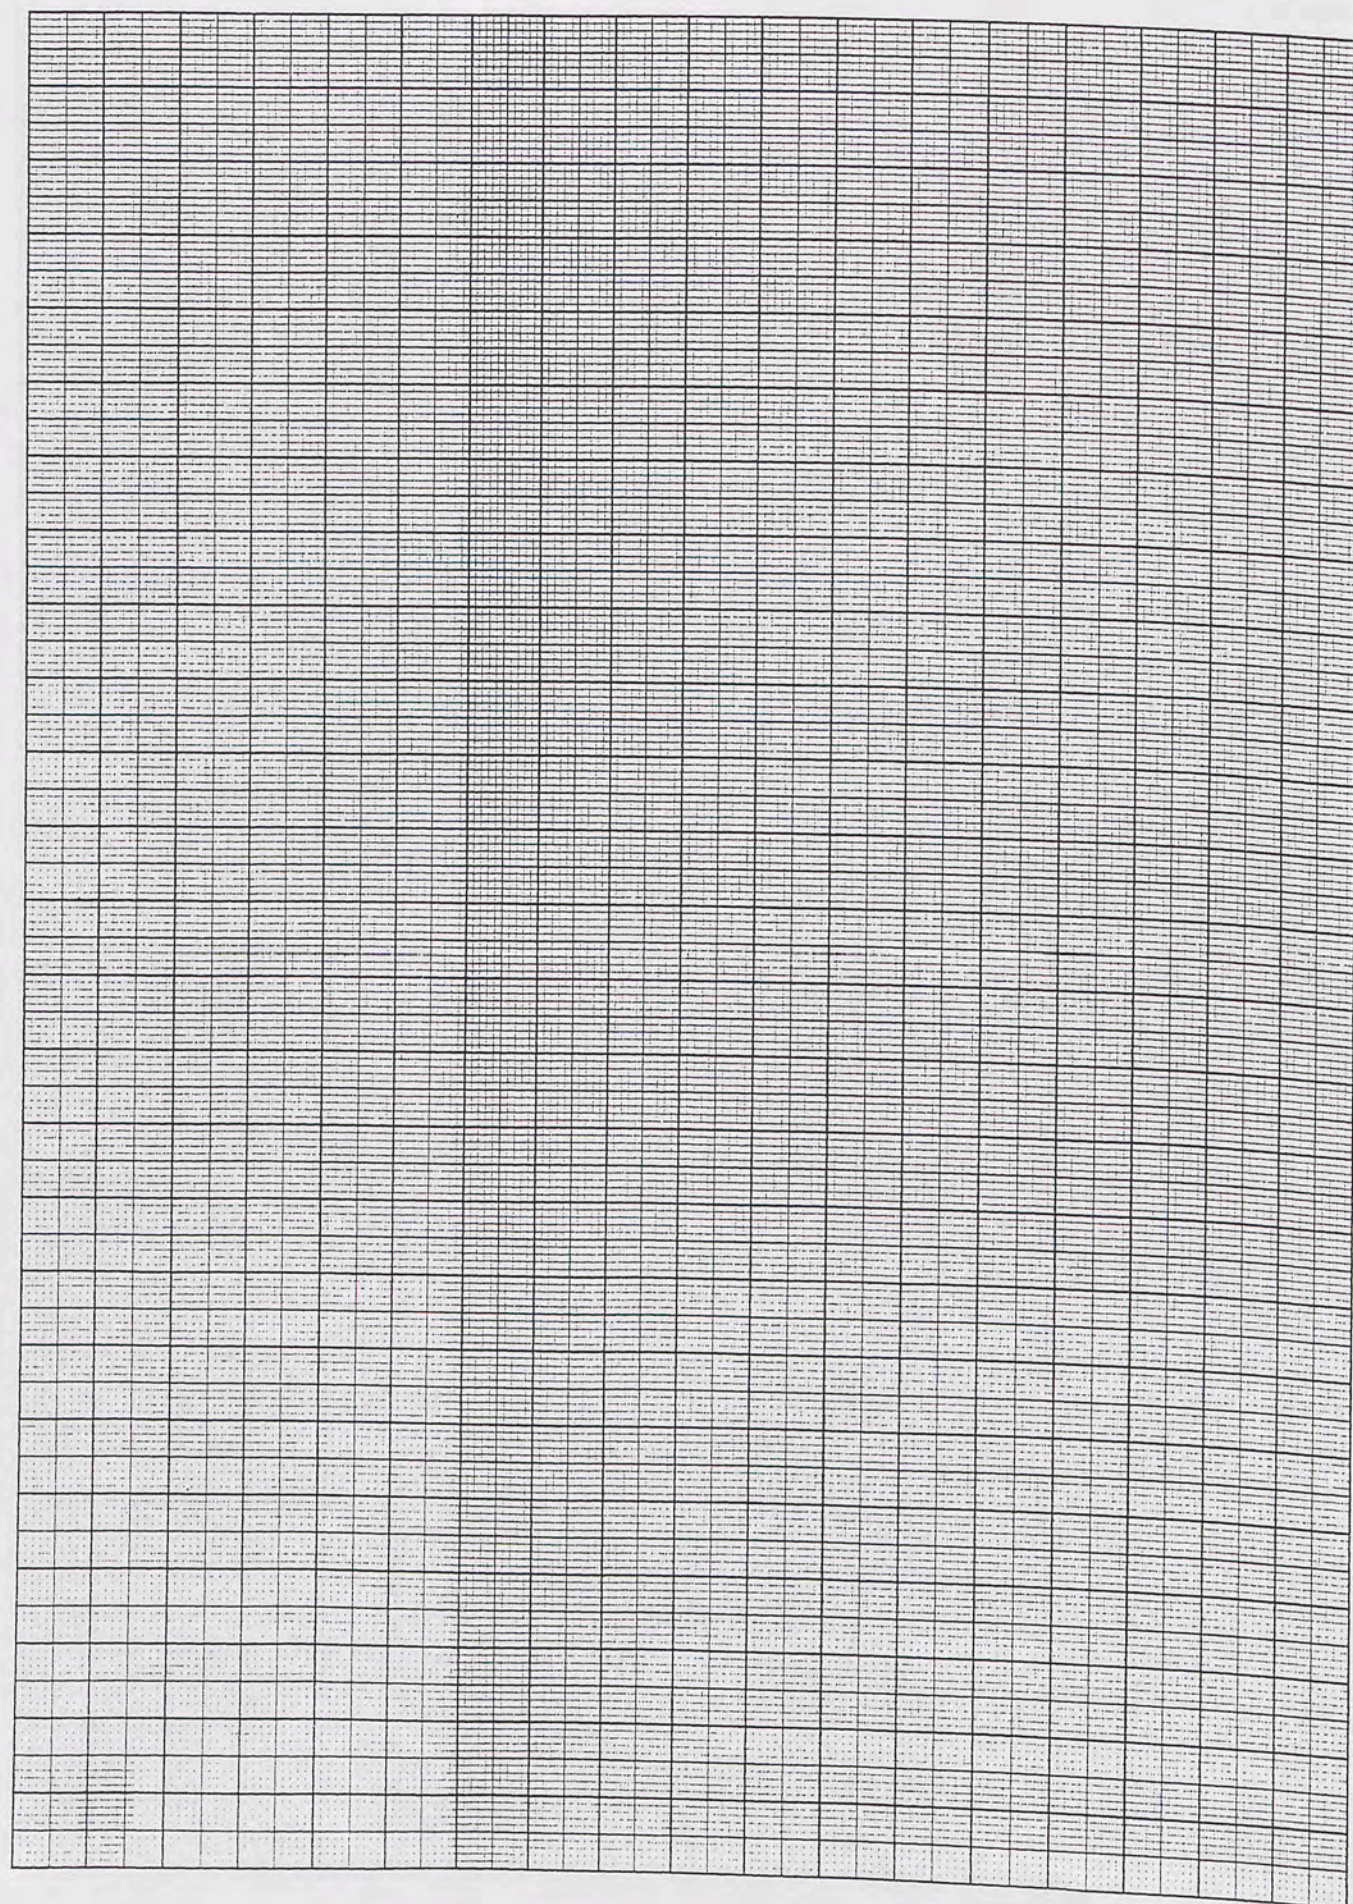
| | New blocks revealed: [F] - possible altar recess evident; [E] column drum in eastern bank (may be an altar similar to trench complex to the west). |
| L3/1 | New context: defined by clay-like soil layer + section along NE axis, 1.50m from eastern bank. Plan: reveal detail of ashlar blocks + possible altar "strip". f. |

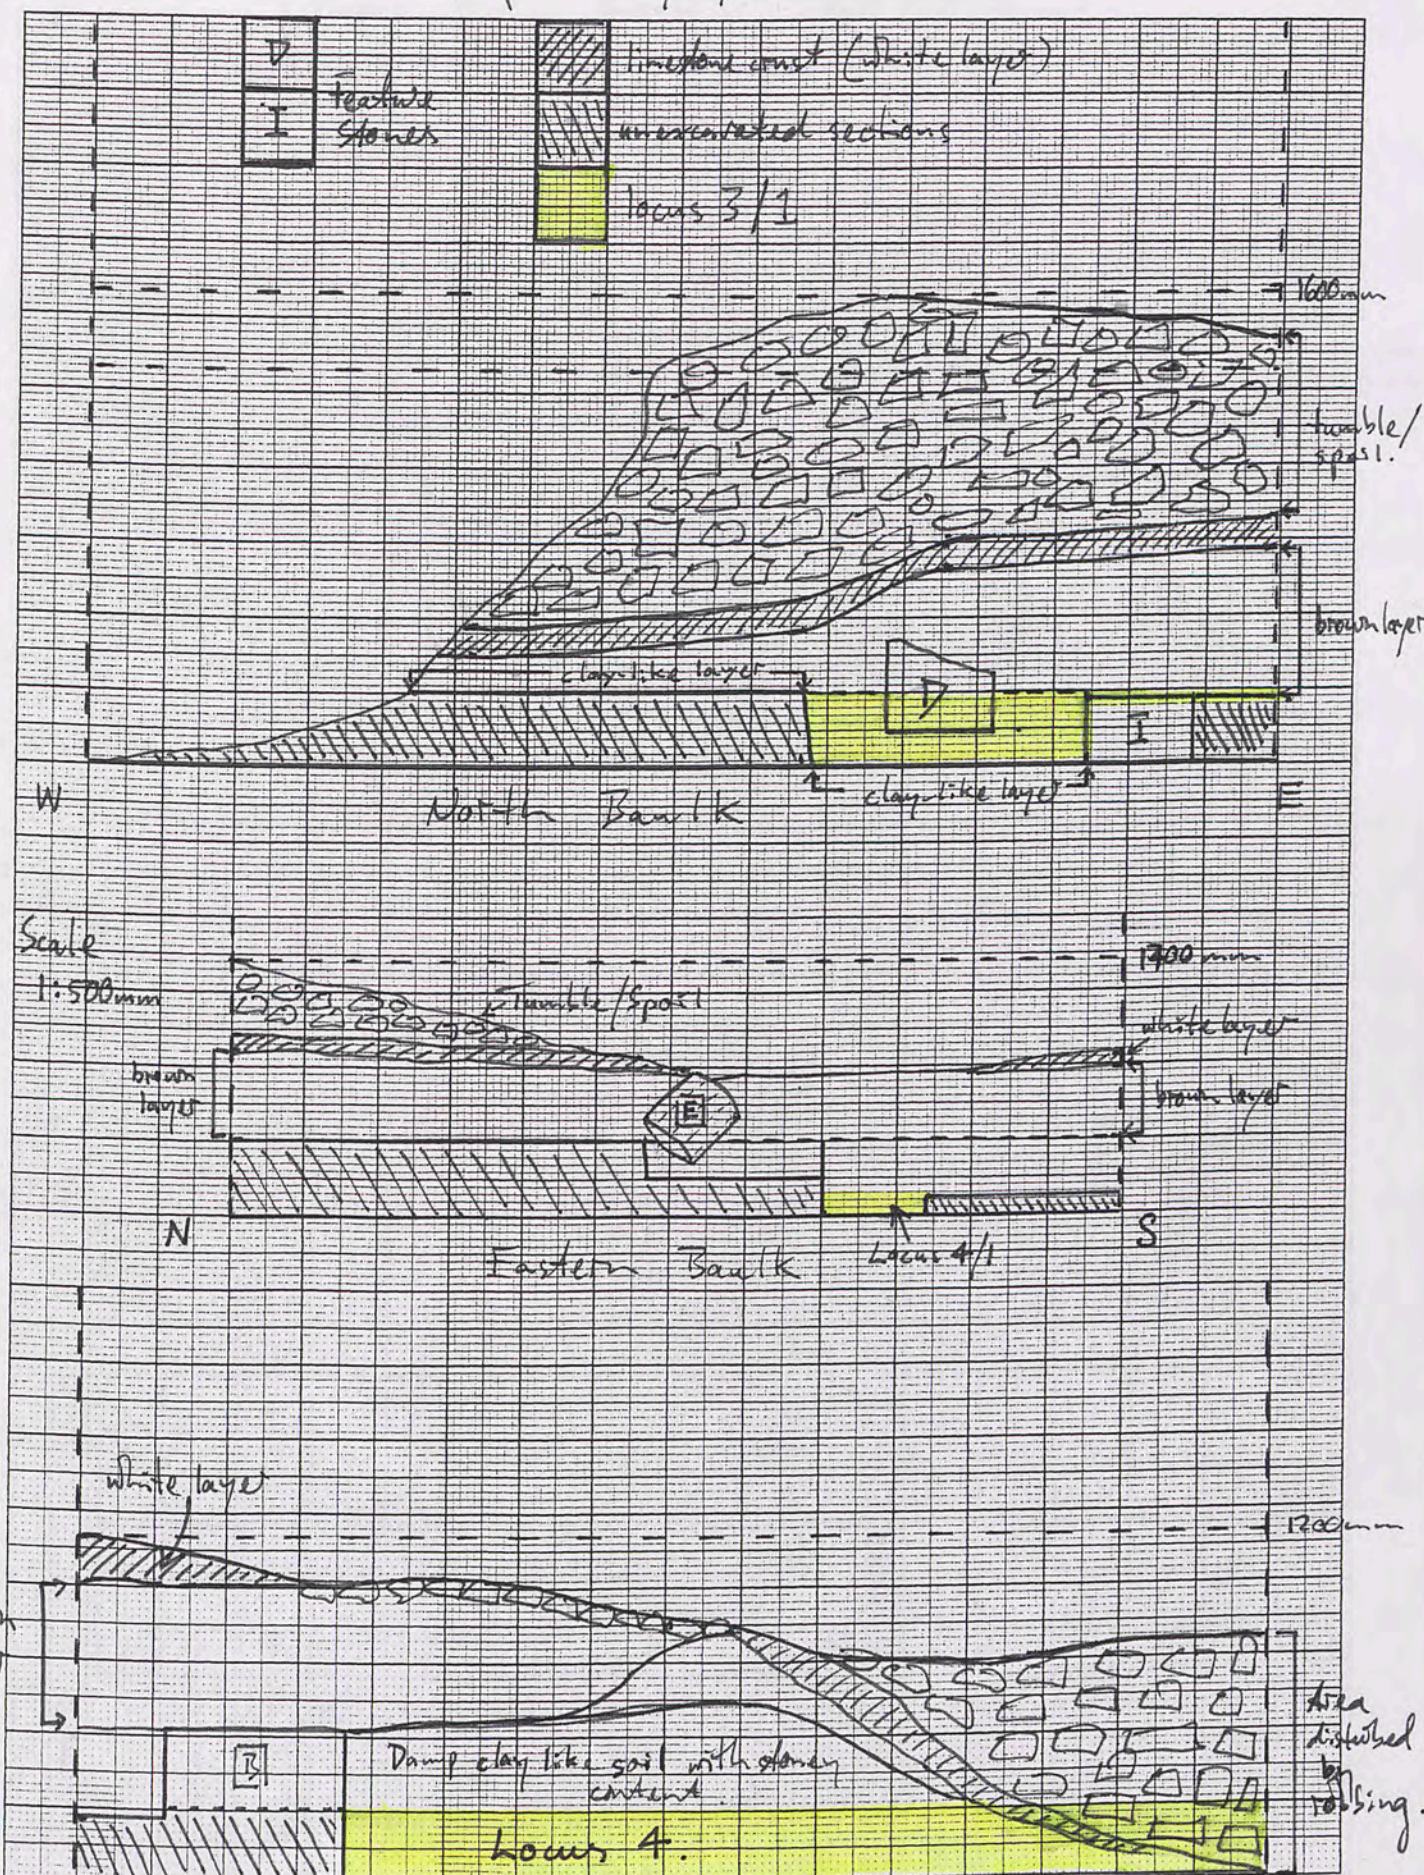
Sections: End day 8 1/5/2001 Scale: 1:250mm.

| (end L4/1) | Current depth: 1040 mm (benchmark - south bank + feature stone [B] - junction of), 250 mm (end L3/1) + 450 mm (end L2/1) |
| | Feature stones [B] + [C] are clearly sitting on earth, as is [A] in adjacent context. |

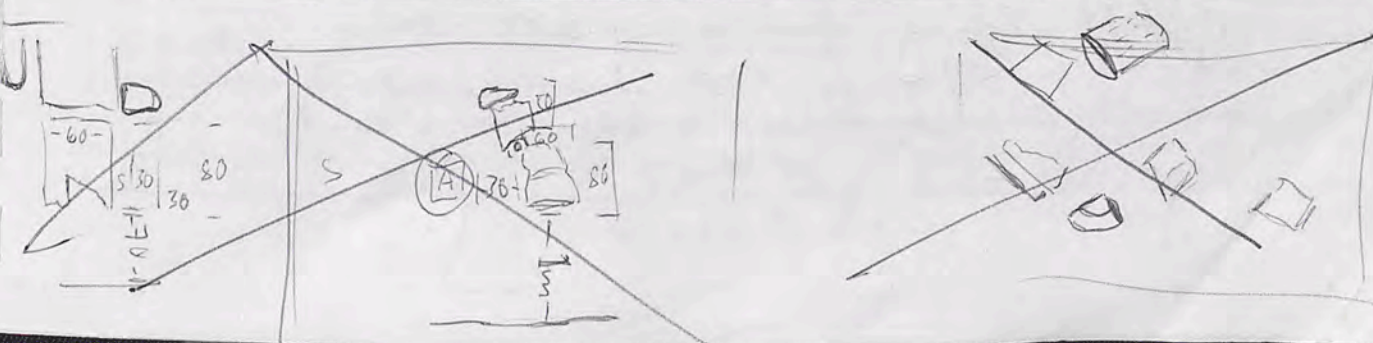
B12 15/5/01 Scale 1:500mm (End of Day) (B12 Fig 5)

| L1/2 | Worked stone (probably ionic volute) found at 260cm in (from Nth bank) & 80cm from ridge btw L1 + L2. (300mm-depth). Photographed CS3, 32-34, BWS #1-3 (1.2.4). |
| | Fragment of Doric capital found 290cm along from North border. (3.1.1) |
| | Object 3.1.2 found 170cm from Nth border. |

| 3/1 | On a second glance 3.1.1 (donc capital) has fluting on its base. This has been photographed & the capital found in B13. (see photo ref.) Small piece of possible architrave or cornice molding lifted from |

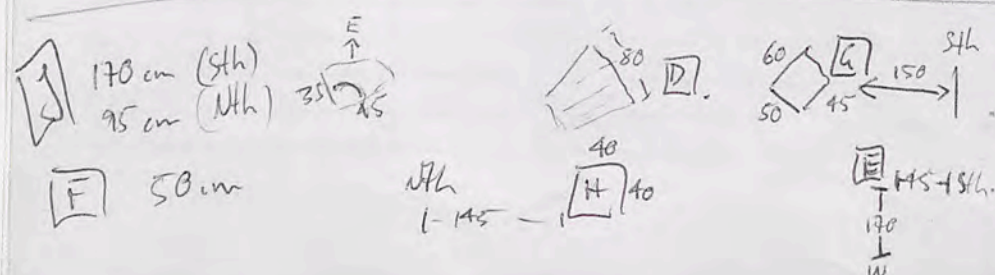
| (1.3.1) | Worked mobile found in remnant of bank btw B9/B12. (1.35m in from Nth bank). |
| (1.3.2) | Volute (a little more worn than 1.2.4) found in Nth bank near junction of L3/1 & L1/3. |

B12 16/5/2007 Scale: 1:500mm. (End of Day)

NB. All features remain as seen in Fig. 6

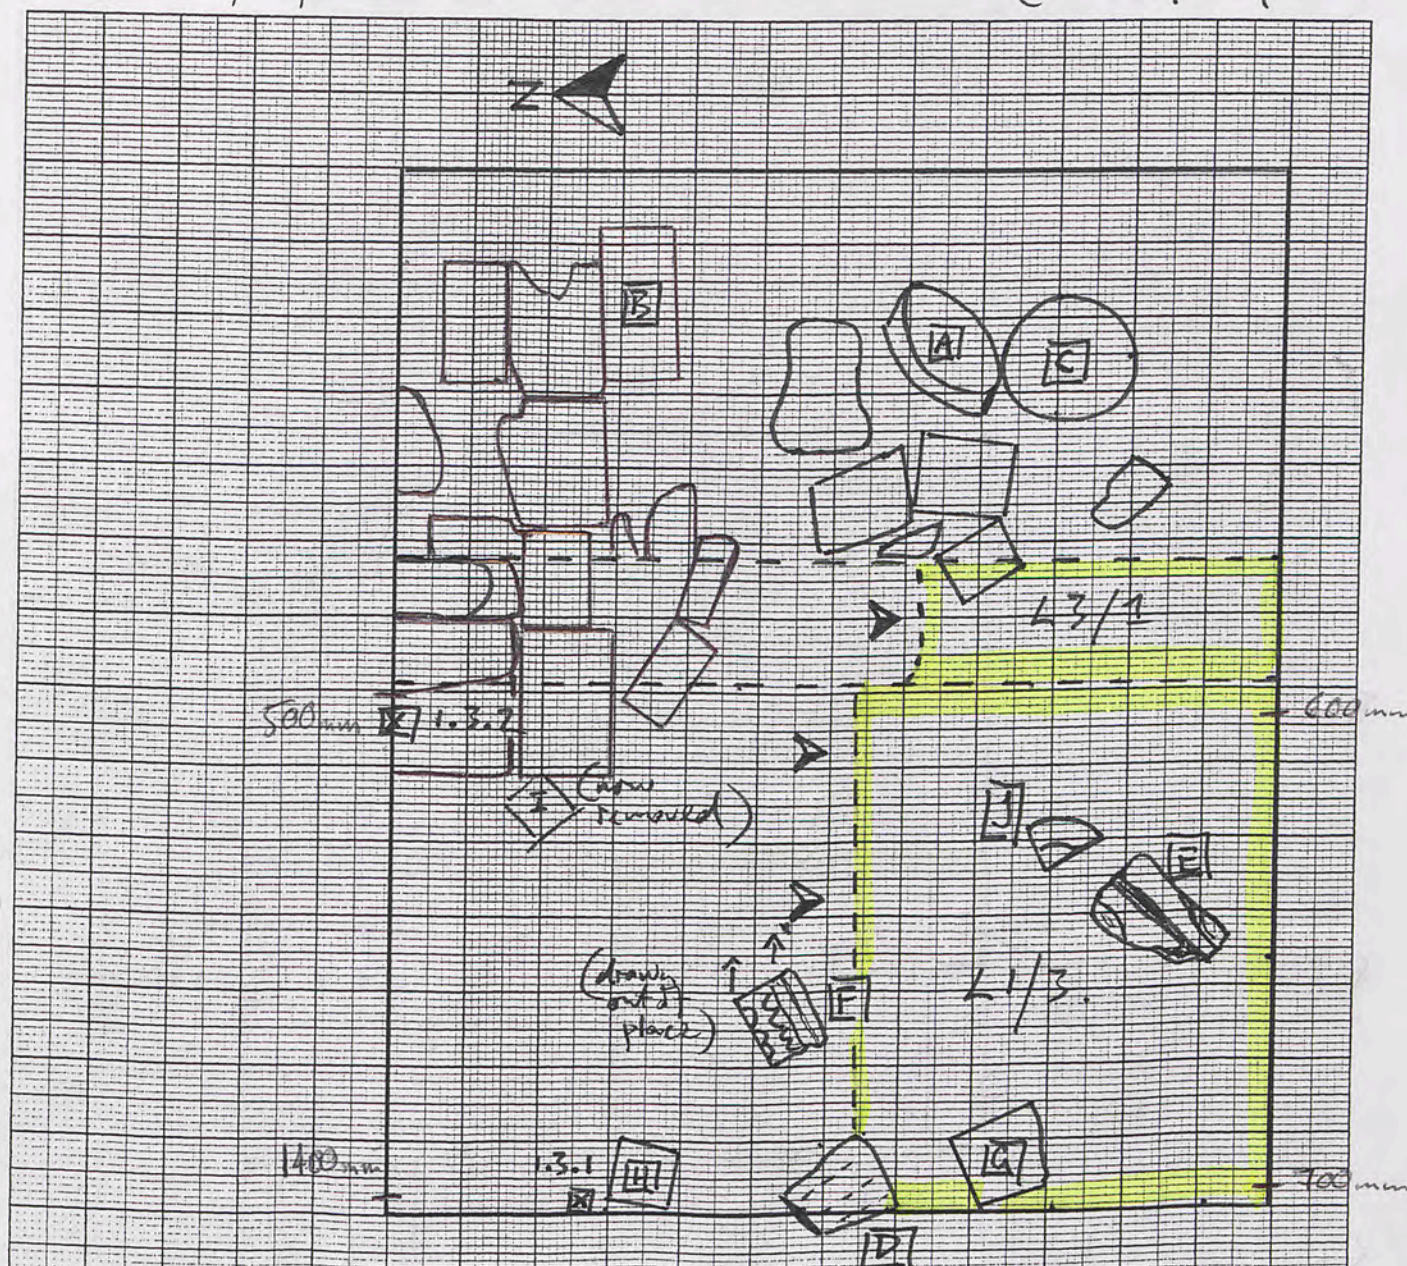
| D | column drum (strap fluted) |

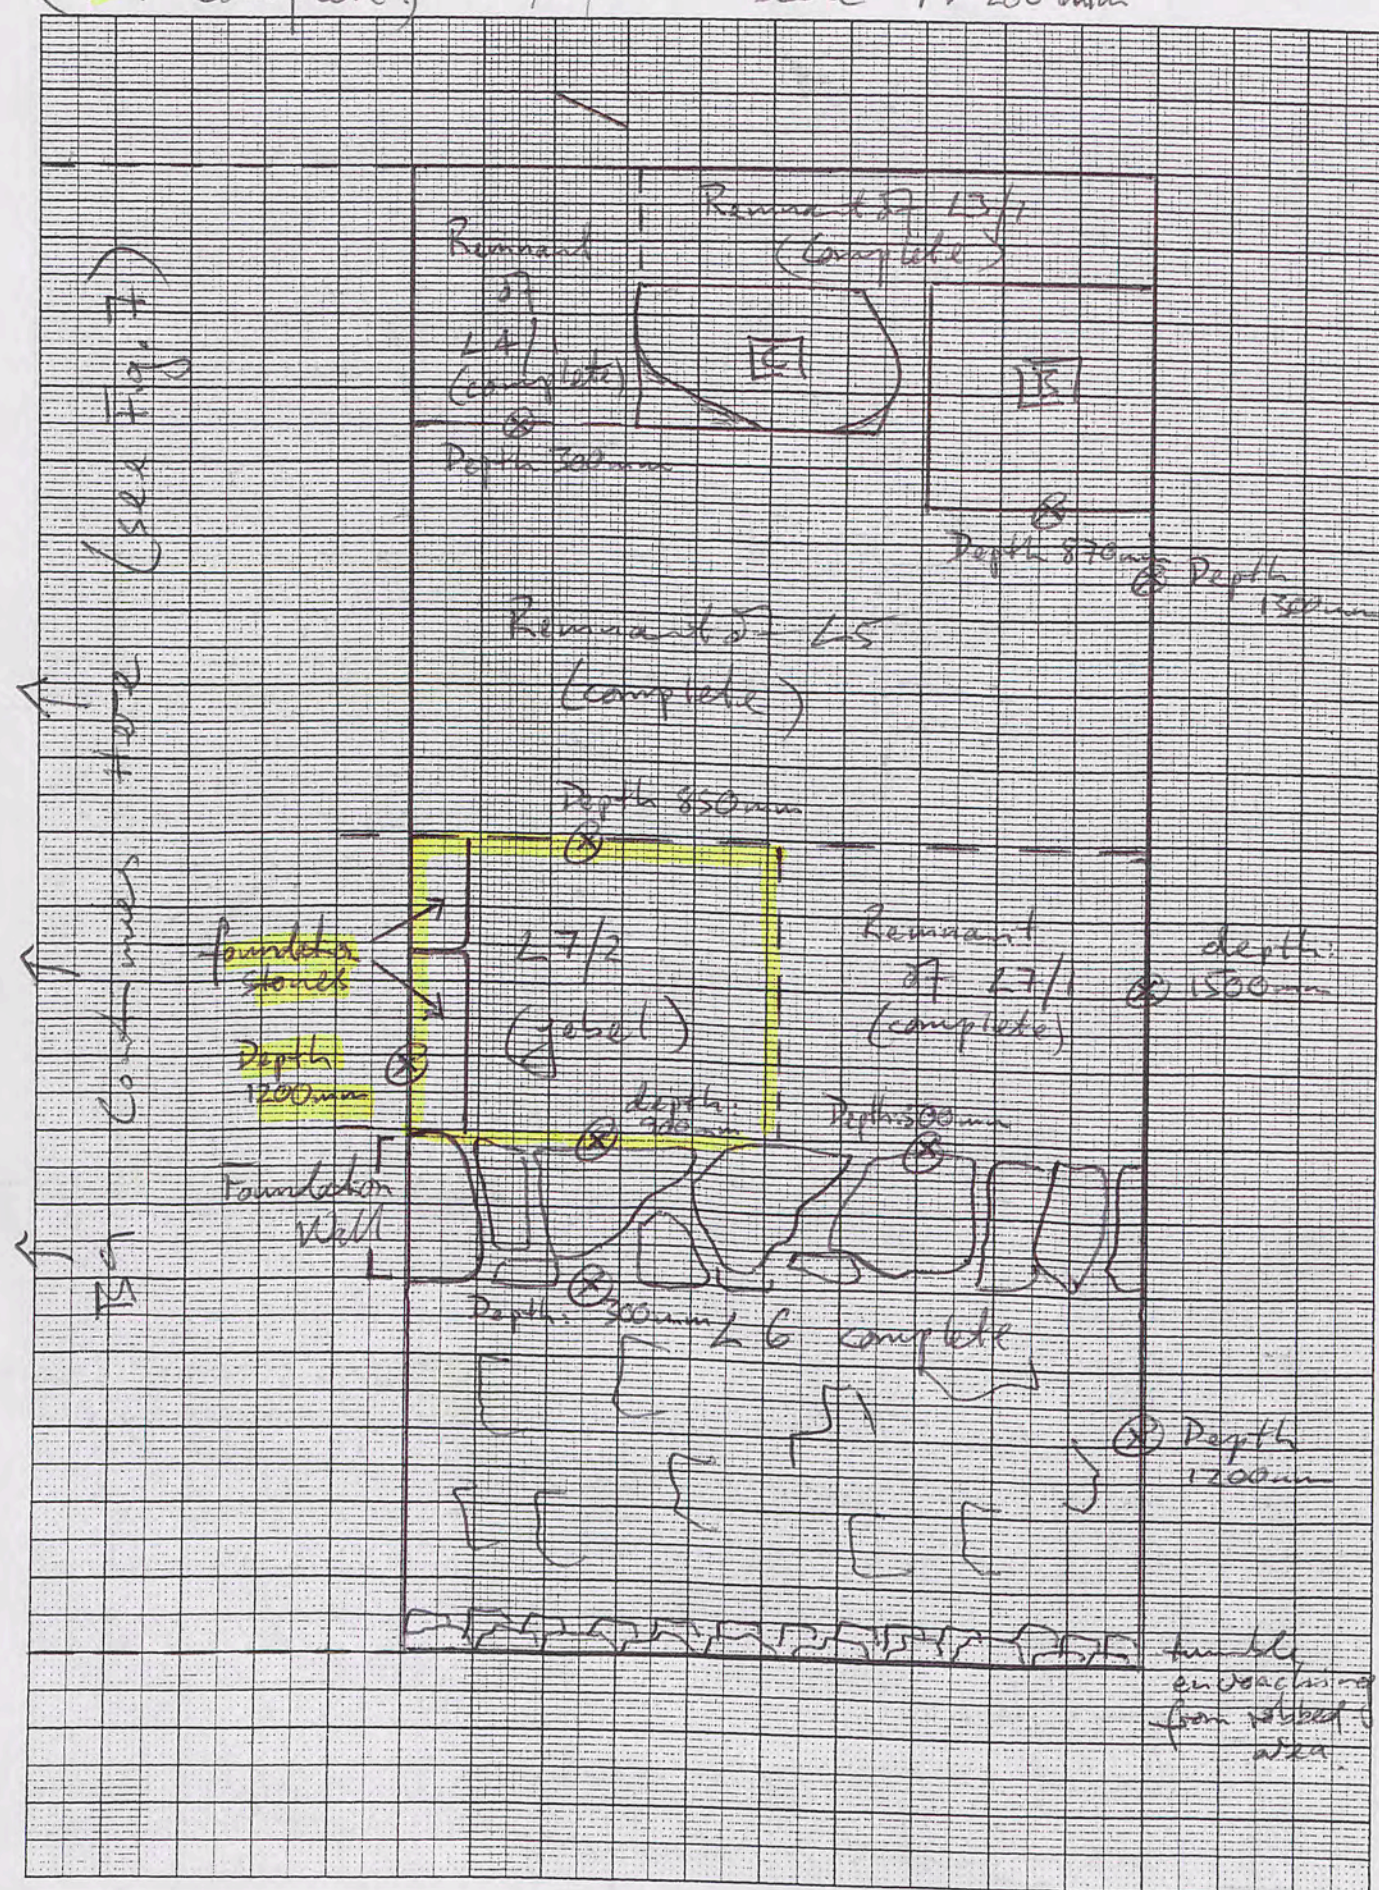
Fig 9. ~~Section~~ <sup>Plan</sup> of Southern end of B9 featuring foundation trench.  
(B9 Complete.) 17/5/01 Scale 1:200 mm

| Context | Report |
|---|---|
| 27/2 | It appears that we finally have reached bedrock.<br>(depth: 900mm).<br>Plan: clear base from grit & foundation<br>stones for photography. |

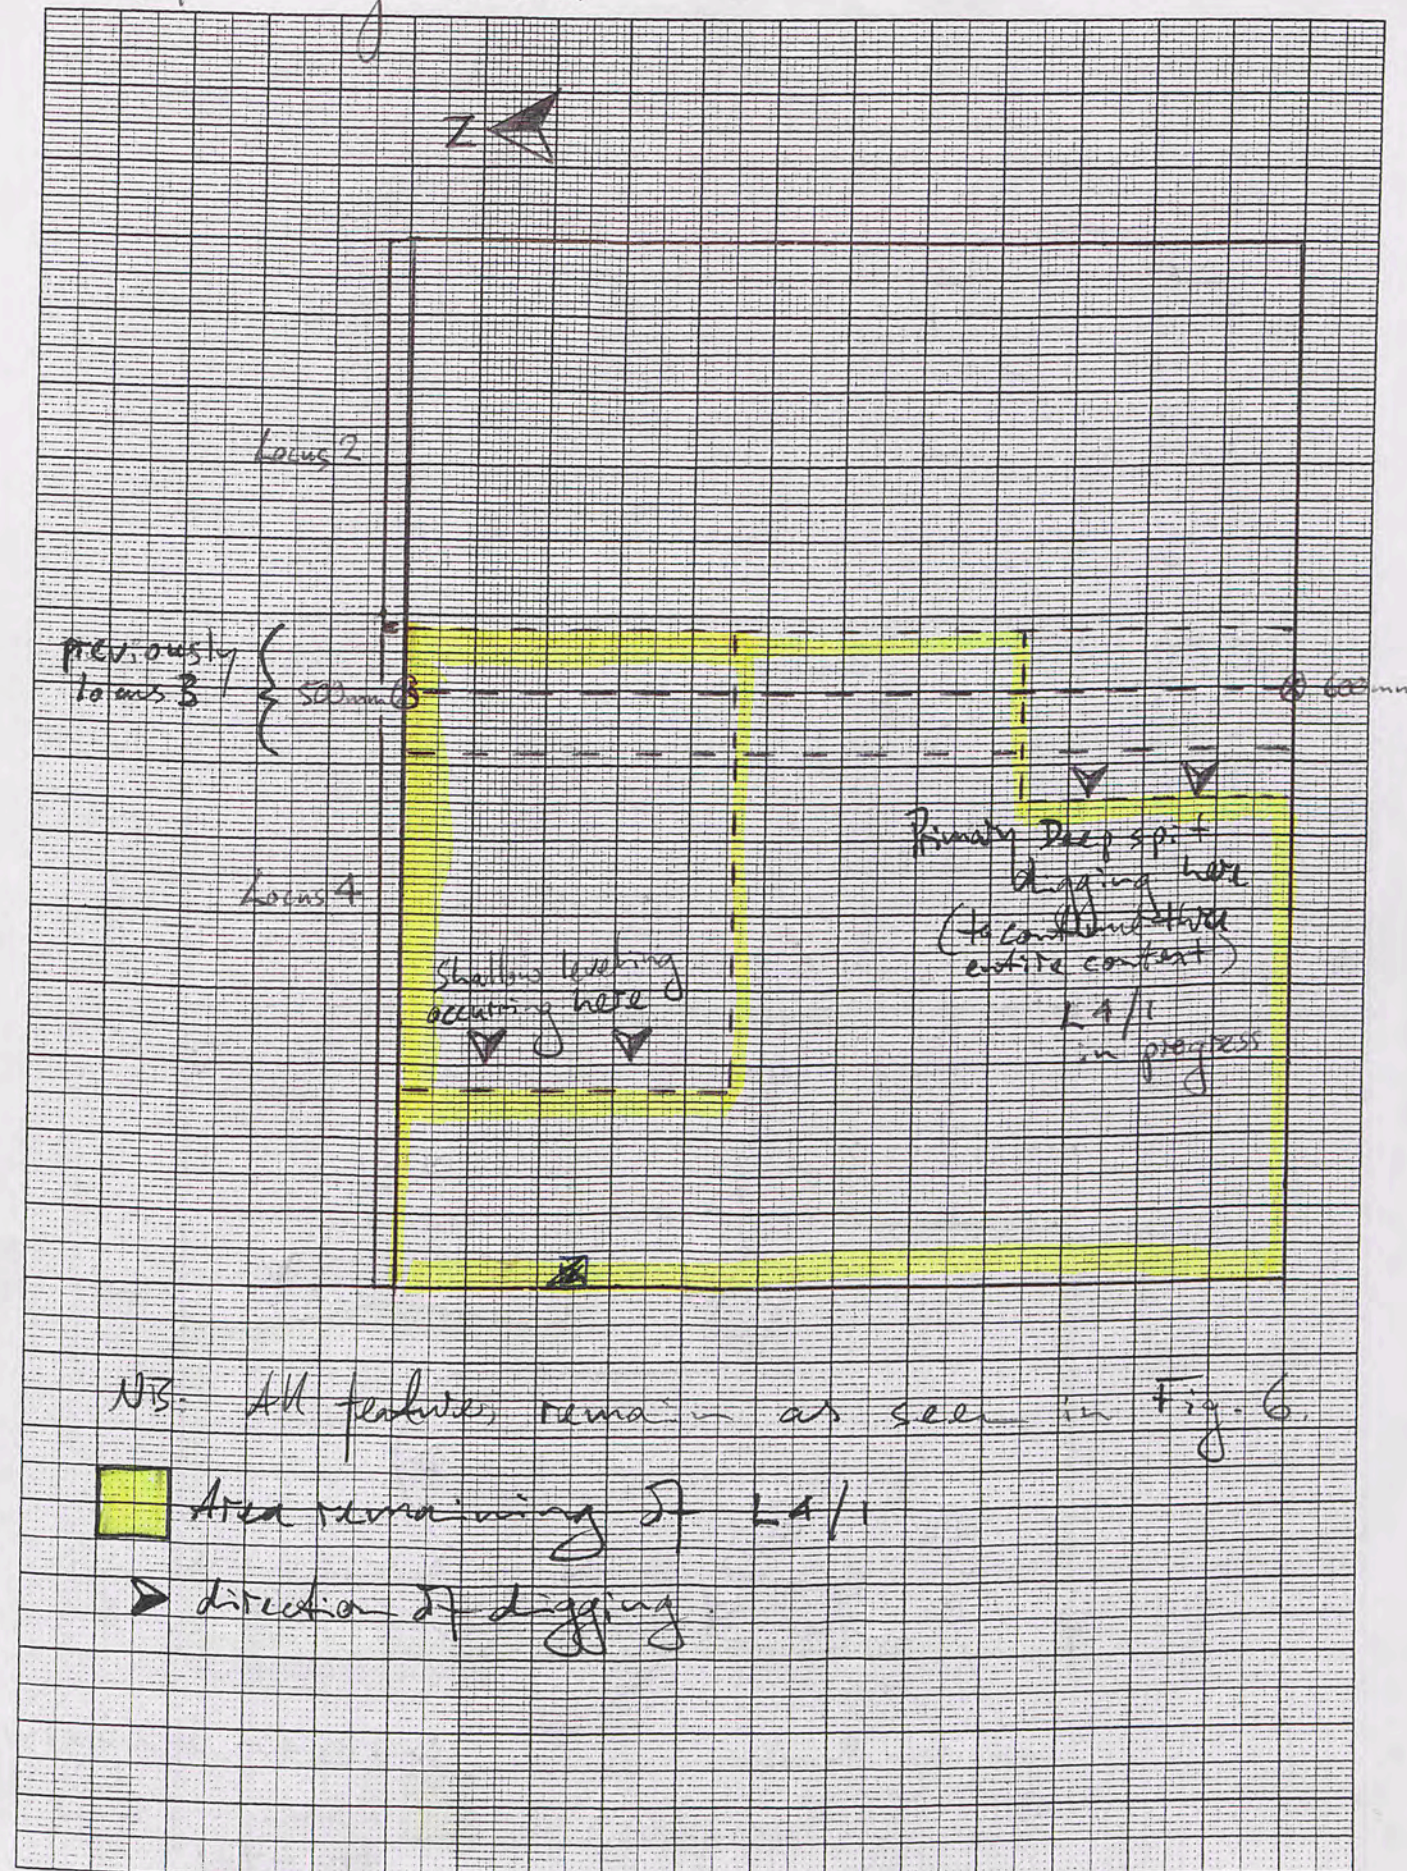
17/5/07 Progress: B12 Scale 1:500 mm

Area remaining of LA/1

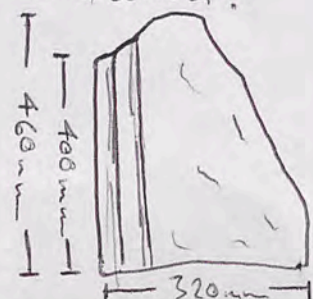
B12 Fig 10 24/5/01 Scale: 1:500mm

L2/3 Note: Worked stone revealed on 9/5/01 (see B12 Fig 3) appears to be a cornice block, though abraded. This will be photographed later in context & all feature stones removed from this bench:

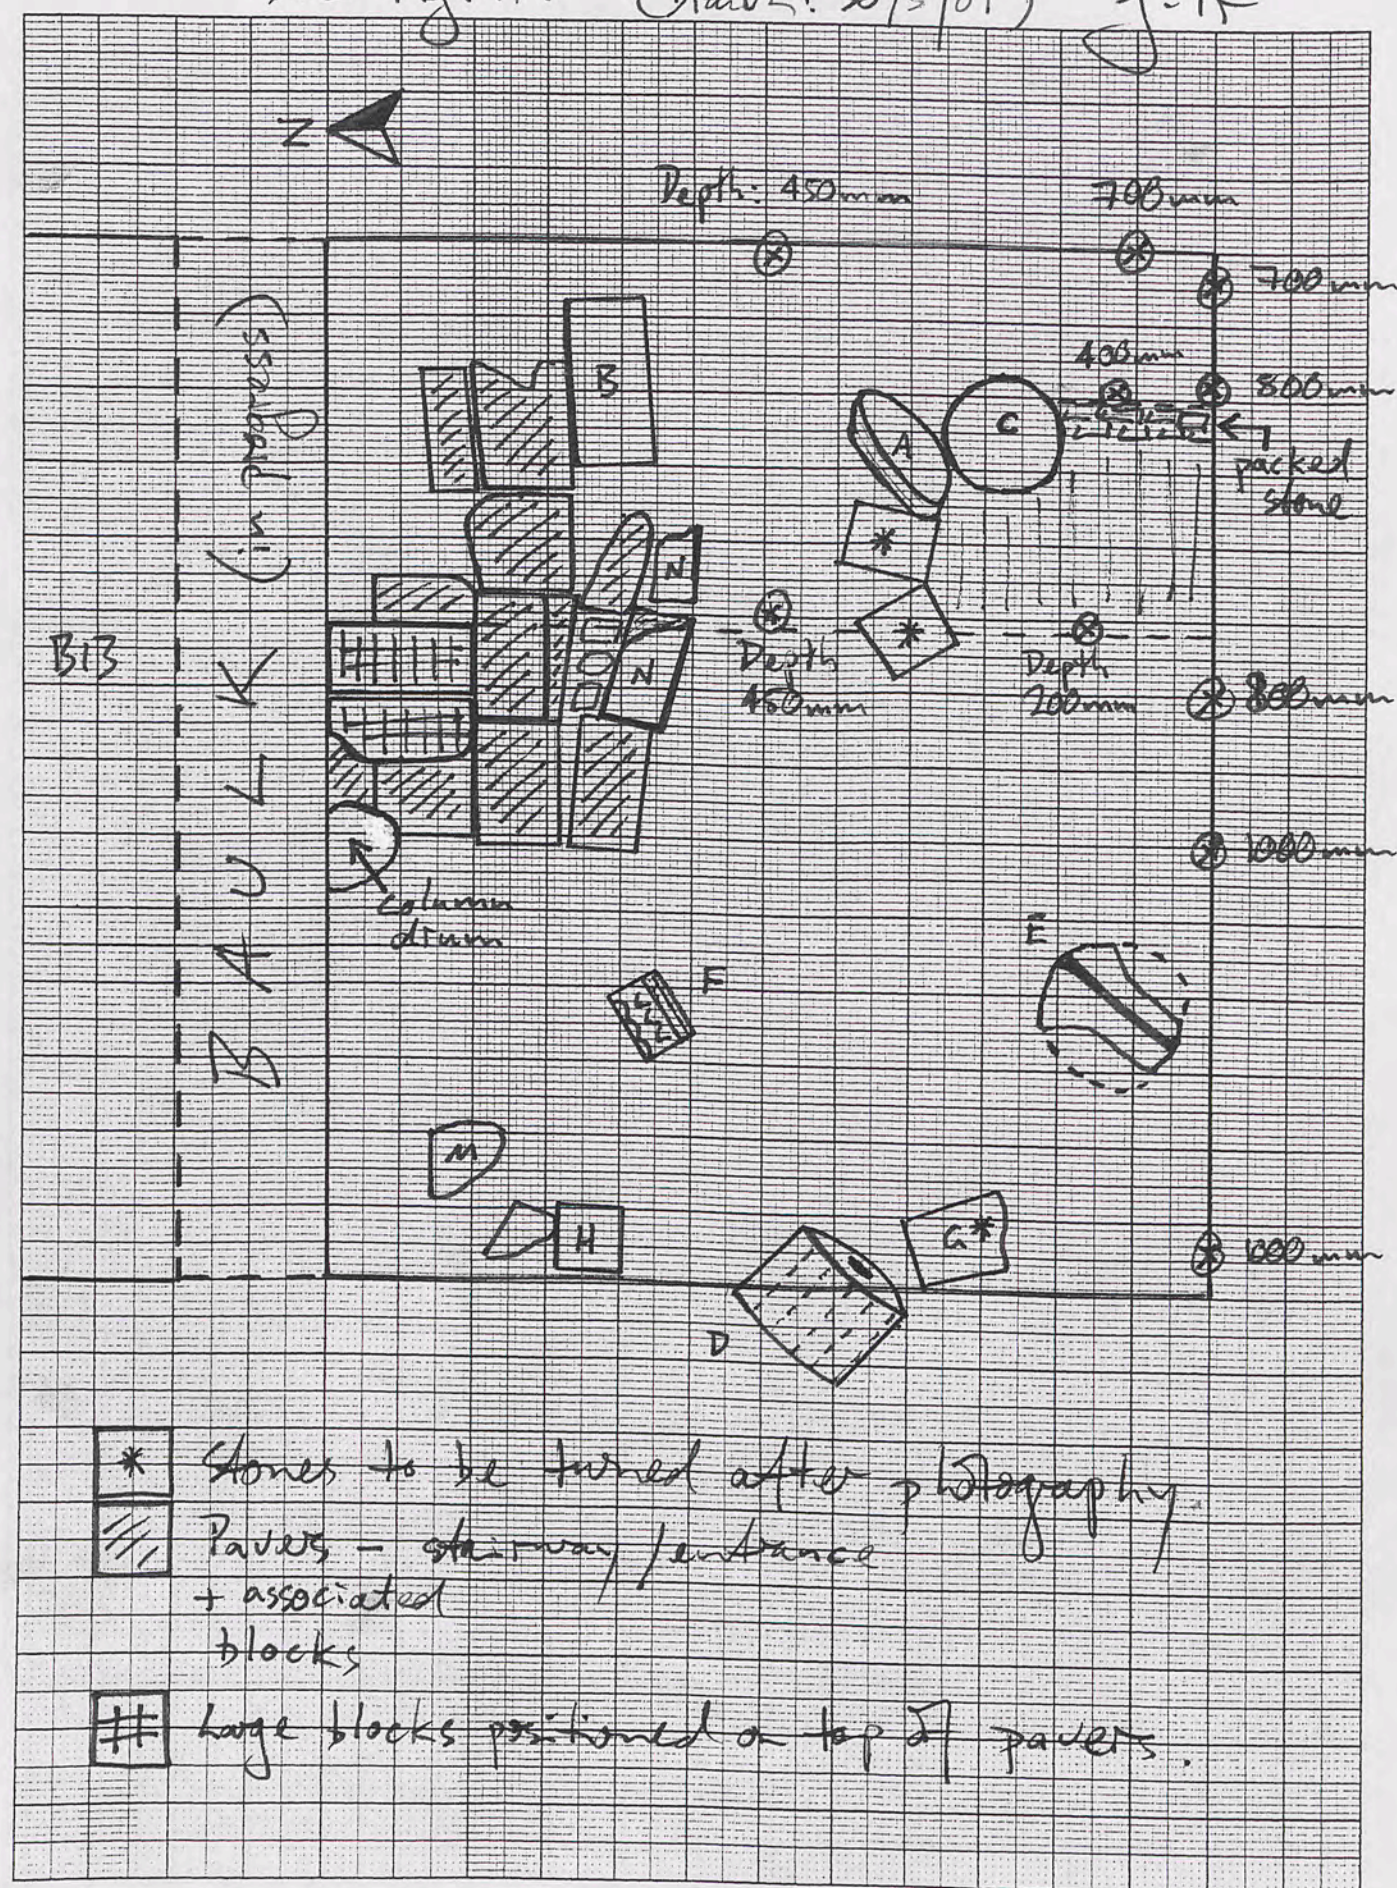
Completed Trench. Scale: 1:500mm. 1mm Squares  
 B12 Fig. 11. (Drawn: 30/5/01) J-T

| | (NB: width & depth along eastern bank - 400mm; Southern bank - 500mm). |

Other main blocks shown in Fig. 11 represent the south aspect of the entrance or stairway.
