# Jebel Khalid 20002

## Field Record Book

Name..... Ed Clarke.....  
Trenches..... T21 (Area B), Western Bank, Southern Bank, Expansion into B22.....  
..... B23, B22 exp W.....  
Dates..... 14 April 2002 - 23 ~~Apr~~ May 2002.....

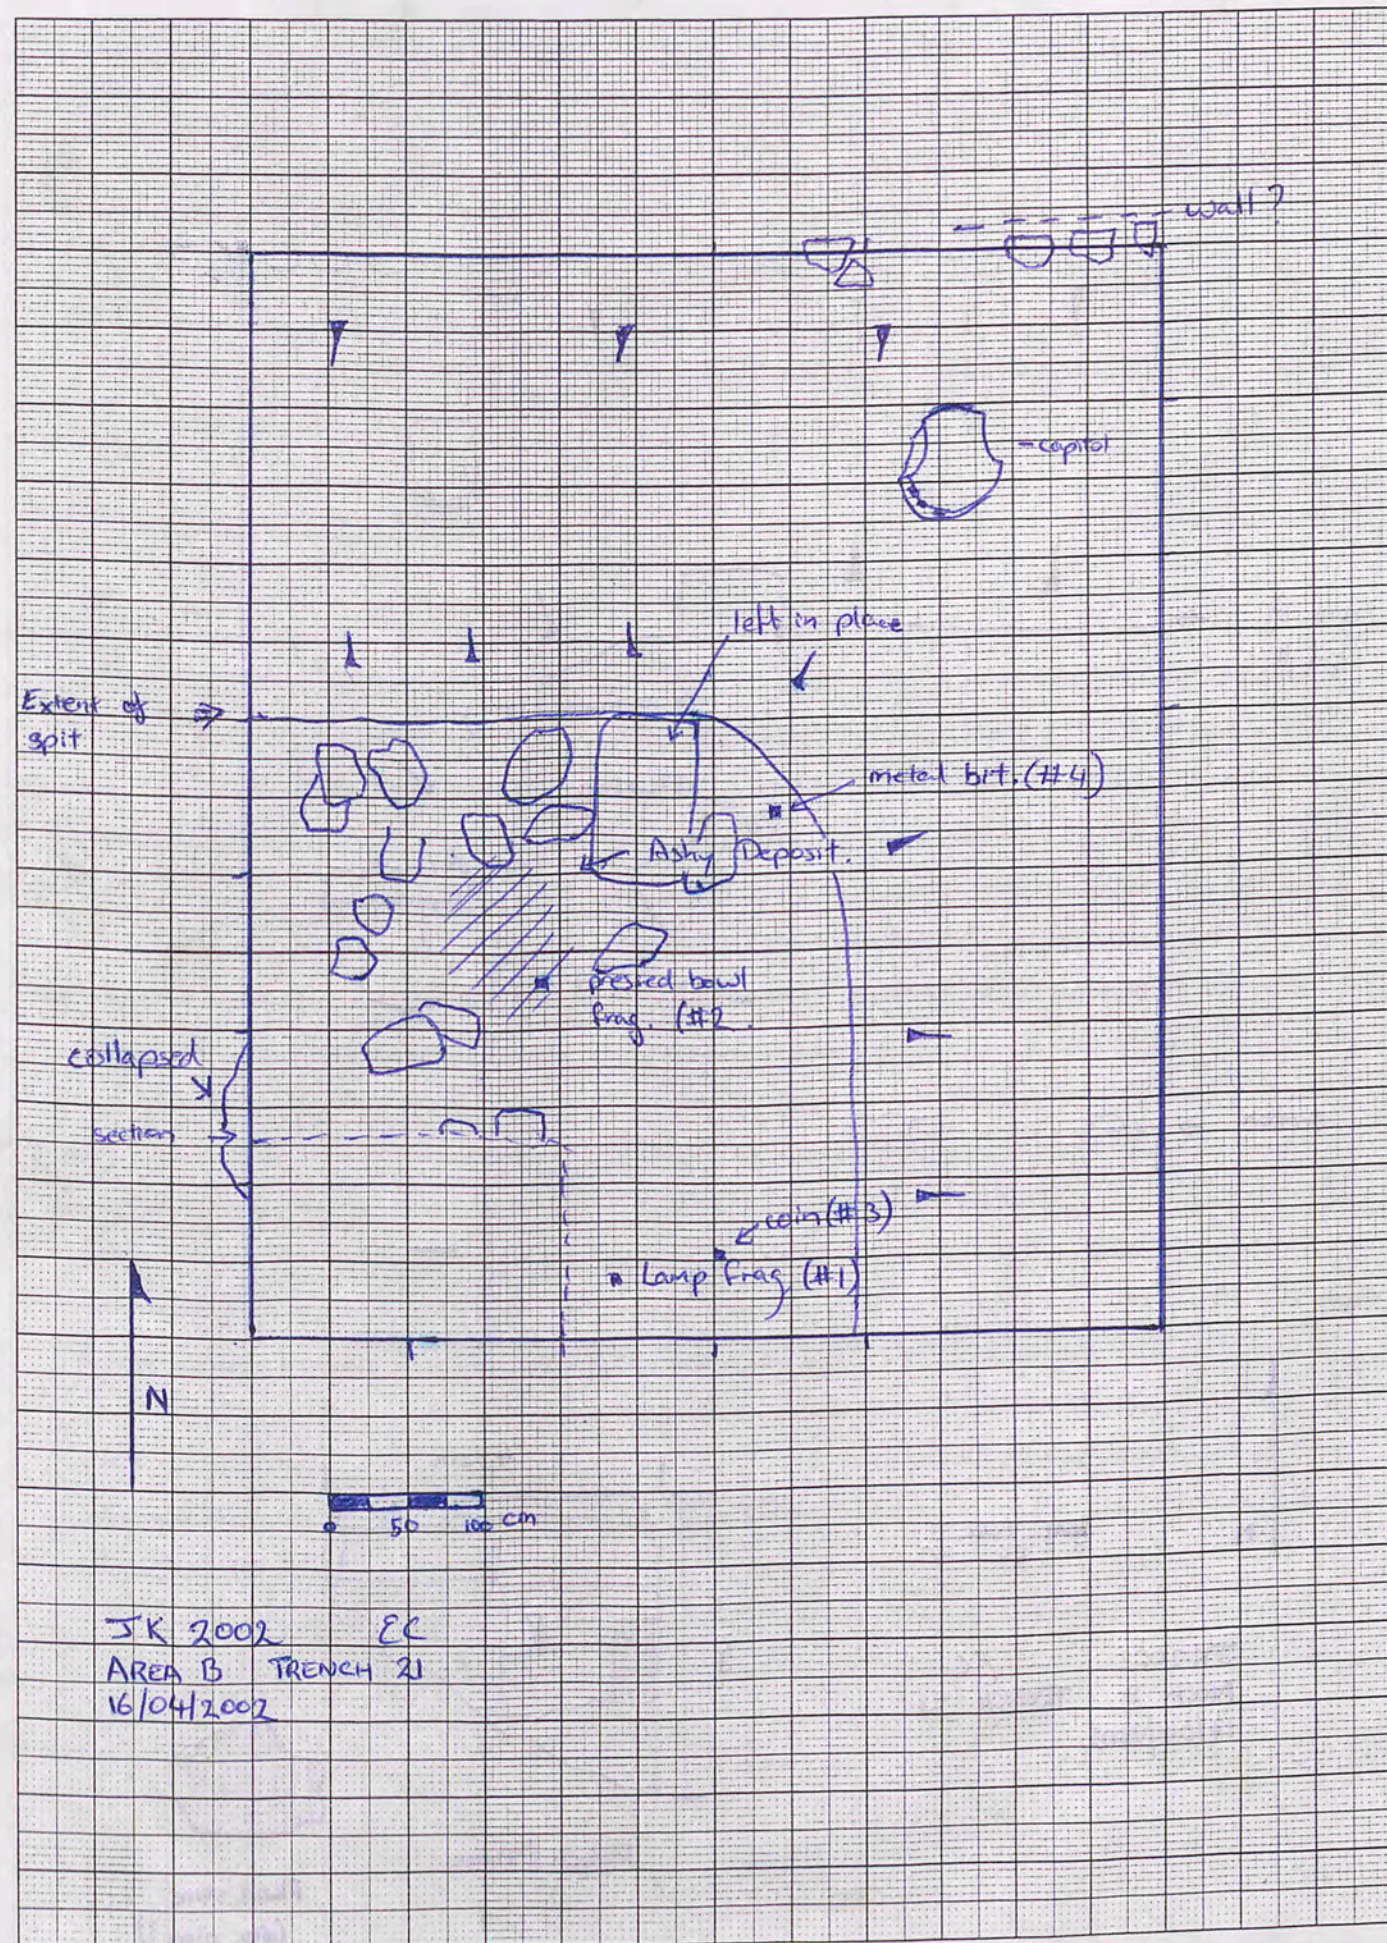
JK 2002 EC  
 AREA B TRENCH 21  
 16/04/2002

NB. External Spring replaced by B. Rowney in roughly the correct position. Northern wall appears to have moved to mostly outside the trench.

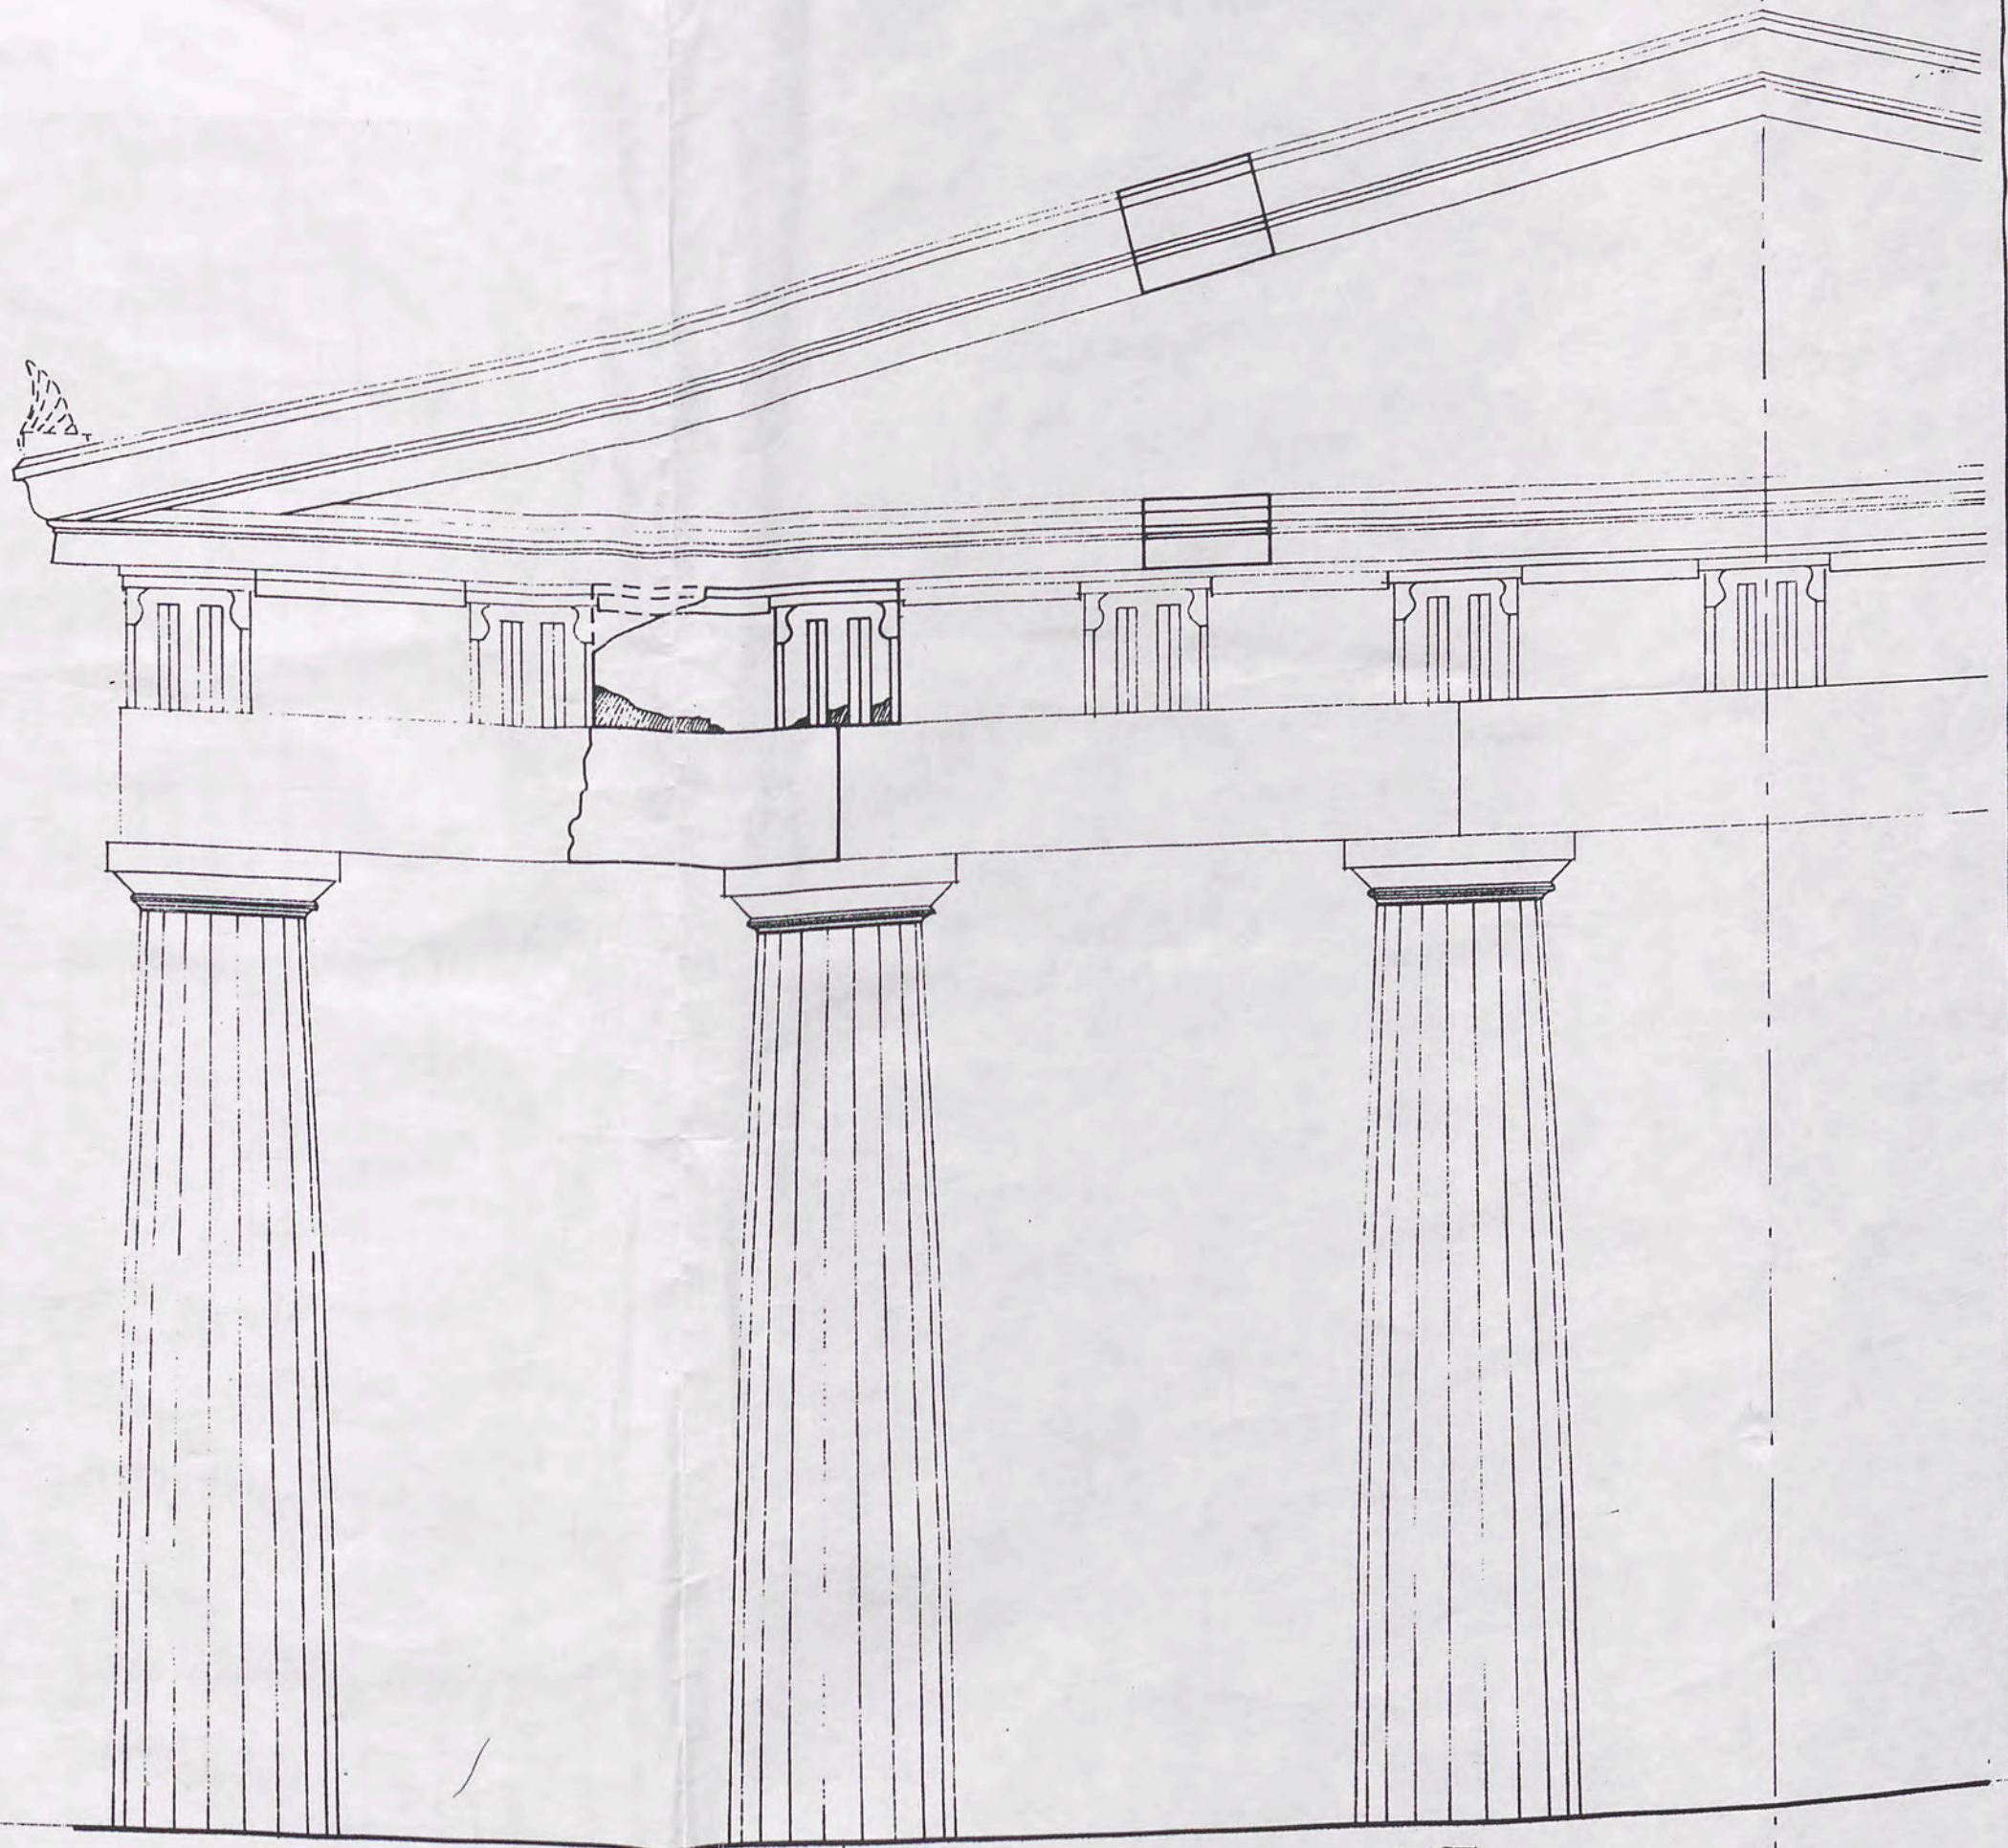
ELEVATION ~ RECONSTRUCTION

AREA B JEBEL KHALID

AUGUST 2000
