# Jebel Khalid

## Field Record Book

Name..... R. THORNLEY  
Trenches..... Room 82 South Baulk (23 Apr 05), Room 91 E-W Baulk (23 Apr)  
Rooms..... 90, 91, 92, 100, 84, 91, 81, 93, 85  
Dates.....

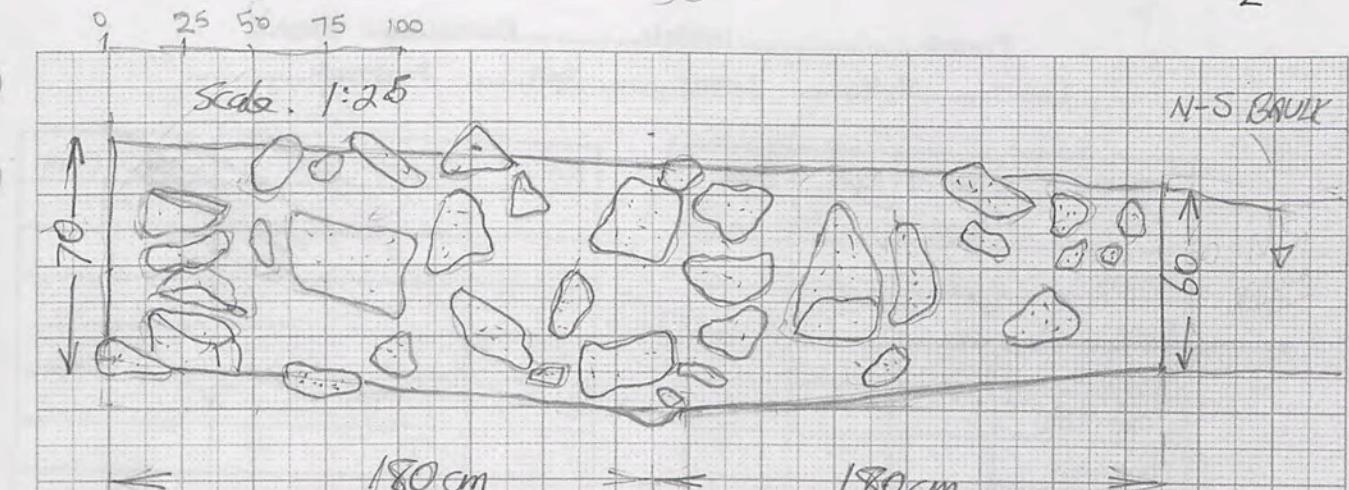
SECTION ROOM 90 E-W BAULK (E END) (N.FACE)

Rooms 90/97 Baulk cleared for photography drawn  
S-Baulk E end of baulk start point. Brown soil & flint  
Shards

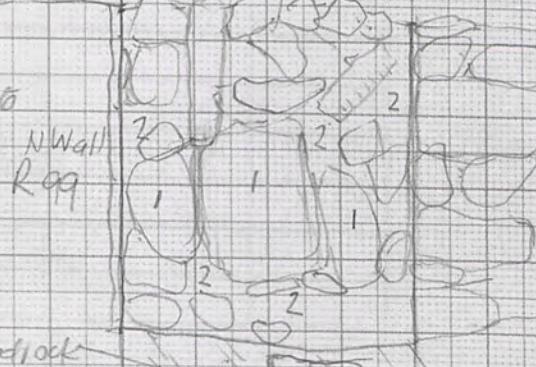
SECTION OF BLOCKED  
DOOR

- 1 Conglomerate  
2 Soil

SECTION - BLOCKED DOOR  
E SIDE FM ROOM 83

1 SECTION - BLOCKED DOOR W SIDE  
FRM ROOM 99

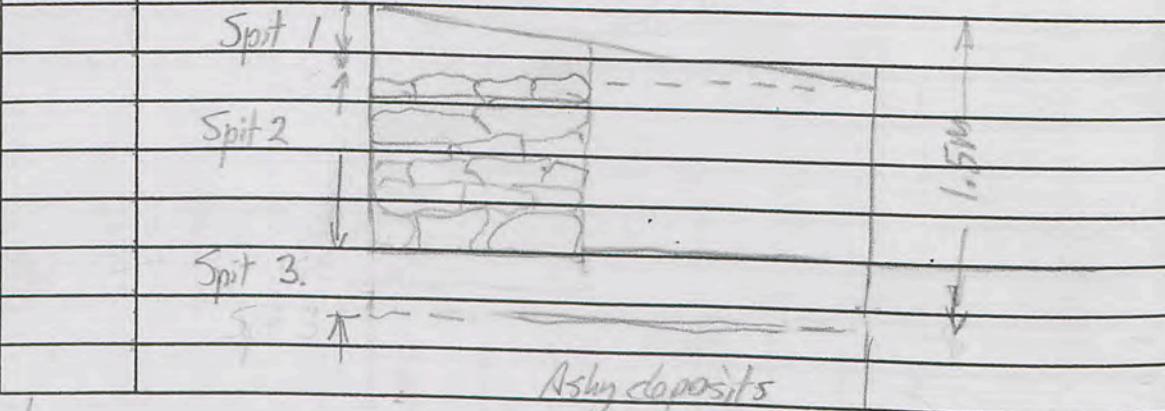
Bedrock  
 Spit 1  
 Spit 2  
 Spit 3  
 Spit 4  
 Ashy deposits  
 Cleared & photographed next day 18 May 05

- Loc 1 Aim to see if the E wall of room is a double wall, with the adjacent house/room.  
 Appears to be double wall in area near N wall.  
 Wall (?) - perhaps a corner? ? wall?  
 Ashy deposits in E wall/bank  
 Sample taken from approx 1.2-1.4m down from top of bank/wall
- Loc 1.2 Wall? in Spit 2 over bank - secondary  
 Ashy deposit below → pottery.
- Loc 1.3 (Continues)
- Loc 1.4 Planned to dig to bedrock to see if E-W wall is on it  
 It is - at c. 1.8M from top of wall
