# Jebel Khalid

## Field Record Book

ACROPOLIS 100  
102

Name..... J. TIDMARSH.....  
Trenches..... Acropolis : 100 / 102.....  
.....  
Dates..... 23/4/06.....

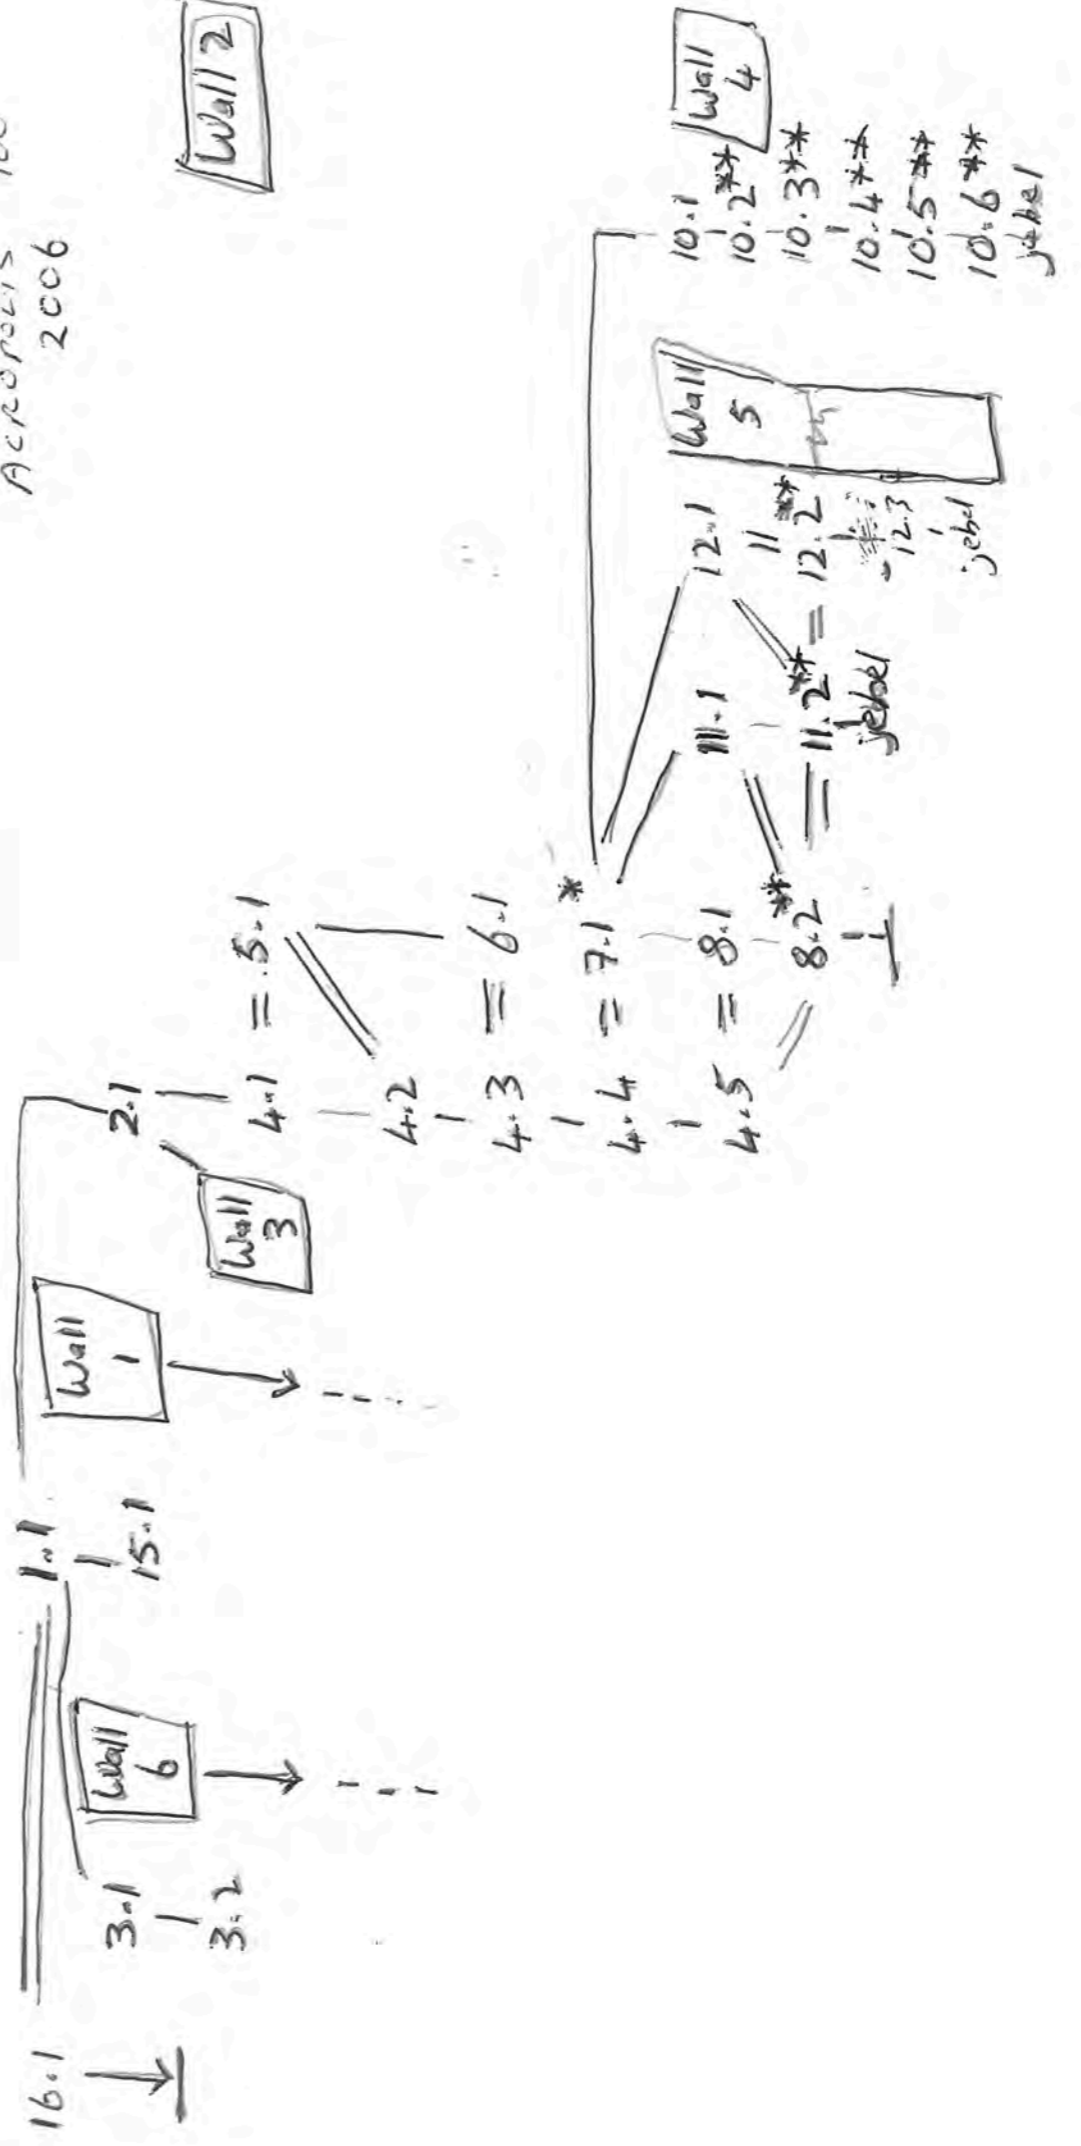
ACROPOLIS 100  
2006

\* = Occupat' Surface  
 \*\* = later phase (II)  
 \*\* = earlier phase (I)  
 N.B only top of 7.1 occupat' surface (later phase)
