Jebel Khalid
2010
Area S

Field Record Book

Name.....	HEATHER JACKSON	BOOK 2
Trenches.....	AREA S T39	
Dates.....	1/5/10

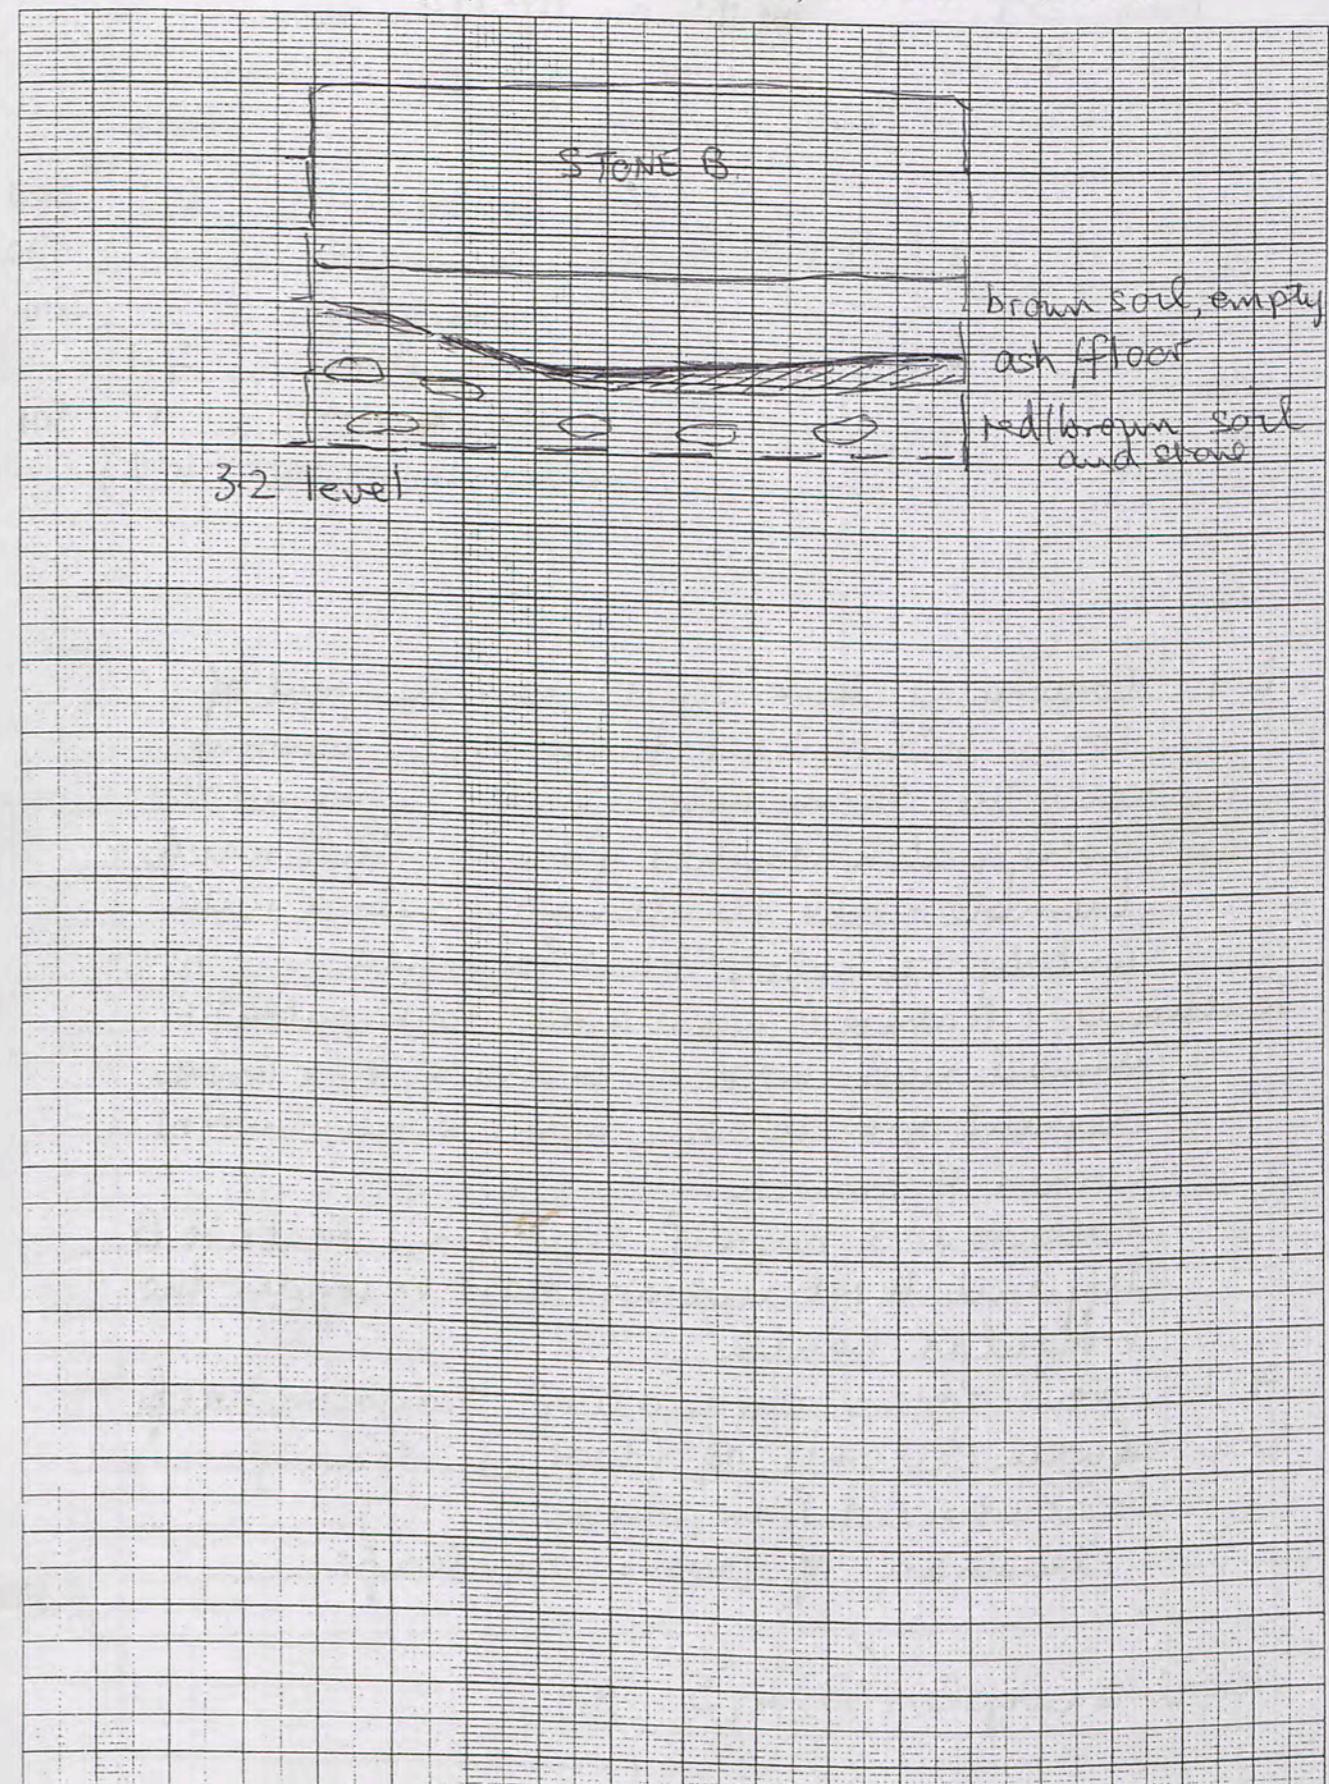
E FACE STONE B, SHOWING FLOOR.

Context	Report
b.1	Continuing to south with little pottery and no objects, reddish brown soil and still much tumble.
∅	Stone B photographed.. 838 Floor not found in south? Fedwa has found floor ² surface ^{25cm} lower than oven floor - above it can be seen several layers of ash, the topmost of which was the oven floor. will leave "oven" in NE corner and exc rest of b.1 to floor 2. Stone B removed. Some charcoal in soil of ashy layer.

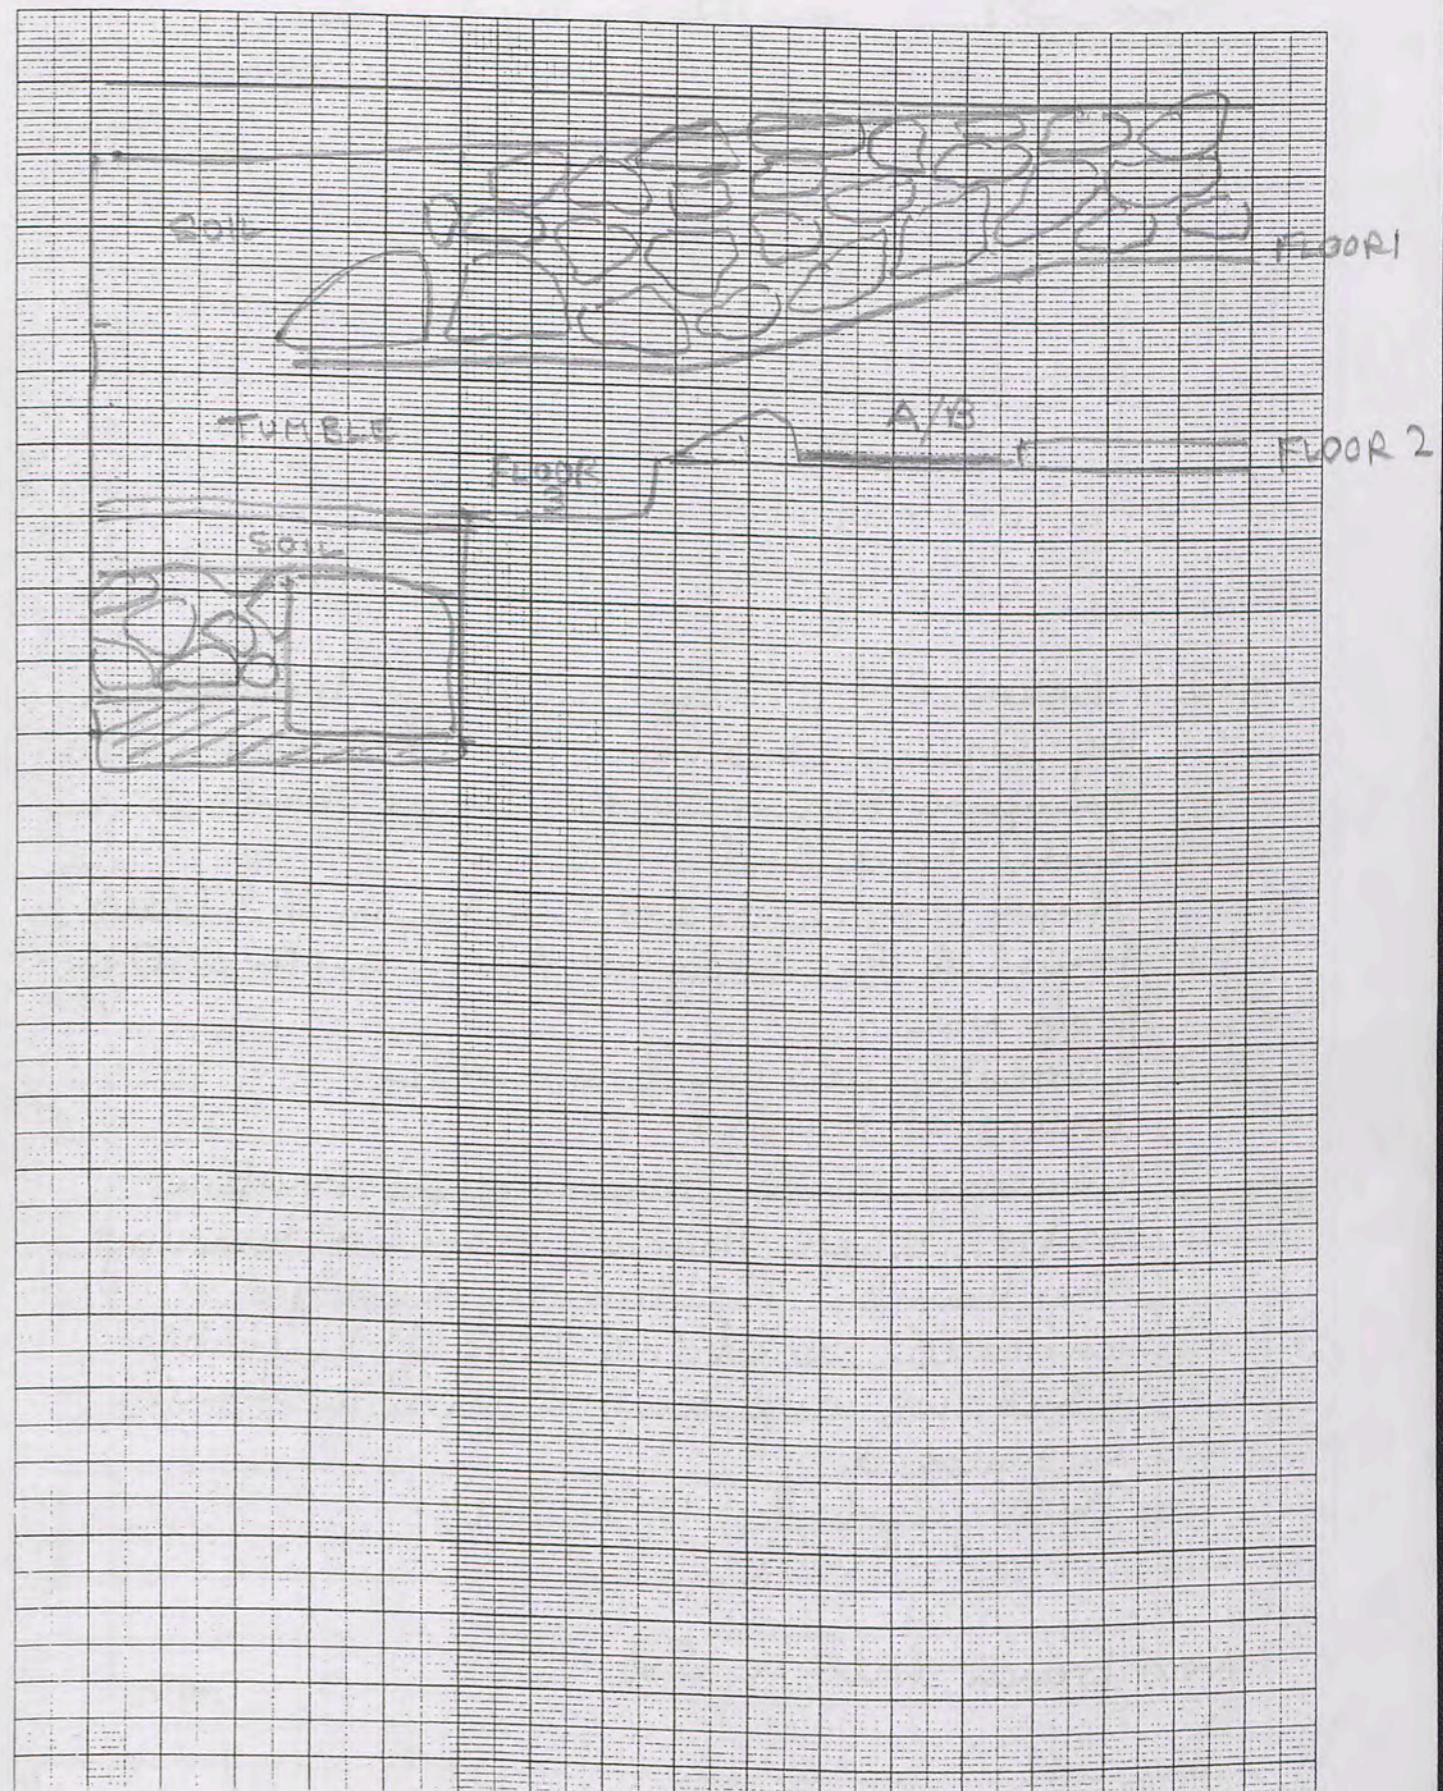
T 39
W. BAULK 1:25

Context	Report
8.1	SE corner. Soil brown & moist; small stones
9.1	SW corner. Ditto. Both loci producing dark brown soil with few stones.
9.1	Has reached a floor, so leaving it at that level continue to bedrock in 8.1 to see wall foundations of walls B, C and D. Wall B is now defined on its east face where Andrea's team is removing the eastern balk. It is now clear that the suspected doorway in it is a reality.

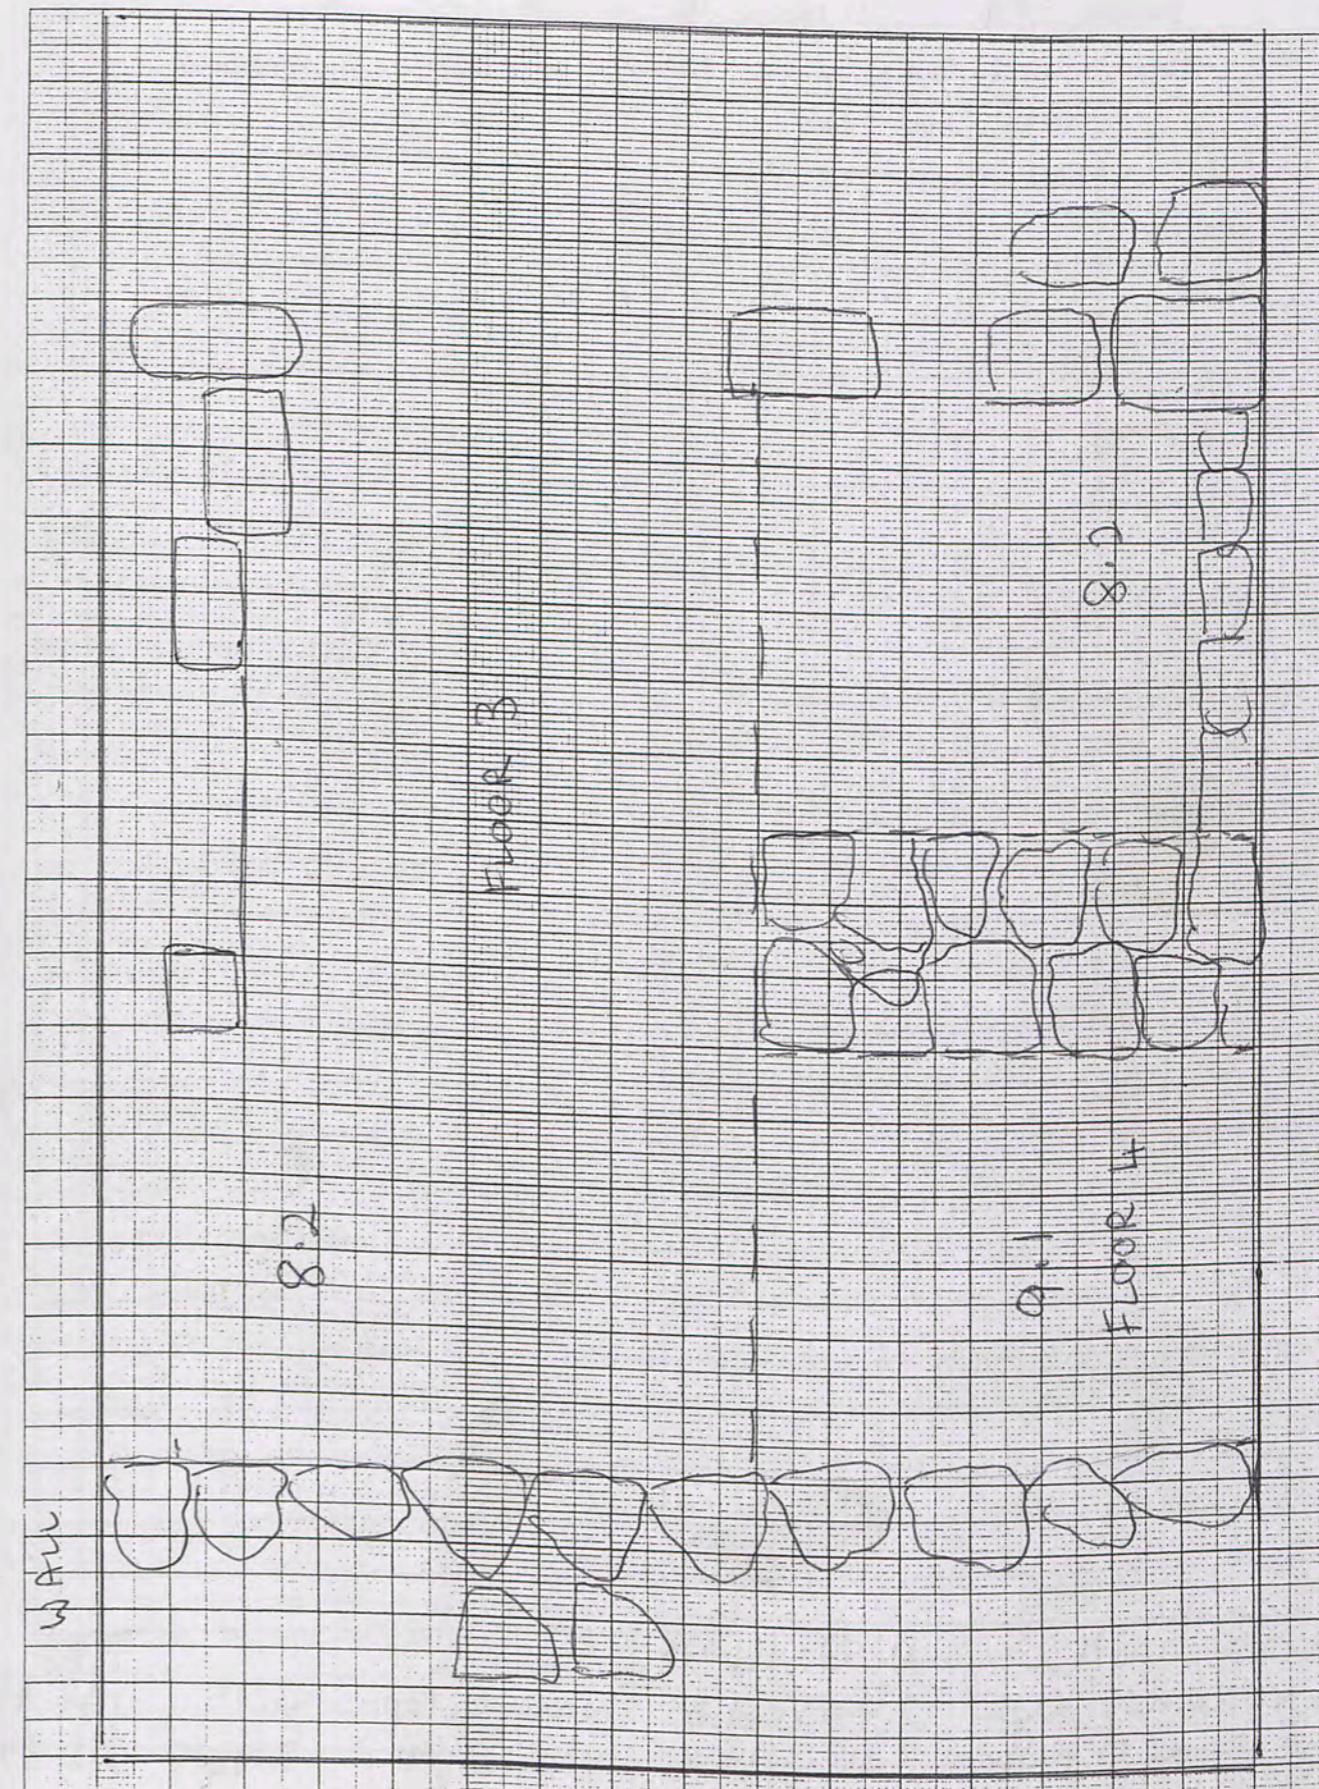
T39
15/5/10

Context	Report
8.2	Below 8.1, i.e. in SW corner bounded by walls C & D (low level). Content dampish brown soil & small stones. Little bone and pottery. Hope to reach bedrock today in this locus.
9.1	Finished Thursday at floor - depth 230 cm from NSL.
8.2	Currently 235 cm from NSL. Bedrock reached Clearing whole trench except eastern metre, where Andre's team are removing the baulk. The doorway east is currently closed (not blocked) by rubble which we will remove when the baulk is finished Photographed. 1052 - 59

Context	Report
1.1	Topsoil removal from new trench to NE of T47. One large stone (benchmark 3) in SE corner. Photographed topsoil.
	Notes on T39 Wall C 70 cm wide, 2-3 courses high, on bedrock, below floor 3. Wall D not exc full width smaller stones, 1 courses high, on bedrock Wall B on bedrock, 9 courses high, larger masonry at Top, different construction, more even, below floor 3
NB	See Andrea's bulk 44/39 for clearance of doorway

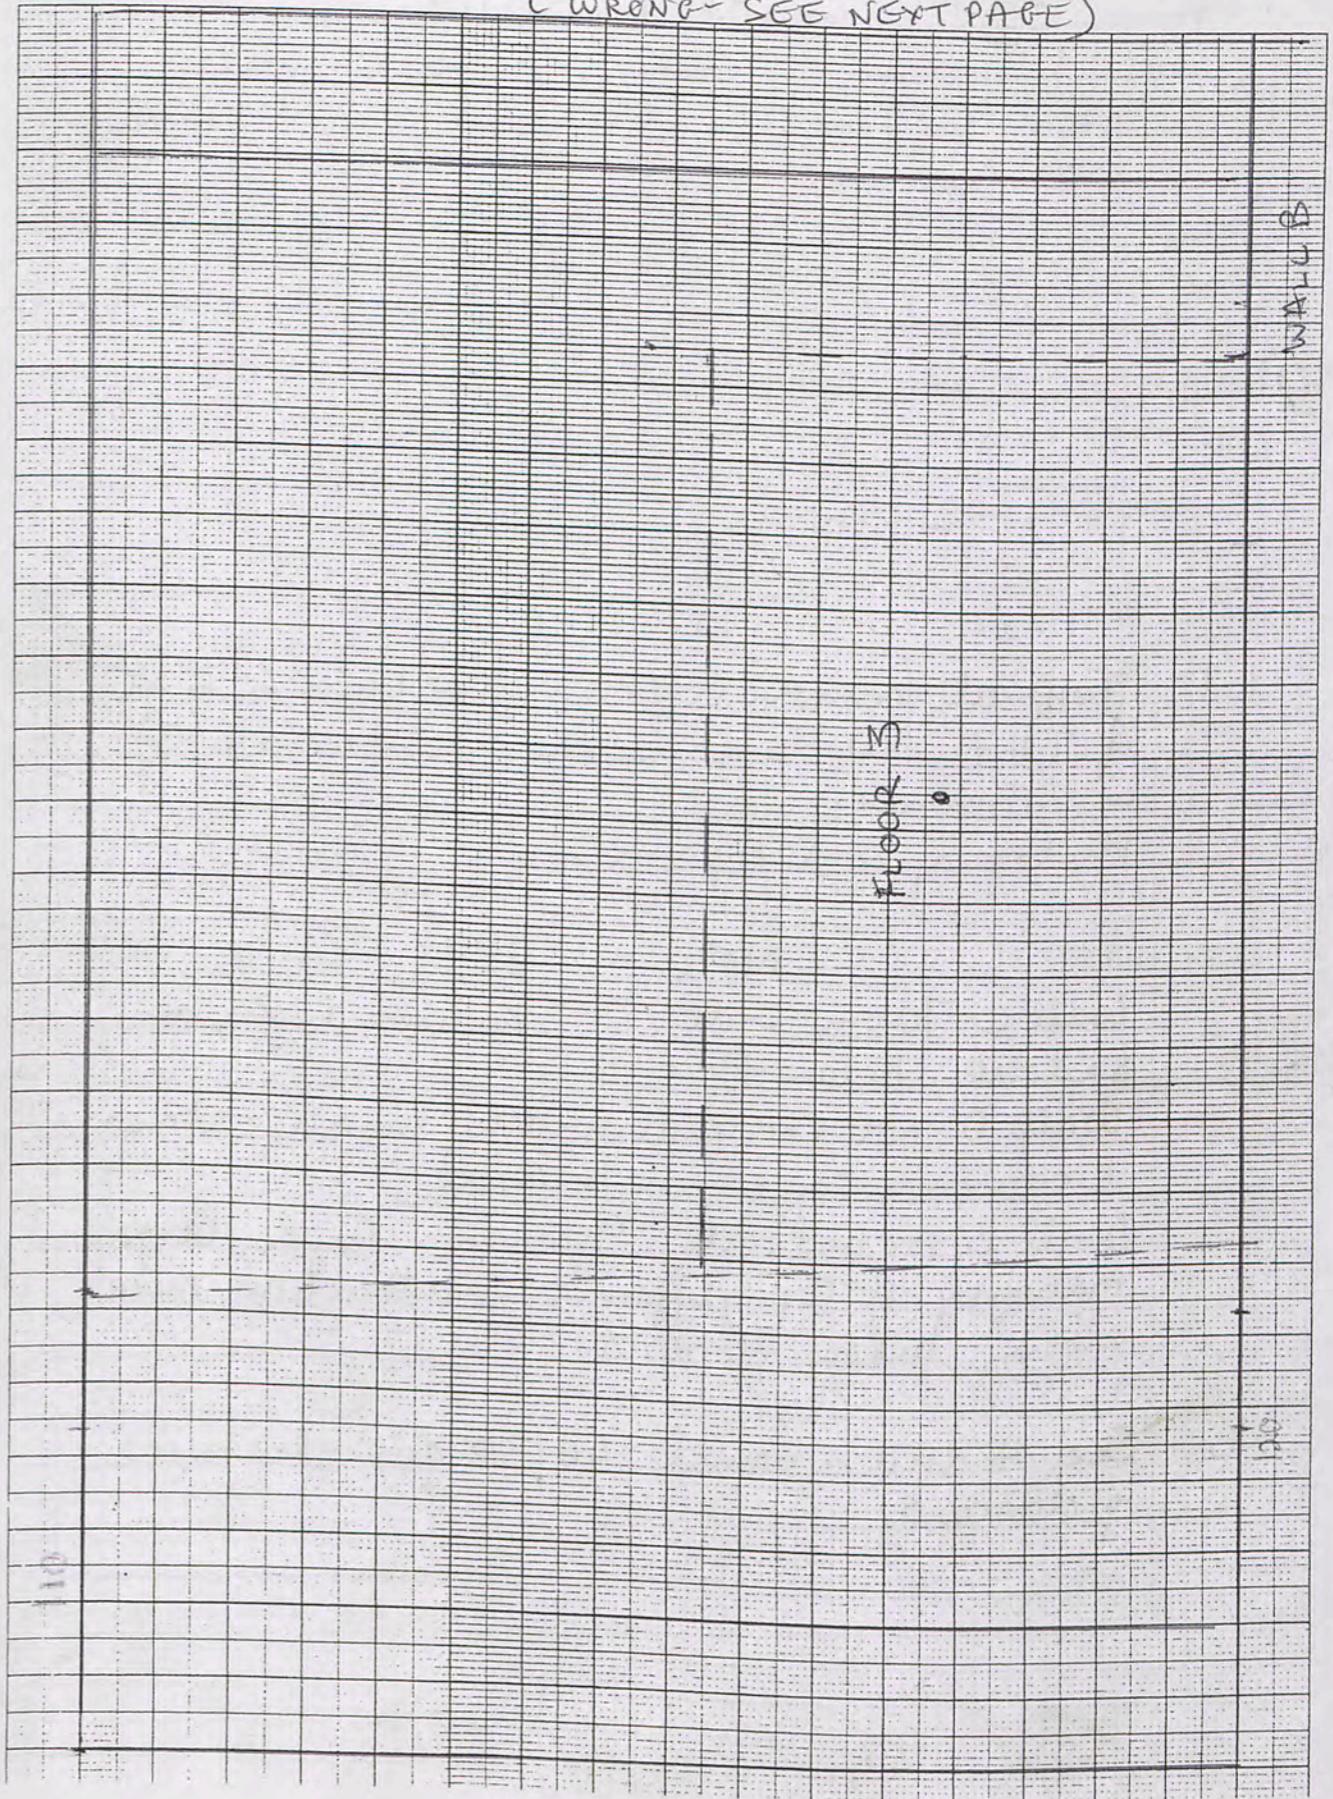
FINAL PLAN
(WRONG SEE NGXT PAGE)

LEVELS	BM 2	0.53.	46.275		
NE corner high		2.7551	43.765	Wall C top	3.79
Feature B floor		3.08	43.195	Wall D "	3.90
Stone at N		3.34	42.935	SW corner 9.1	3.93
Floor 3.		3.33	42.945	SE corner 8.2	4.50

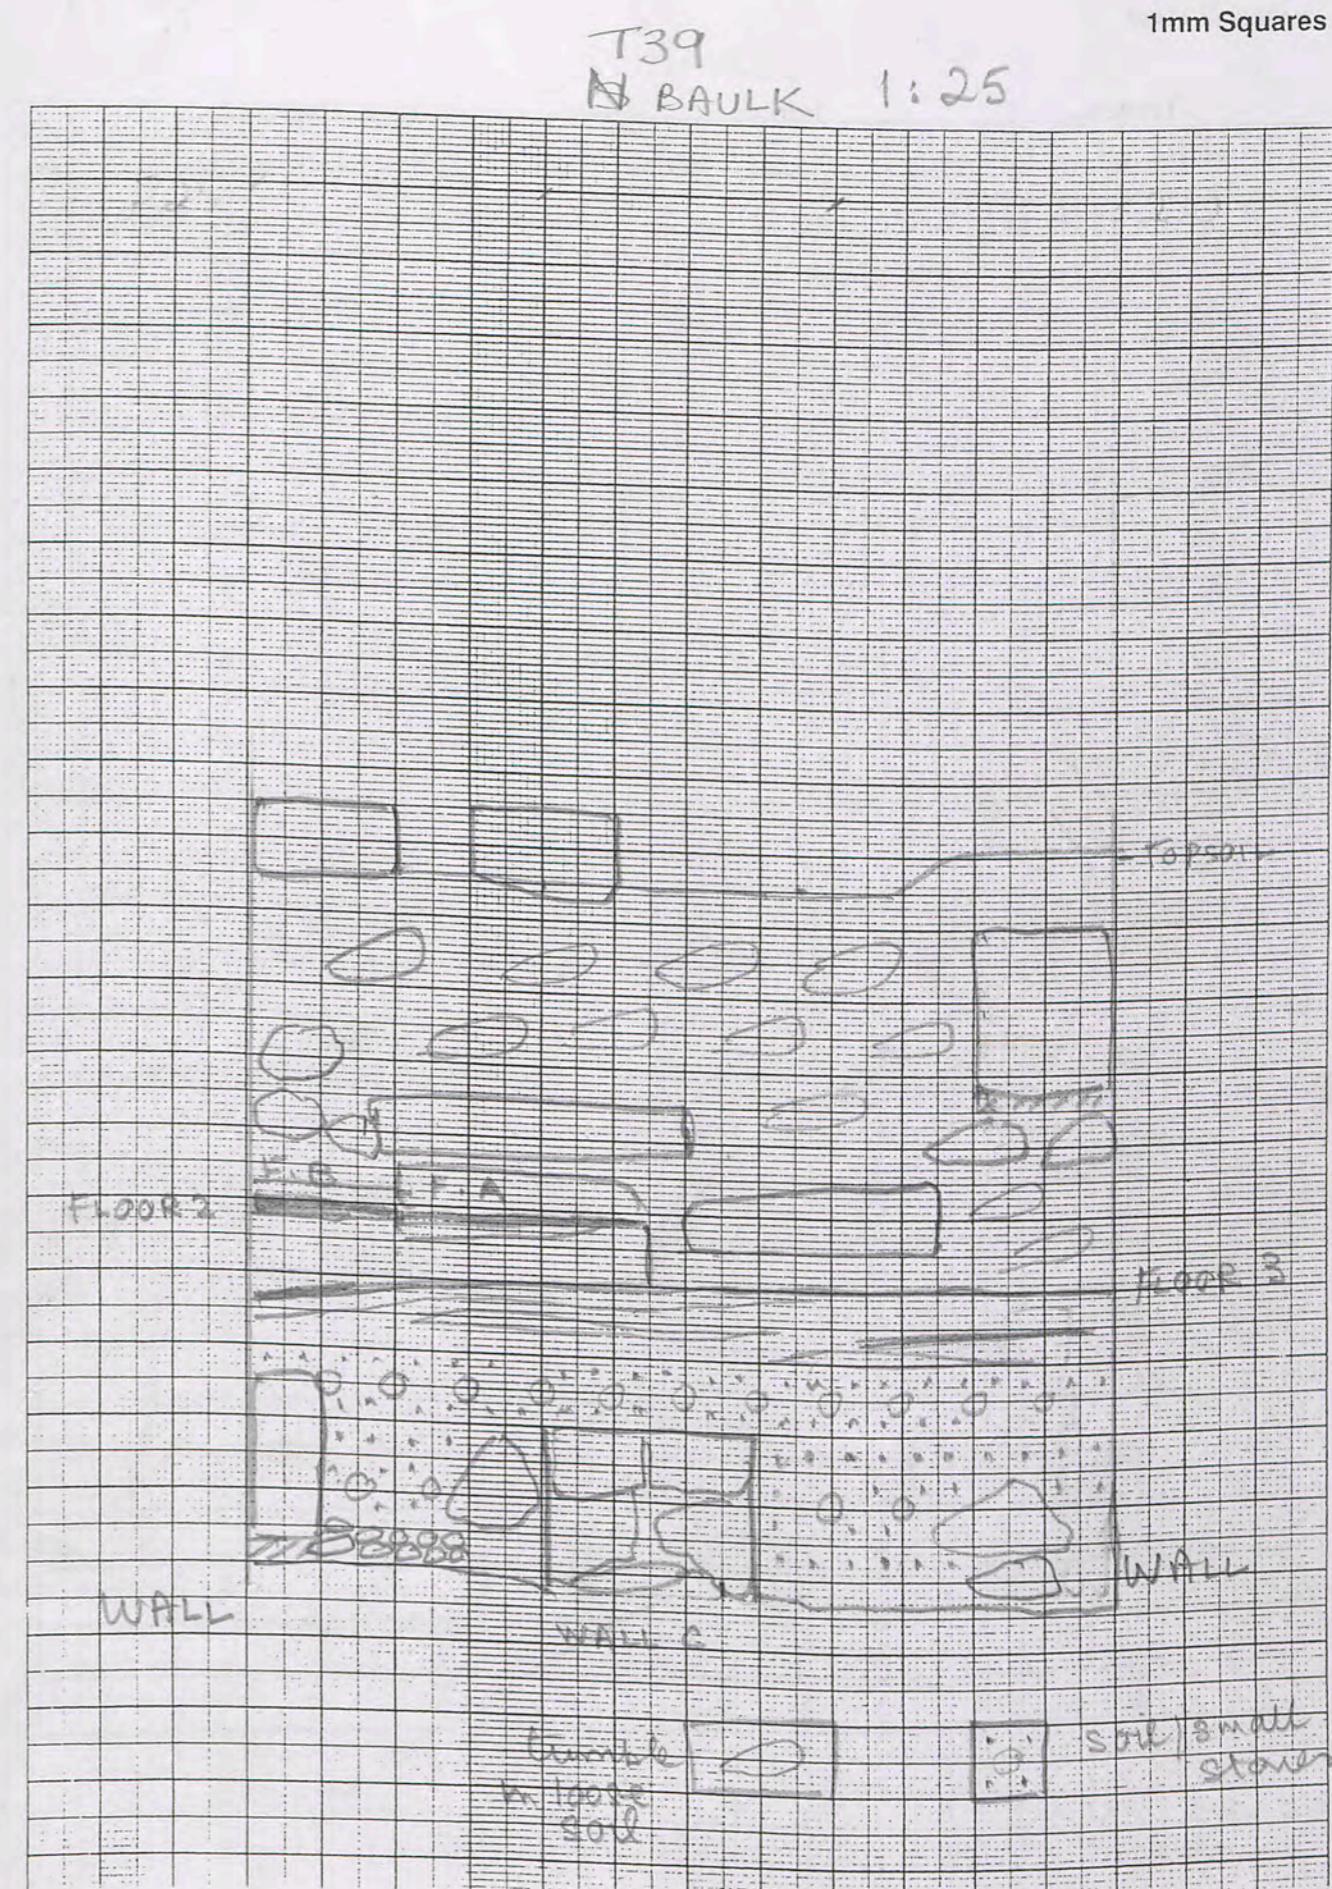
Context	Report
	8.2 125 E/W wall C 65 wide } 3m. 9.1 100 E/W
	Report on T39.
1.	There are at least three occupation levels Floor near bedrock, associated with walls C and D, and base of B
2	Higher floor 3 by 90-100 cm from bedrock 20-25 cm higher, possibly a build-up of some floor, a surface associated with Features A & B, i.e. very ashy areas, possibly decayed timbers. The latter represents the last phase of occupation of this floor
3	Very uneven floor surface under wall A. Perhaps squatter occupation after decay? = Floor 1.
	Tumble between all floors e.g. 2/2B. Most tumble above floor 3.

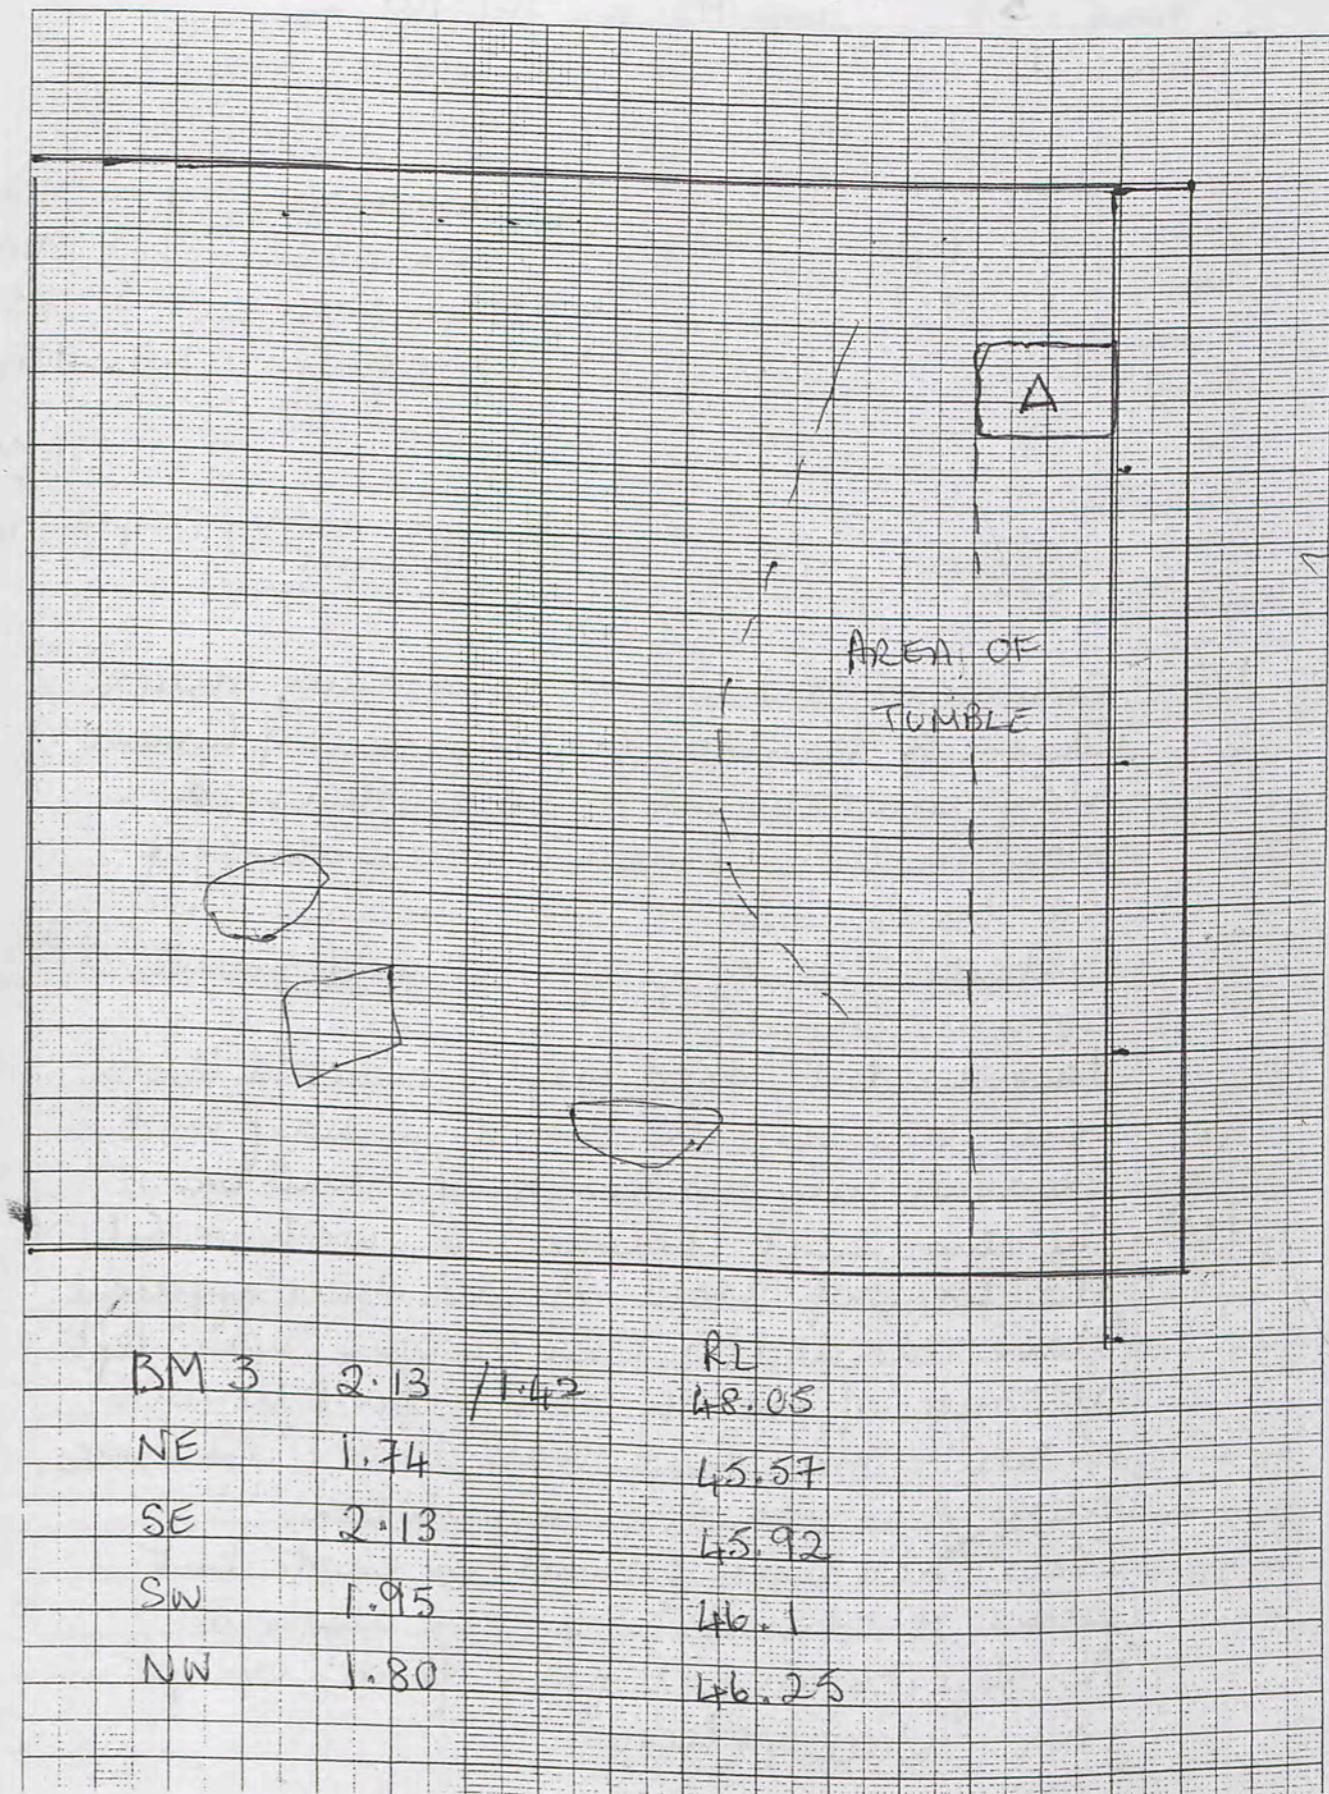
T 53. 17/5/10

AREA OF
TUMBLE

Context	Report
1.1	Still excavating topsoil, with appearance of tumble only in the south, along possible wall line but not looking regular. The purpose of this trench is to find the northern boundary of the supposed street Elw, with drain, found in T47 Cleared and photographed 1210.
1.2	Beginning excavation of spit below topsoil by removing all small stones. This is making clearer the possible wall line running west from benchmark stone A? Still no definite structure.

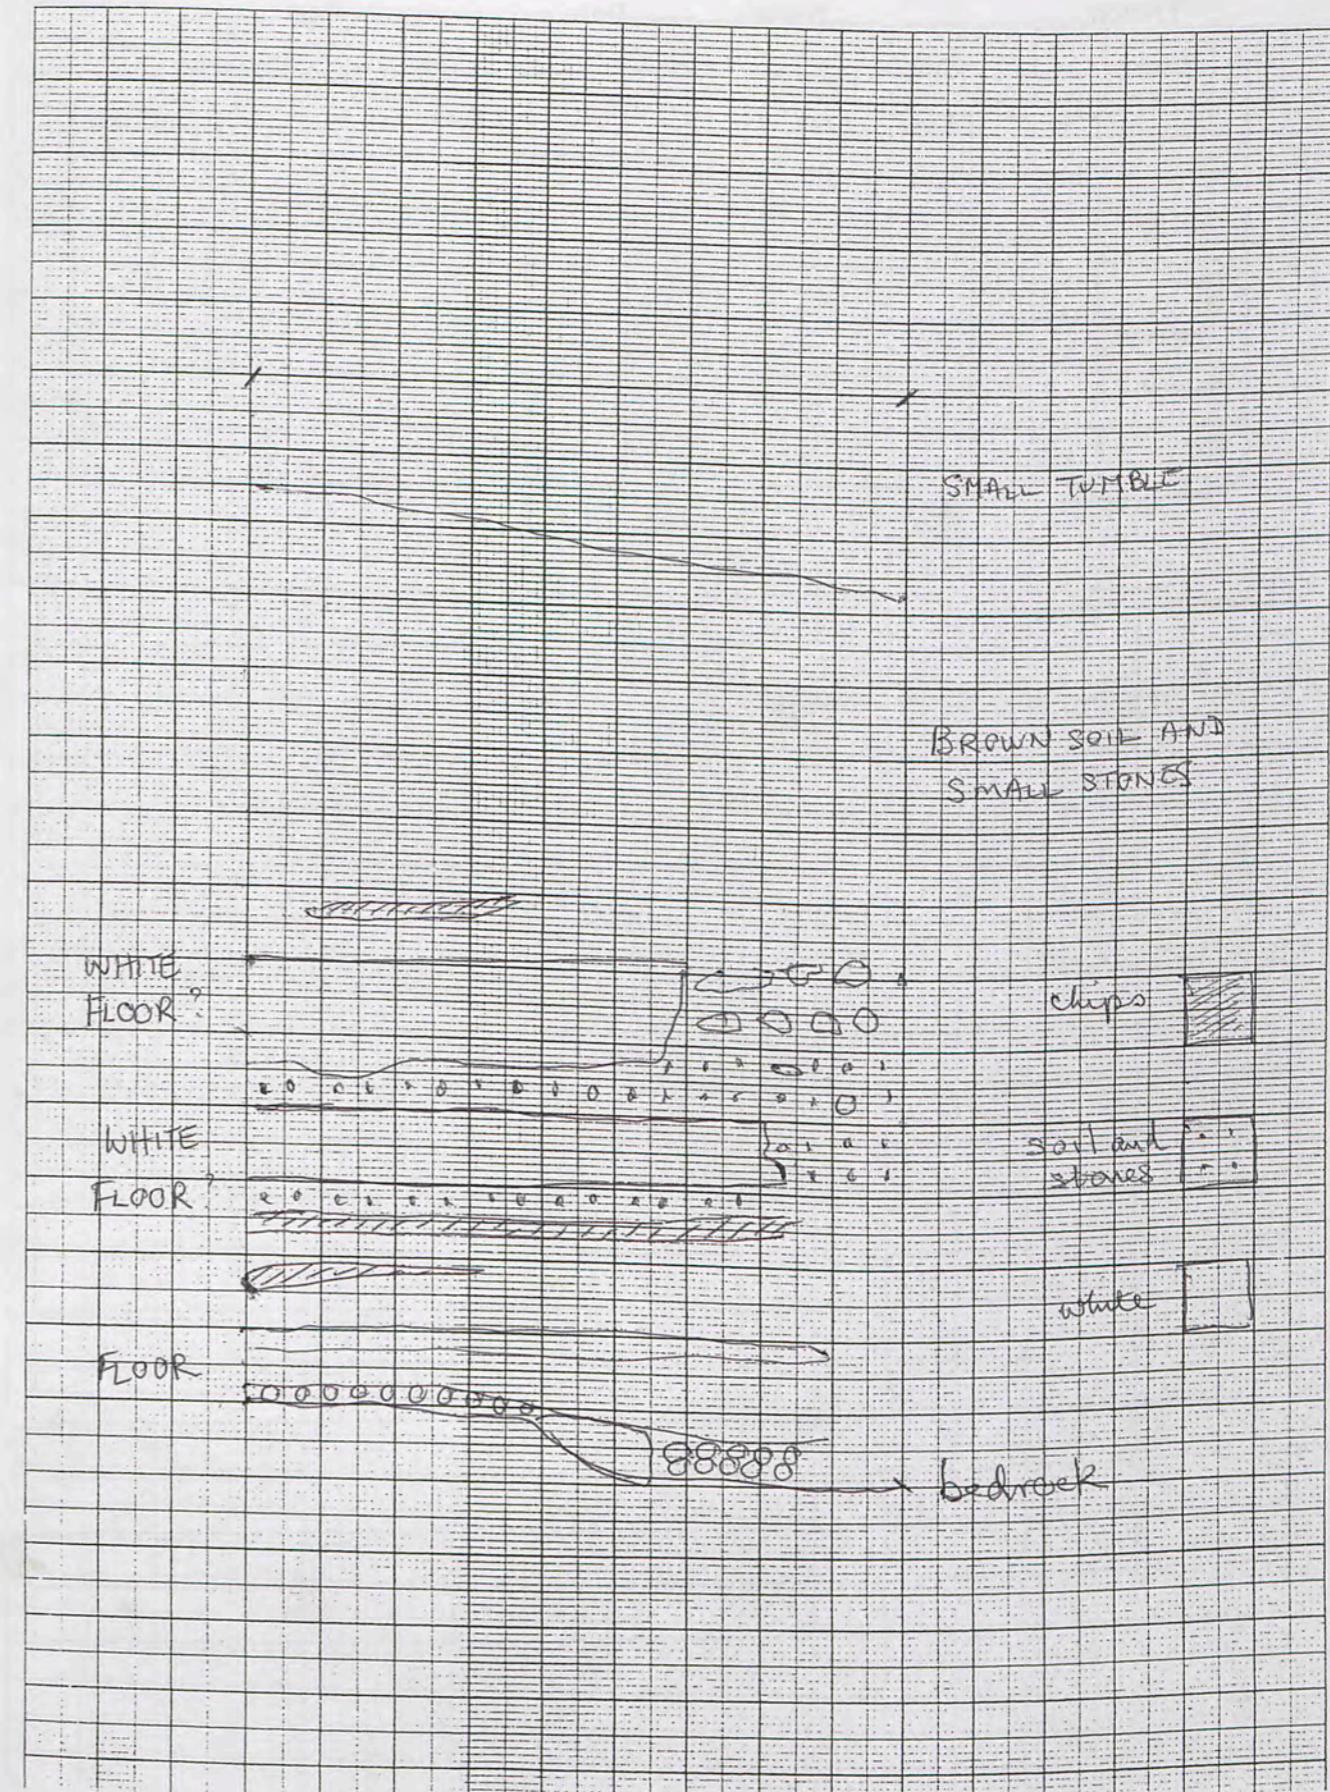
EAST BAULK

Context	Report
	No levels/spits as baulk has to be knocked down from above and all contexts are joined.
	20/5/10
	Continuing to clear spoil. Doorway now clear in SE corner - blocked, then built over. How does this relate to floors found in 2008? Must check previous records.
	Very clear stamped amphora handle - see below - from bottom of spoil.
	Photographed door 1548
	But what about base of N/S wall?

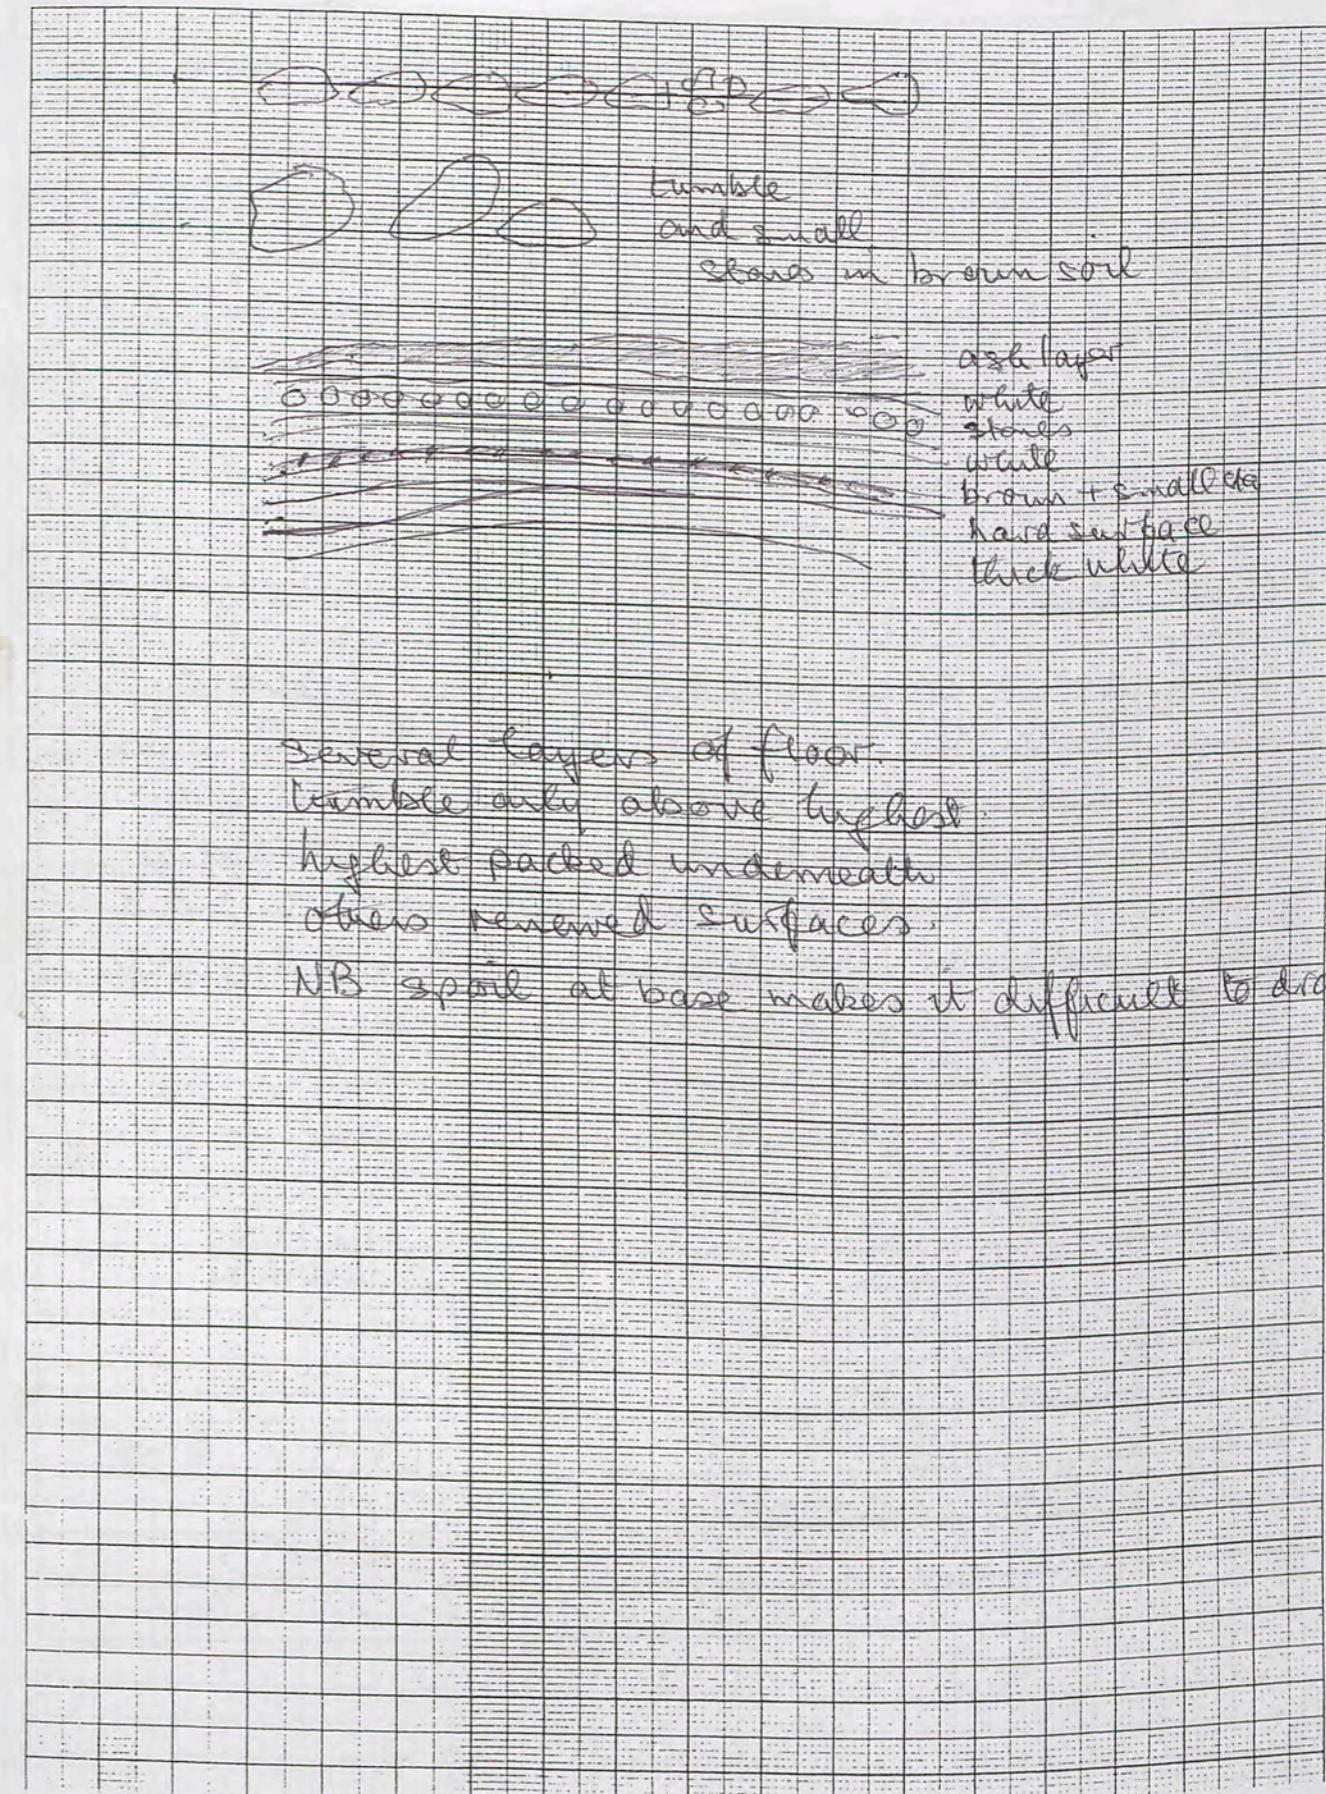
1 metre section

Context	Report
	Area 51 : East wall v well built ala Areas Door only under but north wall built through it Door north into 52 only accessible by step from lower floor as 52 floor on bedrock. Higher floor no step needed Area 50 E (domee) wall shonky - mere reinforcement
NW1 73	Wall across channel in SW corner - 2 layers
(a)	lower N/S wall set back and appears behind lower E/W wall (N wall of drainage channel so built first.)
(b)	Higher wall (set forward) of course is continuation of new wall N/S (house boundary) Conclusion: lower N/S wall definitely built first
61	Note door west has raised threshold sitting on soil. This raised when court yard level raised - suits top floor lower would be 25-30 cm lower

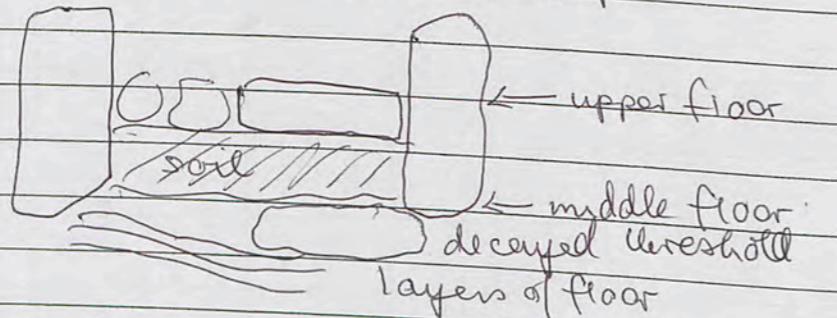
Context	Report
SE 4	Area 3 oven floor highest. Queen slightly below but could have sunk? = Floor 2 covers wall. Floor 3 doesn't cover wall
SW 34	Lower= bedrock. Upper level with door N
42	Door stones' base at middle floor which did not cover N wall and came to mid-top step. Upper floor covered wall & steps.
